Climate Change and Glen Falloch (4) â?? hydro failures and their impact

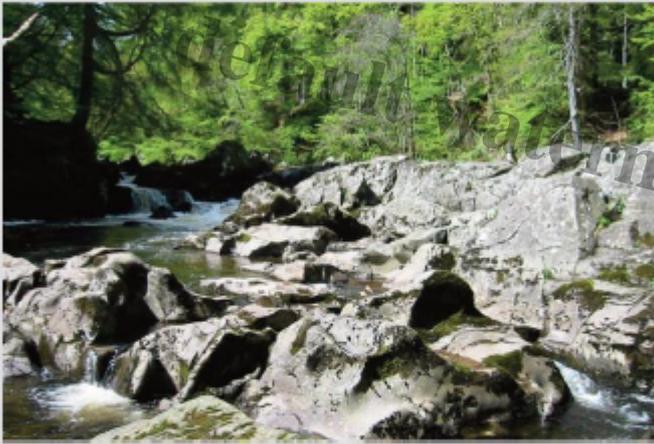
Figure 32 A Bedrock river

Natural features such as bedrock lined channels / pools are common in high energy upland areas (see figure 32 above). As these environments are very stable and not prone to erosion then little or no erosion protection may be necessary. These features can be chosen as an appropriate location for an outfall to reduce the need for erosion protection.
