Climate Change and Glen Falloch (4) – hydro failures and their impact

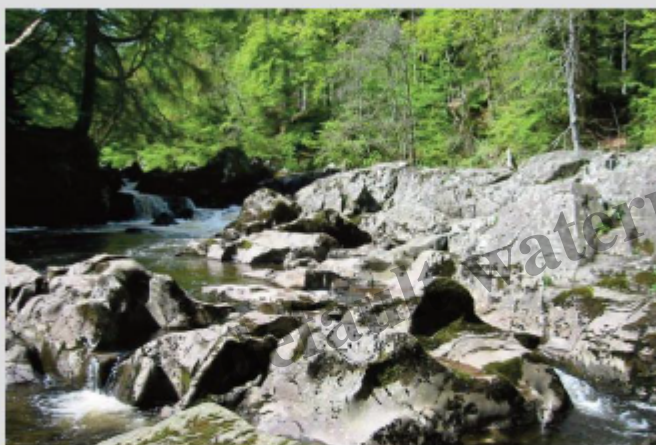
Figure 32 A Bedrock river

Natural features such as bedrock lined channels / pools are common in high energy upland areas (see figure 32 above). As these environments are very stable and not prone to erosion then little or no erosion protection may be necessary. These features can be chosen as an appropriate location for an outfall to reduce the need for erosion protection.
