The Gynack flood diversion channel above Kingussie – at what environmental and financial cost?

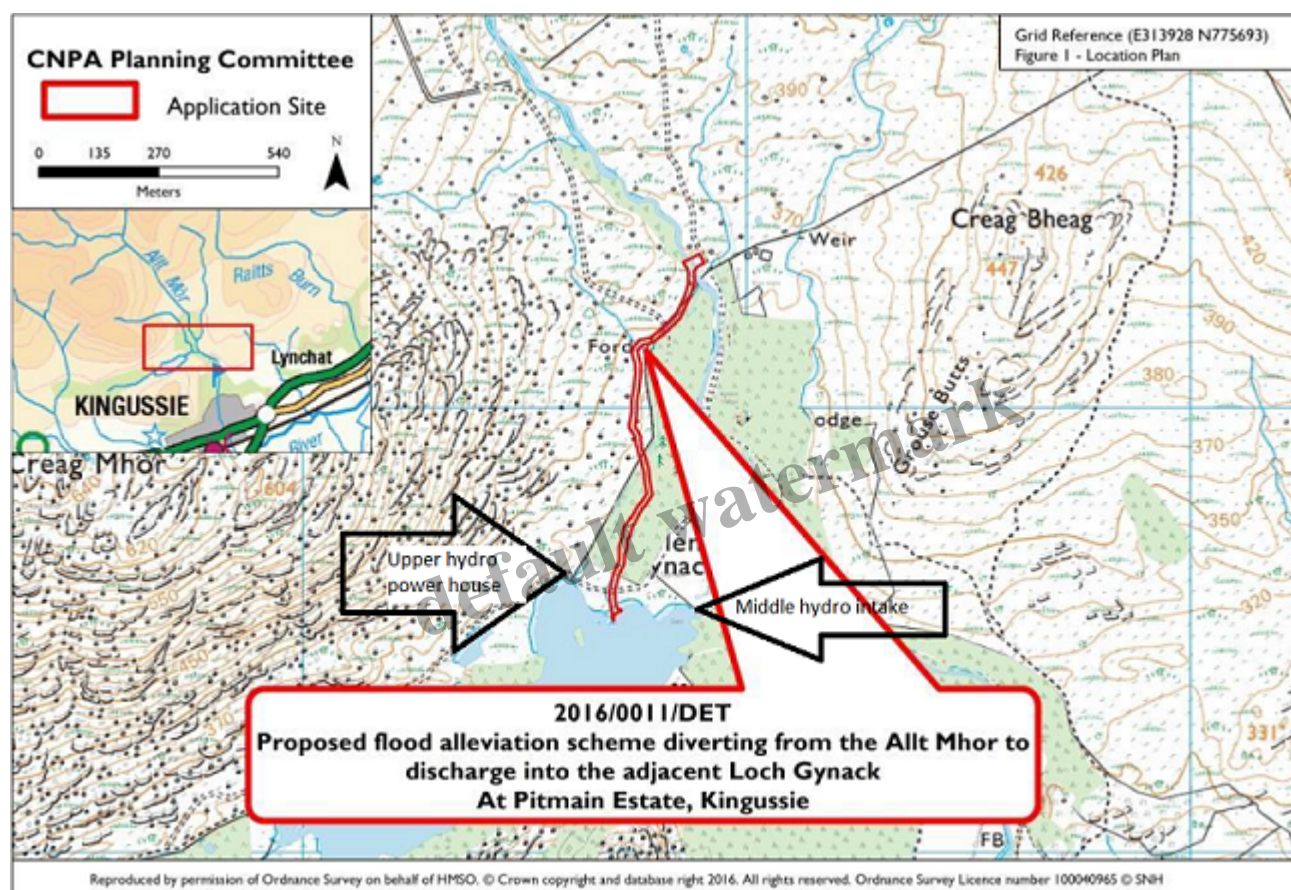
The Gynack overflow channel has been blocked off to prevent it eroding further so that now it will only function in the highest floods October 2019.

all in poor weather (as is evident from the photos!). On my most recent visit I found that the overflow had been effectively closed off (see above) and had ceased functioning. The Cairngorms National Park Authority then kindly confirmed that they had been in discussion with the landowner's agent – who appear to be Savill's – and Highland Council to resolve the issues. According to the CNPA these are partly due to the channel not being constructed as per the planning consent but are also due to more fundamental design issues. This post shows that, as a example of river engineering in our National Parks, its just as disastrous as the Glen Falloch hydro schemes ([see here](#)) and its time we started to learn from these failures.

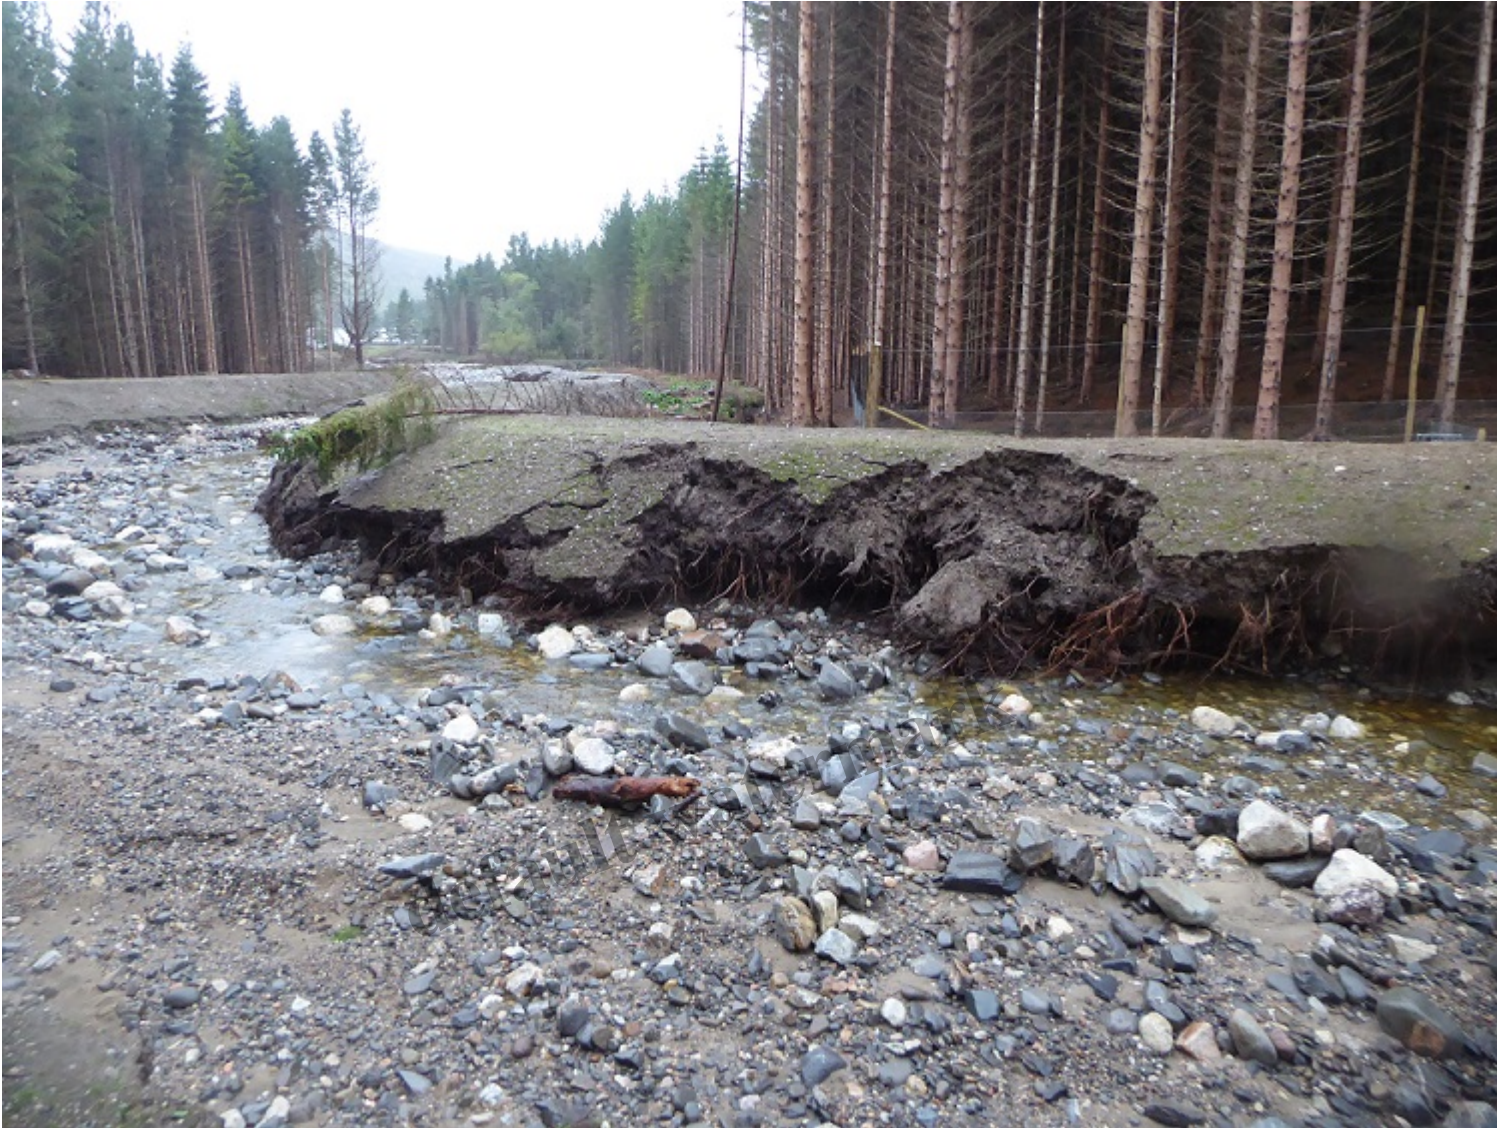
Six months later, when I next visited, the possible consequences were even more obvious. What engineer thought that these earth banks could withstand a river in spate? Why was water allowed to run through the channel before they had had any chance to vegetate? Even if that had been allowed to happen, earth banks such as this would have been highly vulnerable to high water flows, but without vegetation and without any protective matting, the consequences of allowing water to run through the channel should have been obvious. So why the CNPA allow this to happen?

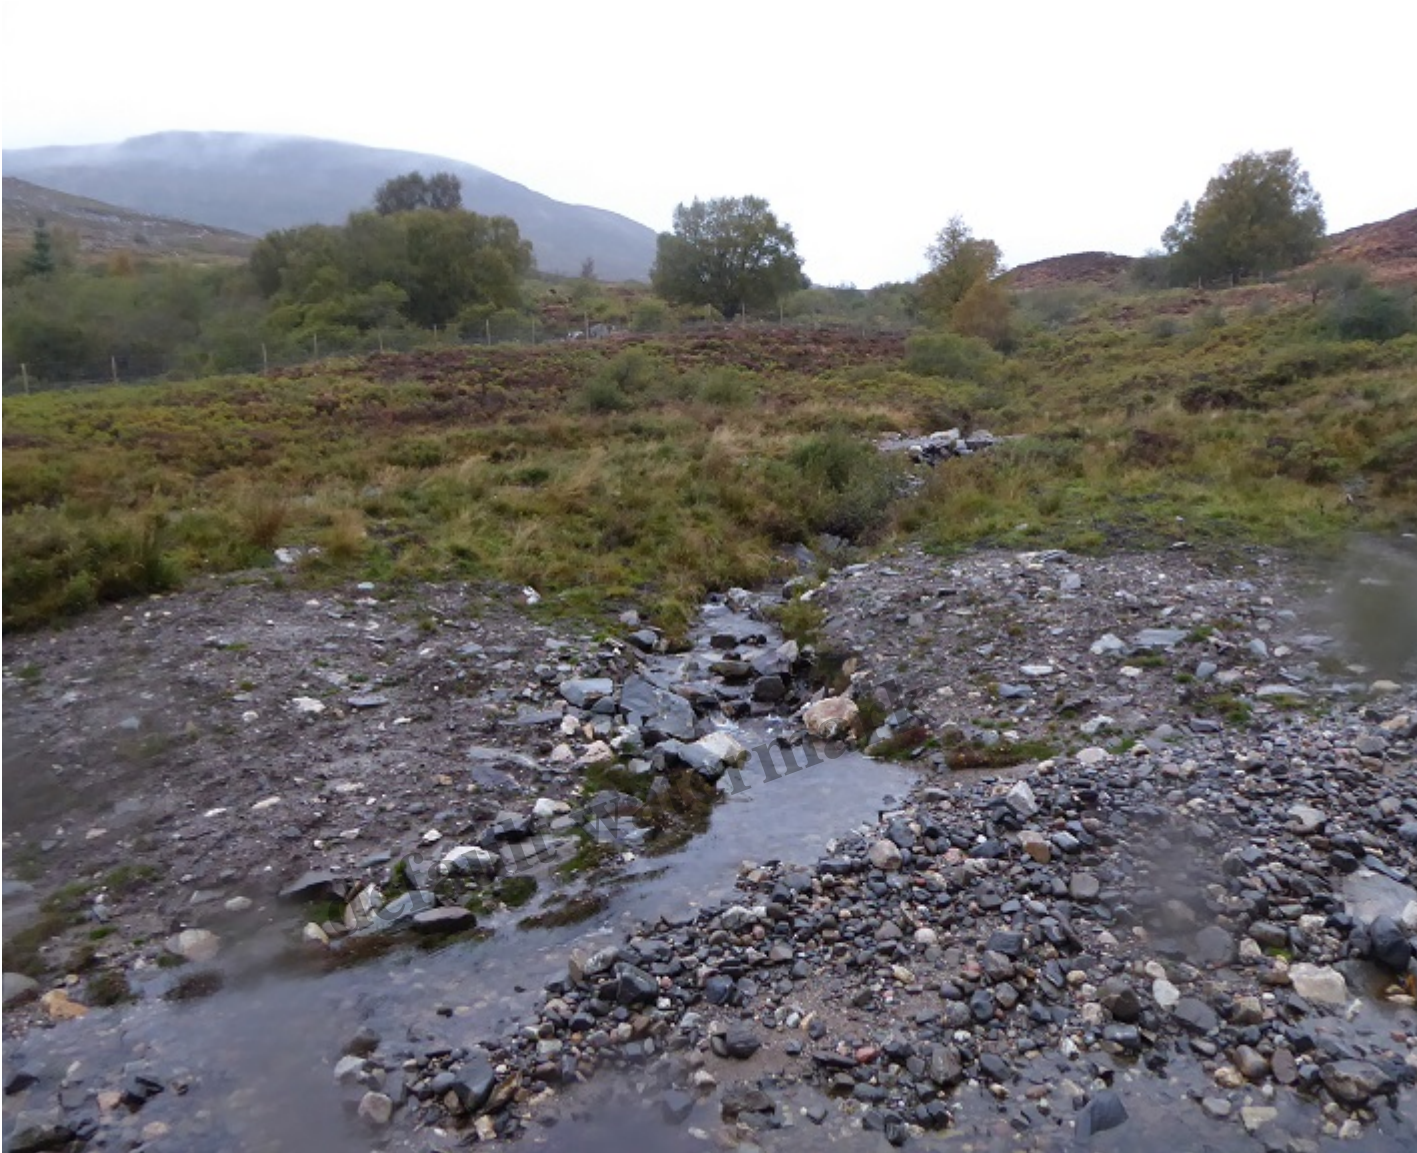
Confluence of overflow with tributary burn feeding into it below the intake
