The Gynack flood diversion channel above Kingussie â?? at what environmental and financial cost?

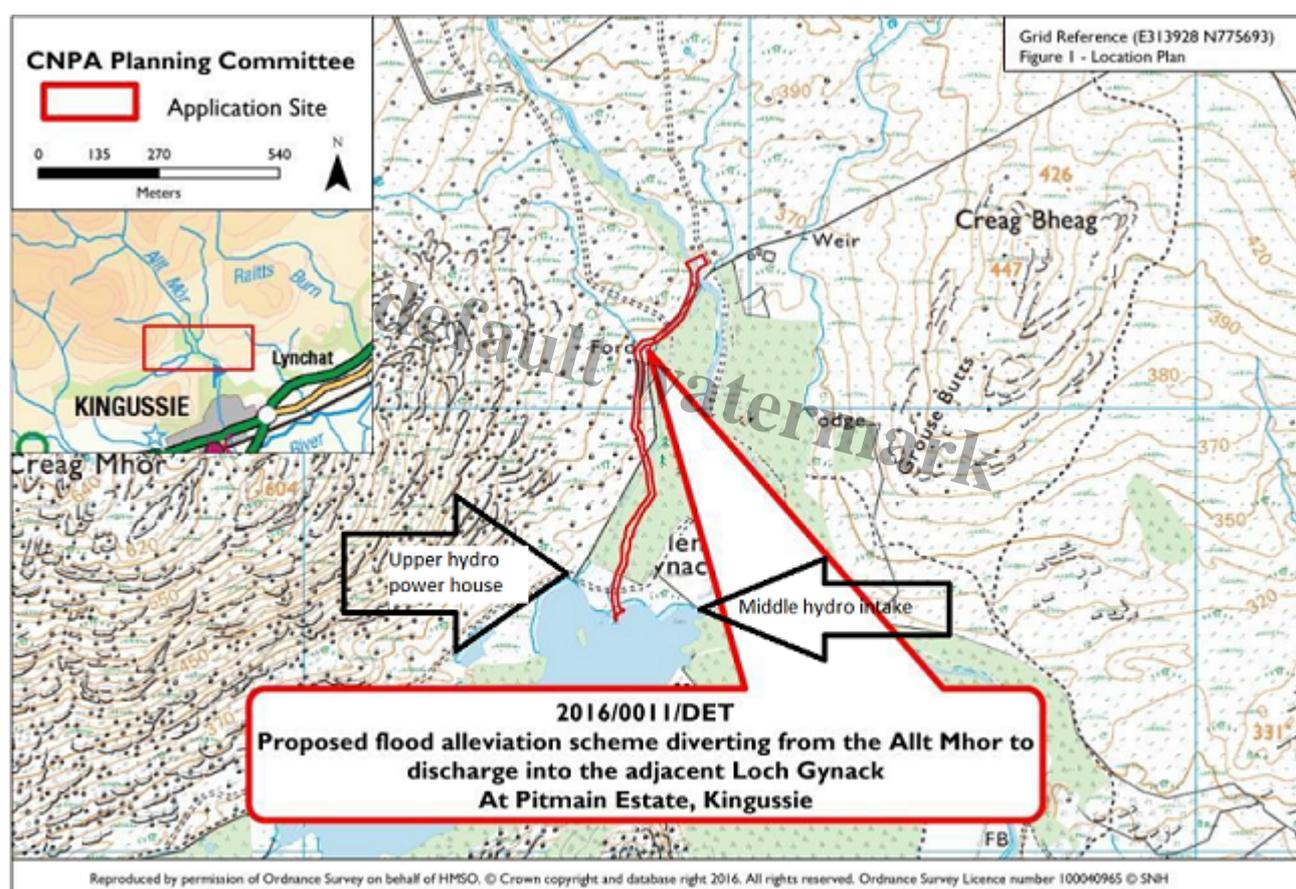
The Gynack overflow channel has been blocked off to prevent it eroding further so that now it will only function in the highest floods October 2019.

all in poor weather (as is evident from the photos!). On my most recent visit I found that the overflow had been effectively closed off (see above) and had ceased functioning. The Cairngorms National Park Authority then kindly confirmed that they had been in discussion with the landowner's agent who appear to be Savill's and Highland Council to resolve the issues. According to the CNPA these are partly due to the channel not being constructed as per the planning consent but are also due to more fundamental design issues. This post shows that, as a example of river engineering in our National Parks, its just as disastrous as the Glen Falloch hydro schemes ([see here](#)) and its time we started to learn from these failures.

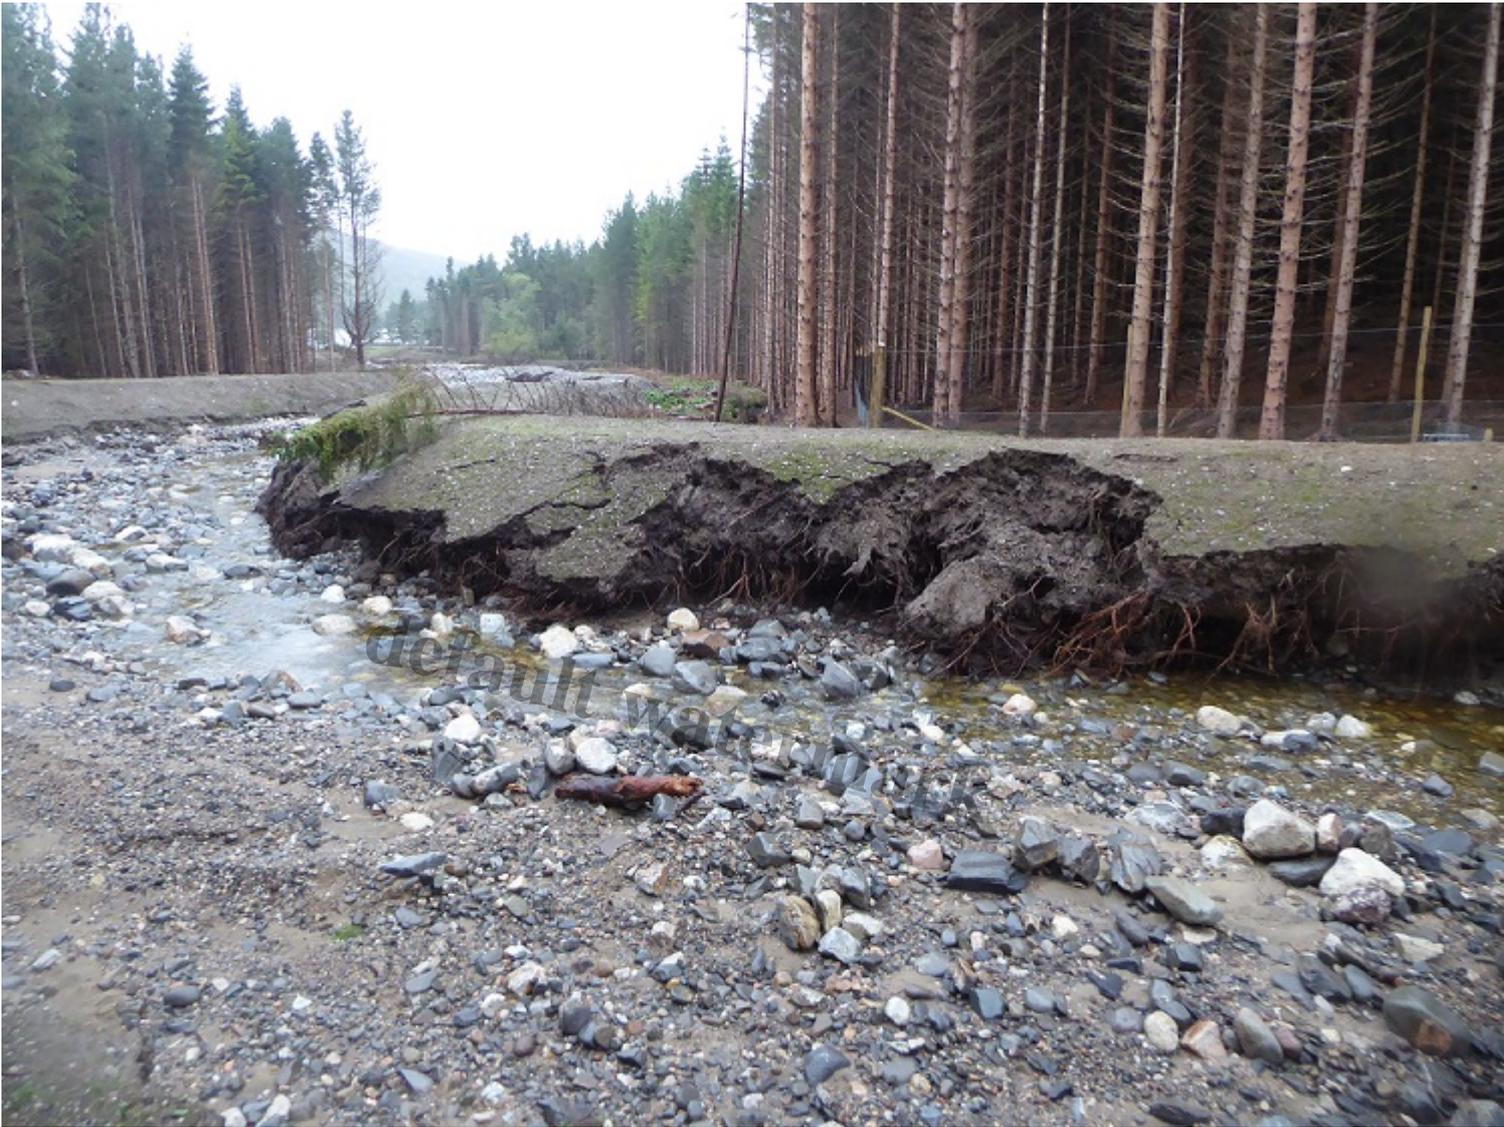
Six months later, when I next visited, the possible consequences were even more obvious. What engineer thought that these earth banks could withstand a river in spate? Why was water allowed to run through the channel before they had had any chance to vegetate? Even if that had been allowed to happen, earth banks such as this would have been highly vulnerable to high water flows, but without vegetation and without any protective matting, the consequences of allowing water to run through the channel should have been obvious. So why the CNPA allow this to happen?

What is clear, however, is that somewhere along the line there has been a failure in planning. Had the channel not been constructed through a forest plantation and had it not been for the tree roots which permeated the based over which the raised bank had been constructed, its likely that whole sections of bank might have been swept away.
