The Gynack flood diversion channel above Kingussie – at what environmental and financial cost?

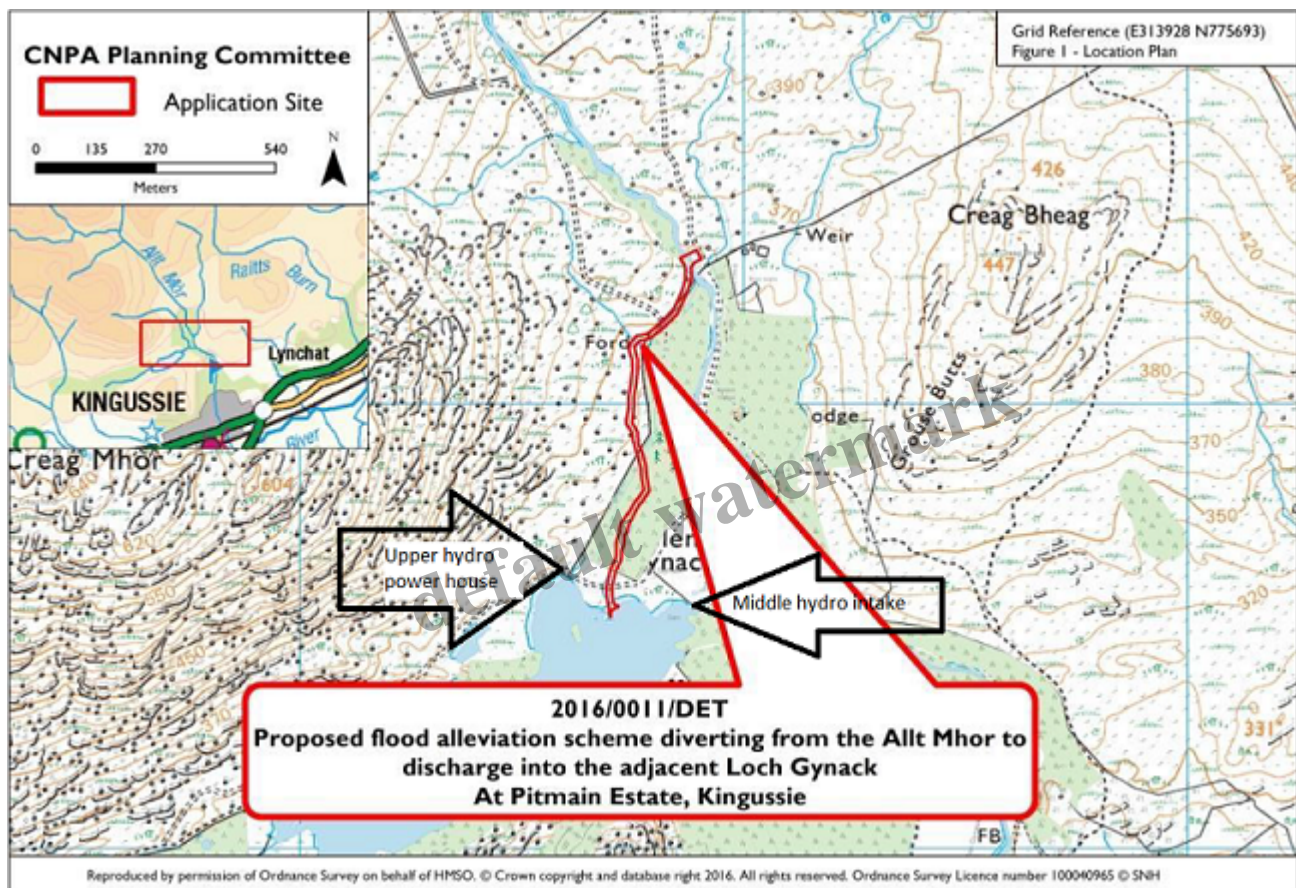
The Gynack overflow channel has been blocked off to prevent it eroding further so that now it will only function in the highest floods October 2019.

all in poor weather (as is evident from the photos!). On my most recent visit I found that the overflow had been effectively closed off (see above) and had ceased functioning. The Cairngorms National Park Authority then kindly confirmed that they had been in discussion with the landowner's agent – who appear to be Savill's – and Highland Council to resolve the issues. According to the CNPA these are partly due to the channel not being constructed as per the planning consent but are also due to more fundamental design issues. This post shows that, as an example of river engineering in our National Parks, it's just as disastrous as the Glen Falloch hydro schemes ([see here](#)) and it's time we started to learn from these failures.
