The Gynack flood diversion channel above Kingussie – at what environmental and financial cost?

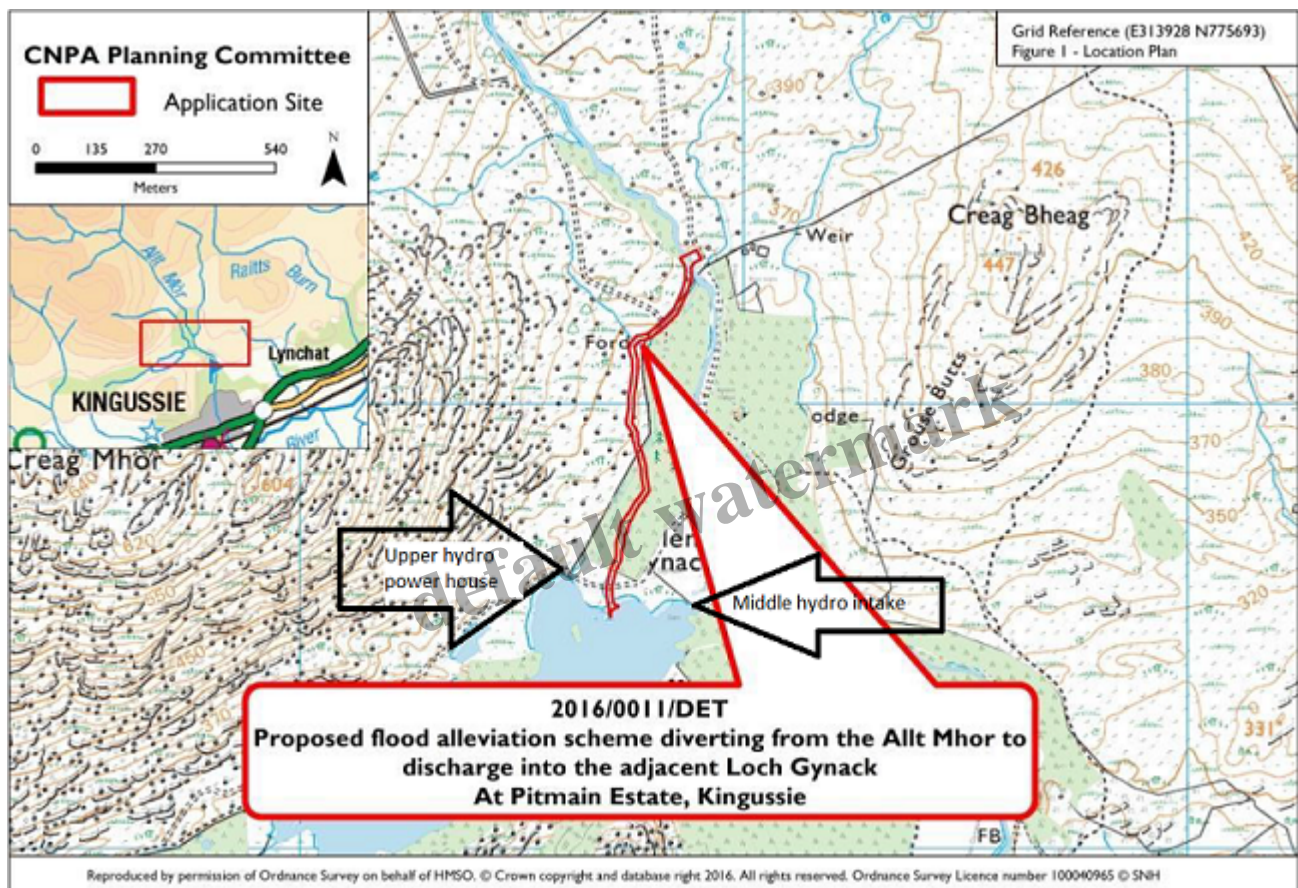
The Gynack overflow channel has been blocked off to prevent it eroding further so that now it will only function in the highest floods October 2019.

all in poor weather (as is evident from the photos!). On my most recent visit I found that the overflow had been effectively closed off (see above) and had ceased functioning. The Cairngorms National Park Authority then kindly confirmed that they had been in discussion with the landowner's agent – who appear to be Savill's – and Highland Council to resolve the issues. According to the CNPA these are partly due to the channel not being constructed as per the planning consent but are also due to more fundamental design issues. This post shows that, as an example of river engineering in our National Parks, it's just as disastrous as the Glen Falloch hydro schemes ([see here](#)) and it's time we started to learn from these failures.

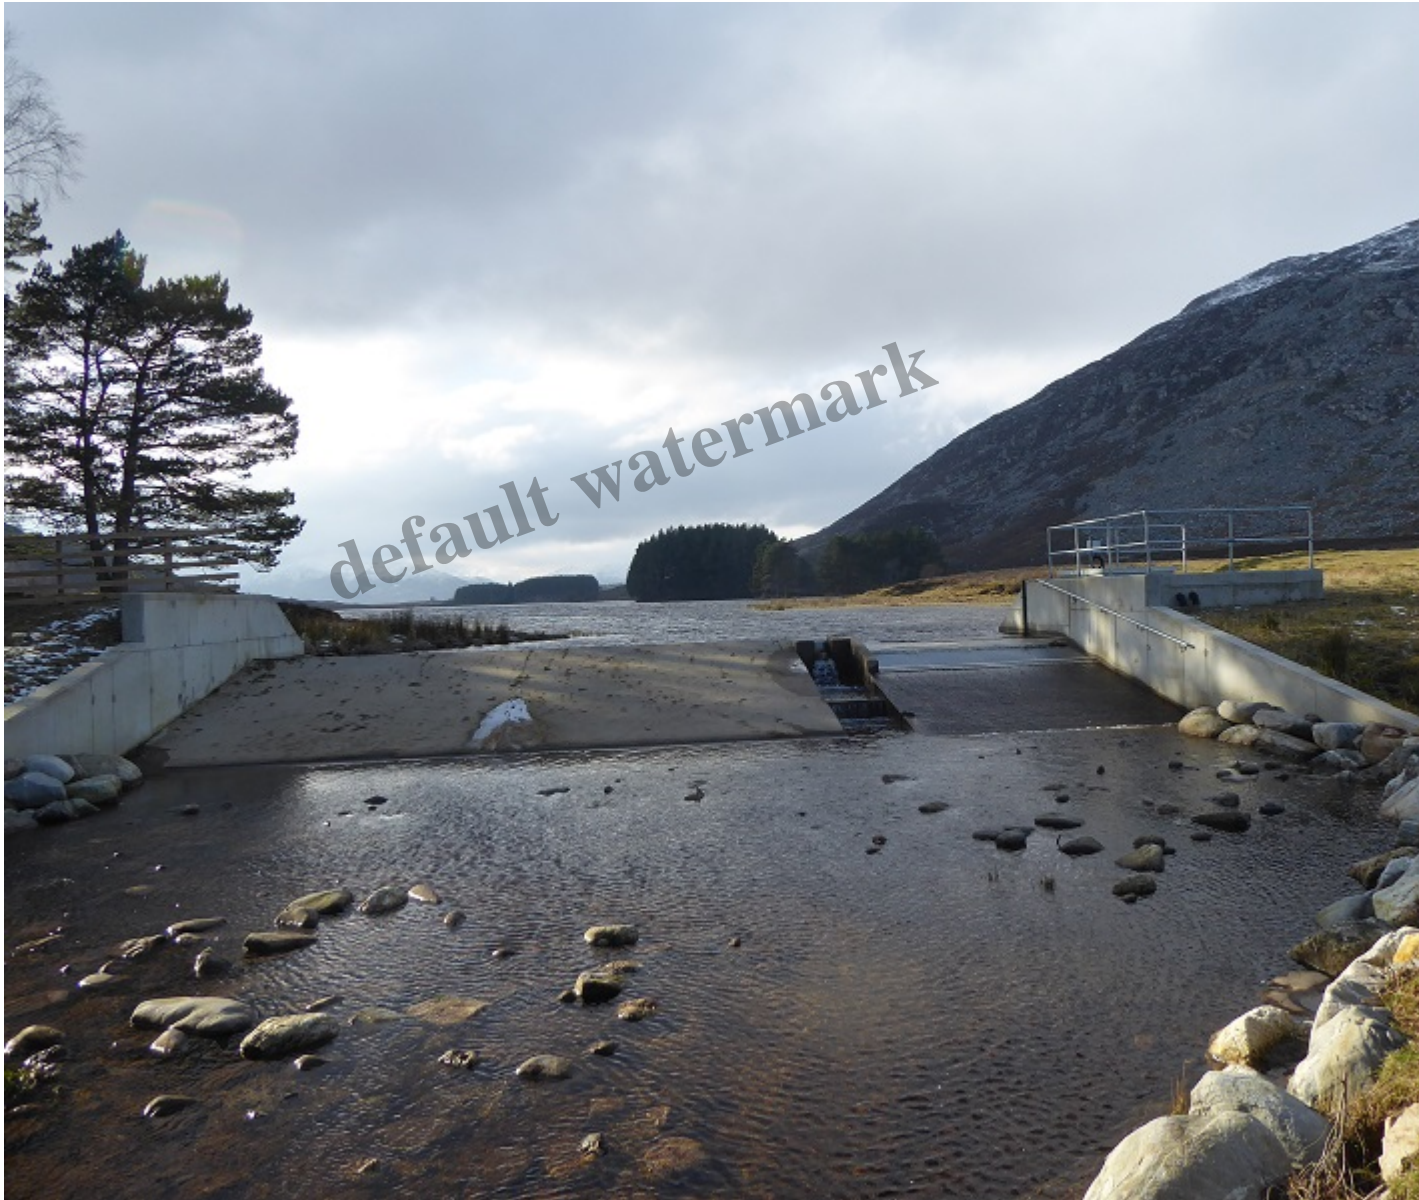
The hydro intake at the outflow of Loch Gynack which abstracts much of the water flowing out of the
