The Gynack flood diversion channel above Kingussie – at what environmental and financial cost?

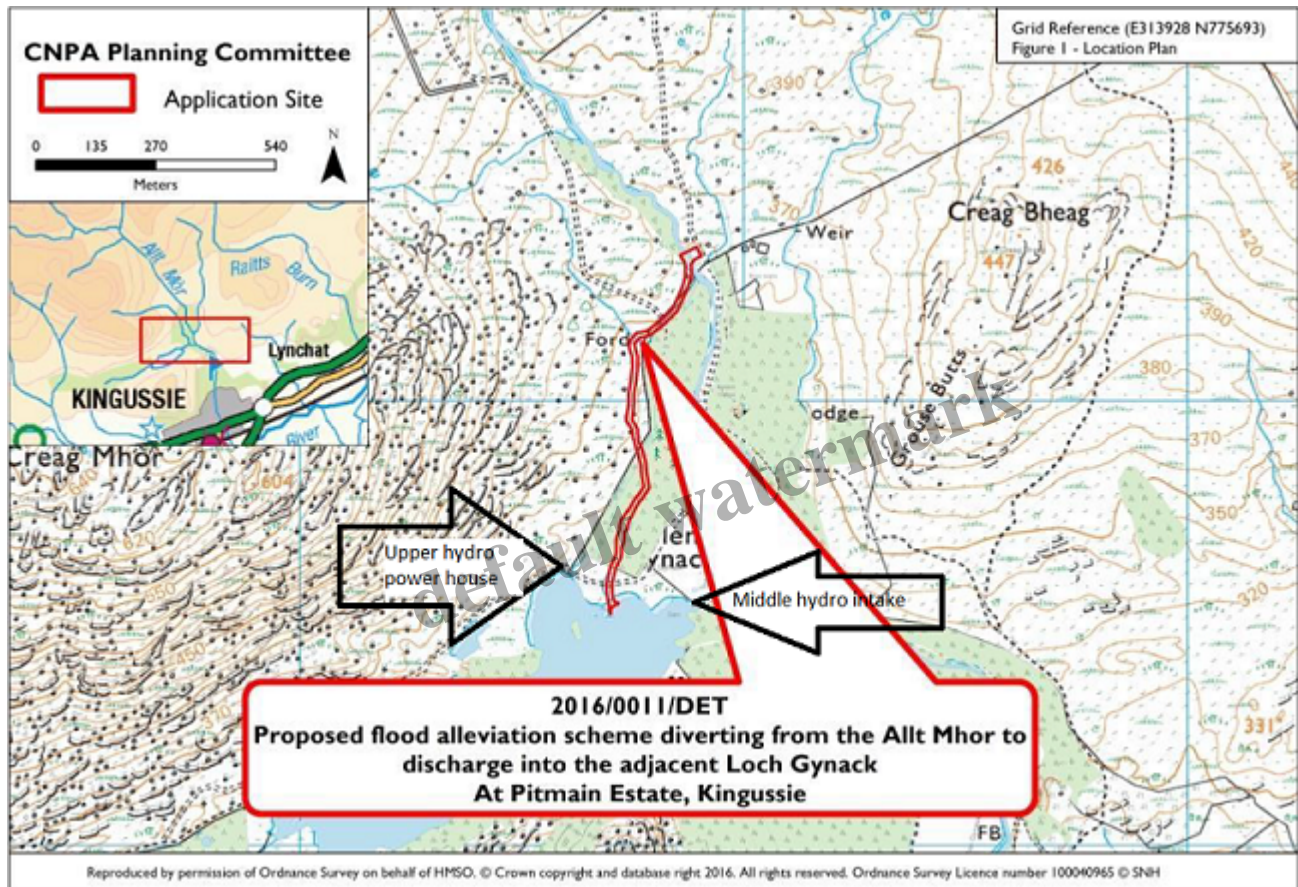
The Gynack overflow channel has been blocked off to prevent it eroding further so that now it will only function in the highest floods October 2019.

all in poor weather (as is evident from the photos!). On my most recent visit I found that the overflow had been effectively closed off (see above) and had ceased functioning. The Cairngorms National Park Authority then kindly confirmed that they had been in discussion with the landowner's agent – who appear to be Savill's – and Highland Council to resolve the issues. According to the CNPA these are partly due to the channel not being constructed as per the planning consent but are also due to more fundamental design issues. This post shows that, as an example of river engineering in our National Parks, it's just as disastrous as the Glen Falloch hydro schemes ([see here](#)) and it's time we started to learn from these failures.

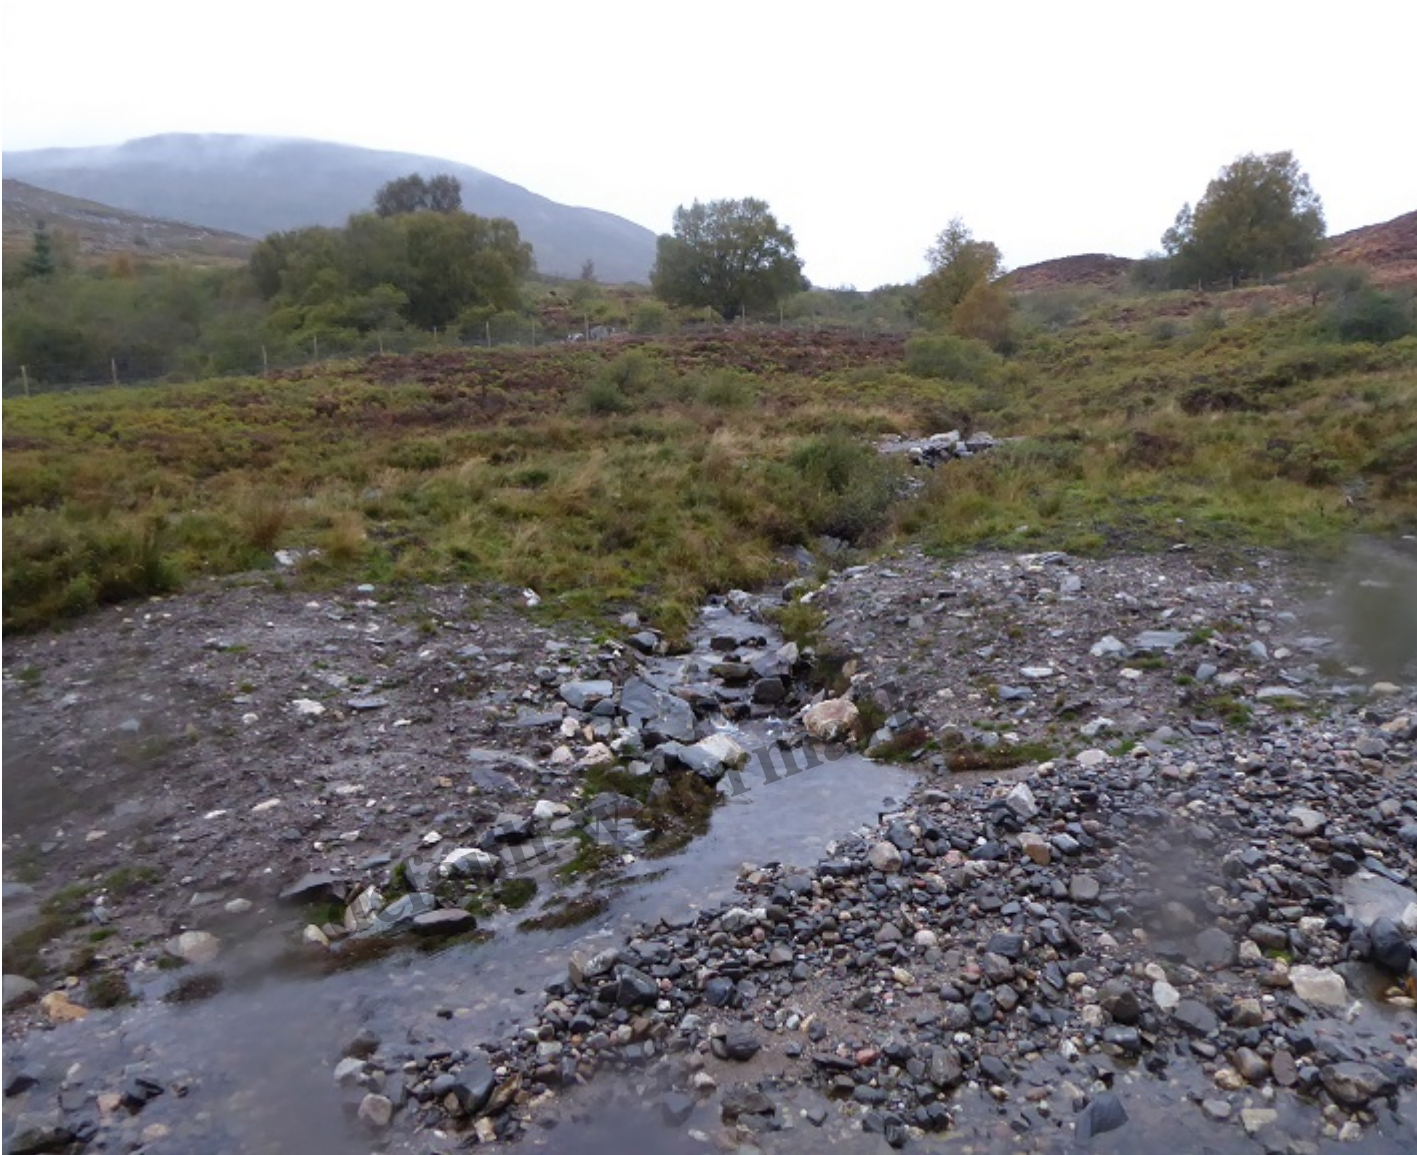
Confluence of overflow with tributary burn feeding into it below the intake
