## More National Park hydro planning failures â?? Ballimore and Glen Ample

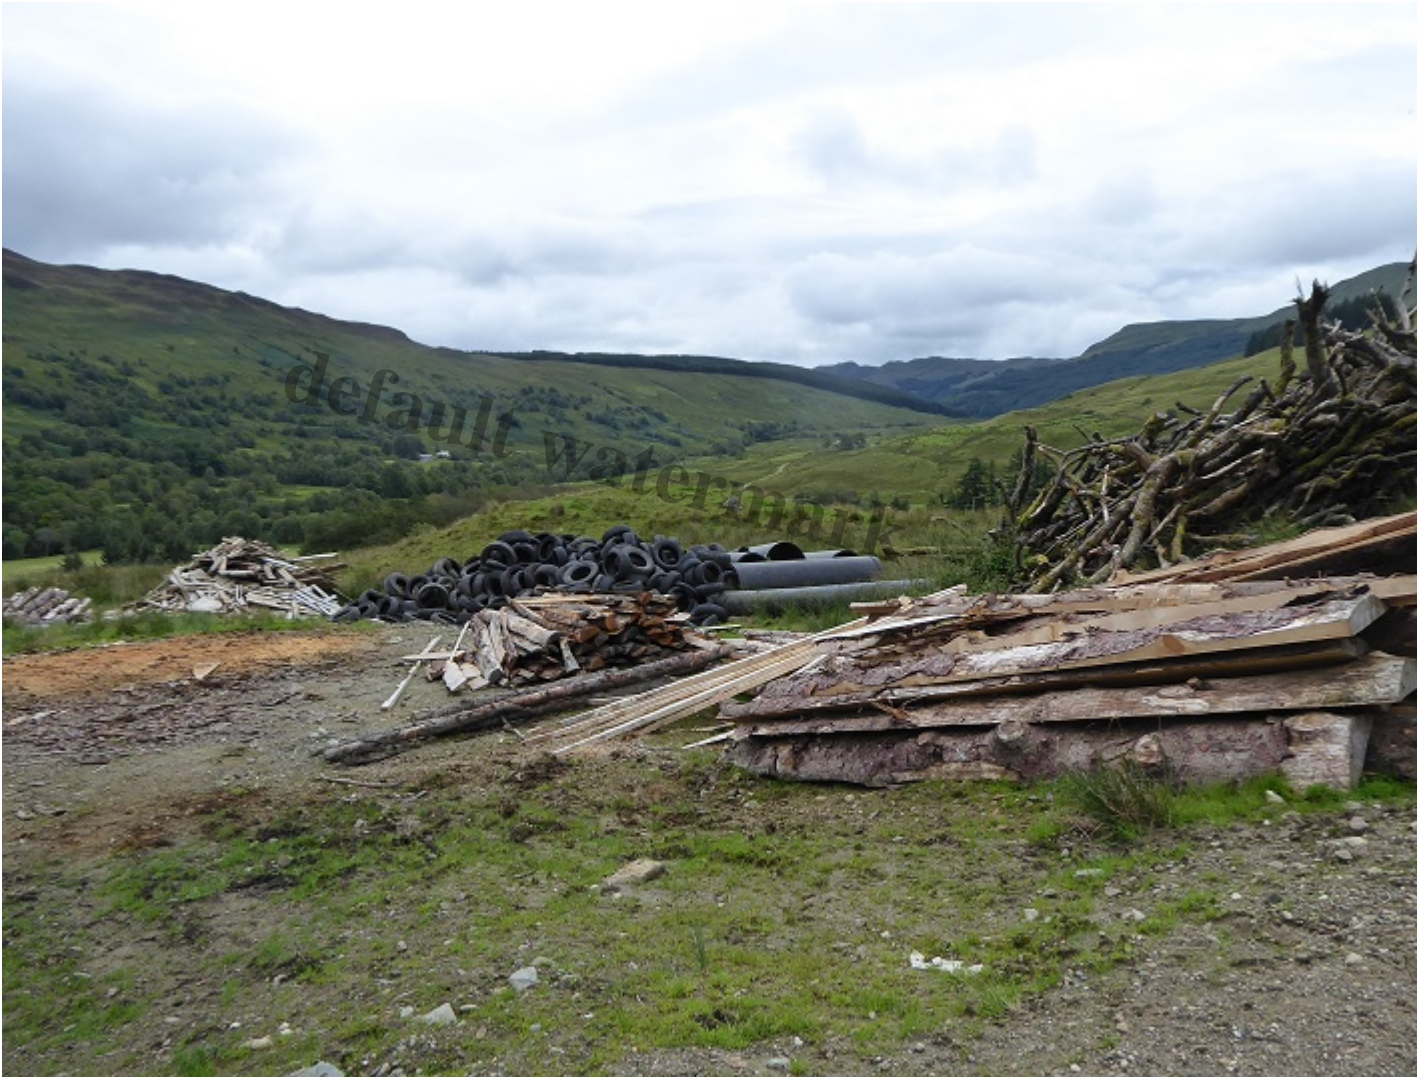
Looking up towards the head of Glen Buckie from a track north of Ballimore Farm. Note the pipes.

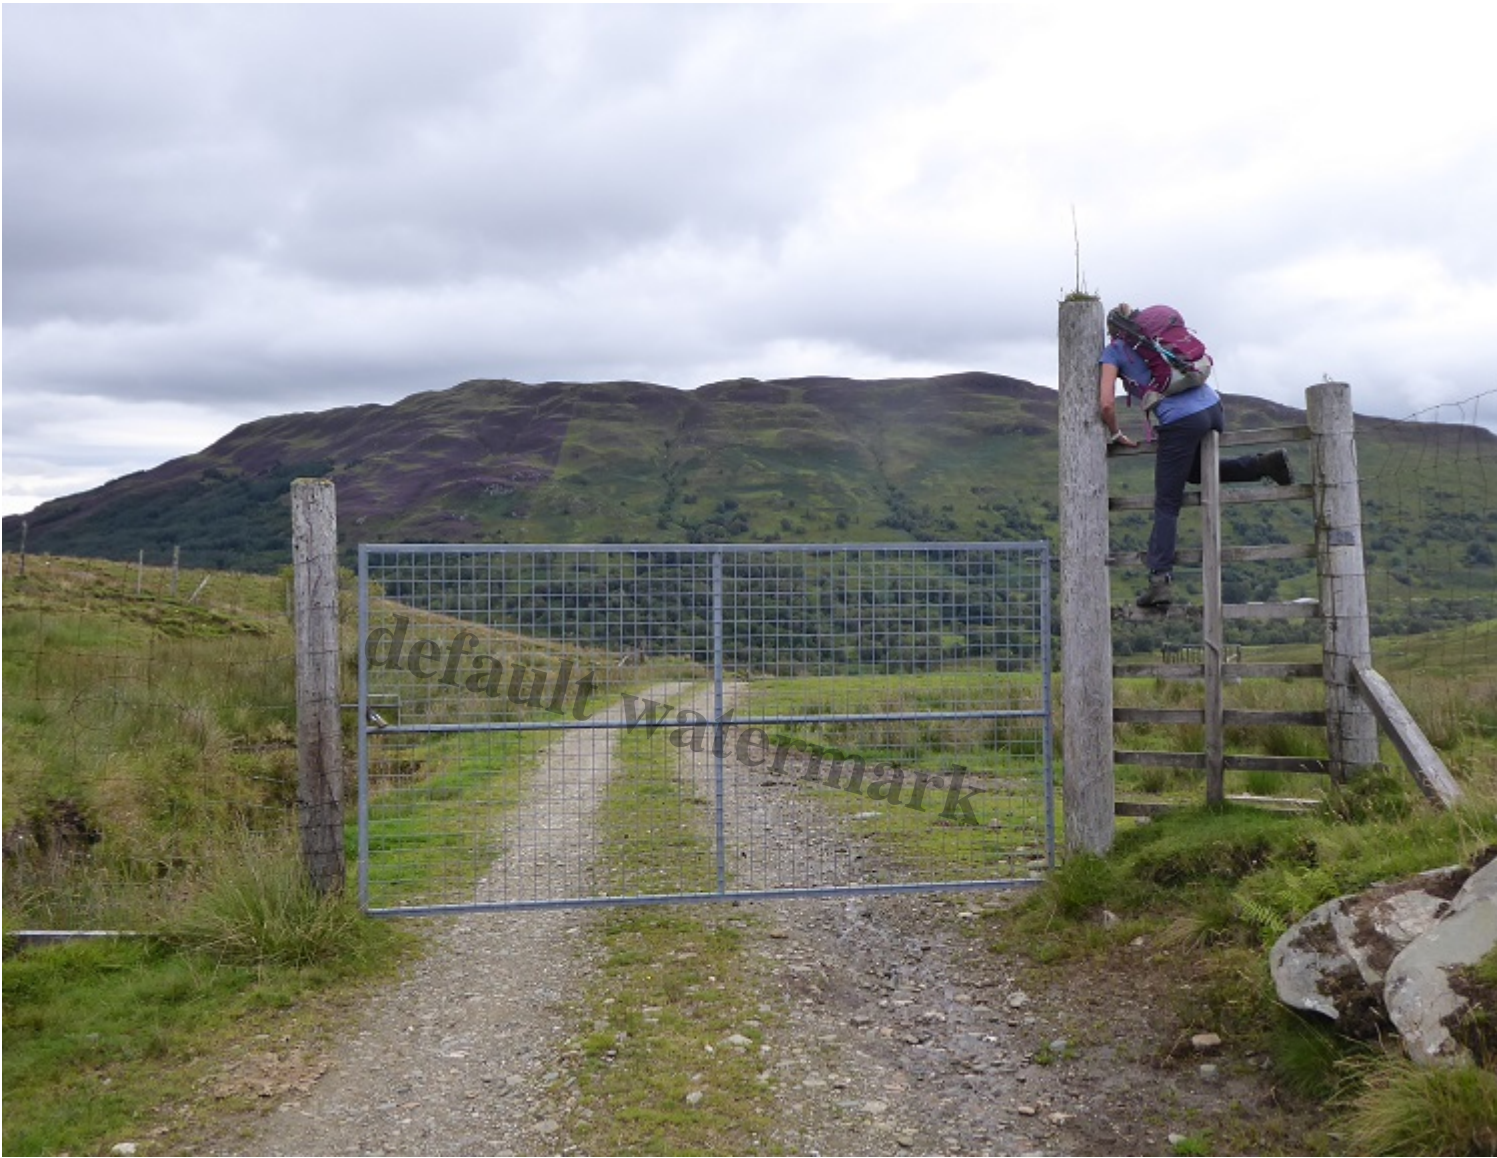
Shortly afterwards we came to a locked gate, the first of four I noted. All are contrary to our access legislation which makes it unlawful to obstruct access and the farm should not have done this. The combination of the locked gate and high deer fencing creates a barrier to access which many people would not be able to get past. In case you are wondering, there were cattle on both sides of the fence so the purpose of the locked gate is not to prevent rustling.

Climbing fences may be ok if you are fit, but people should be able to walk and cycle up this glen â?? how many members of Loch Lomond and Trossachs National Park Authority could cross the fence with a bike? The LLTNPA as Access Authority has a statutory duty to uphold access rights but is still failing dismally on the ground.

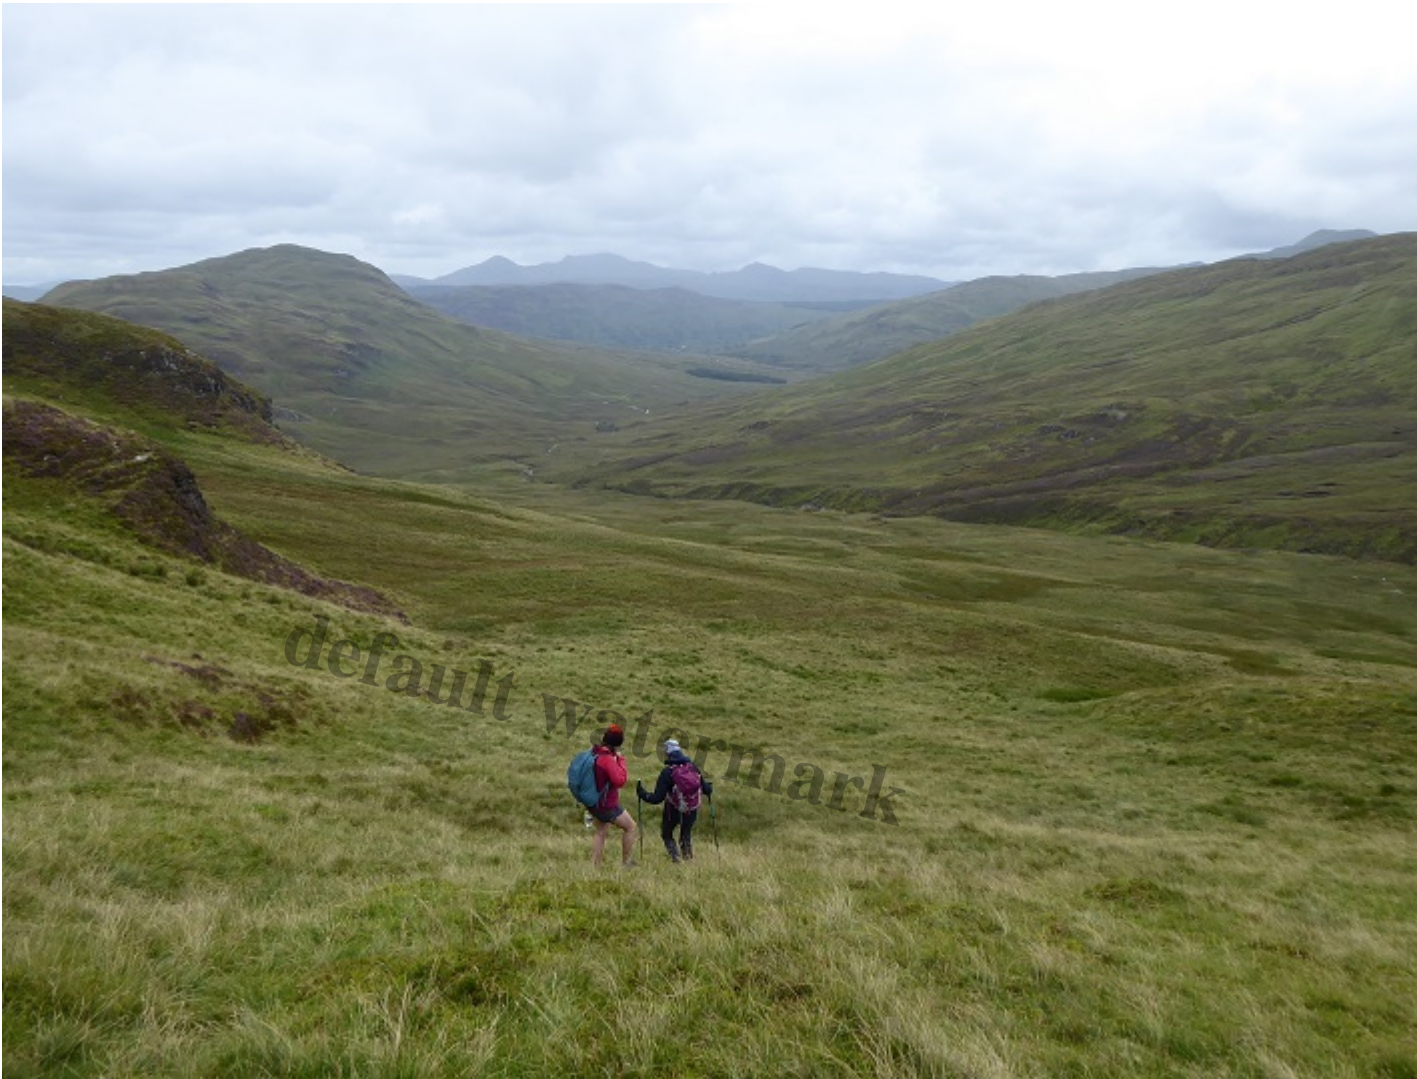
The mid-section of Gleann Dubh is covered by fine hummocky moraine. There are two intakes to the hydro scheme – originally three were planned – and it was agreed a new temporary track should be constructed across the Allt Fathan Glinne to build the first intake:

*– A temporary access track leading from an existing farm track (south of the sheepfold) to the south intake. This will be returned to its pre-construction condition following construction. – (Delegated Report April 2015).*

I can find no subsequent application to retain the track, as happened with the Glen Falloch schemes, and nothing else in the planning papers ([see here](#)) that explains who agreed it should be retained and

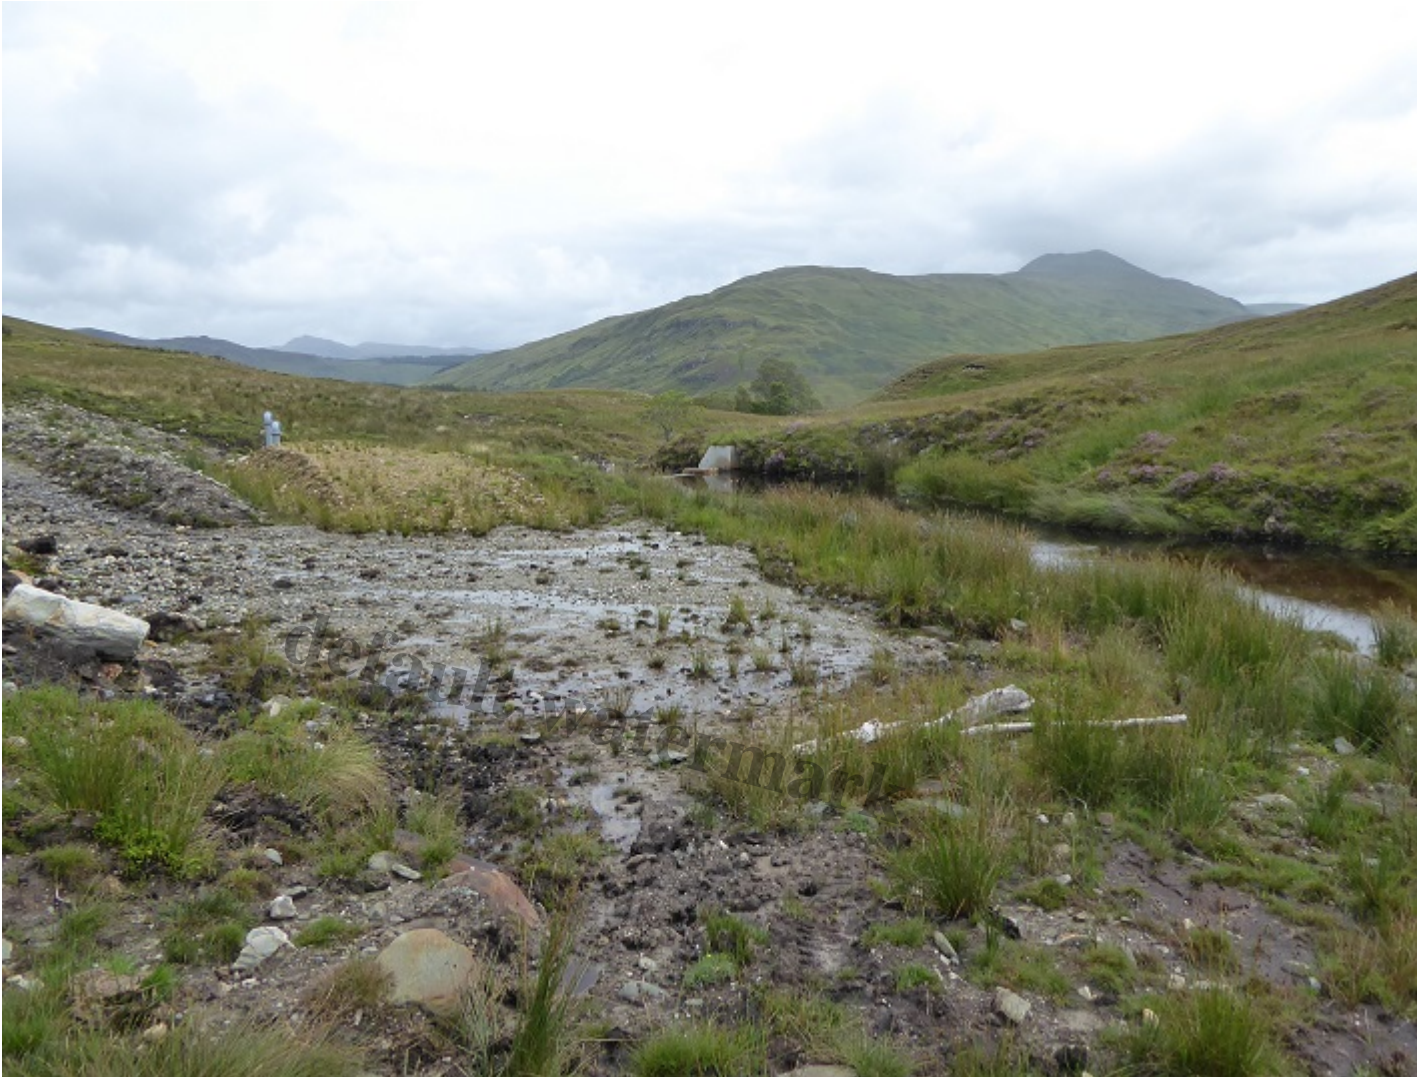
The intake is just visible at the end of the long pool it has created, Ben Vane beyond on right

The documents in the Planning Application describing how the area would be restored are sweet nothings.

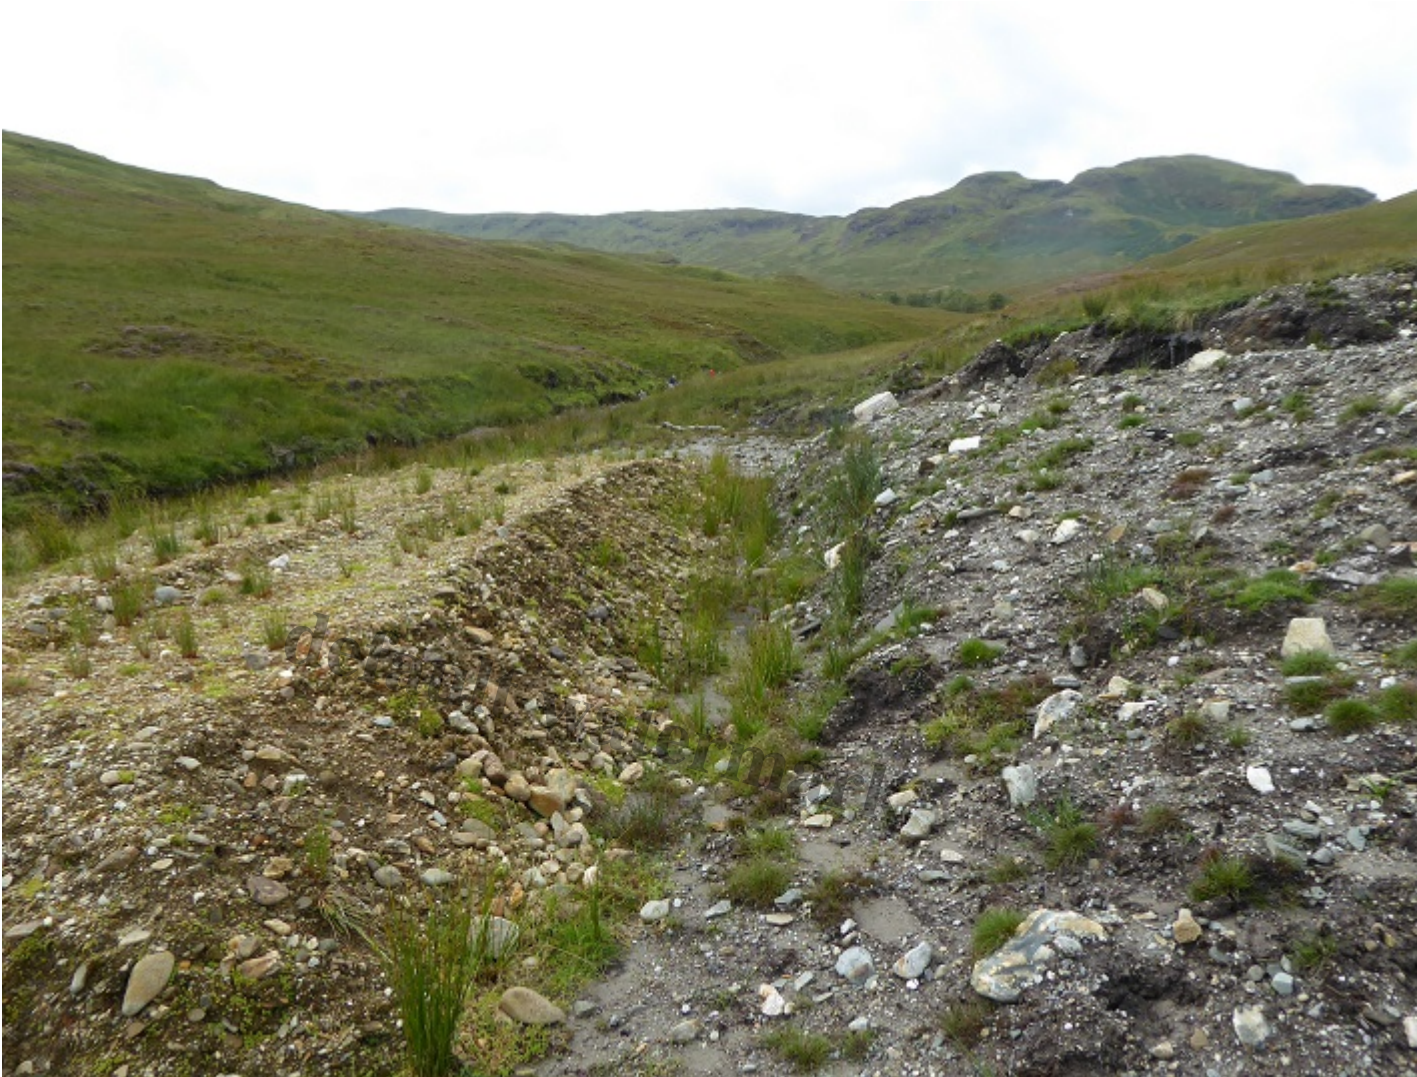
Looking back up the Allt Fathan Ghlinne.

Light touch regulatory regimes don't work

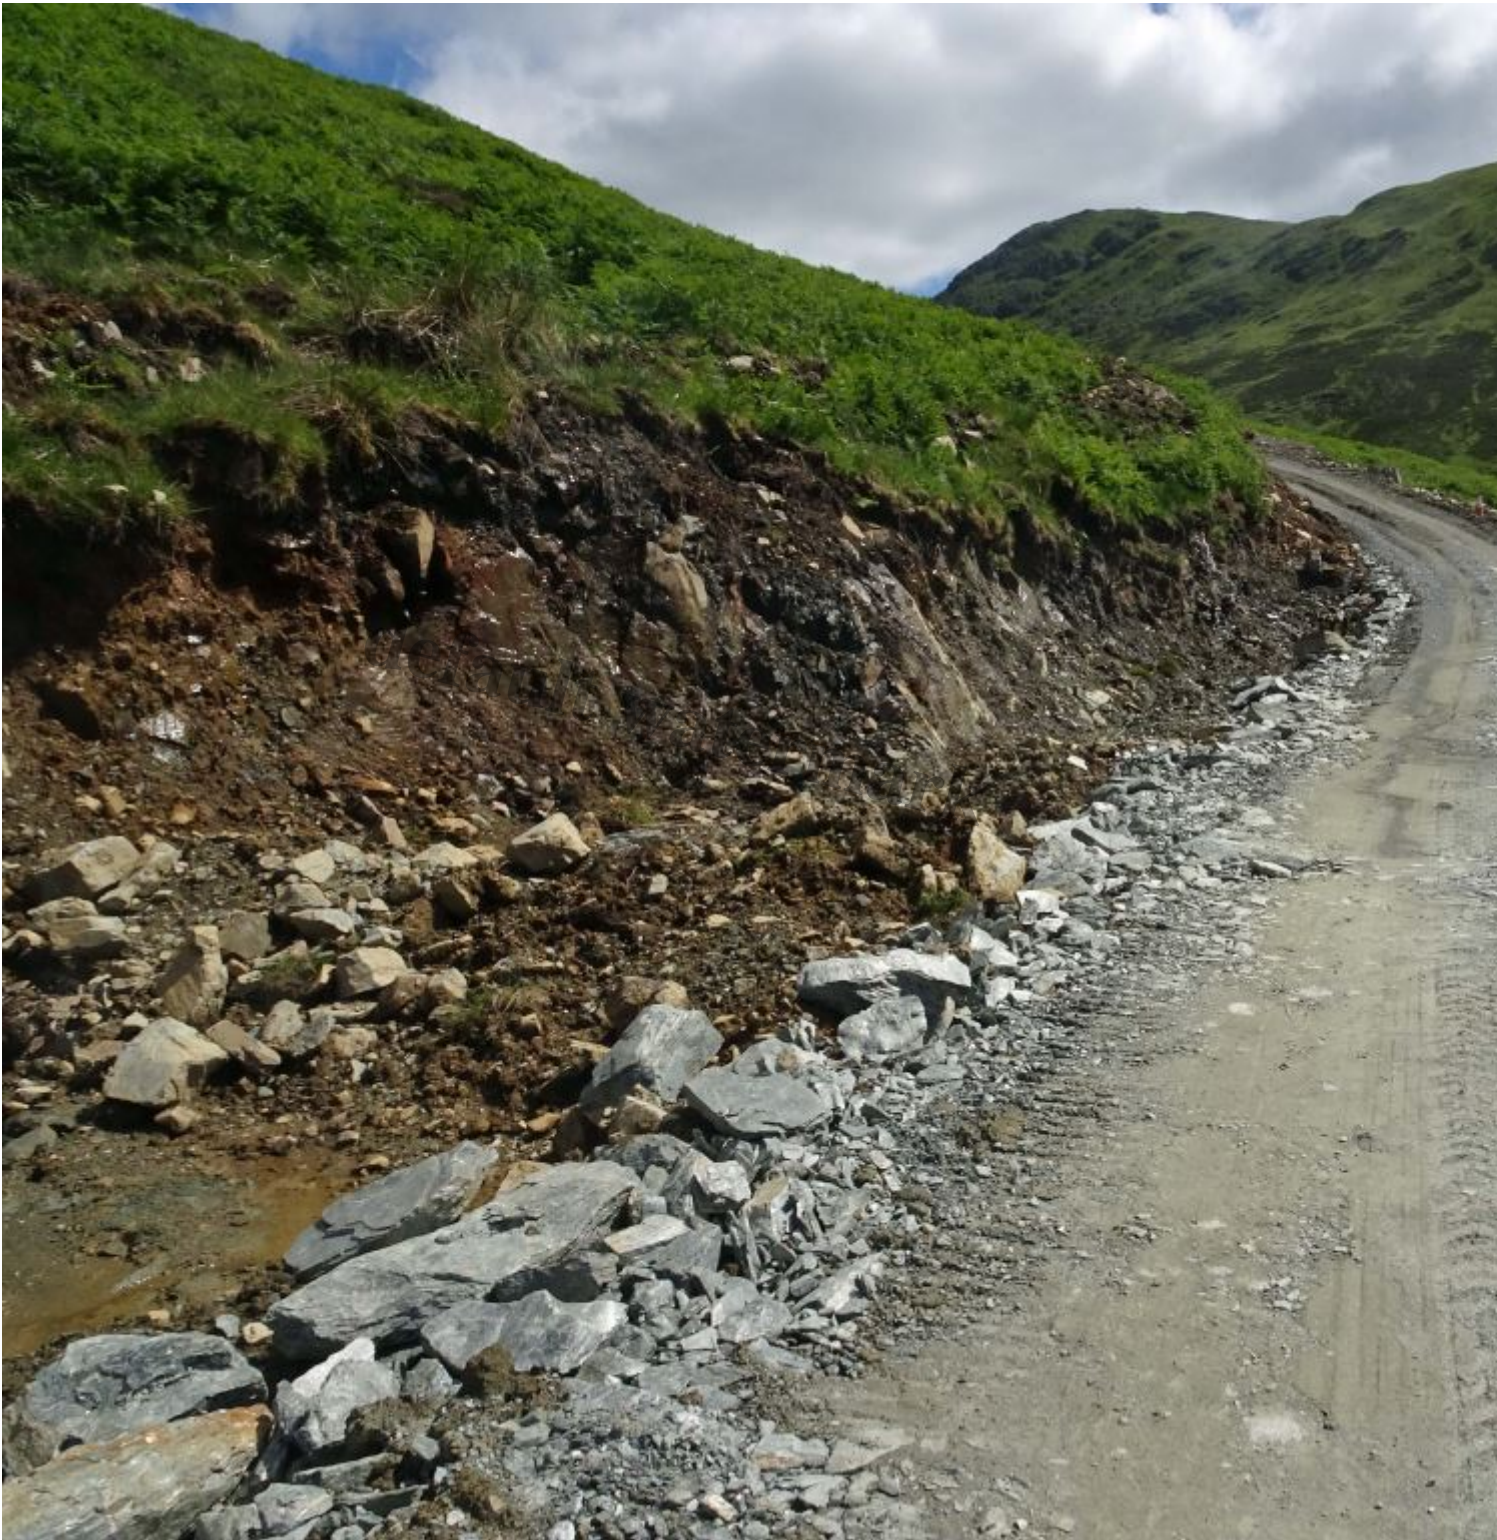
The vertical cutting of the slope has created a bench running across the hillside that is contrary to the Park's best practice guidelines. There is no sign of any of the turf that has been removed to create this and, as a consequence, effective restoration will be even more difficult.

It is not the fault of the people who do the work, they need an income like everyone else and just do what they are told. But it is the responsibility of the National Park Authority, once it has agreed to development going ahead, to ensure the staff overseeing these projects do the right thing.

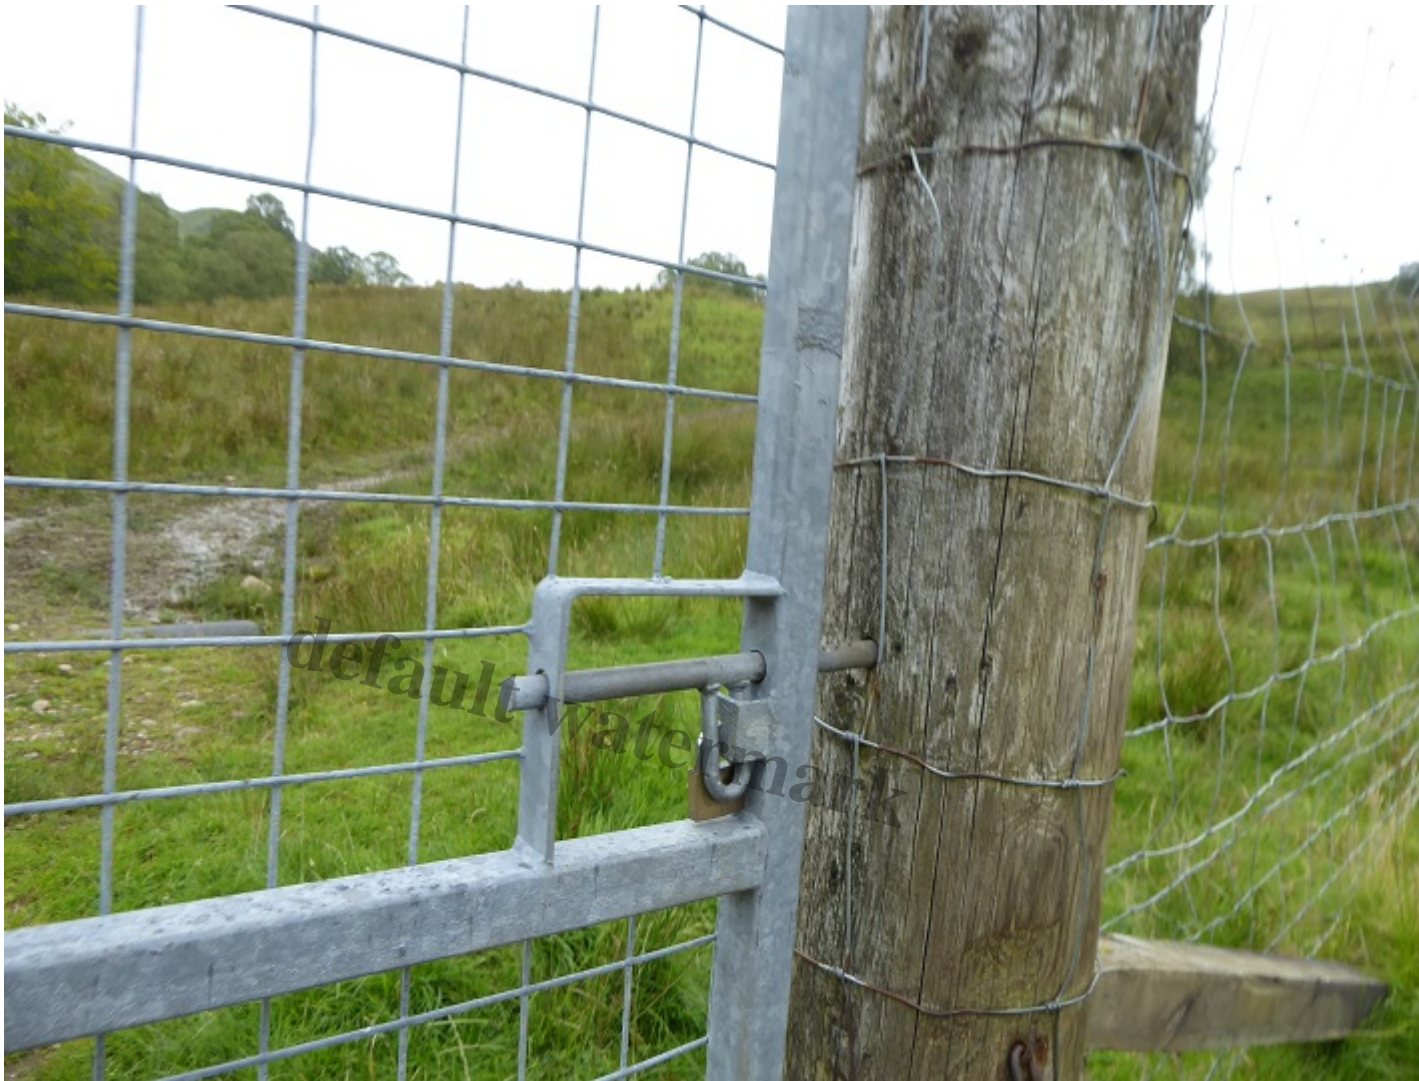
The fourth locked gate
