More National Park hydro planning failures – Ballimore and Glen Ample

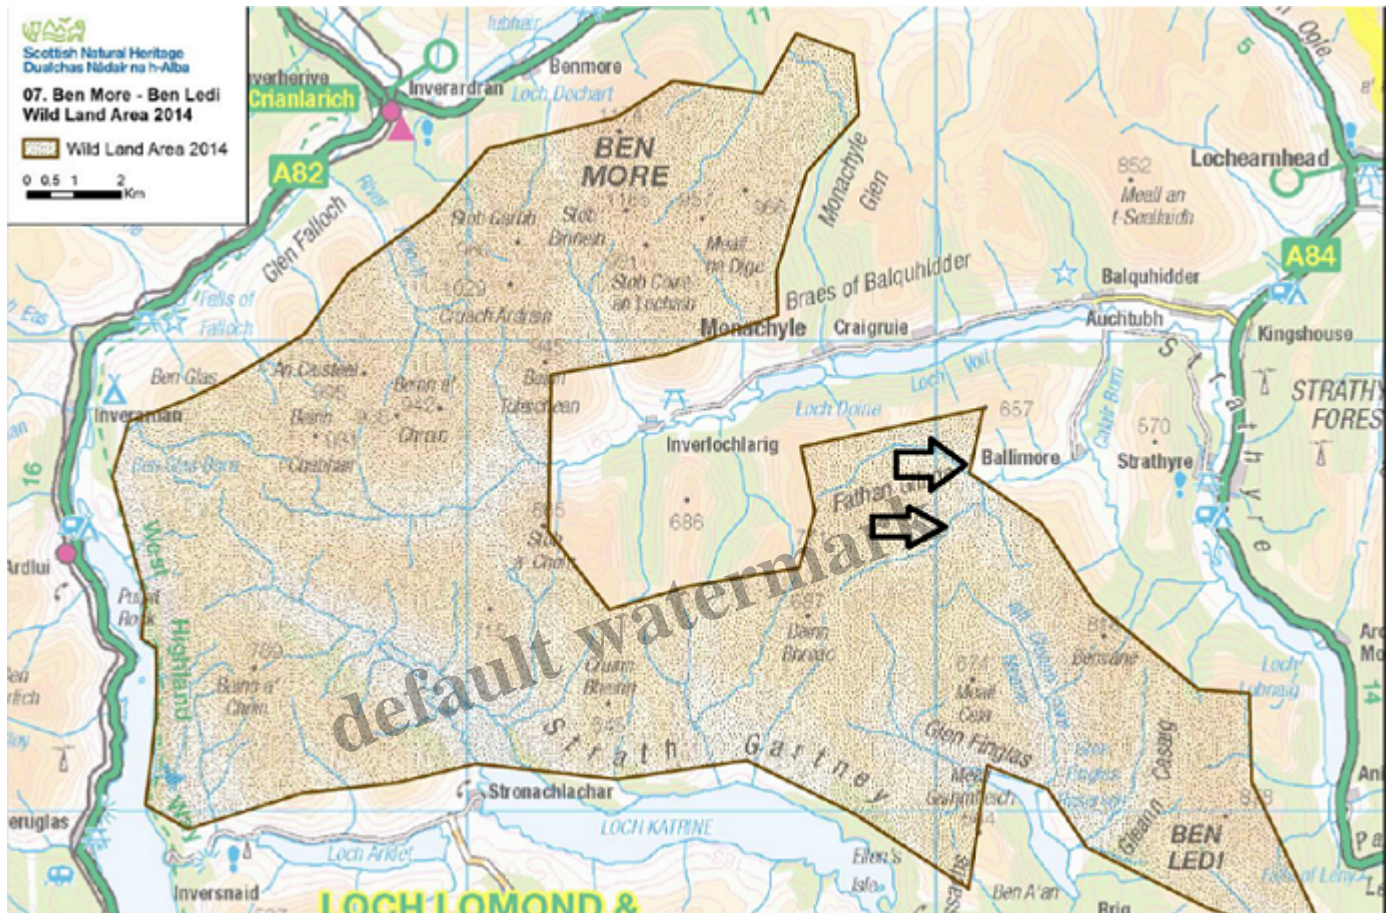
Location of hydro intakes

There is NOT A SINGLE REFERENCE TO THE WILD LAND AREA or the importance of wild land qualities in the LLTNPA Report. It is not surprising therefore that this Wild Land Area, identified in 2014, has done nothing to prevent this scar intruding into the coire. The LLTNPA record when it comes to protecting wild land is almost non-existent (think the Cononish goldmine etc).

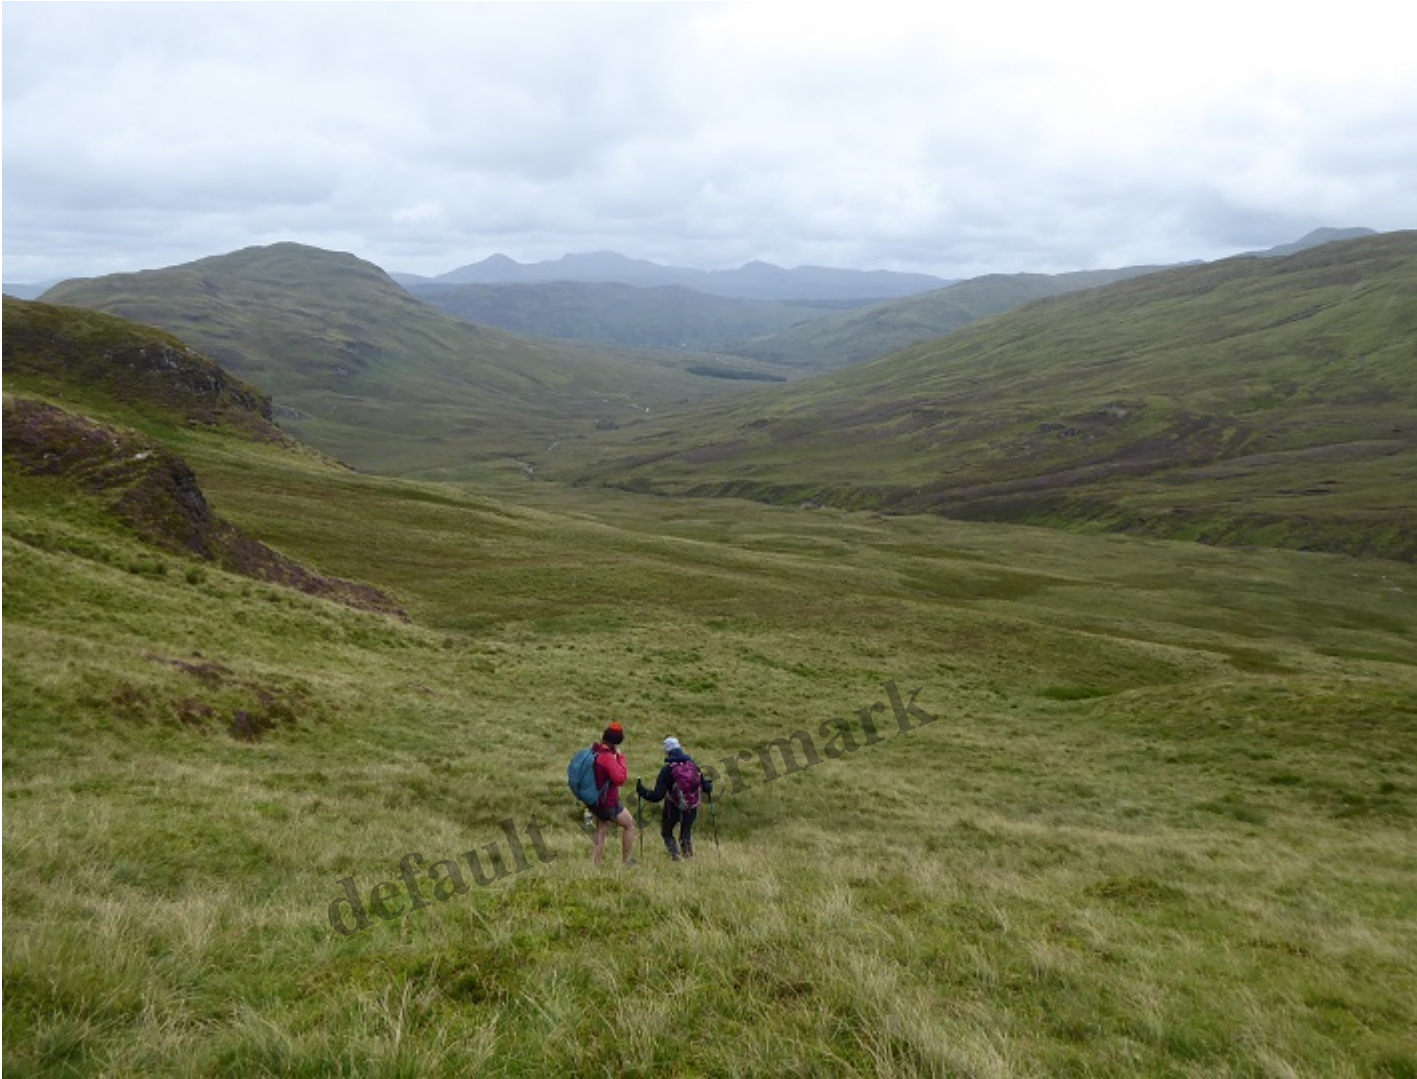
Looking over to Ben Vorlich and Stuc a Chroin

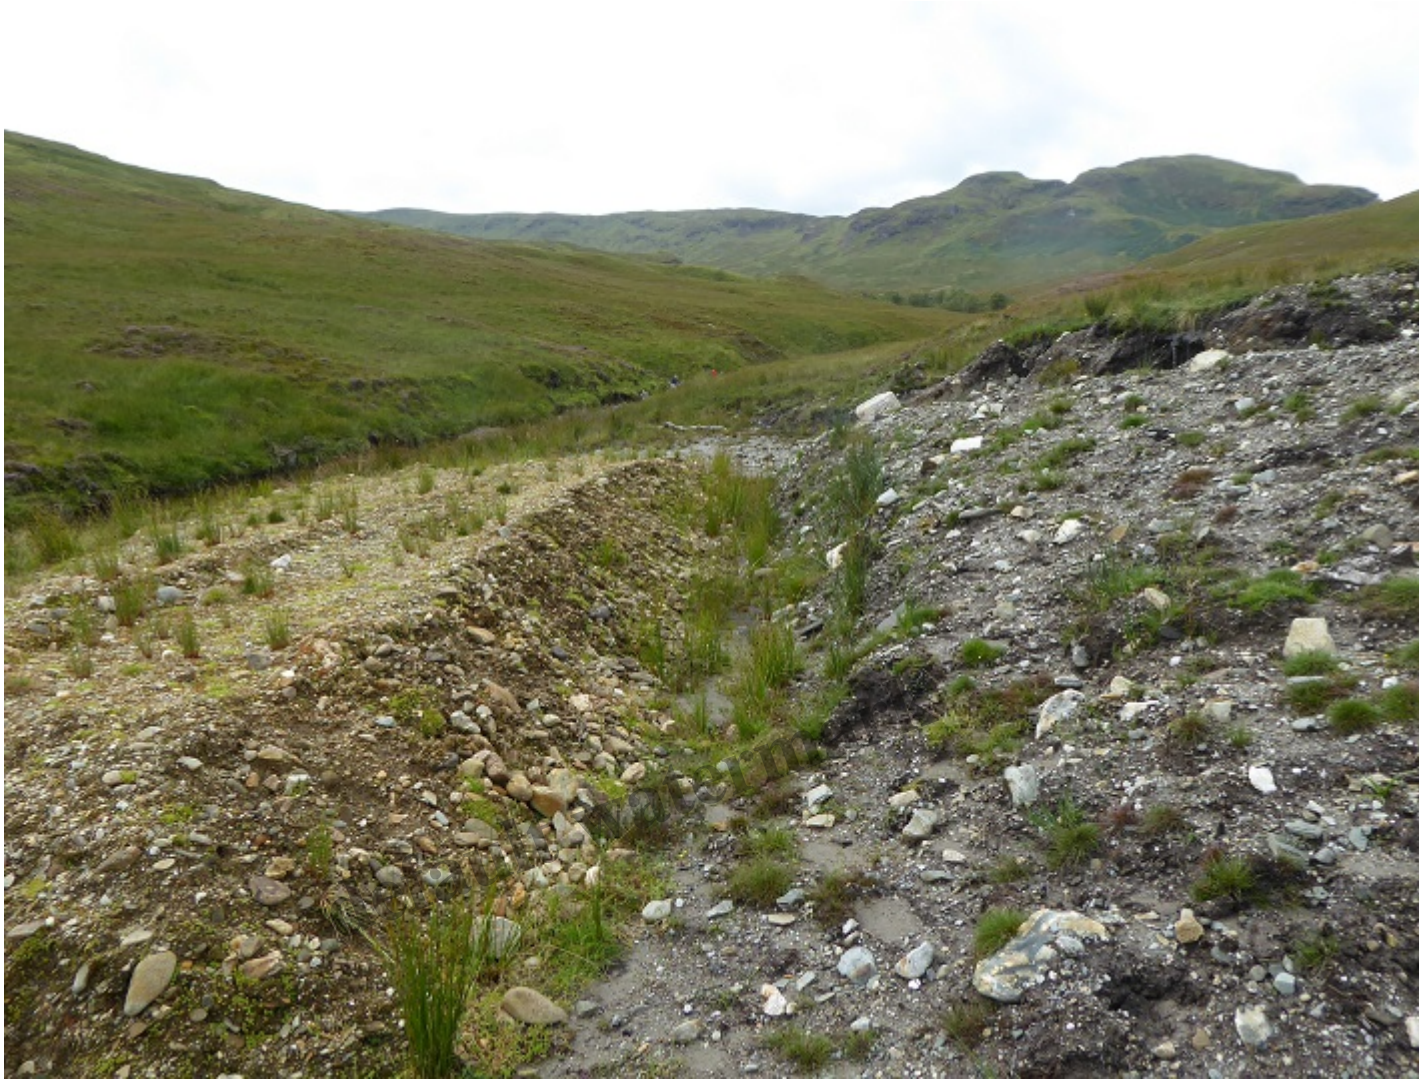
Looking back up the Allt Fathan Ghlinne.

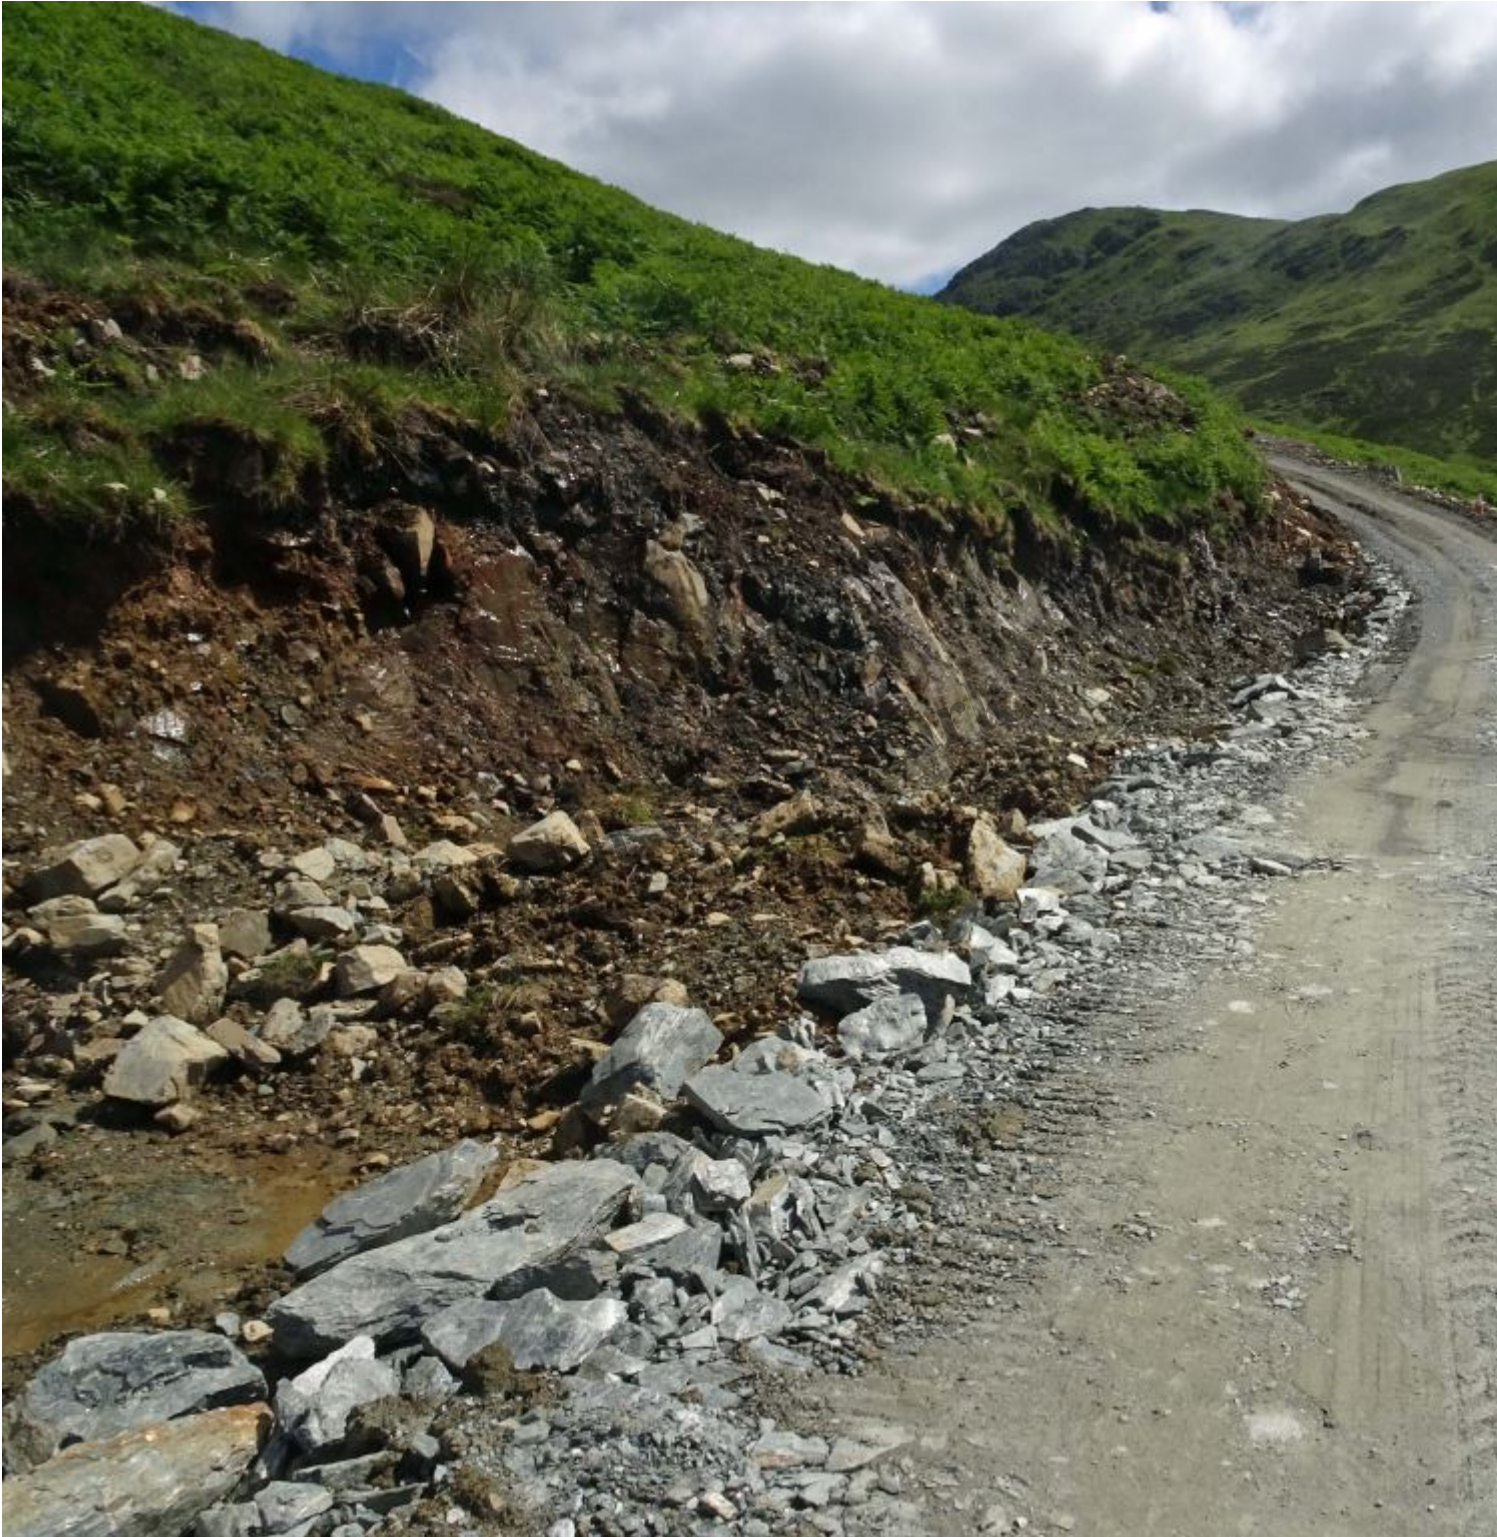
It is not the fault of the people who do the work, they need an income like everyone else and just do what they are told. But it is the responsibility of the National Park Authority, once it has agreed to development going ahead, to ensure the staff overseeing these projects do the right thing.
