Unsustainable run of river hydro schemes – Glen Falloch one year on

Intake 1 – Upper Glen Falloch

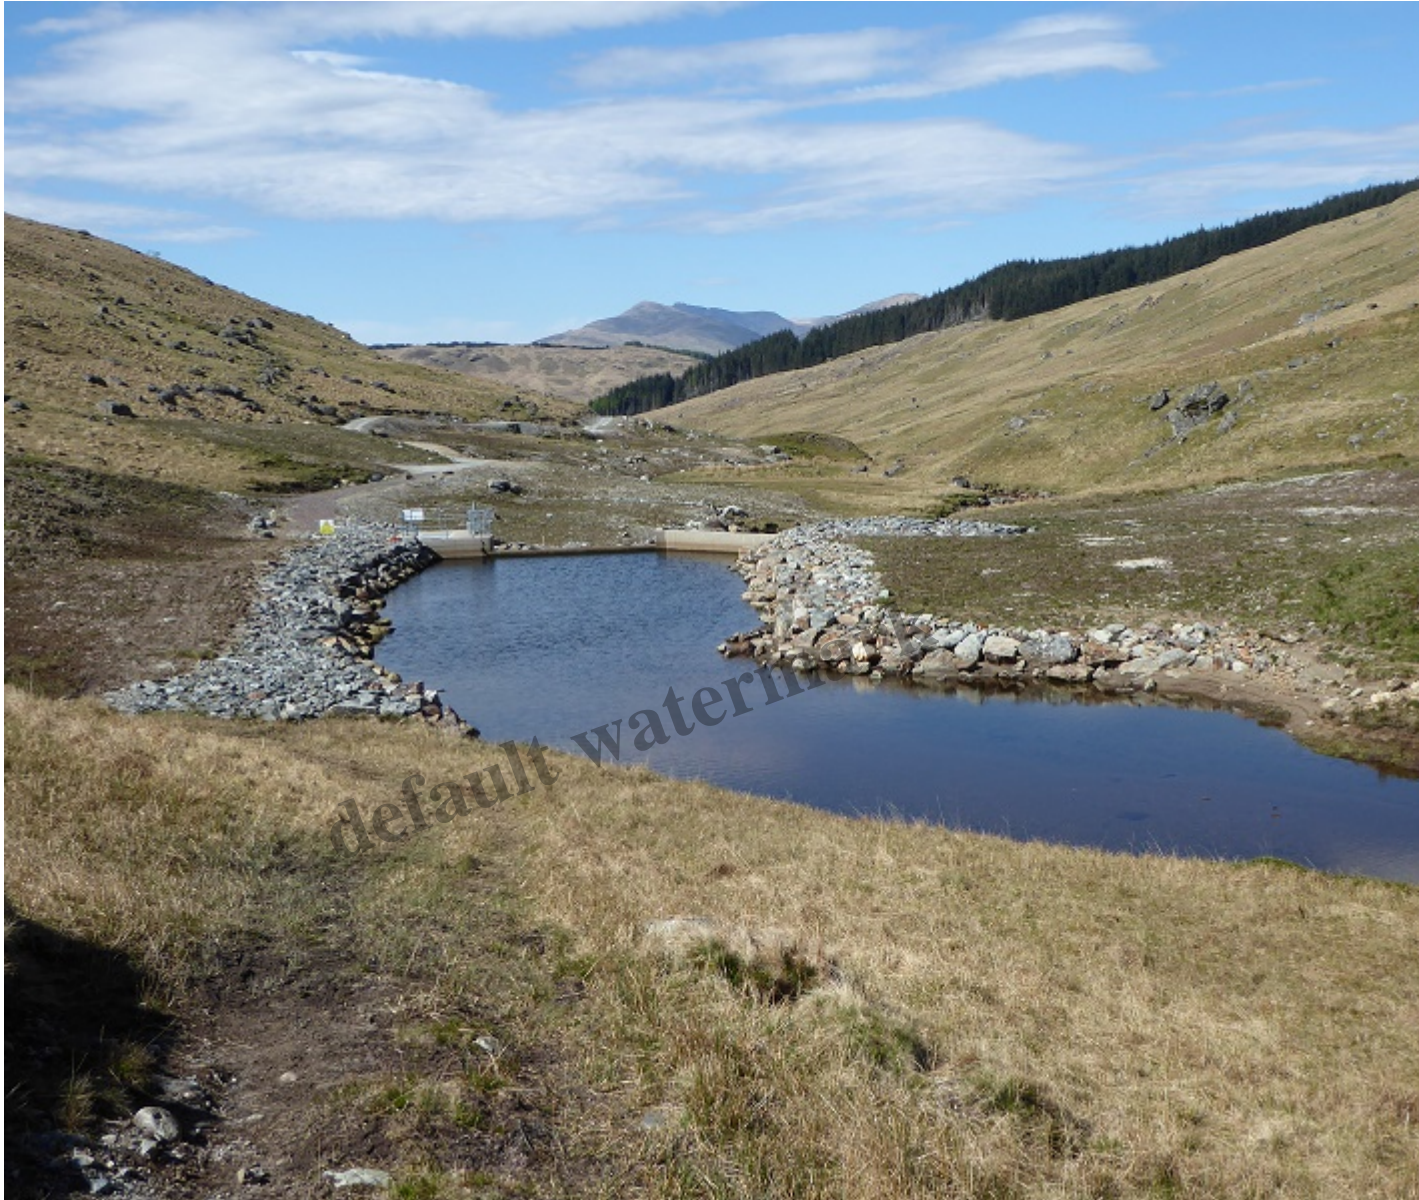
2017 after construction

In September 2019, the pool was still there, despite the serious floods the previous month but with signs of additional infilling:
