## Unsustainable run of river hydro schemes â?? Glen Falloch one year on

### Intake 1 â?? Upper Glen Falloch

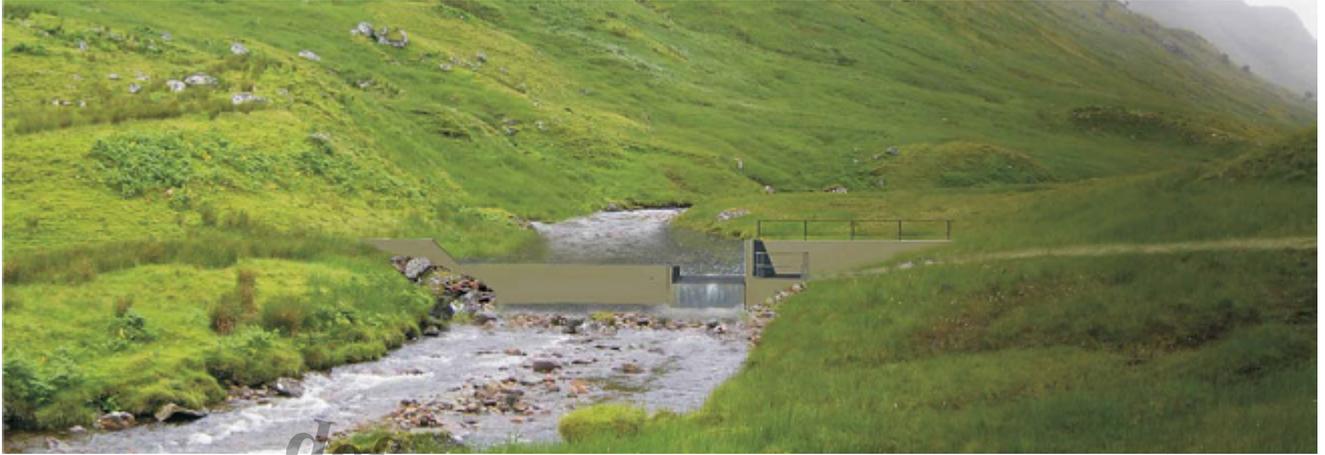
Visualisation from landscape assessment 2009. The actual location was moved slightly downstream.

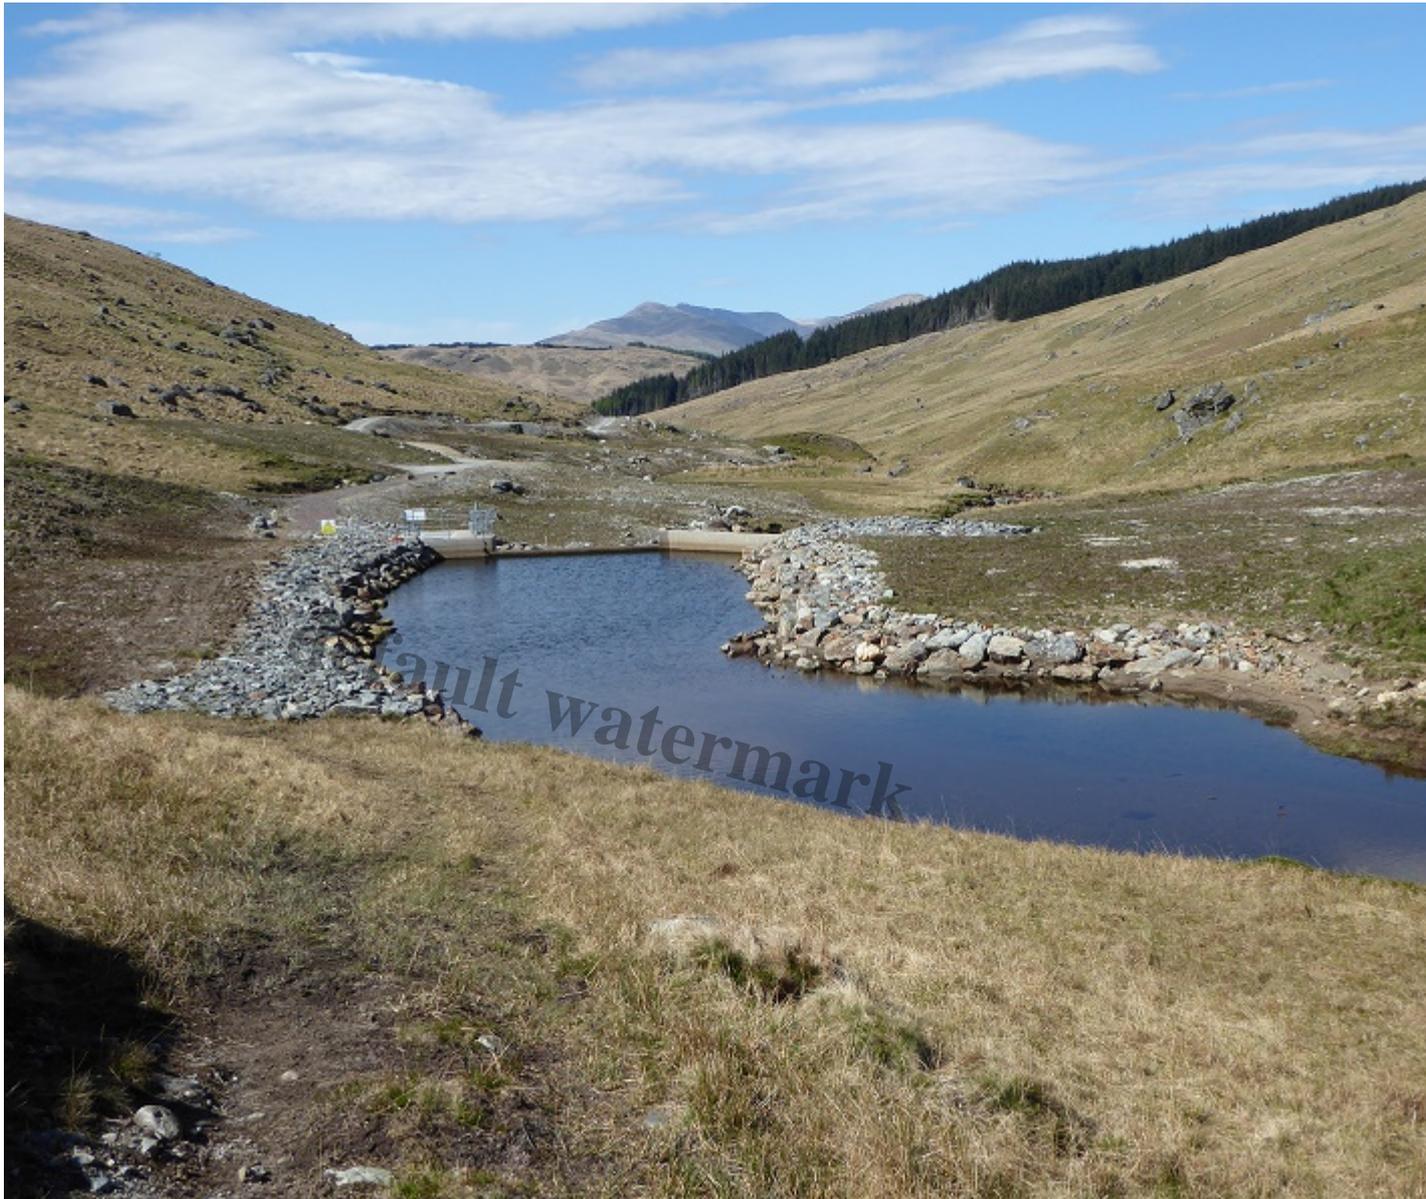
2017 after construction

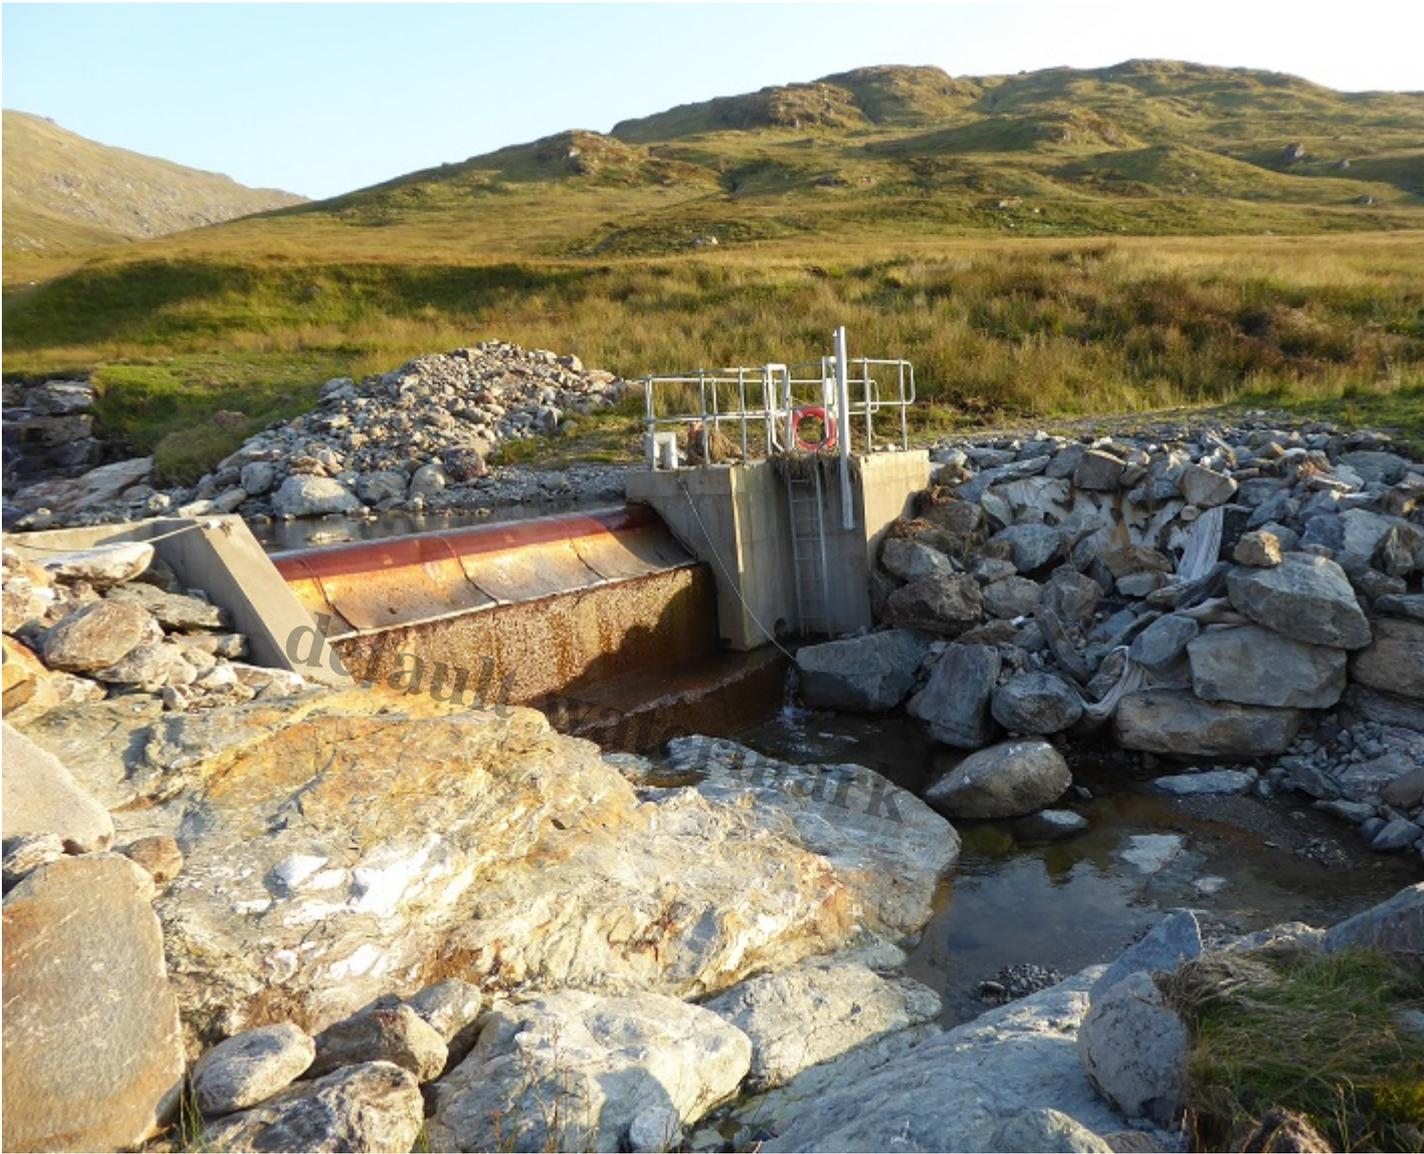
September 2019

A year ago there was a pile of boulders that had been excavated from the pool to get the hydro functioning again:

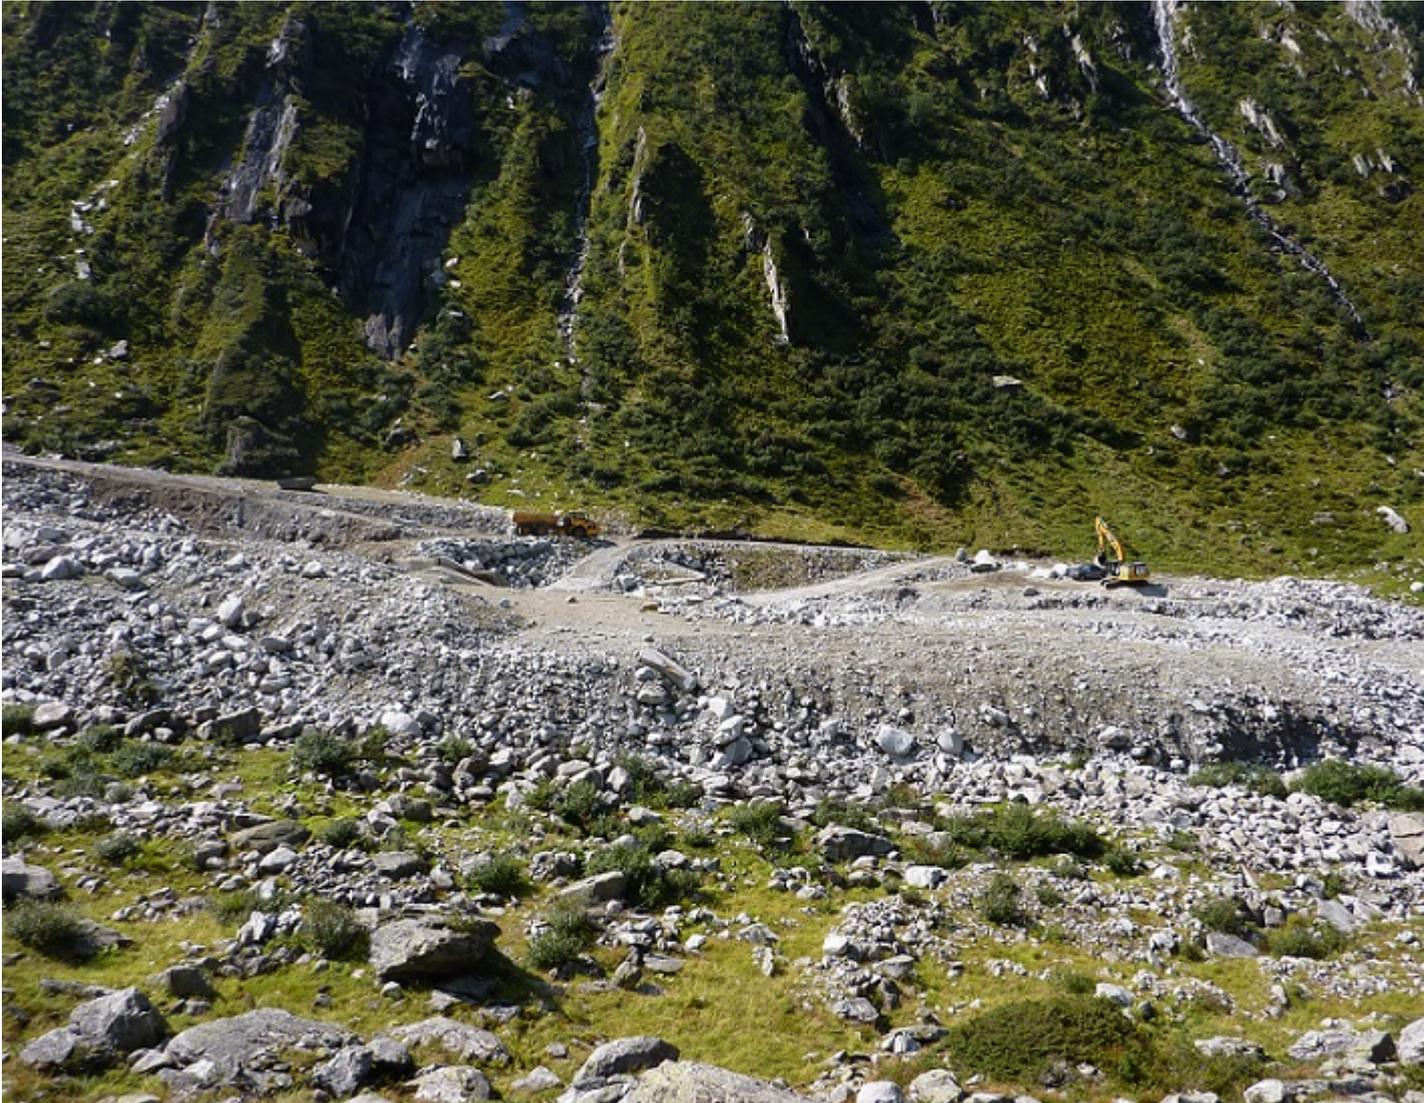
An example from an Austrian National Park – the concrete hydro intake is visible just to the left and forward from the dumper truck

A reader yesterday – see comments – mentioned that infilling and subsequent excavation of intakes was a longstanding issue from older hydro schemes in Scotland and also in the Alps. Little consideration appears to have been given to the historical evidence in deciding where to locate run of hydro schemes.
