Hill road upgrades and the planning system – Strone three years on

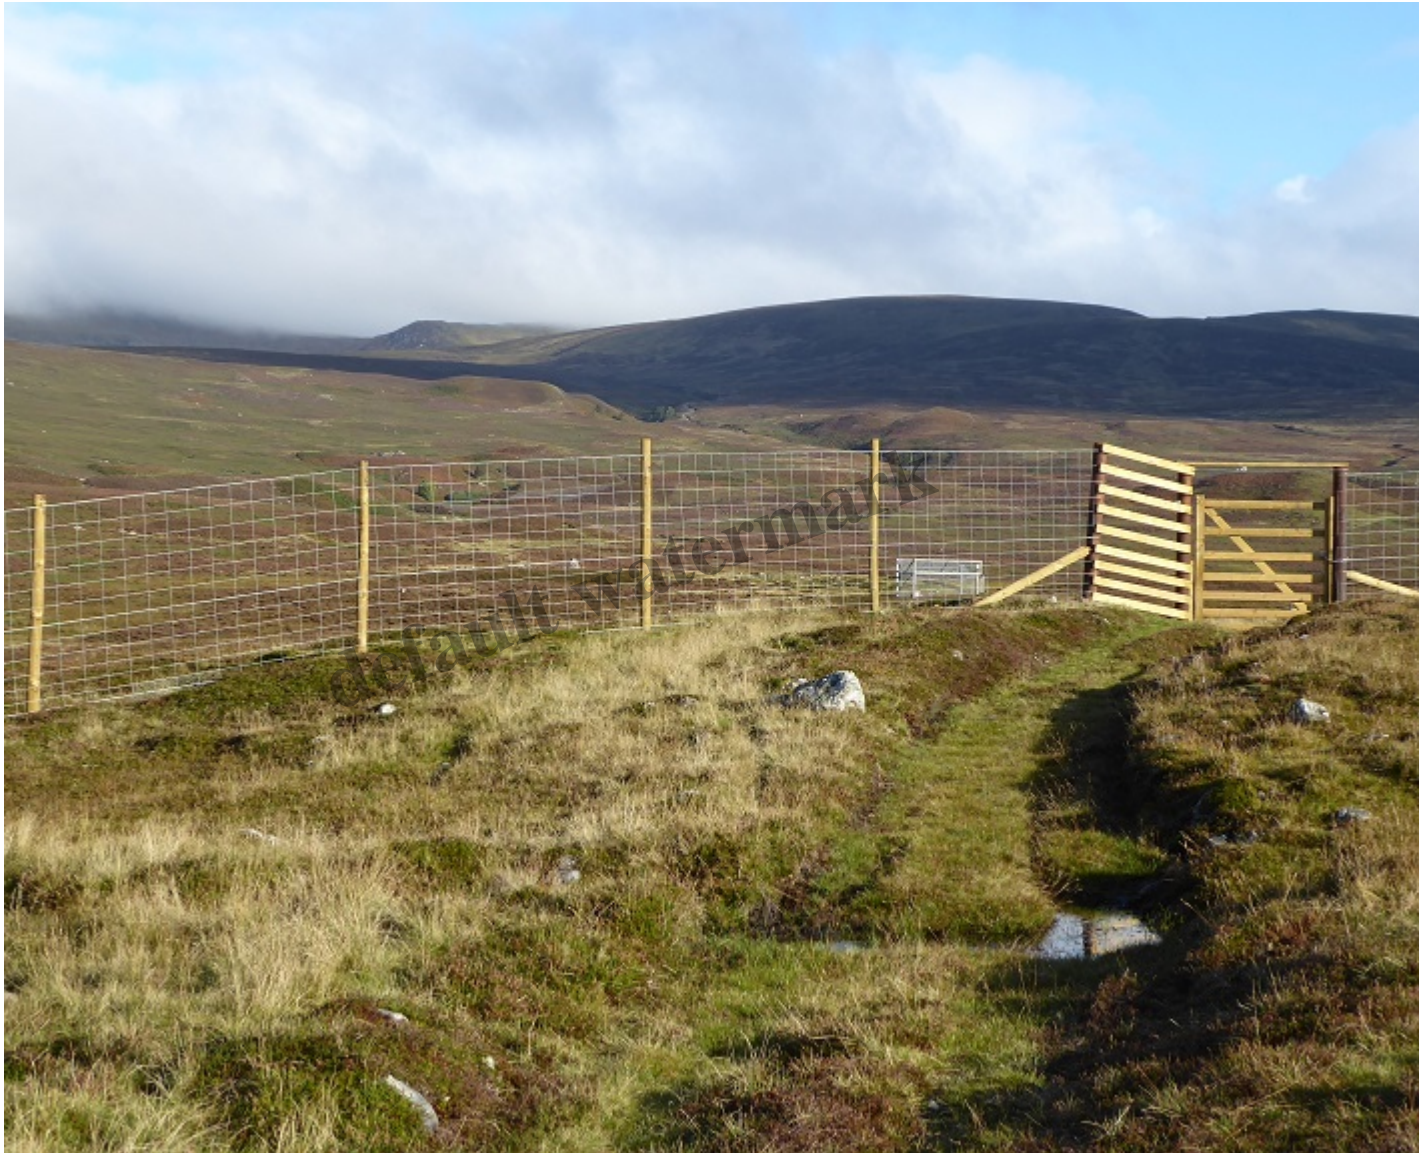
View over to the Allt na Beinne from near the wildcat trail behind Newtonmore. The track from Strone is visible beyond (mid-picture). Note the deer fence, part of an extensive network of new fences on the Pitmain and Glen Bancher estates, and the crow trap beyond.
