Hill road upgrades and the planning system – Strone three years on

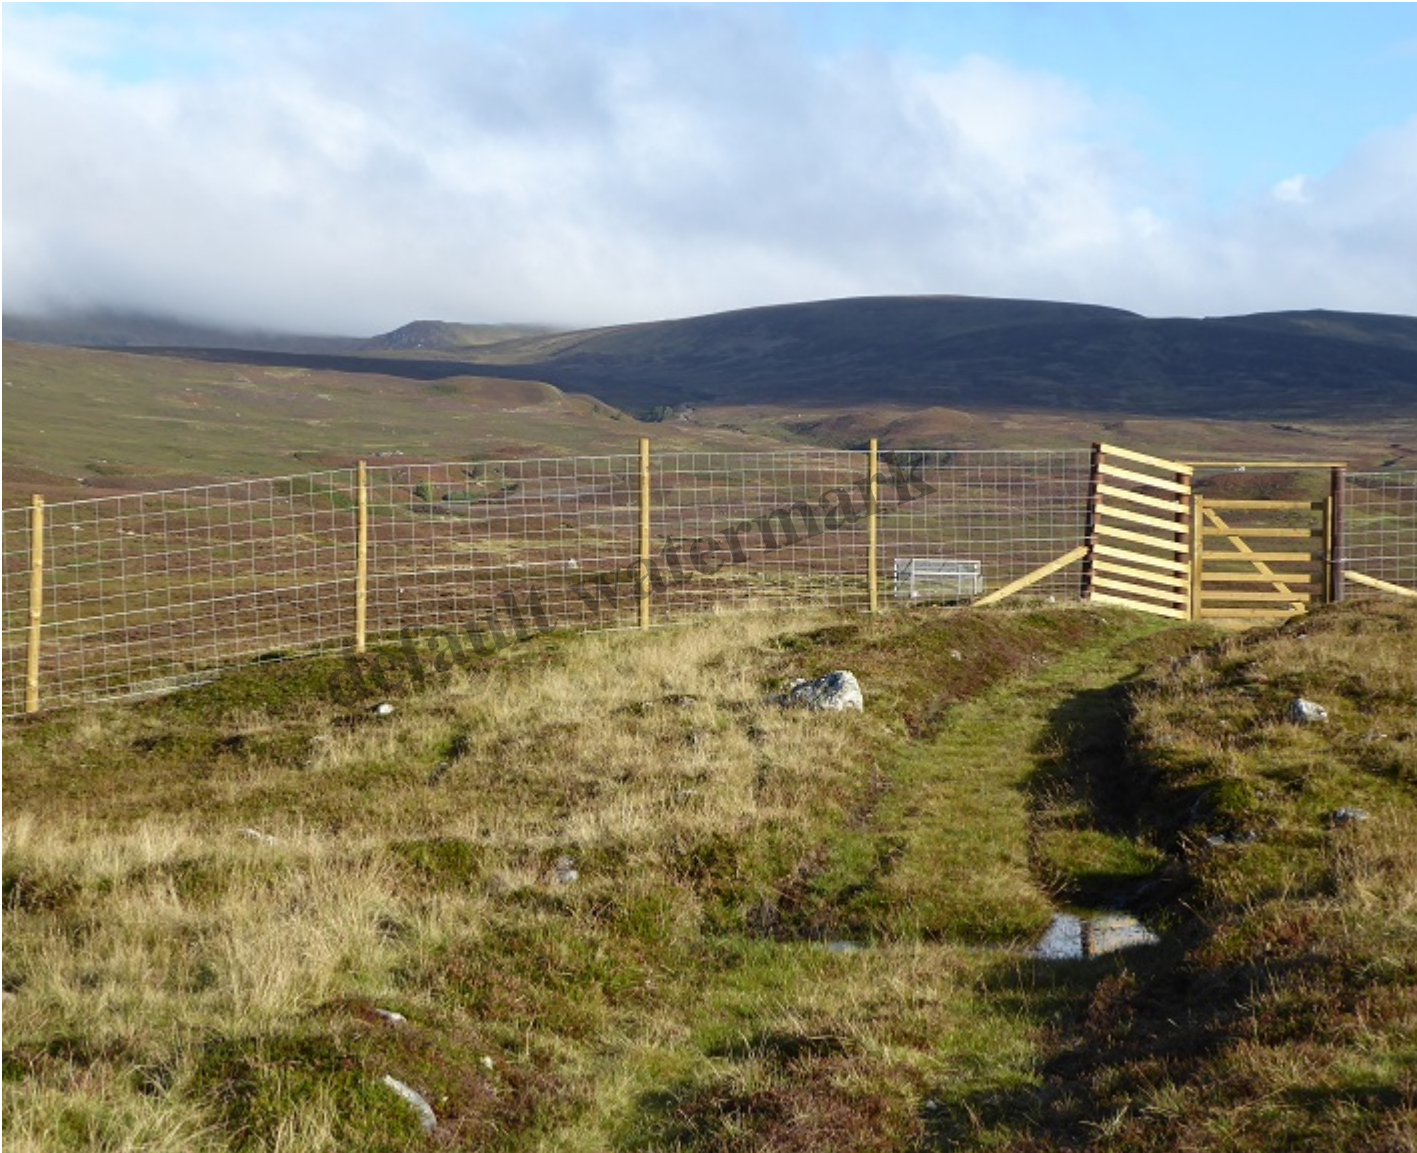
View over to the Allt na Beinne from near the wildcat trail behind Newtonmore. The track from Strone visible beyond (mid-picture). Note the deer fence, part of an extensive network of new fences on the Pitmain and Glen Banchor estates, and the crow trap beyond.

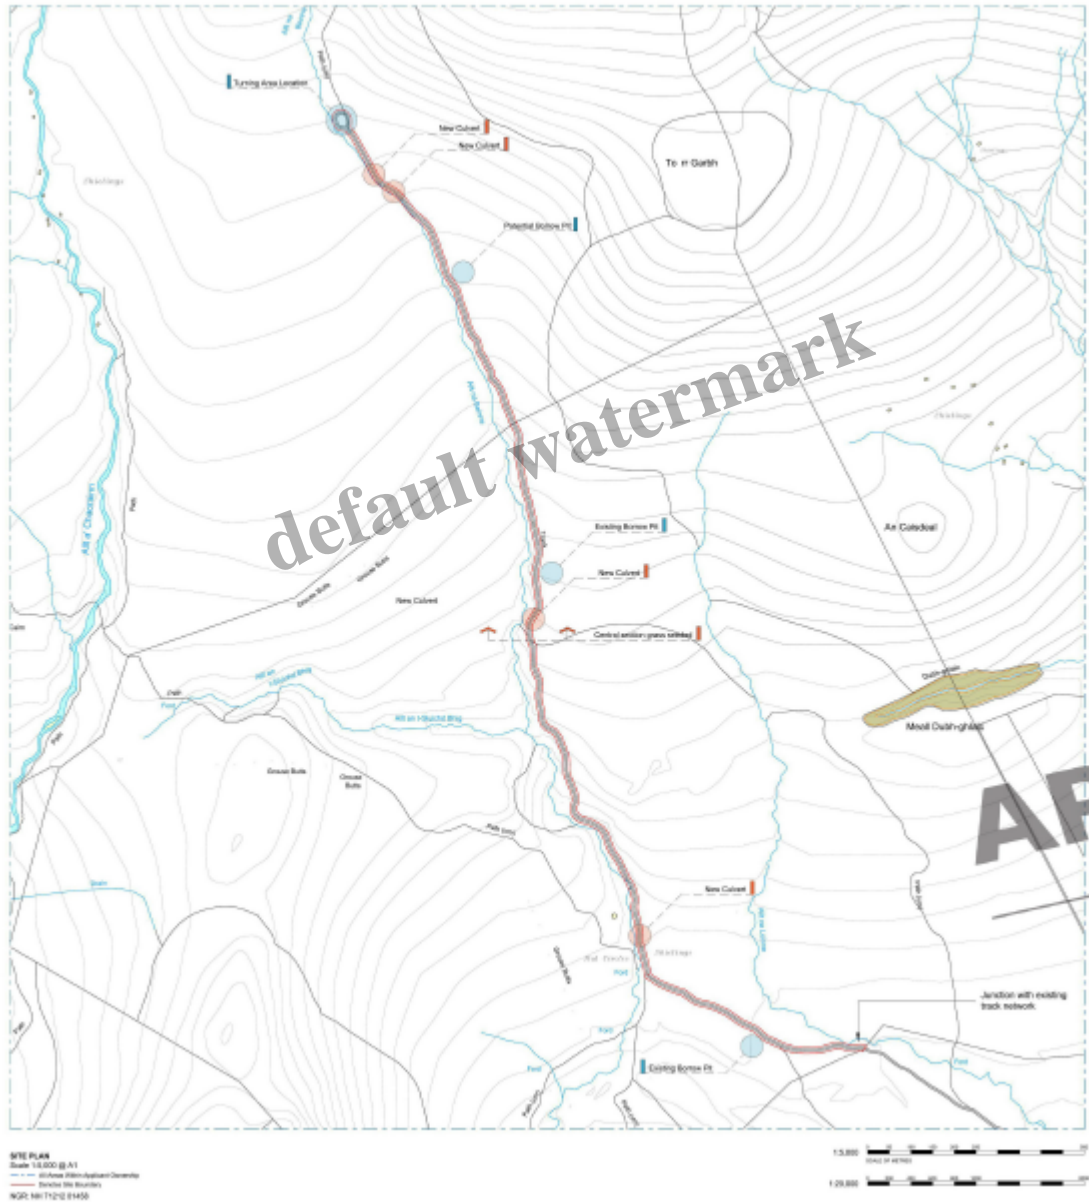
2019/0121/DET CONDITIONS 1 AND 4

Plan of track showing culverts and borrow pits
