Hill road upgrades and the planning system â?? Strone three years on

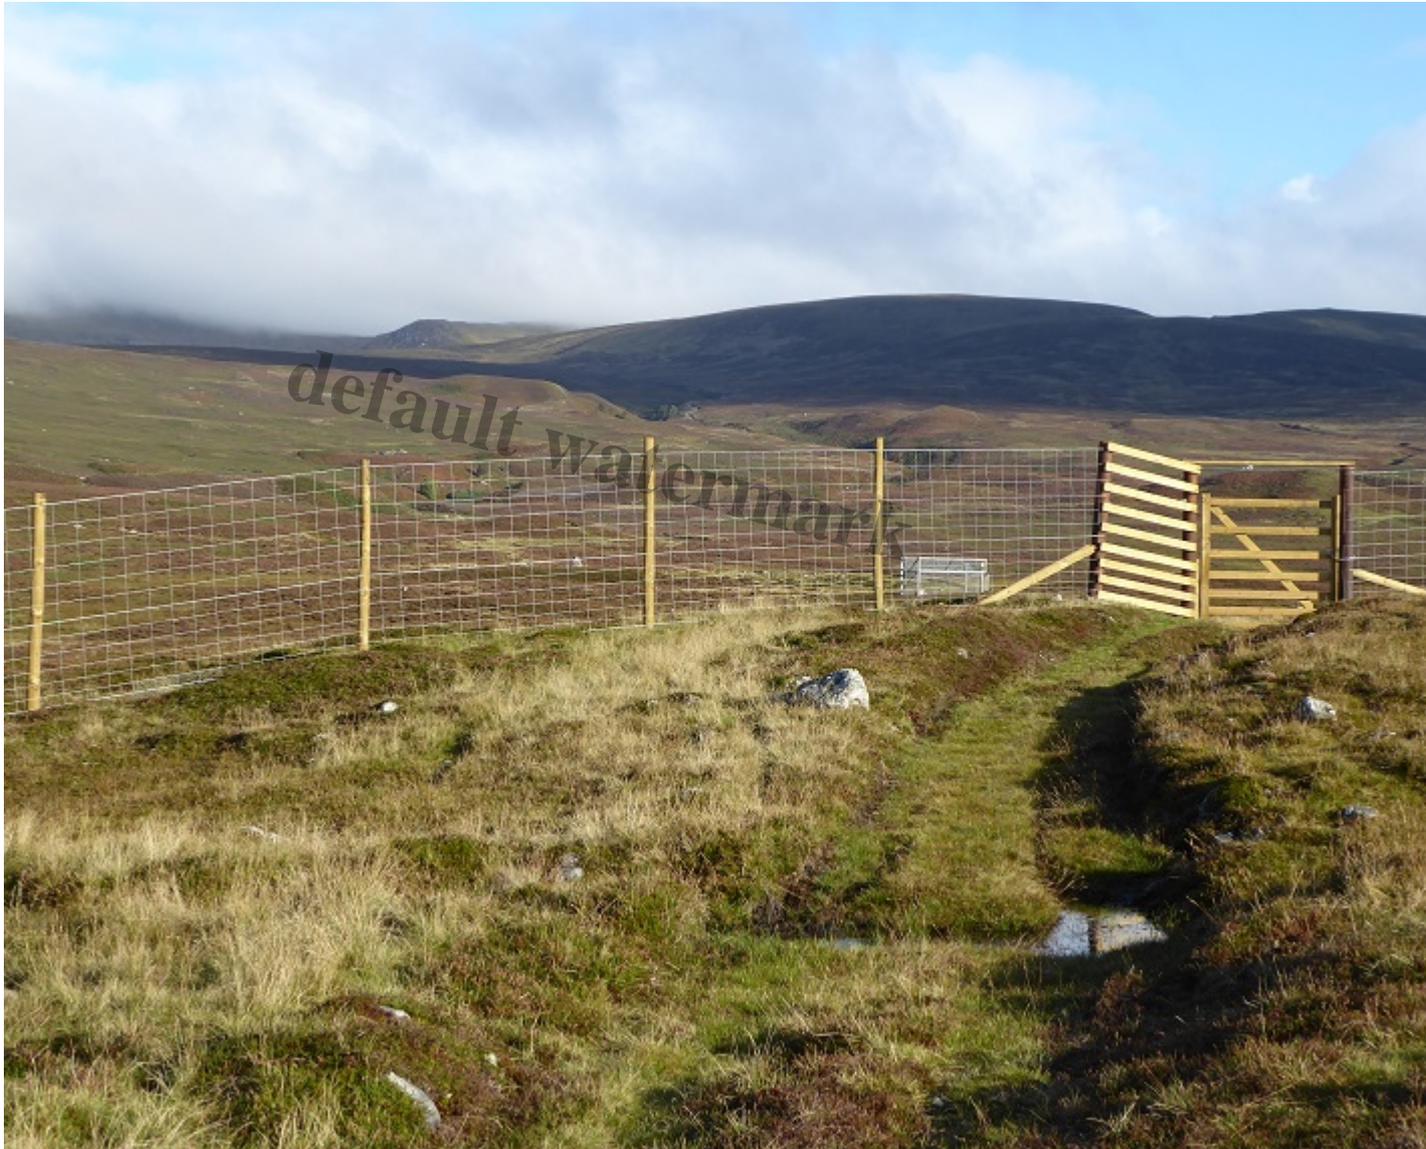
View over to the Allt na Beinne from near the wildcat trail behind Newtonmore. The track from Strone visible beyond (mid-picture). Note the deer fence, part of an extensive network of new fences on the and Glen Banchor estates, and the crow trap beyond.
