Will the repair of the Cairngorm Funicular Railway work (2)?

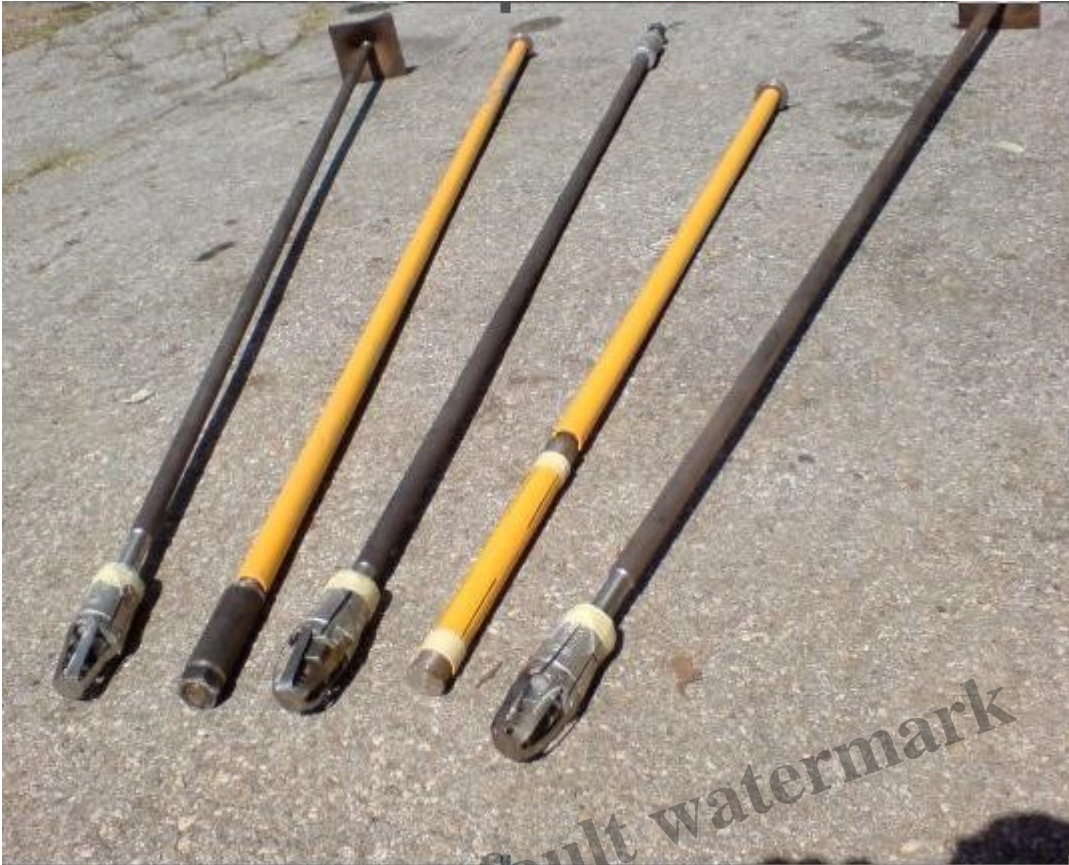
A hole is drilled into the concrete base, the anchor bolt/stud is put in the hole and as the nut is tightened, it expands the collar which locks the bolt/stud in place. Smaller versions of this are used by many D.I.Y'ers around the home.

Although this is only one type of bolt, other types could have been used which would have been concreted into holes drilled in the base foundation, with nuts and washers placed on top and tightened to hold the Anchor Blocks in place.
