Will the repair of the Cairngorm Funicular Railway work (2)?

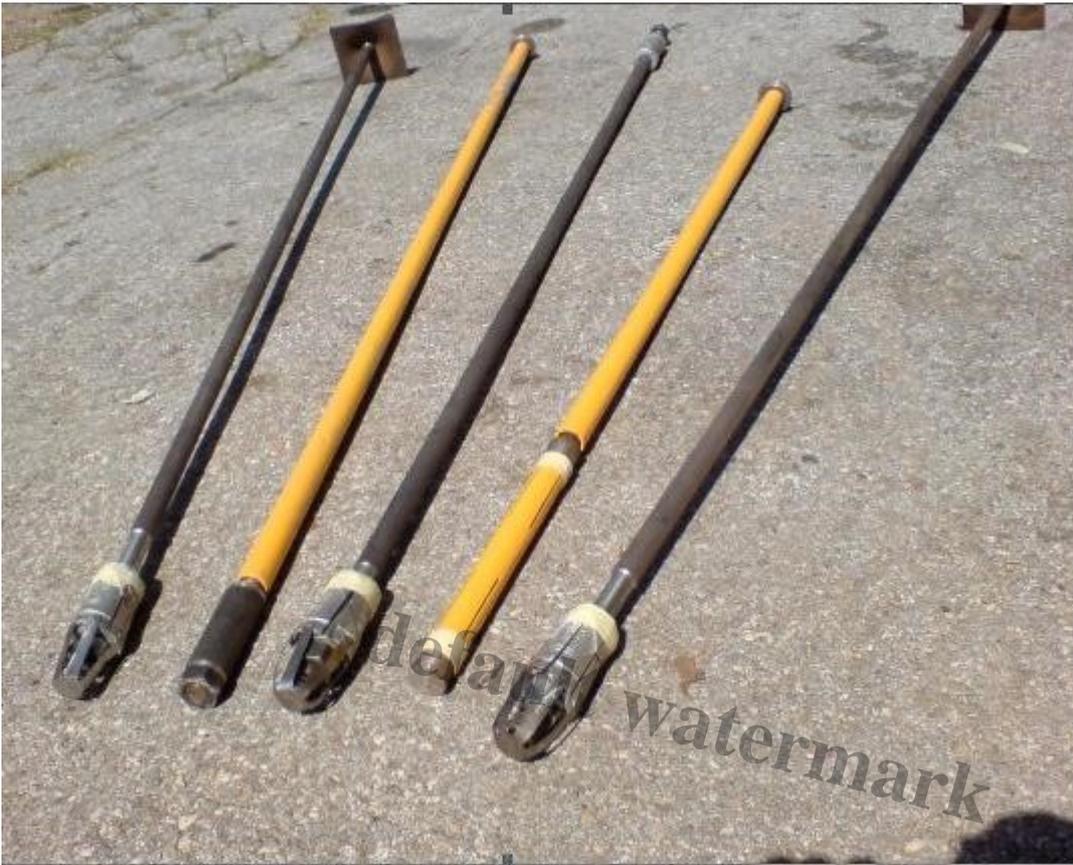
A hole is drilled into the concrete base, the anchor bolt/stud is put in the hole and as the nut is tightened, it expands the collar which locks the bolt/stud in place. Smaller versions of this are used by many D.I.Yers around the home.

Although this is only one type of bolt, other types could have been used which would have been concreted into holes drilled in the base foundation, with nuts and washers placed on top and tightened to hold the Anchor Blocks in place.
