Will the repair of the Cairngorm Funicular Railway work (3)?

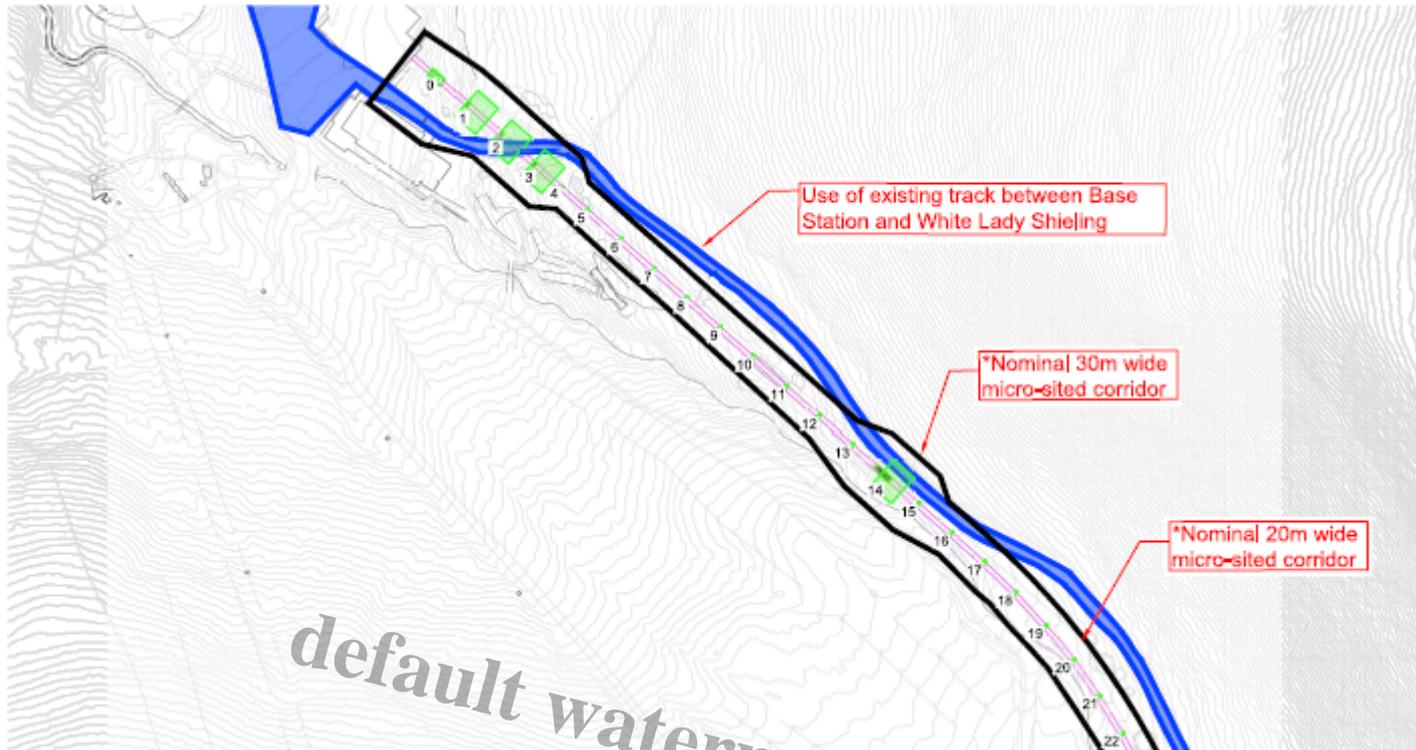
Extract from Planning documents. Green squares indicate work where ground works are planned and include pier 14, an anchor block, but not the ten piers below.

Unfortunately we are unable to do a site visit at present and have been unable to check from photos if it is the only pier in that section that exhibits damage. If it is, then why is it in such poor condition? Above ground work was not included in the planning application to the Cairngorms National Park Authority and because of that it is not clear what superstructural repairs are include in the Â£16m repair to the funicular. Information about that is important for understanding what has gone wrong and why repairs are needed.

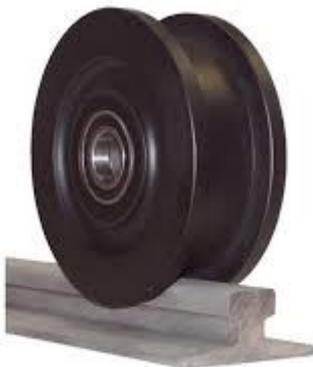
Another problem caused by the wheels is wear and tear on the **sides** of one rail. The wheels on one side of the carriage bogies are double flanged as in the picture below:-

So not only are the wheels on that side wearing the top of the rail, but the sides as well. The funicular could have been not only running on rails which are corrugated on the top, but with wear and tear which would make it rattle from side to side as well! Any vibration and shaking will have been transferred into the piers and bases, and the taller the pier, the worse would be the effect on the foundations.
