Will the repair of the Cairngorm Funicular Railway work (3)?

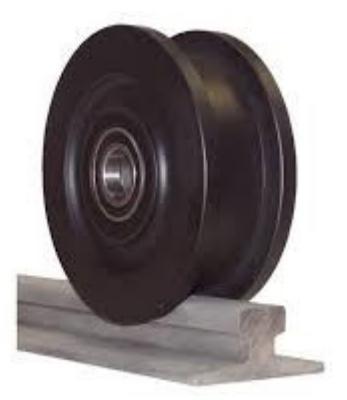
Another problem caused by the wheels is wear and tear on the sides of one rail. The wheels on one side of the carriage bogies are double flanged as in the picture below:-

So not only are the wheels on that side wearing the top of the rail, but the sides as well. The funicular could have been not only running on rails which are corrugated on the top, but with wear and tear which would make it rattle from side to side as well! Any vibration and shaking will have been transferred into the piers and bases, and the taller the pier, the worse would be the effect on the foundations.
