Will the repair of the Cairngorm Funicular Railway work (4)?

Following on from my last post ([see here](#)), which looked at whether vibration from poorly maintained rails could have caused damage to the piers supporting the funicular, this post focuses on the concrete parts of the structure, especially the ends of the “I” support beams and the in-situ blocks. The “I” beams are described as such because of their shape, “I”, when viewed through vertical section while the “in-situ” blocks are so-described because they were poured “in situ” (rather than pre-cast like the “I” beams).

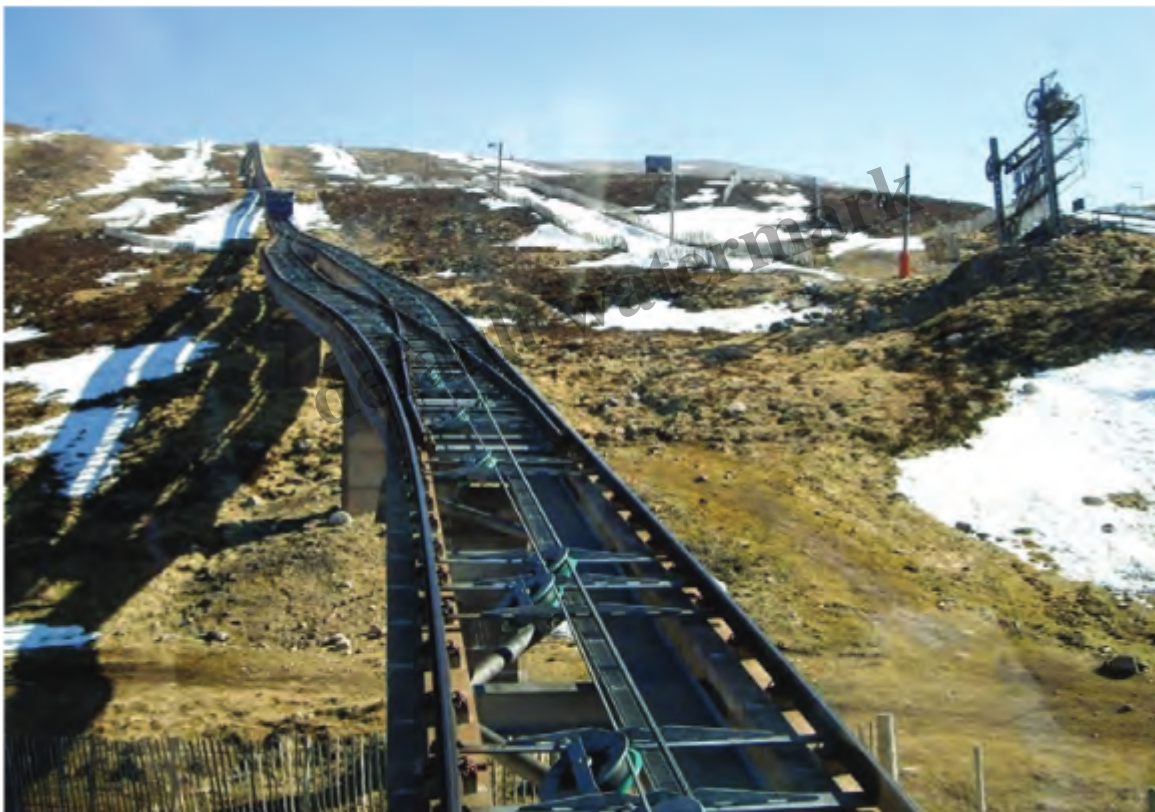
Figure 2-2 Passing loop
Photo credit the COWI report.

The picture above is probably the best one showing the layout of the tracks, including the passing loop, but also shows two piers referred to below. Pier 52 is the one showing to the left of the track with pier 51 just visible between the lower pulley and the next two. The photo also shows how the funicular destroyed Cairn Gorm’s iconic White Lady ski run, one more reason why it should never have been built and should be removed asap.
