Will the repair of the Cairngorm Funicular Railway work (4)?

Following on from my last post ([see here](#)), which looked at whether vibration from poorly maintained rails could have caused damage to the piers supporting the funicular, this post focuses on the concrete parts of the structure, especially the ends of the support beams and the in-situ blocks. The beams are described as such because of their shape, "I", when viewed through vertical section while the in-situ blocks are so-described because they were poured in situ (rather than pre-cast like the beams).

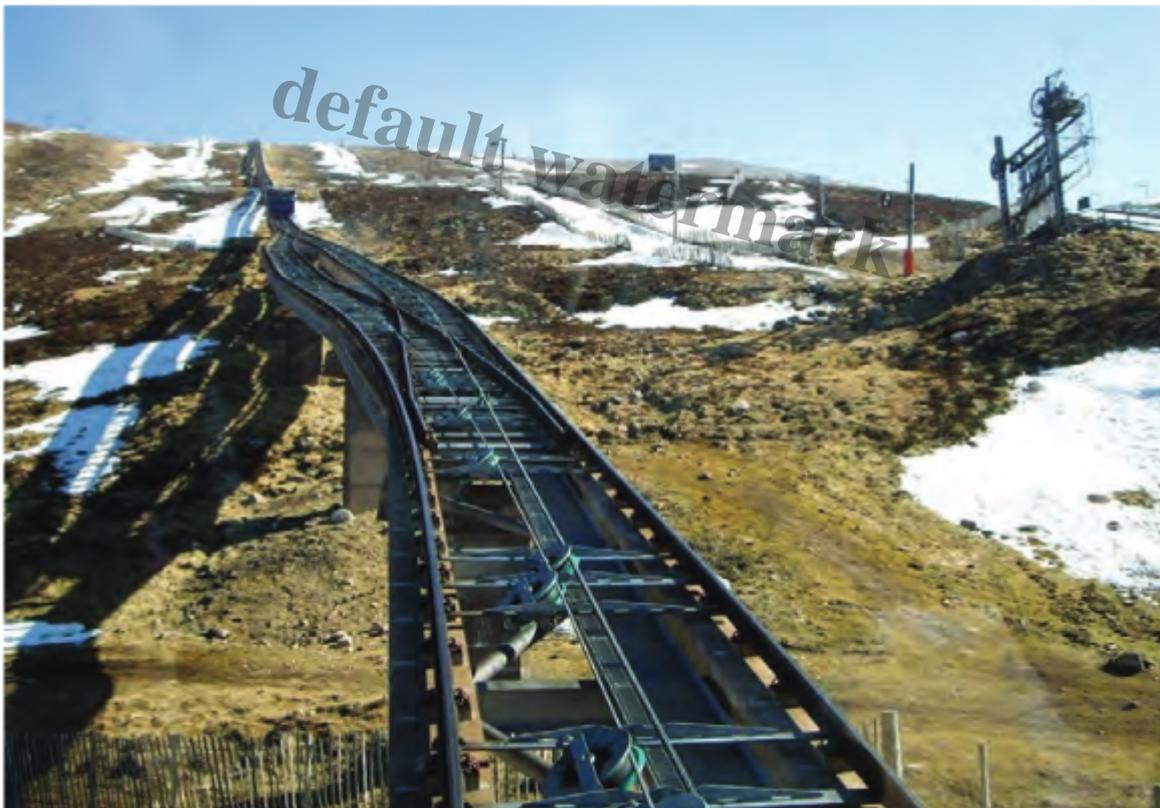
Figure 2-2 Passing loop
Photo credit the COWI report.

The picture above is probably the best one showing the layout of the tracks, including the passing loop, but also shows two piers referred to below. Pier 52 is the one showing to the left of the track with pier 51 just visible between the lower pulley and the next two. The photo also shows how the funicular destroyed Cairn Gorm's iconic White Lady ski run, one more reason why it should never have been built and should be removed asap.
