## The Ben Glas hydro scheme and Glen Falloch five years on – what does the LLTNPA stand for?

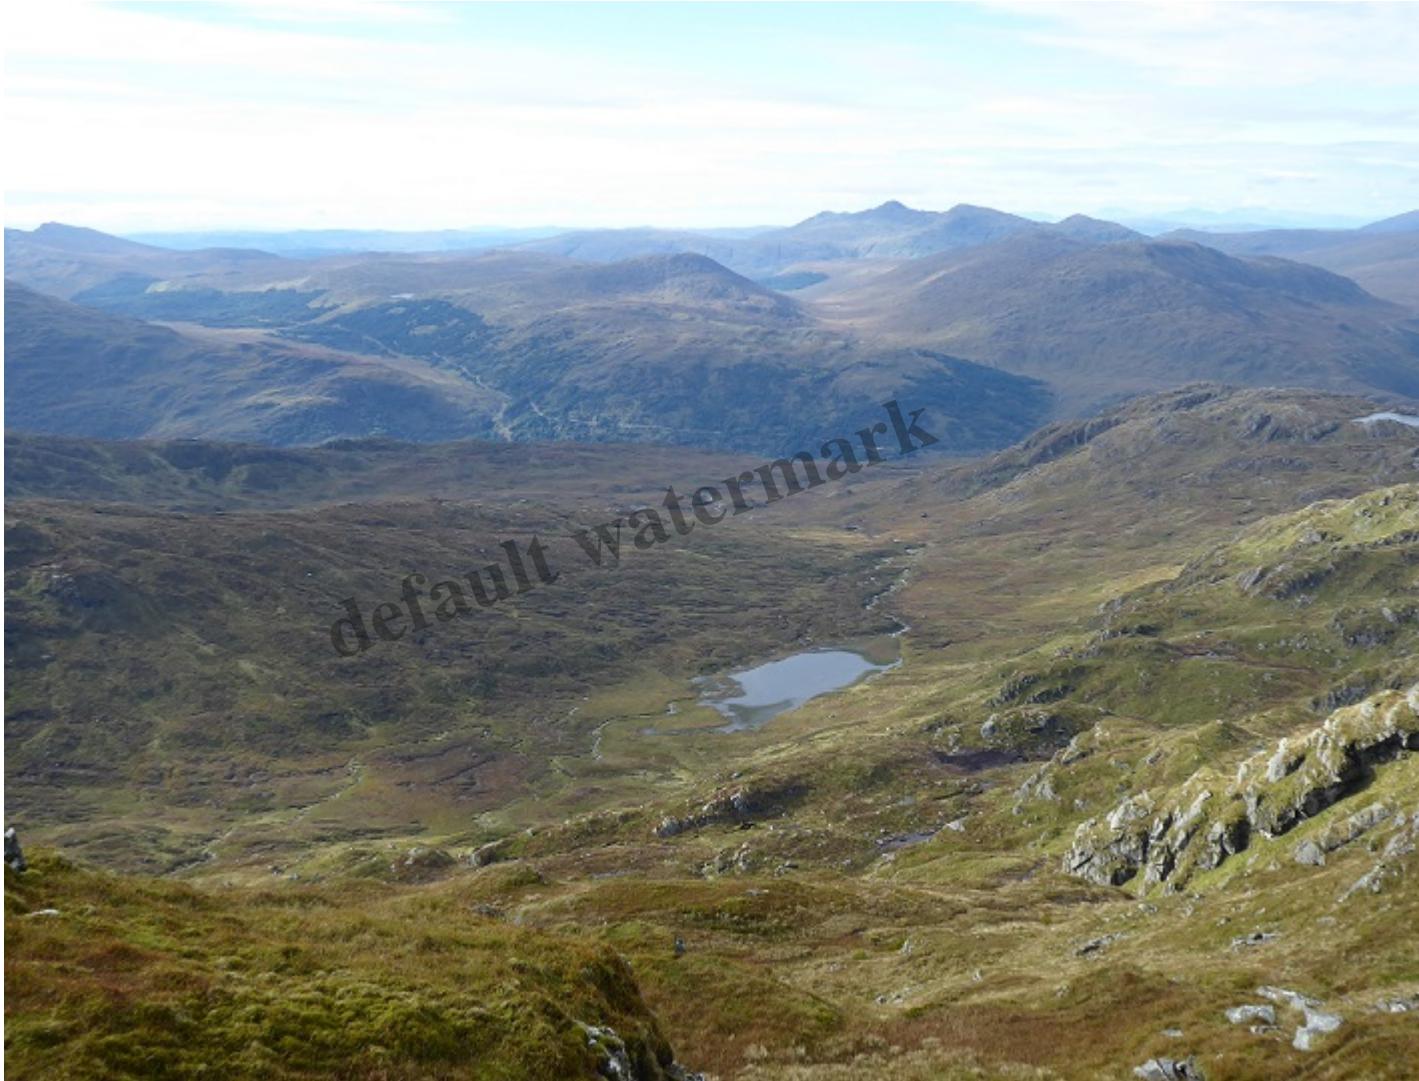
View from upper slopes of Beinn Chabhair out of the wild land area above Eagle Falls and the Ben Glas hydro intakes. Photo Credit Louise Brimelow October 2021.

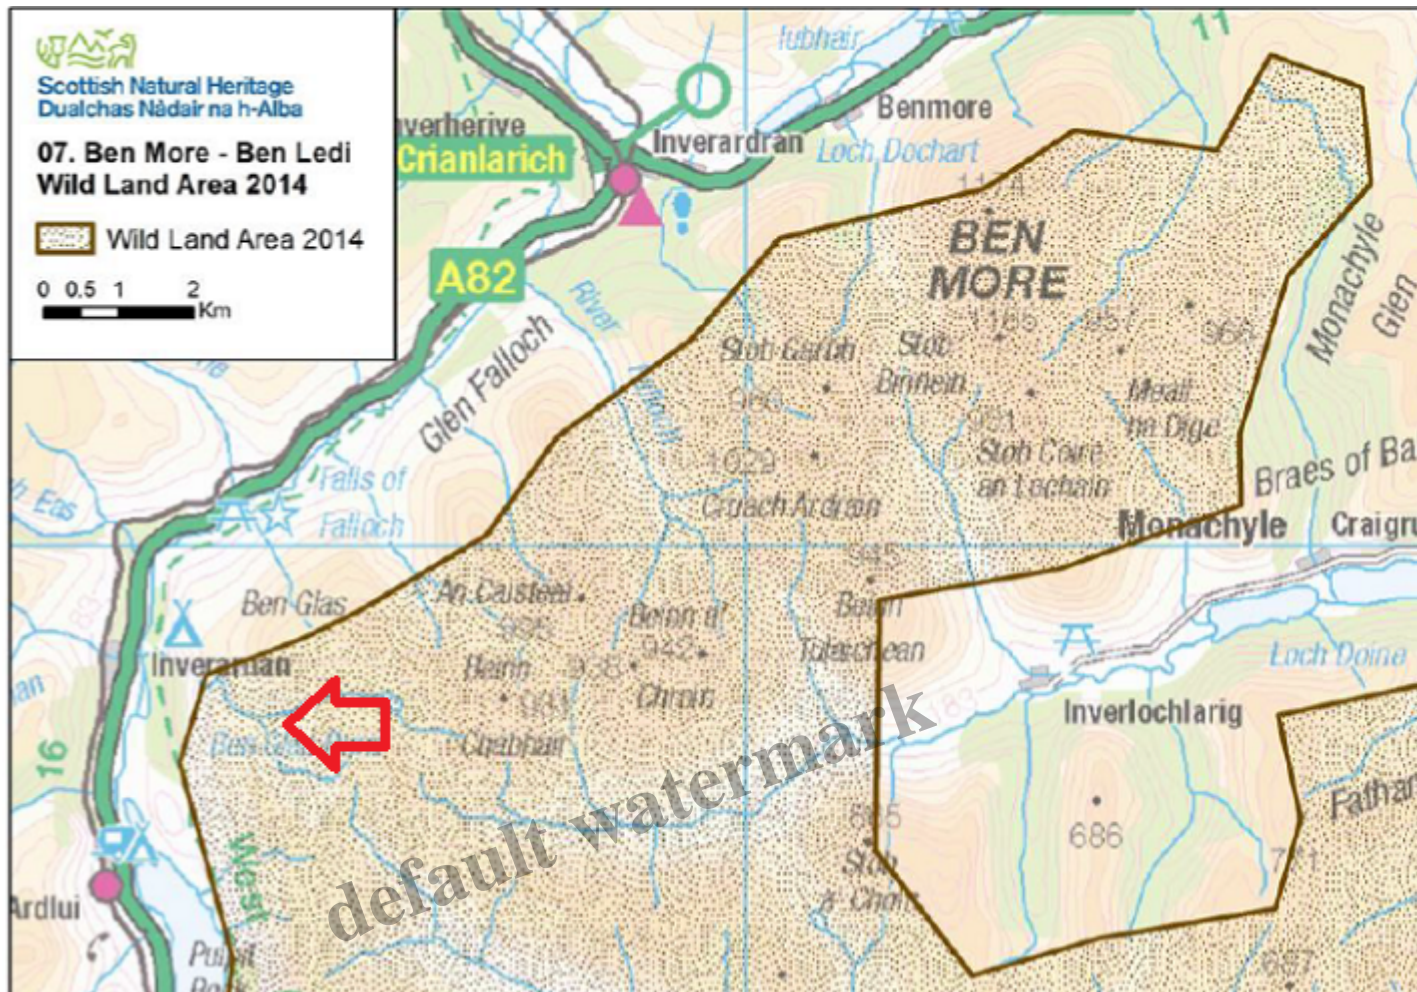
The two intakes are located just above the main fork in the burn which flows over Eagle Falls

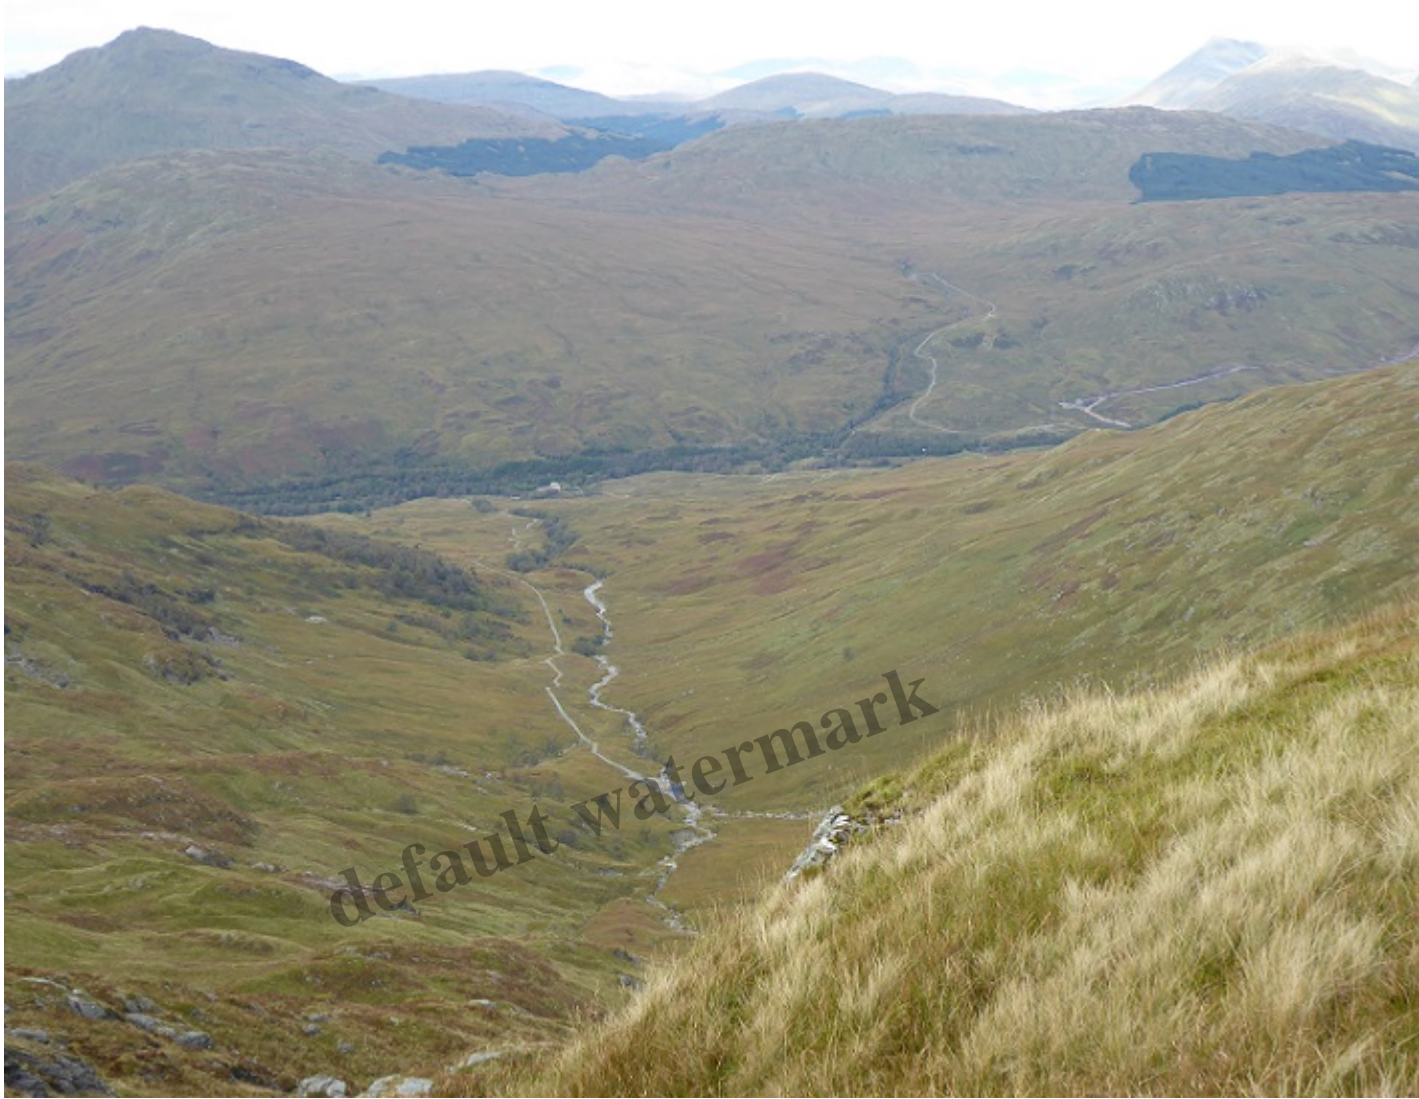
View north from Beinn Chabhair ridge, Beinn Dubhcraig left, Beinn Dorain right.

Across Glen Falloch from the Allt a Chuilinn, the Eas Eonan hydro track runs up to the Ben Lui Wild Area, with the Cononish Goldmine know gnawing into it from the far side. Looking at the photo I was shocked by the visual impact of the new track just to its right. This has been constructed as part of Scottish and Southern Energy (SSE)'s VISTA project intended to reduce the visual impact of overhead powerlines by burying them.
