The Ben Glas hydro scheme and Glen Falloch five years on â?? what does the LLTNPA stand for?

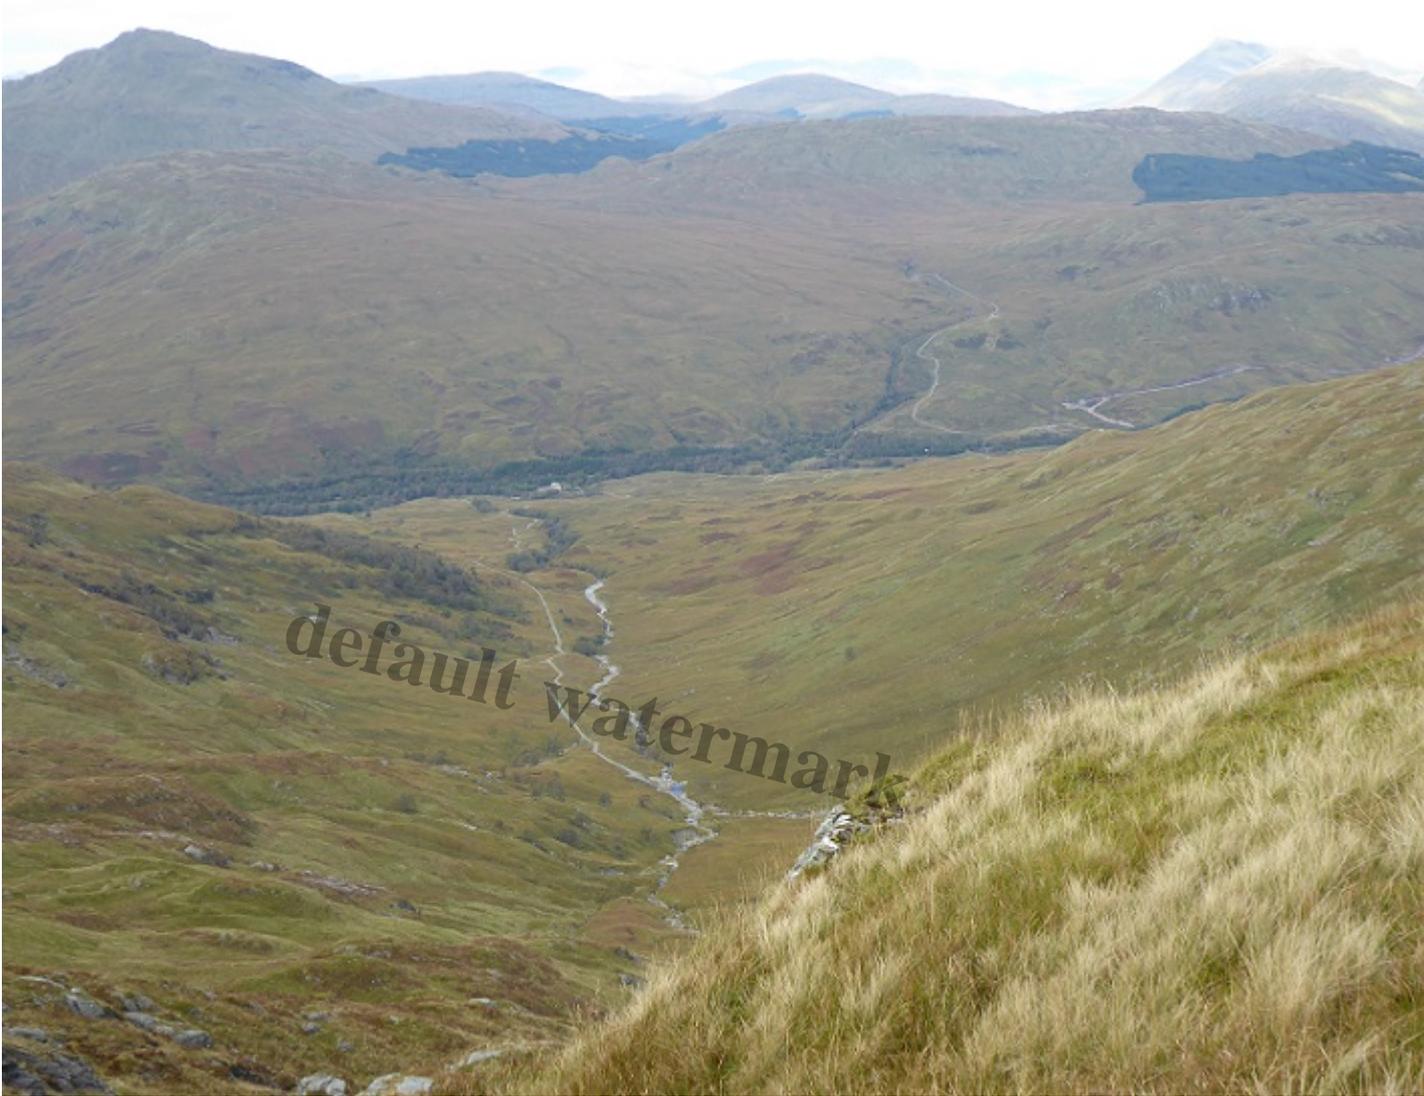
View north from Beinn Chabhair ridge, Beinn Dubhcraig left, Beinn Dorain right.

Across Glen Falloch from the Allt a Chuilinn, the Eas Eonan hydro track runs up to the Ben Lui Wild Area, with the Cononish Goldmine know gnawing into it from the far side. Looking at the photo I was shocked by the visual impact of the new track just to its right. This has been constructed as part of Scottish and Southern Energy (SSE)'s VISTA project intended to reduce the visual impact of overhead powerlines by burying them.
