Further photos of the hydro destruction in Glen Etive – the Allt Chaorainn

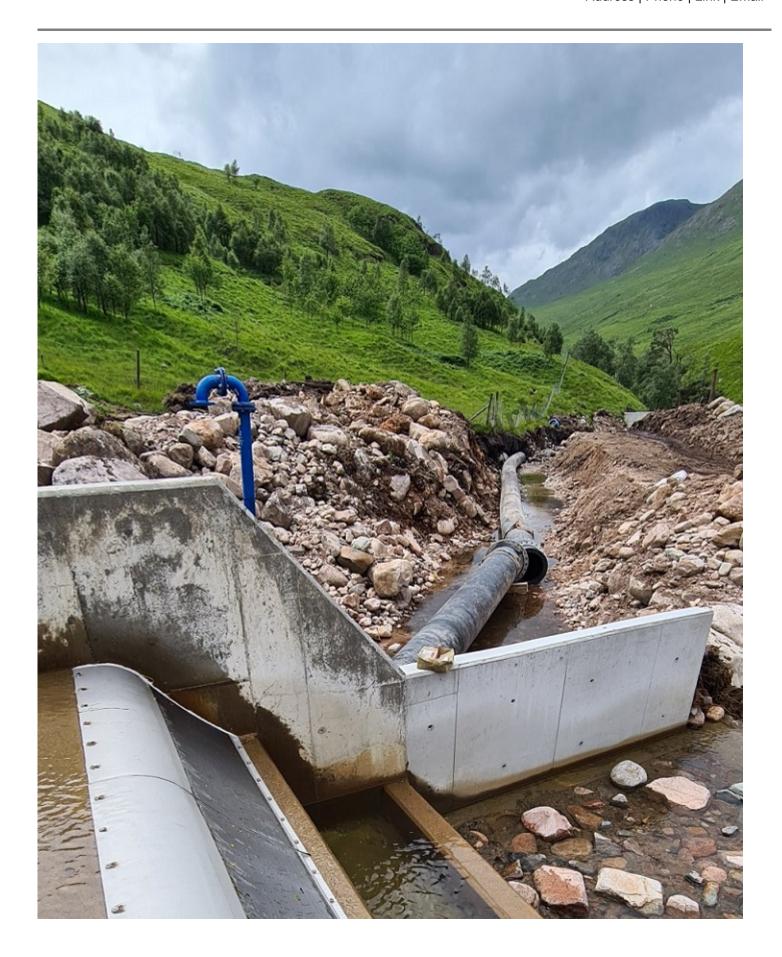
"There are 2 (forgive me for not getting the technical terms correct) water extraction points. As I understand it, one minor [ed "secondary is probably a more accurate term] one on the Allt Coire Ghiubhasan at grid NN 19923 50015 and the second, main one, at grid NN 19881 49992. There is a feeder from the minor to the main extraction and from there the combined waters run down the hill to the control station."
