Further photos of the hydro destruction in Glen Etive â?? the Allt Chaorainn

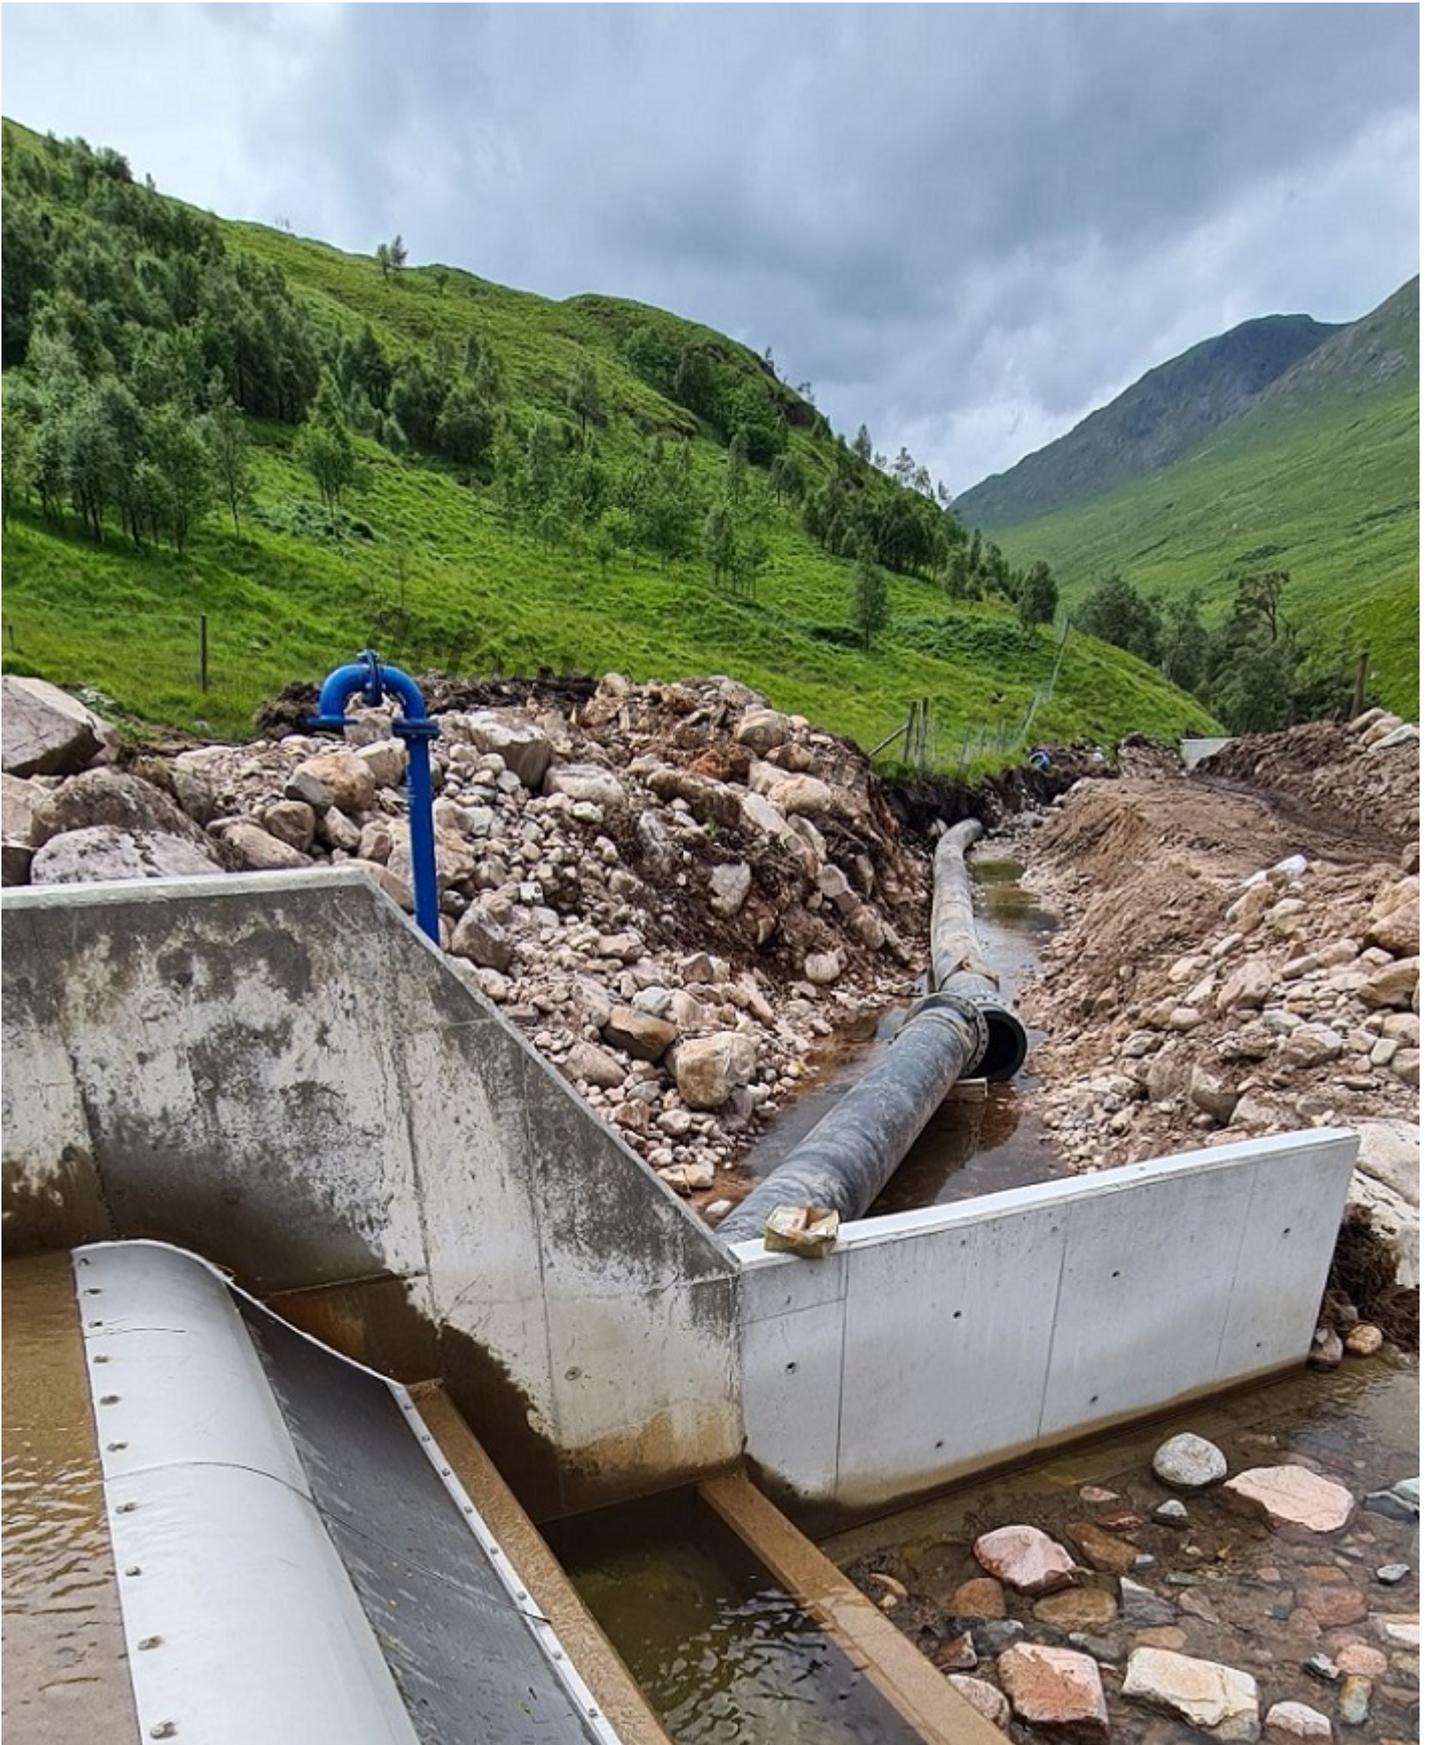
â??There are 2 (forgive me for not getting the technical terms correct) water extraction points. As I understand it, one minor [ed â??secondary is probably a more accurate term] one on the Allt Coire Ghiubhasan at grid NN 19923 50015 and the second, main one, at grid NN 19881 49992. There is a

feeder from the minor to the main extraction and from there the combined waters run down the hill to the control station.â?•
