## Further photos of the hydro destruction in Glen Etive – the Allt Chaorainn

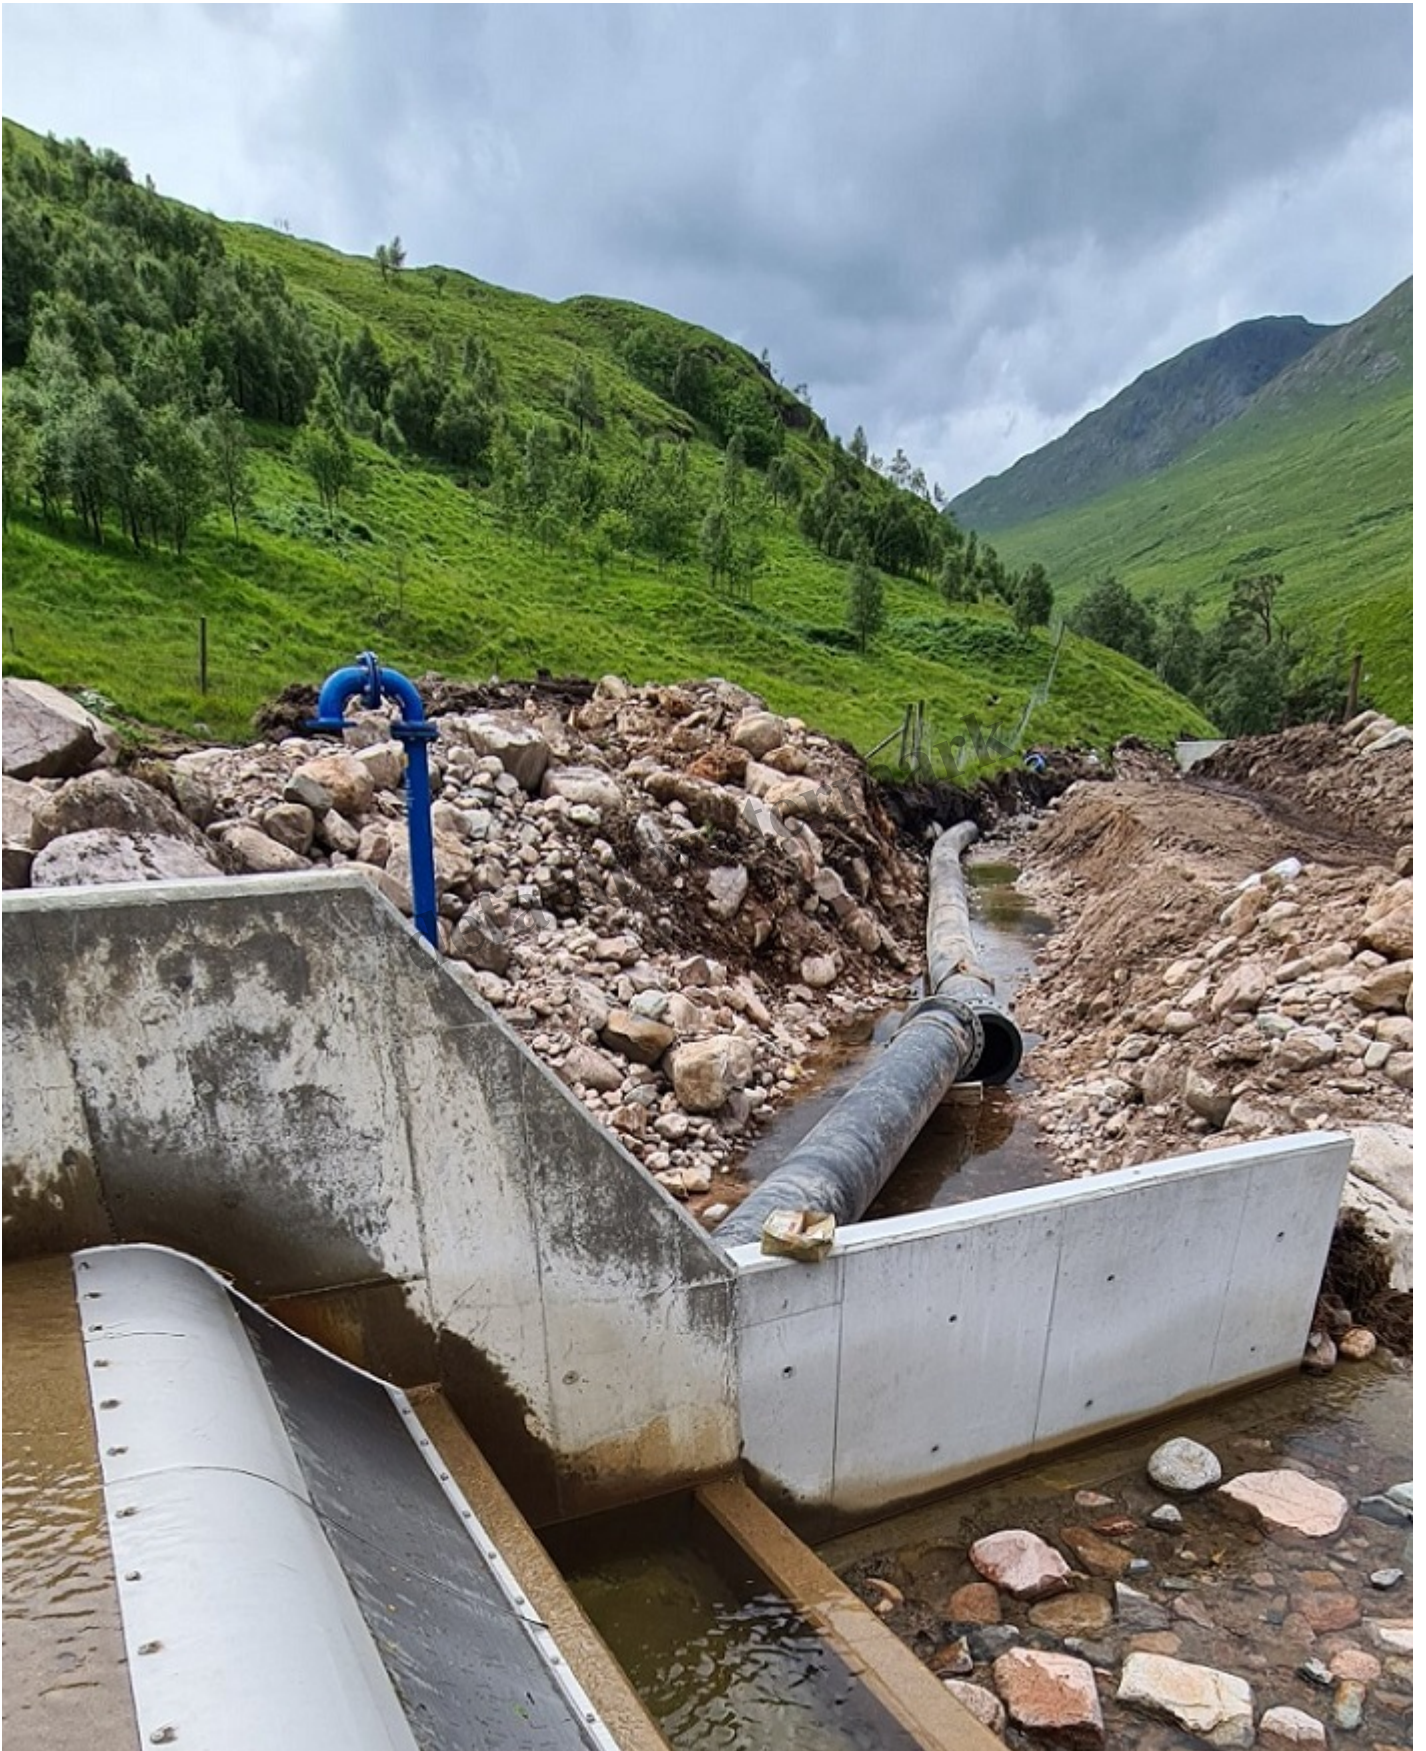
*“There are 2 (forgive me for not getting the technical terms correct) water extraction points. As I understand it, one minor [ed “secondary is probably a more accurate term] one on the Allt Coire Ghiubhasan at grid NN 19923 50015 and the second, main one, at grid NN 19881 49992. There is a feeder from the minor to the main extraction and from there the combined waters run down the hill to the control station.”*
