## The Strengthening Works on the funicular railway.

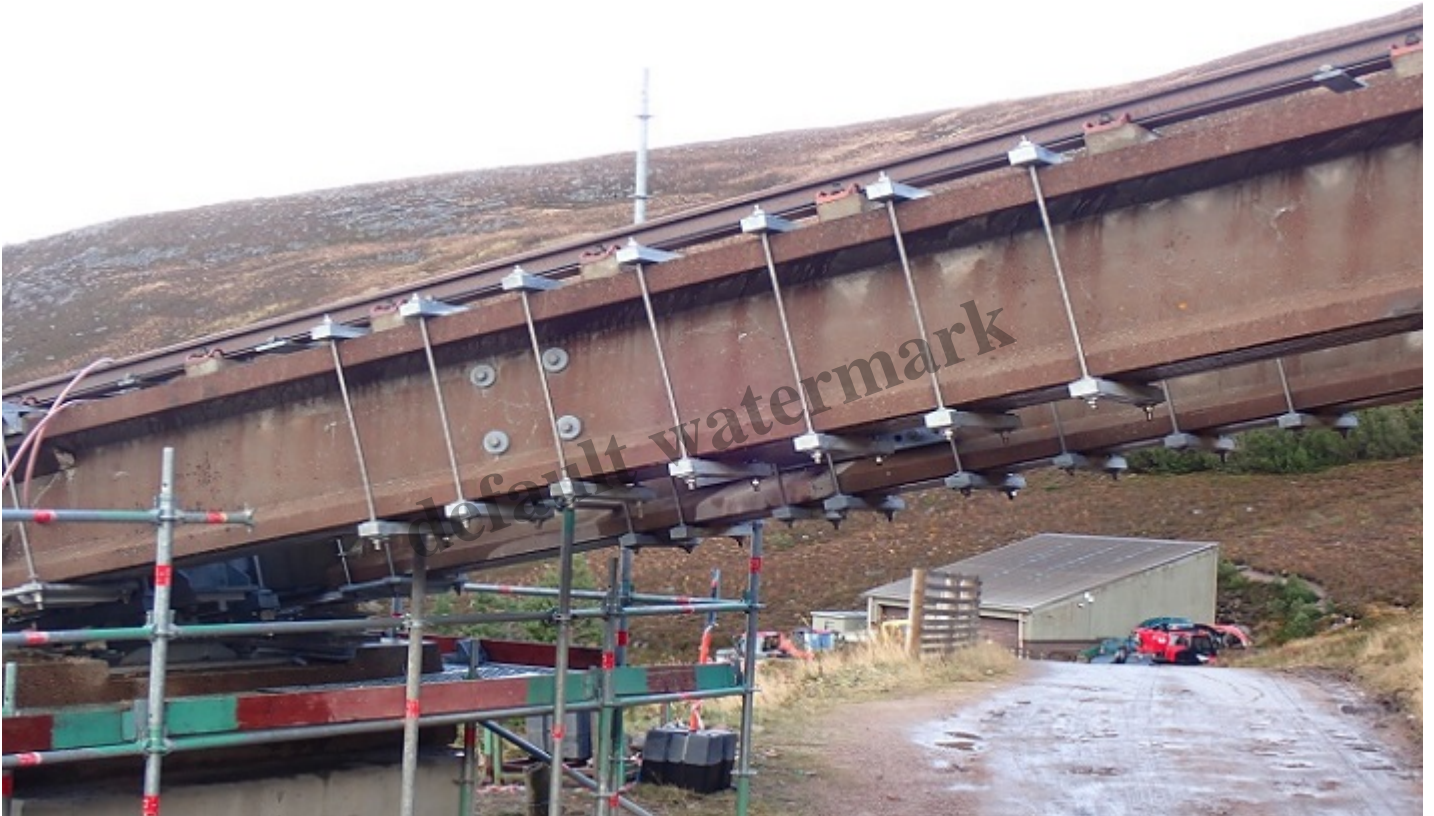
When I commented on this picture in my second post on the funicular court cases ([see here](#)) I had not realised that there are two different types of brackets holding the beams together. The second type can just be seen at the very edge of the left hand side, but, is better seen in this picture of pier 60 which appeared on social media last Saturday:-
