## HIE, concrete and the death of Cairn Gorm as a ski resort (2)?

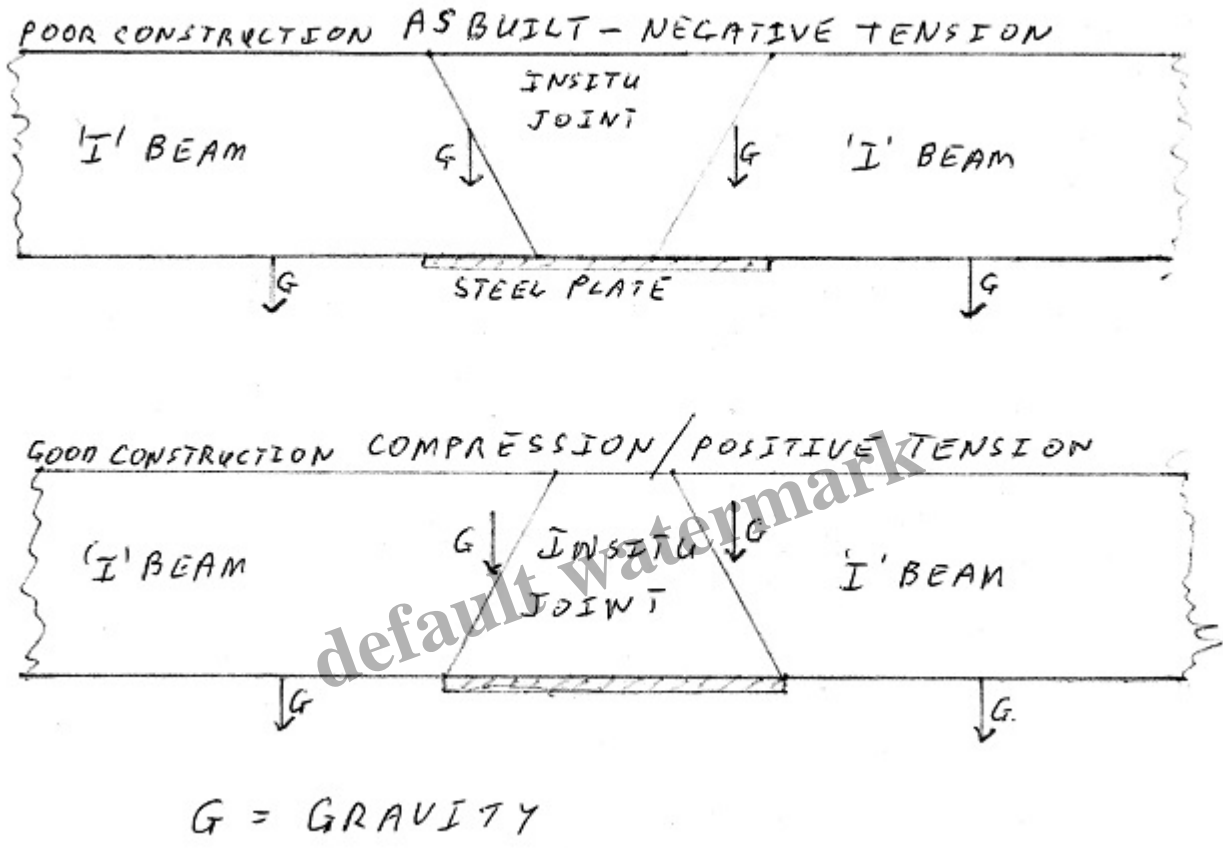
After my last post I had conversations with a couple of people about my conclusions that the insitu stitch/ joints are the wrong way up, i.e. instead of the joint being wedge shaped, as in the picture above, it should be more of a pyramid, as in my drawing below.

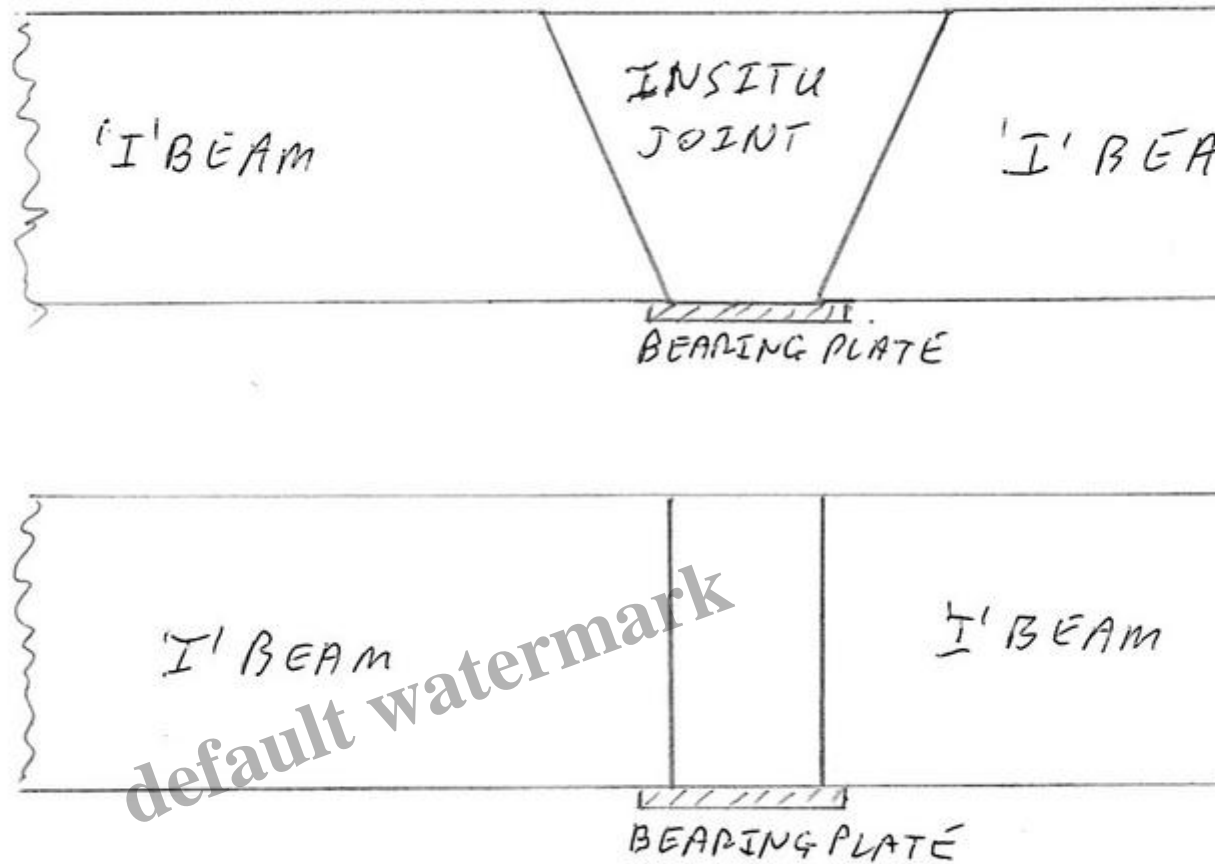
Having said that, there is a third option, the beams could have been made with straight, vertical ends, as shown below,

The bearing plate is the same length but supporting the whole end of each beam. A better design would be longer
