Flood prevention failure in the Cairngorms – the River Gynack overflow channel

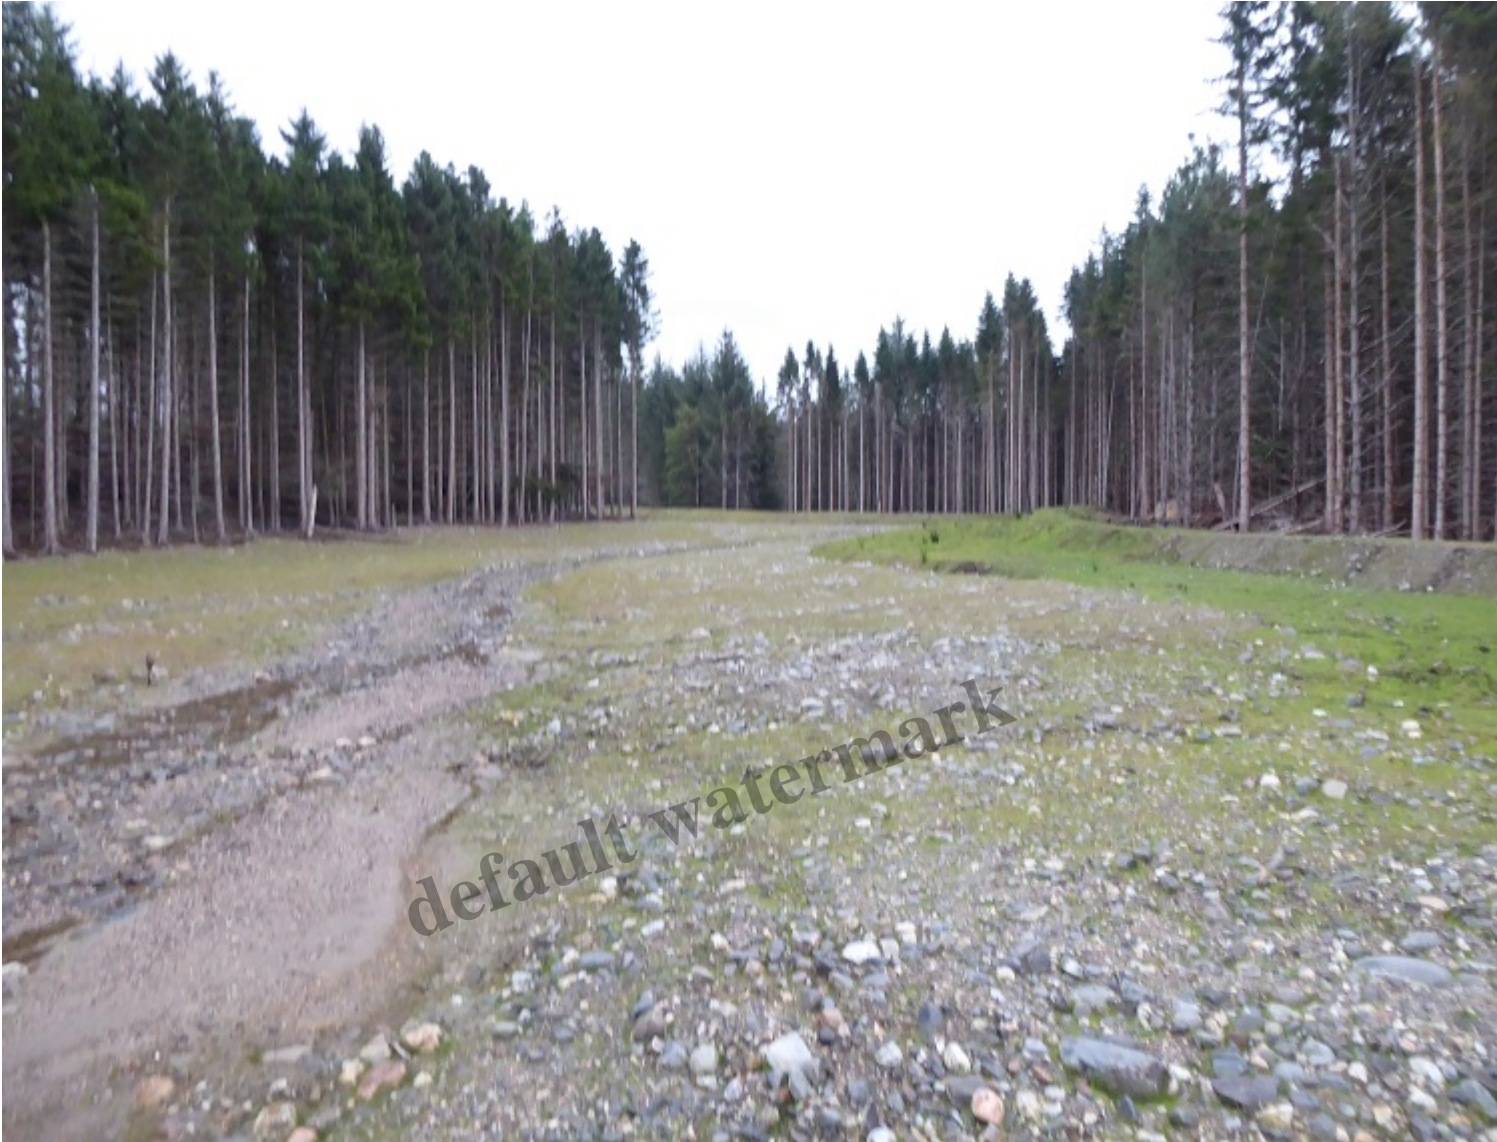
The lower section of the overflow channel appears more likely to work. Except where undercut, grass covered earth banks are generally quite resistant to floods, shedding the water. The reason the banks failed previously was not just that they were bare, they were also formed out of light peaty soil, an unsuitable growing medium, and placed far too close together.

Whether the widely spaced earth banks will work depends on the volume of water that gets into the channel. While the intake from the Gynack is limited in size, the first burn that flows into the overflow can be sizeable in flood:
