Flood prevention failure in the Cairngorms â?? the River Gynack overflow channel

November 22, 2023

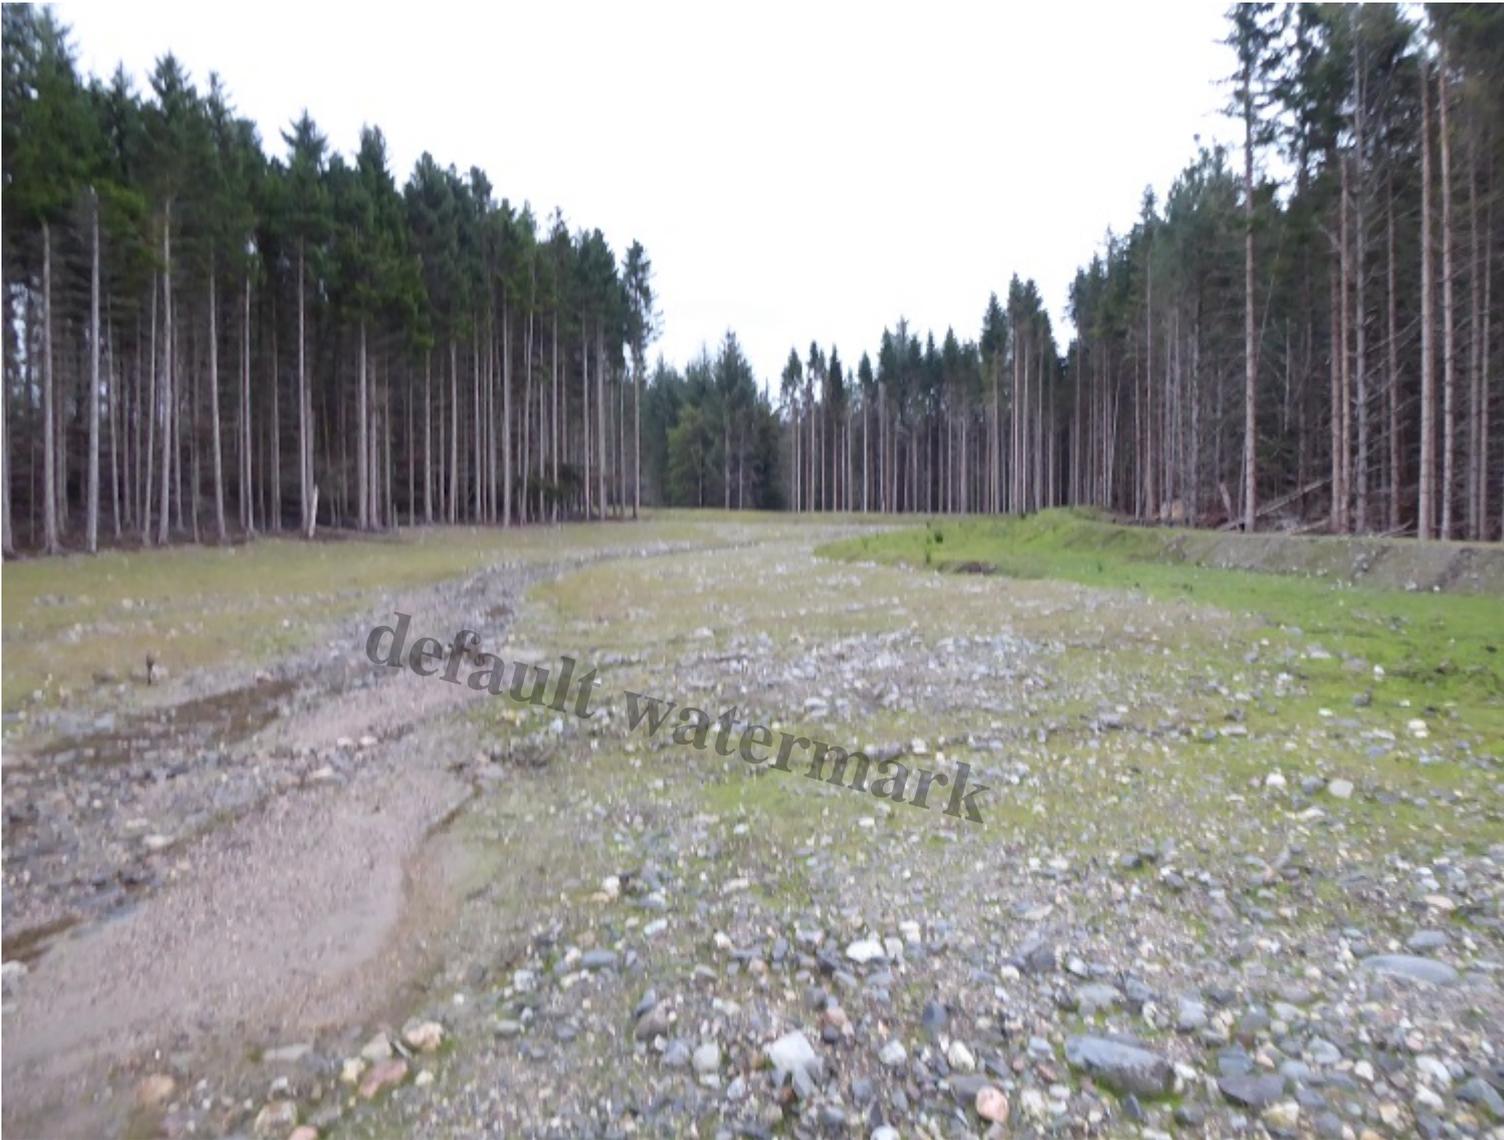
The lower section of the overflow channel appears more likely to work. Except where undercut, grass covered earth banks are generally quite resistant to floods, shedding the water. The reason the banks failed previously was not just that they were bare, they were also formed out of light peaty soil, an unsuitable growing medium, and placed far too close together.

Whether the widely spaced earth banks will work depends on the volume of water that gets into the channel. While the intake from the Gynack is limited in size, the first burn that flows into the overflow can be sizeable in flood:
