HIE's decision to close the Cairn Gorm funicular again (3)

### (A) The steel strengthening brackets

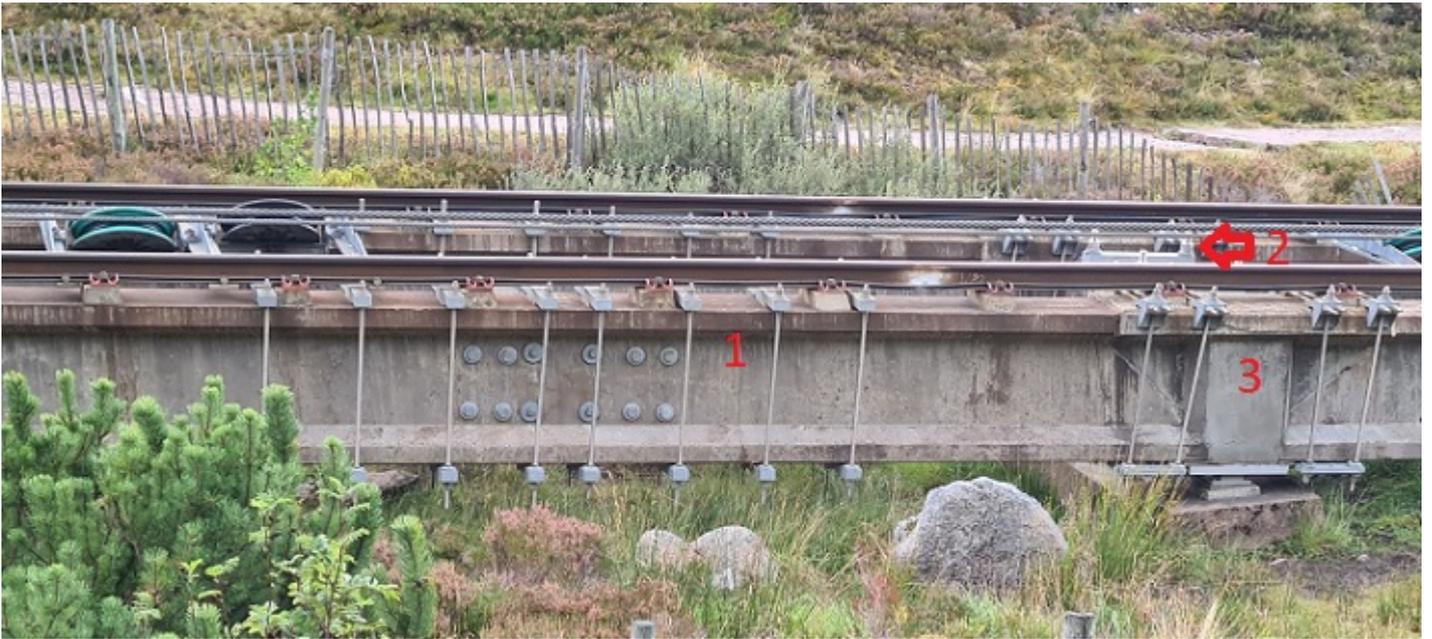
Type 3. The brackets around the scarf joint, more clearly seen on the right of the next picture.

As far as I can determine from surveys taken in January and February 2023 the following number of brackets have been added to the funicular structure:

Type 1 no. 917;

Type 2 no. 179;

Type 3 no. 333.

Total no 1429.
