HIE's decision to close the Cairn Gorm funicular again (3)

(A) The steel strengthening brackets

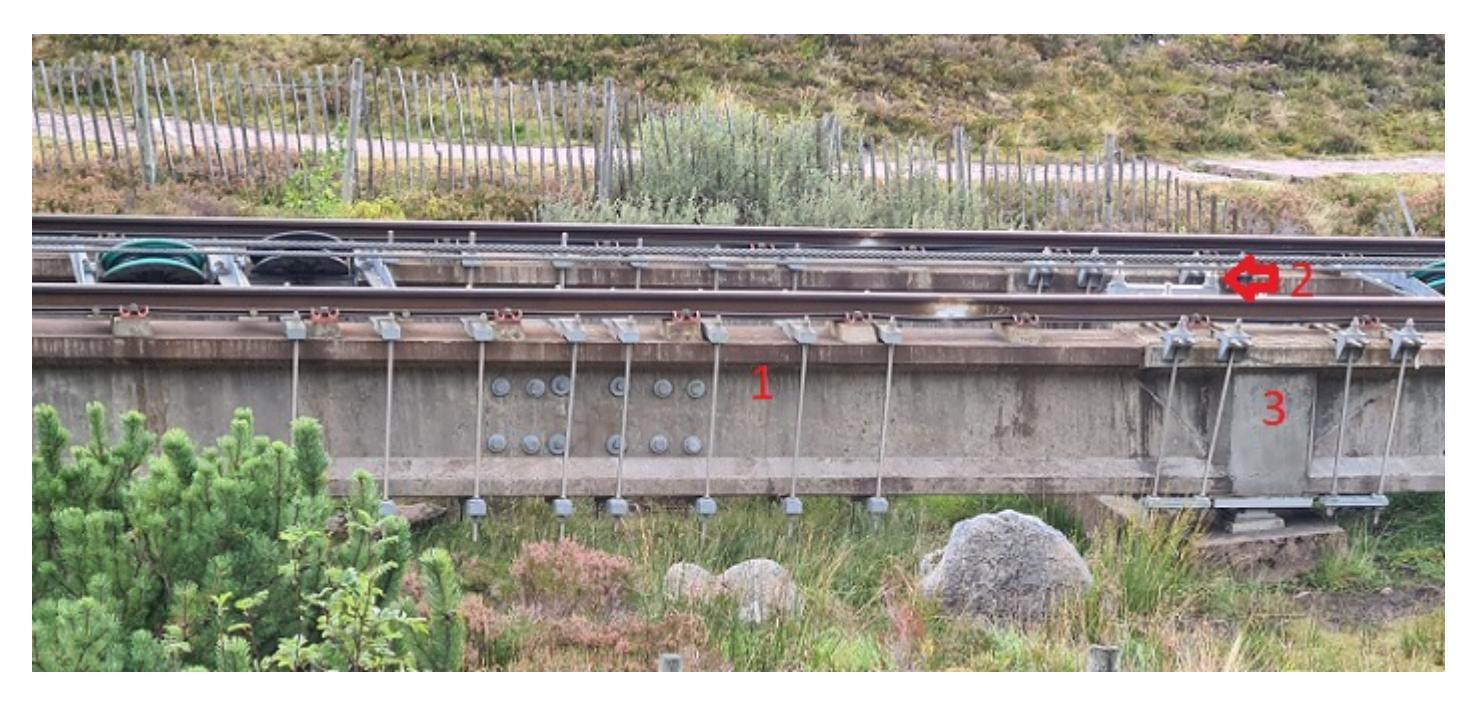
This picture shows the three different types of bracket used in the strengthening works.

- Type 1. The bracket in the foreground (used in the central section of the "I" beam
- Type 2. The brackets around the insitu block either side of the number 23
- Type 3. The brackets around the scarf joint, more clearly seen on the right of the next picture.
