HIE's decision to close the Cairn Gorm funicular again (3)

(A) The steel strengthening brackets

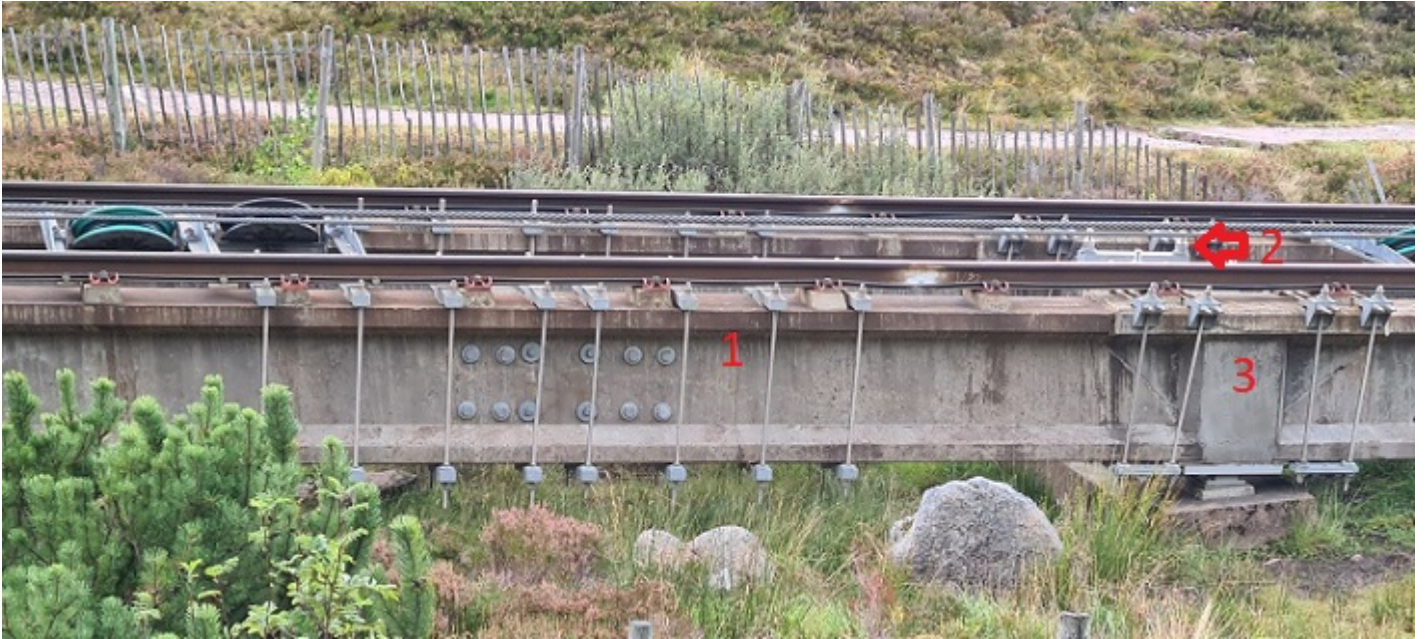
Type 3. The brackets around the scarf joint, more clearly seen on the right of the next picture.

As far as I can determine from surveys taken in January and February 2023 the following number of brackets have been added to the funicular structure:

Type 1... no. 917;

Type 2... no. 179;

Type 3... no. 333.

Total ... no 1429.
