The further potential for undergrounding powerlines in our National Parks and the example of Glen Tromie

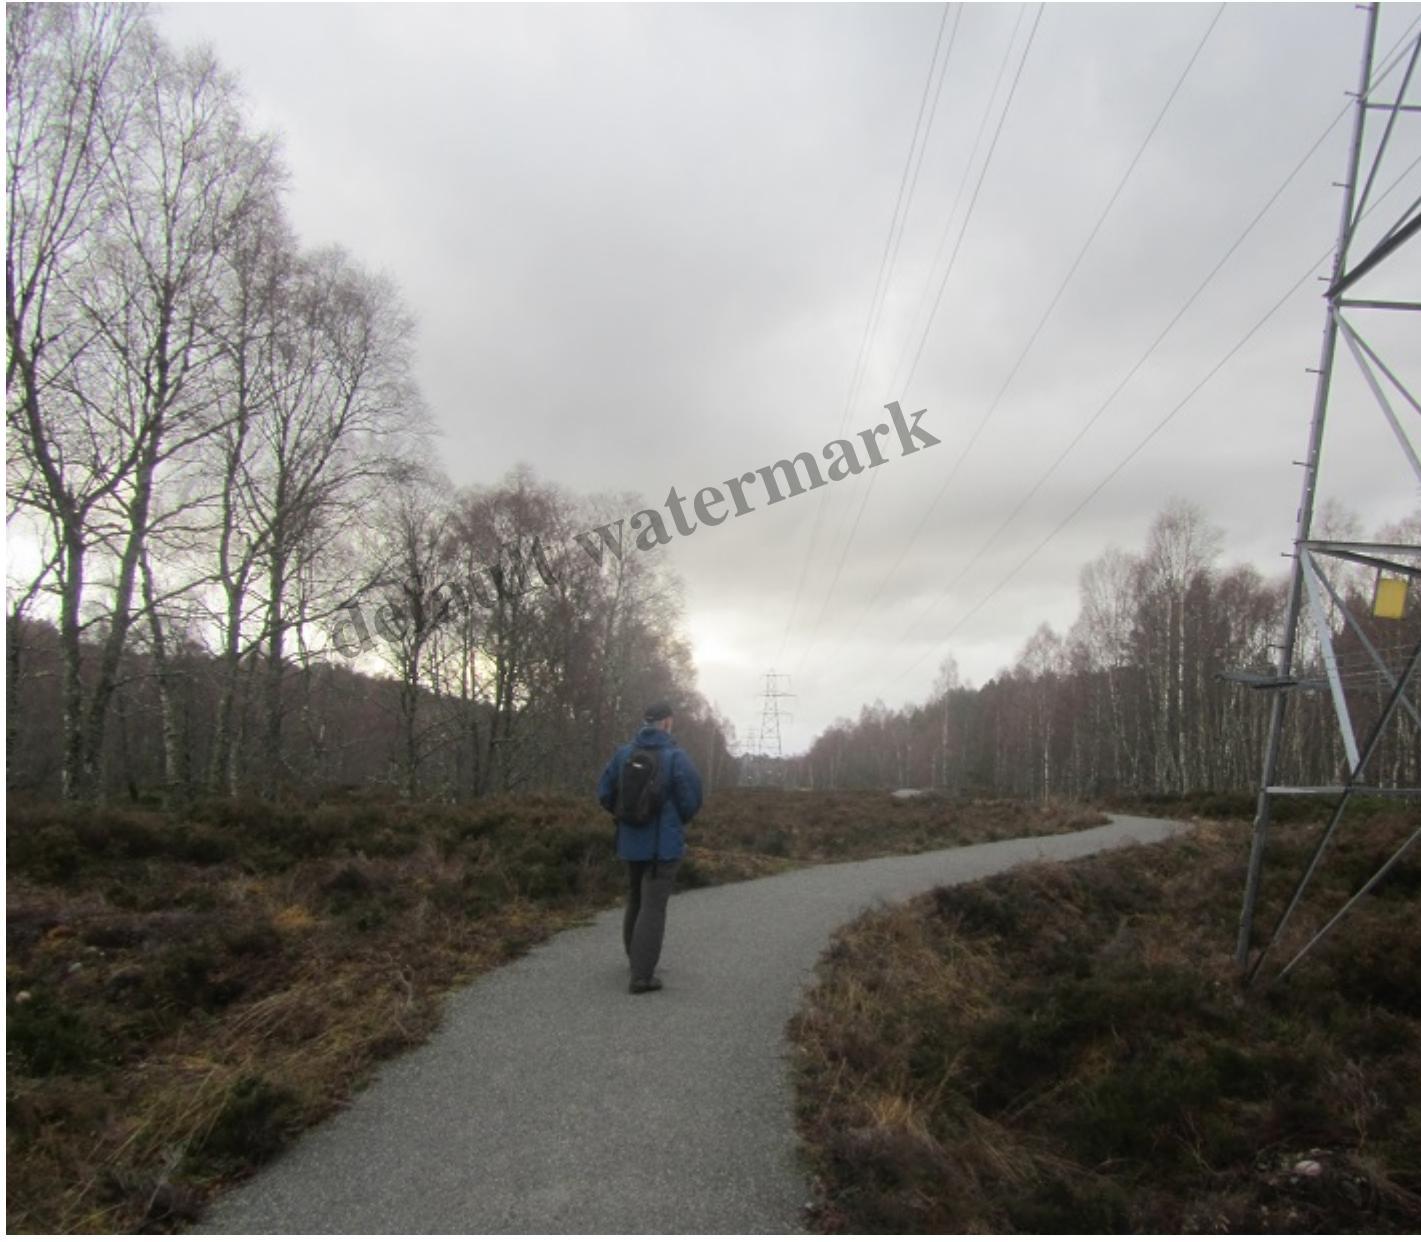
The powerlines which blighted the Speyside Way extension south of Aviemore have now been remo

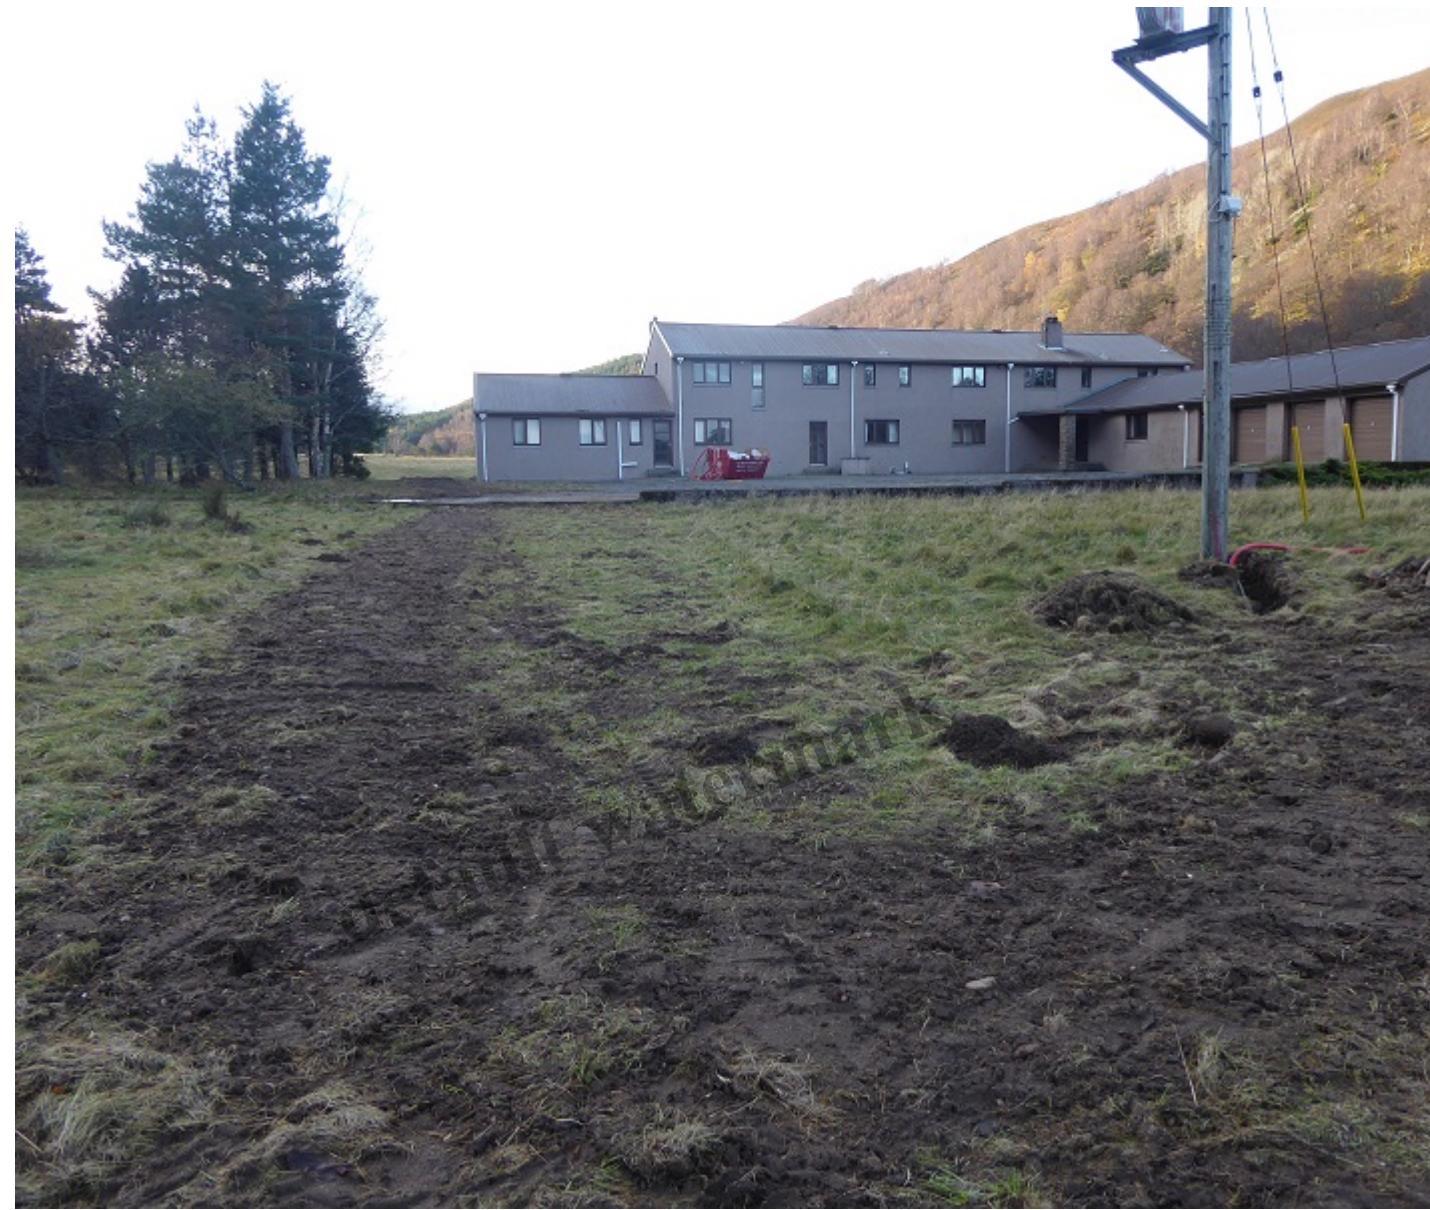
The current work to underground the Glen Tromie powerline starts at the hideous Lynaberack Lodge Tromie. The ground here, where the undergrounded line joins with the overhead powerline, is more than almost anywhere else along the route.

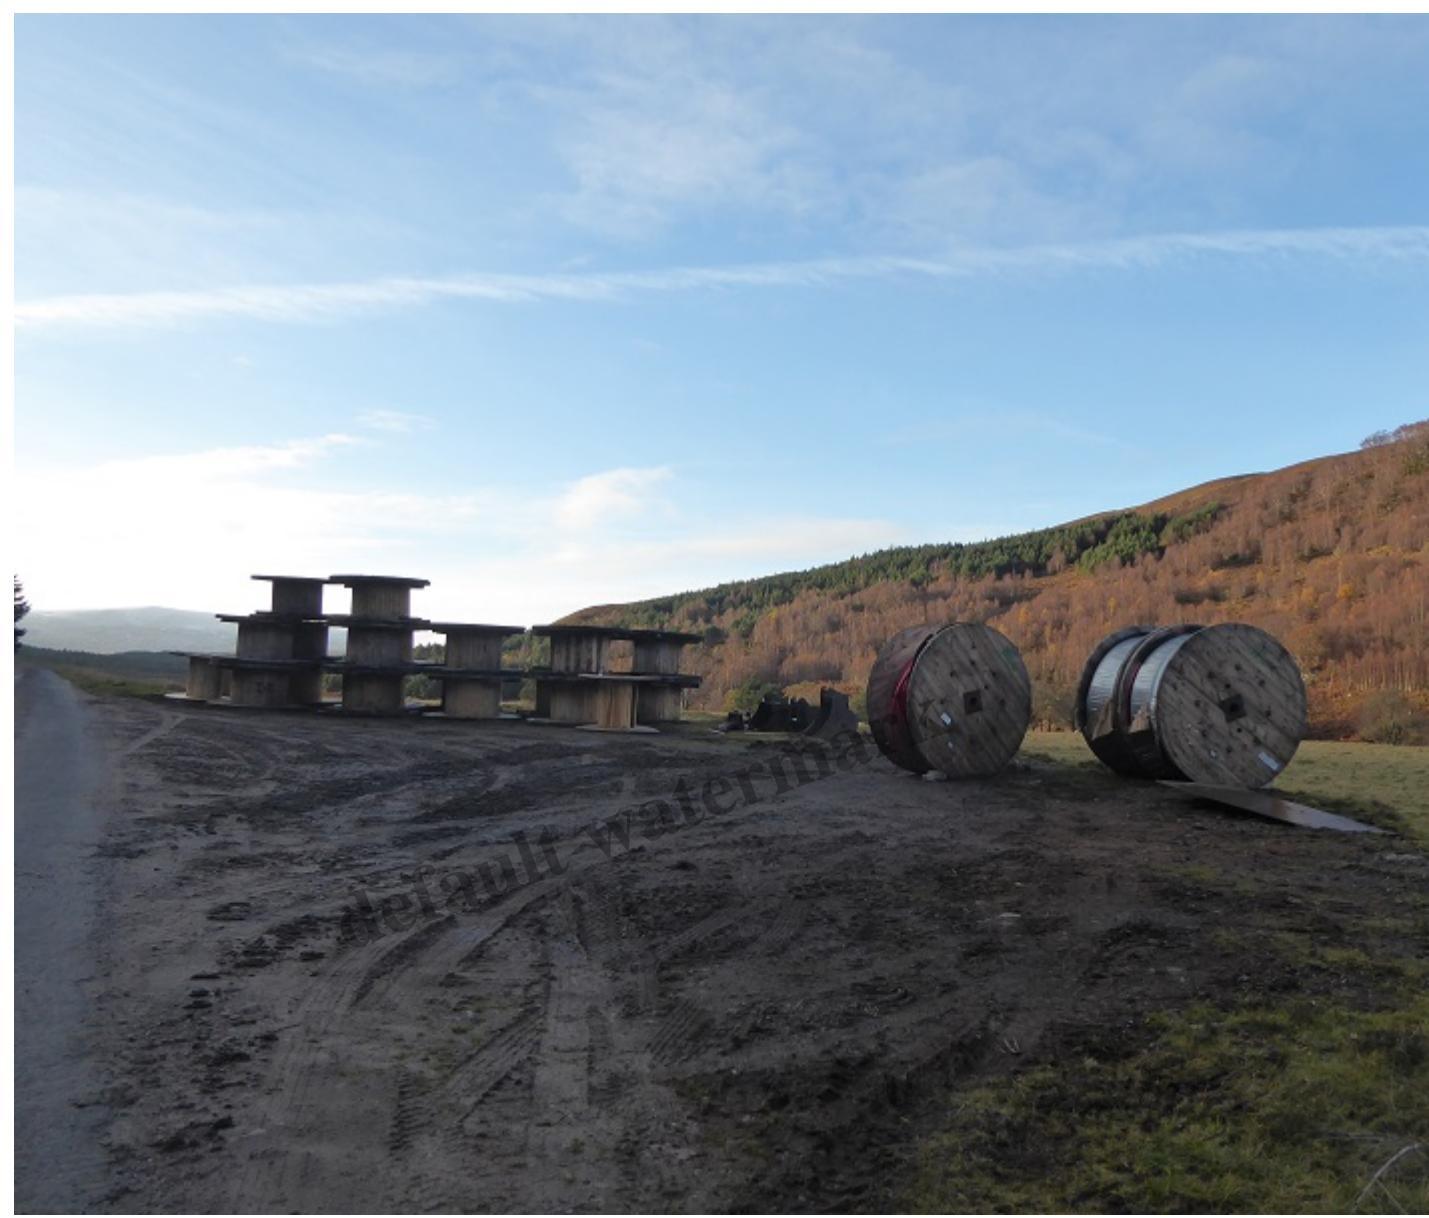
Evidence of the amount of new electric cable which has been undergrounded

The work is not yet complete. While the contractors have buried the new cable, it is not yet connected and removal of the existing powerline and clear-up has still to happen. The advantage,in terms of the timing of my visit, was I could record the landscape impact of the existing powerline.

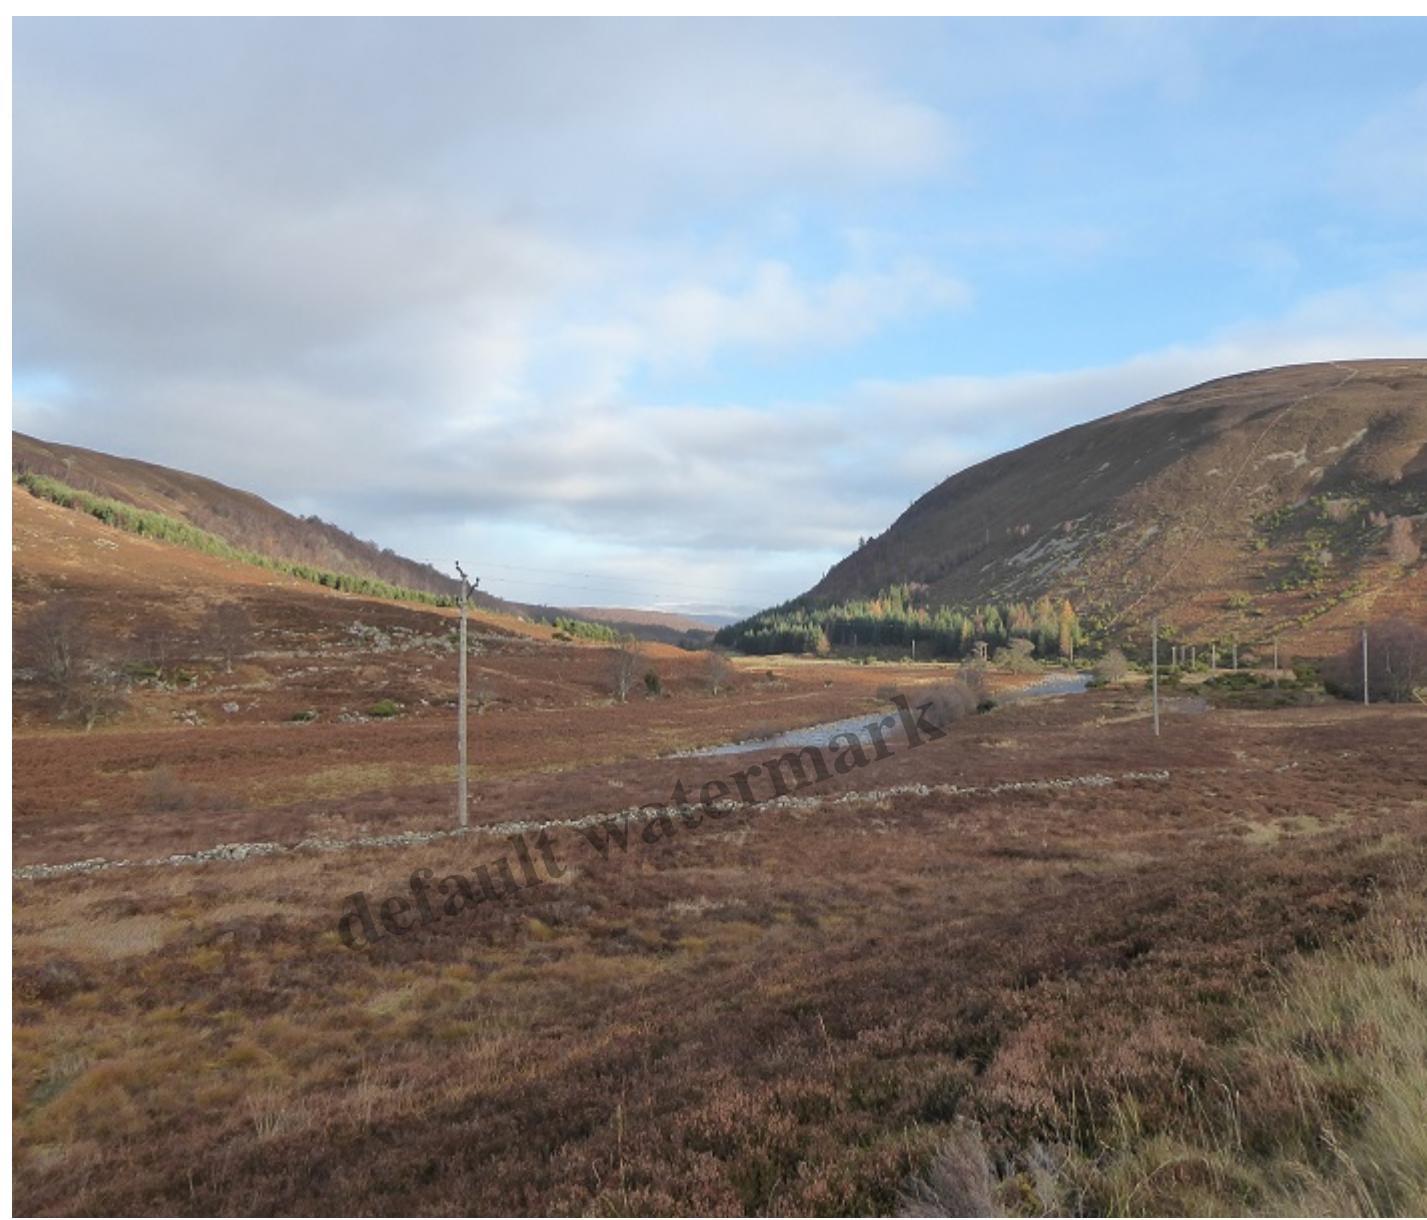
The road is just to the right of the photo

Imagine the difference, when this section of powerline is removed. While there is still a road running up the glen, to the person walking or cycling along it the view will feel significantly wilder.

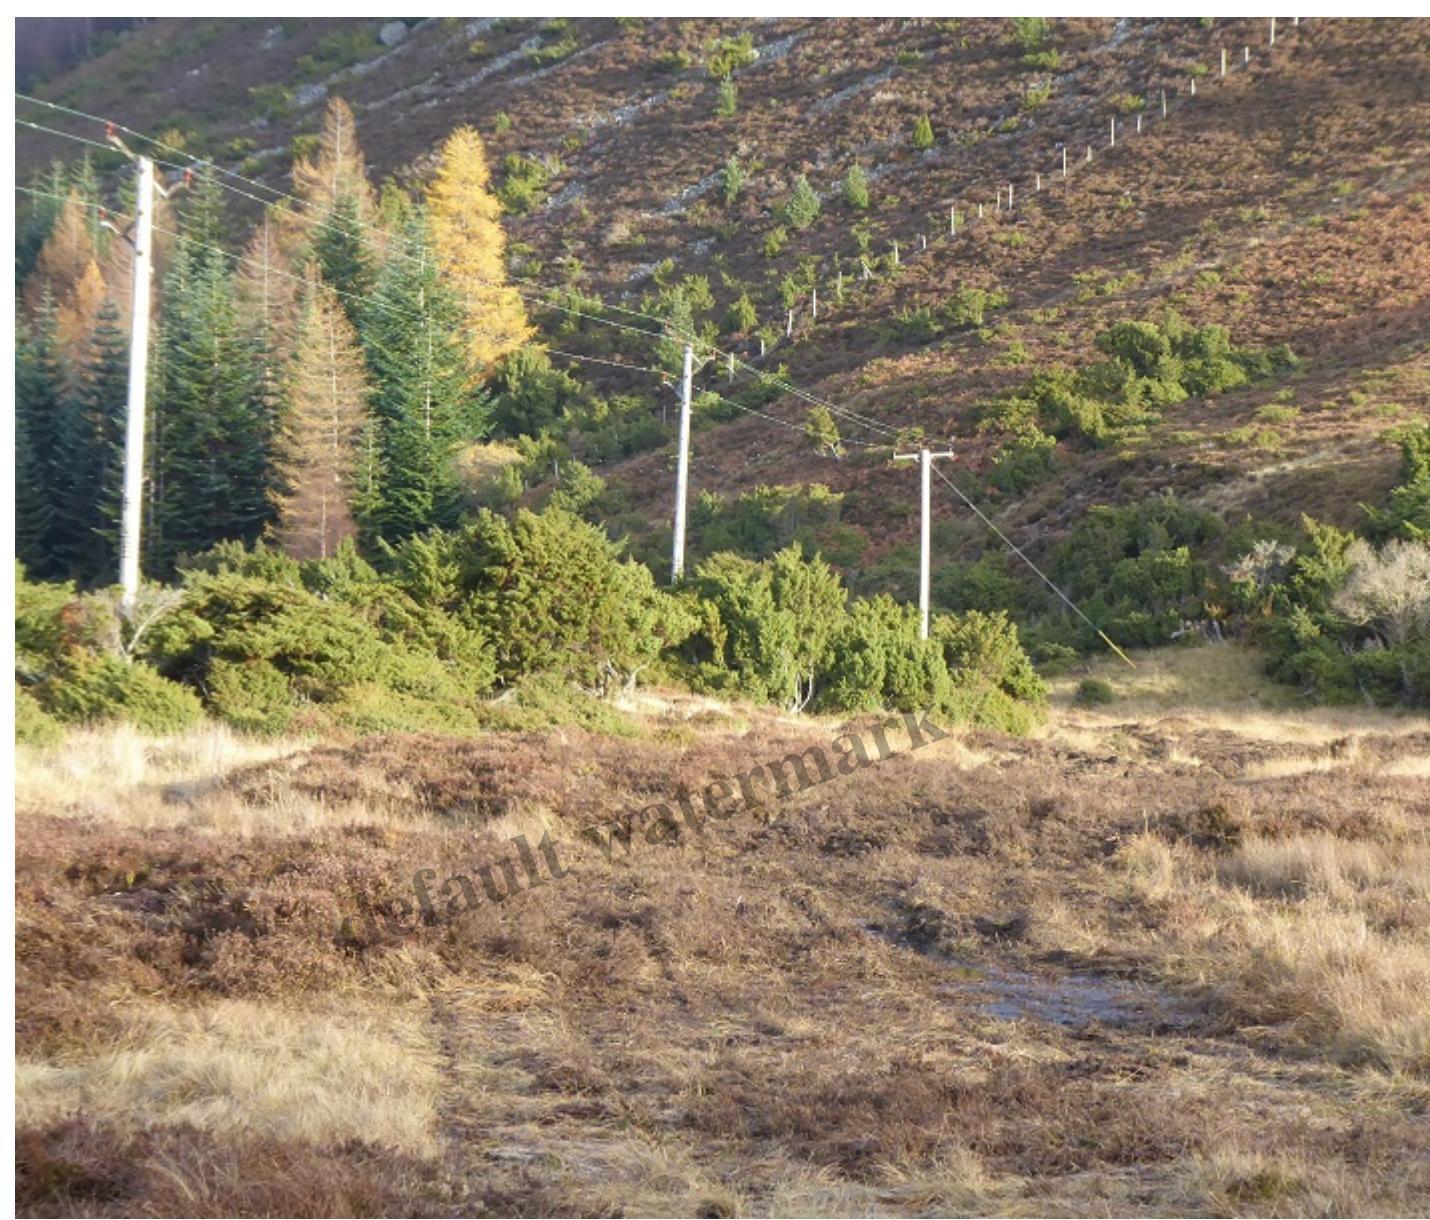
The new powerline, which lies beneath the vehicle track starting bottom centre, will replace the pylor

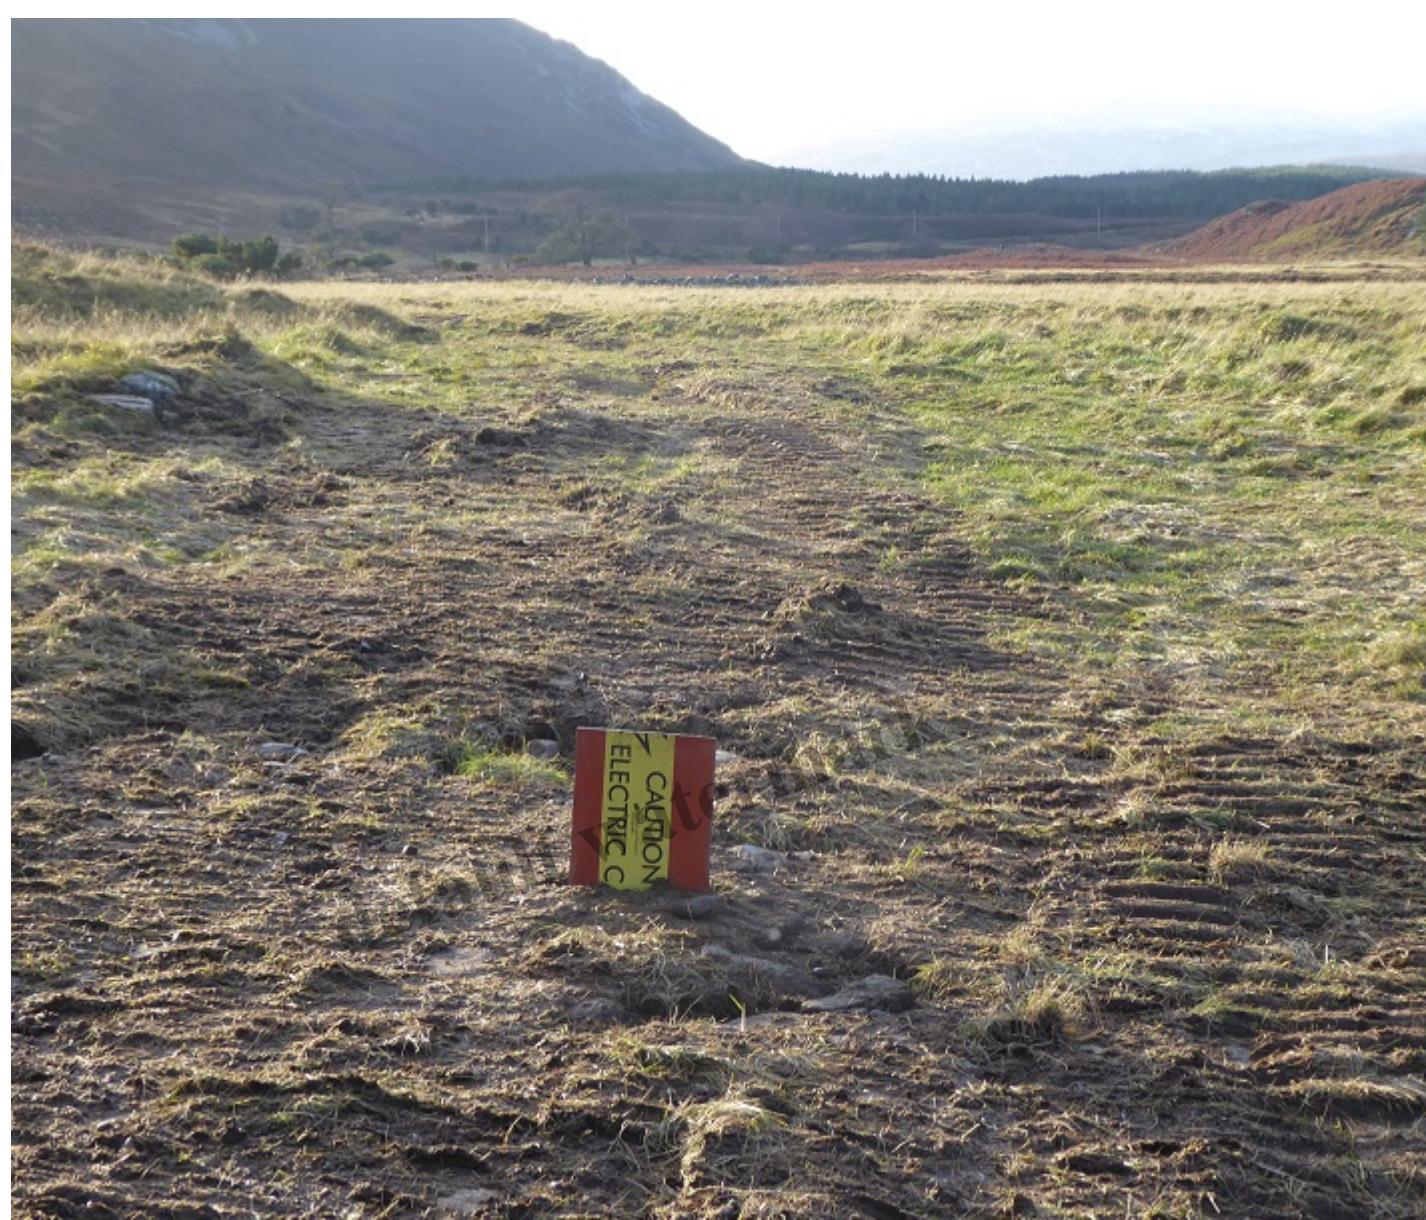
Few people would know, just a couple of week after the work had been carried out, that the reason f ground disburbance is an electric cable had been buried unless it was for the sign

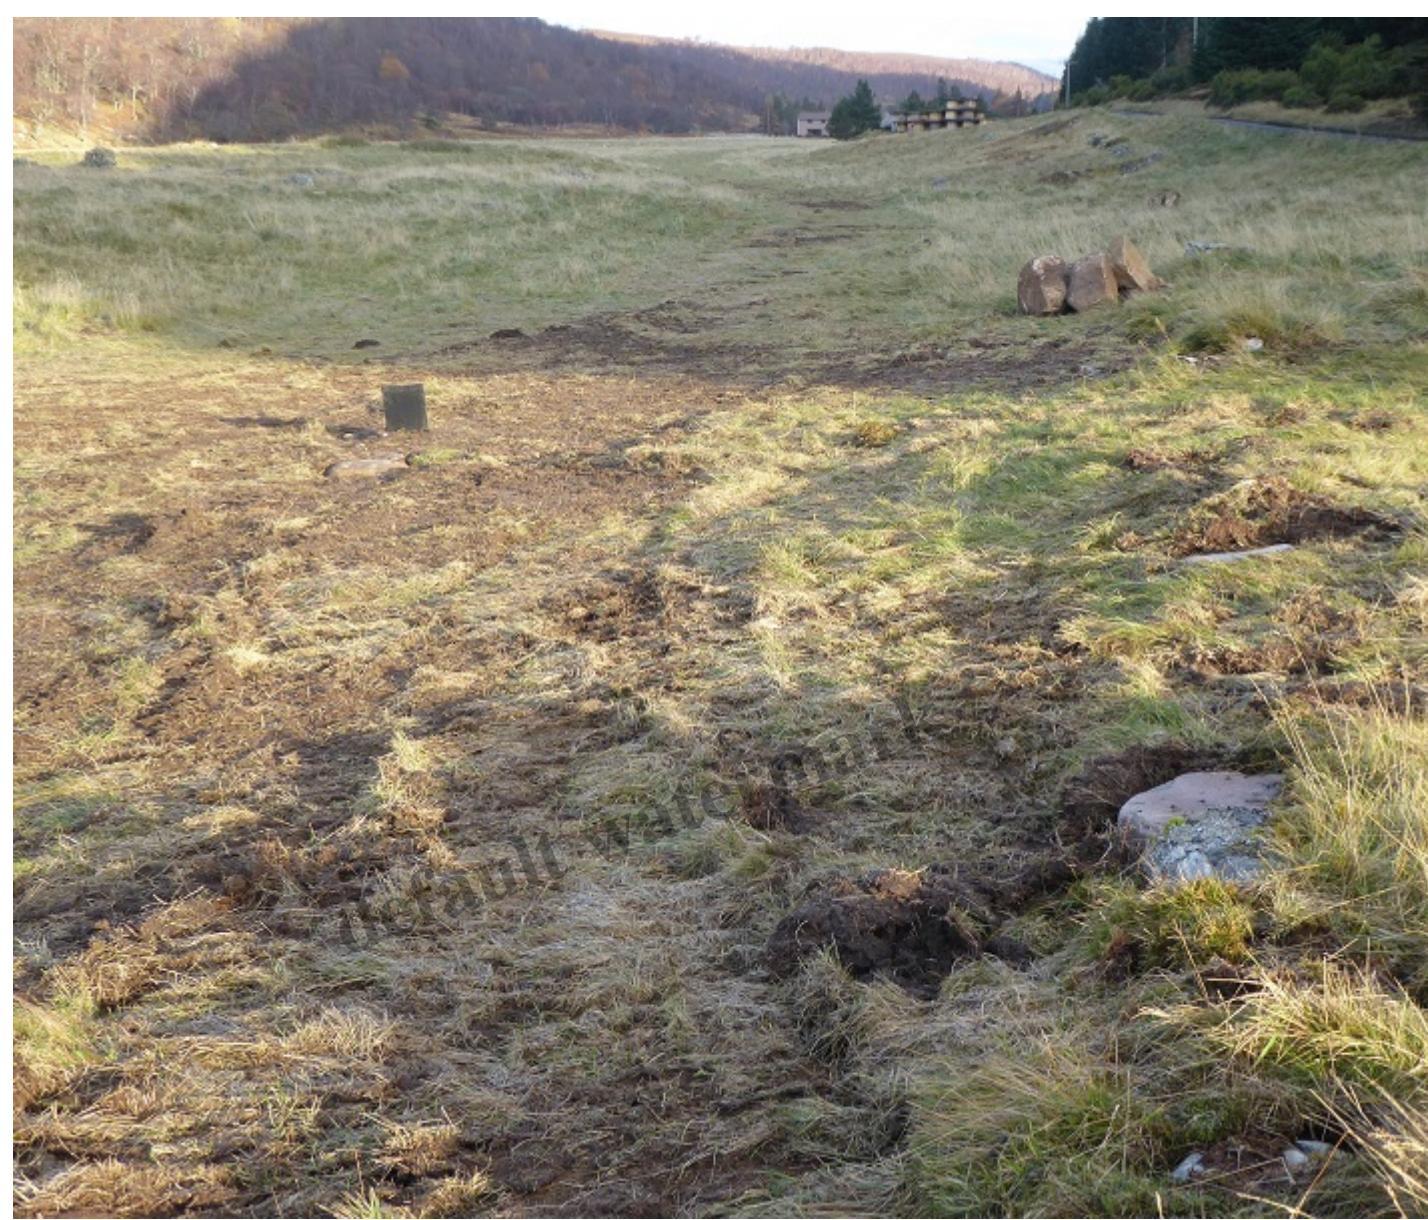
You can however see some evidence that a mole plough has been used. In places boulders have be excavated to allow the passage of the plough and cable.

Apart from the removal of boulders, the vegetation has been little disturbed and on the grassy floor of the glen should recover from the passage of vehicles very quickly. I suspect by next summer, when the grass has had time to grow again, it will be very hard to detect the line of the buried cable.

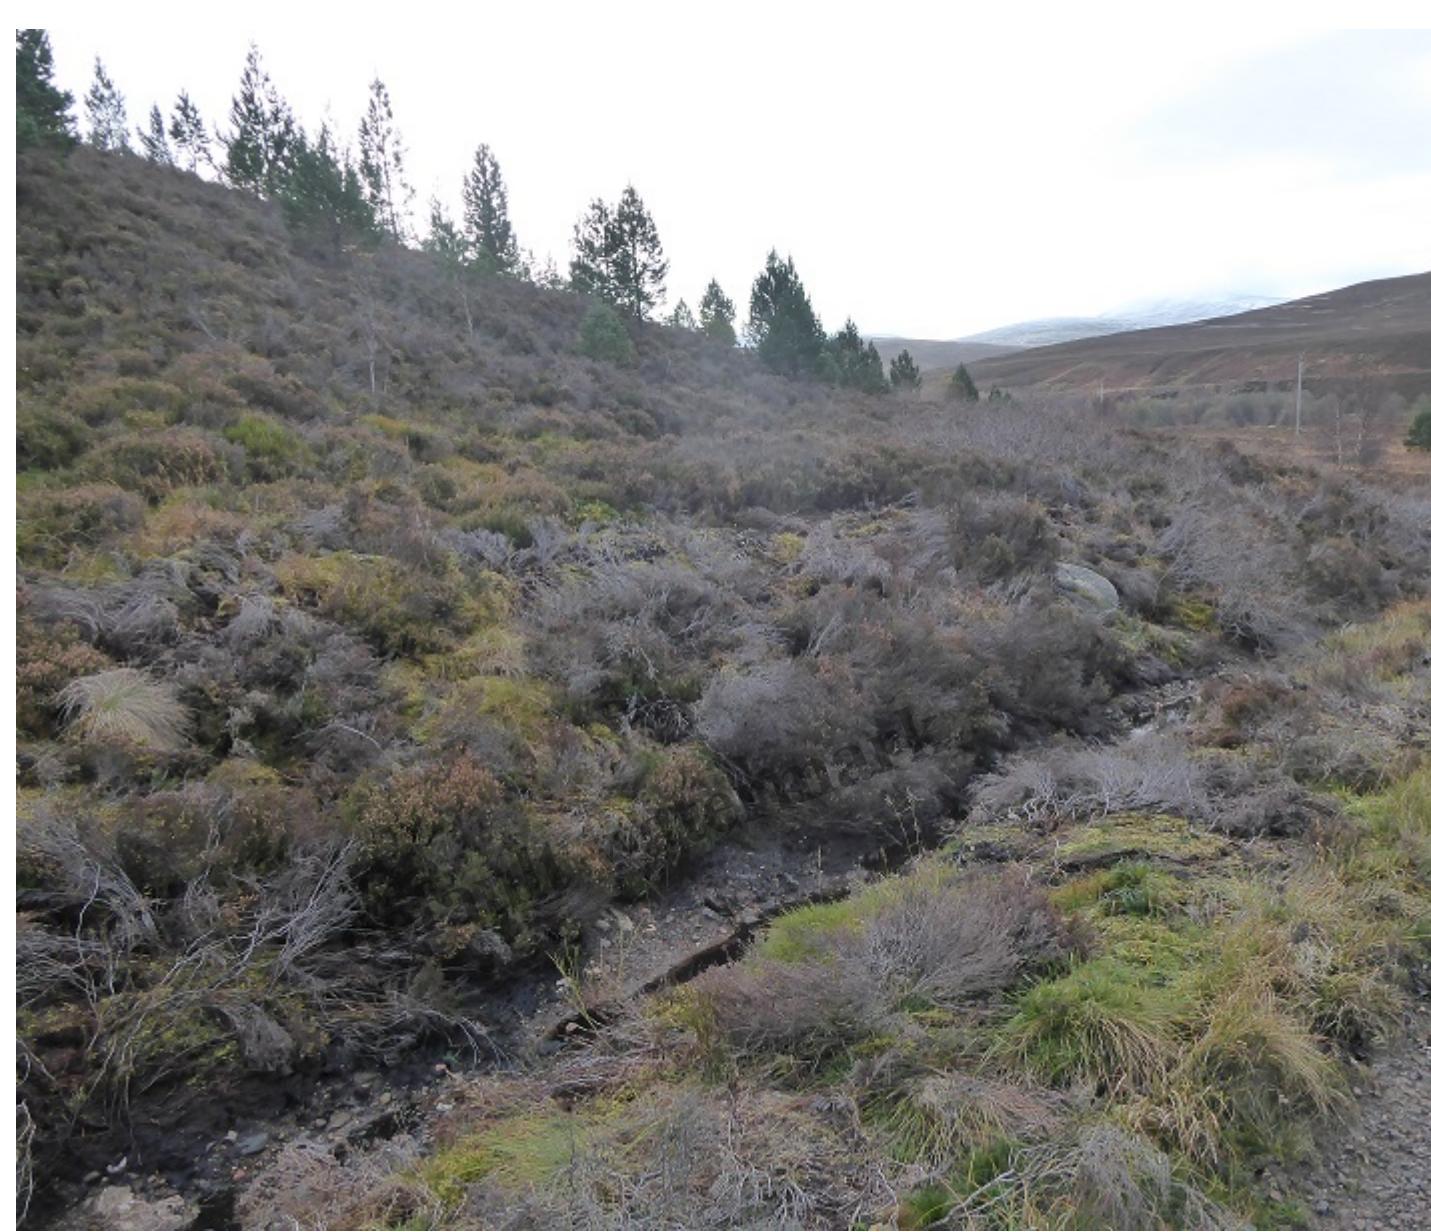
The buried cable is under the disturbed heather on the left side of the road

I was most impressed that the mole plough could also be used on heather moorland and cause so little destruction to vegetation. Again, I think the vegetation here should more or less fully recover in a season.

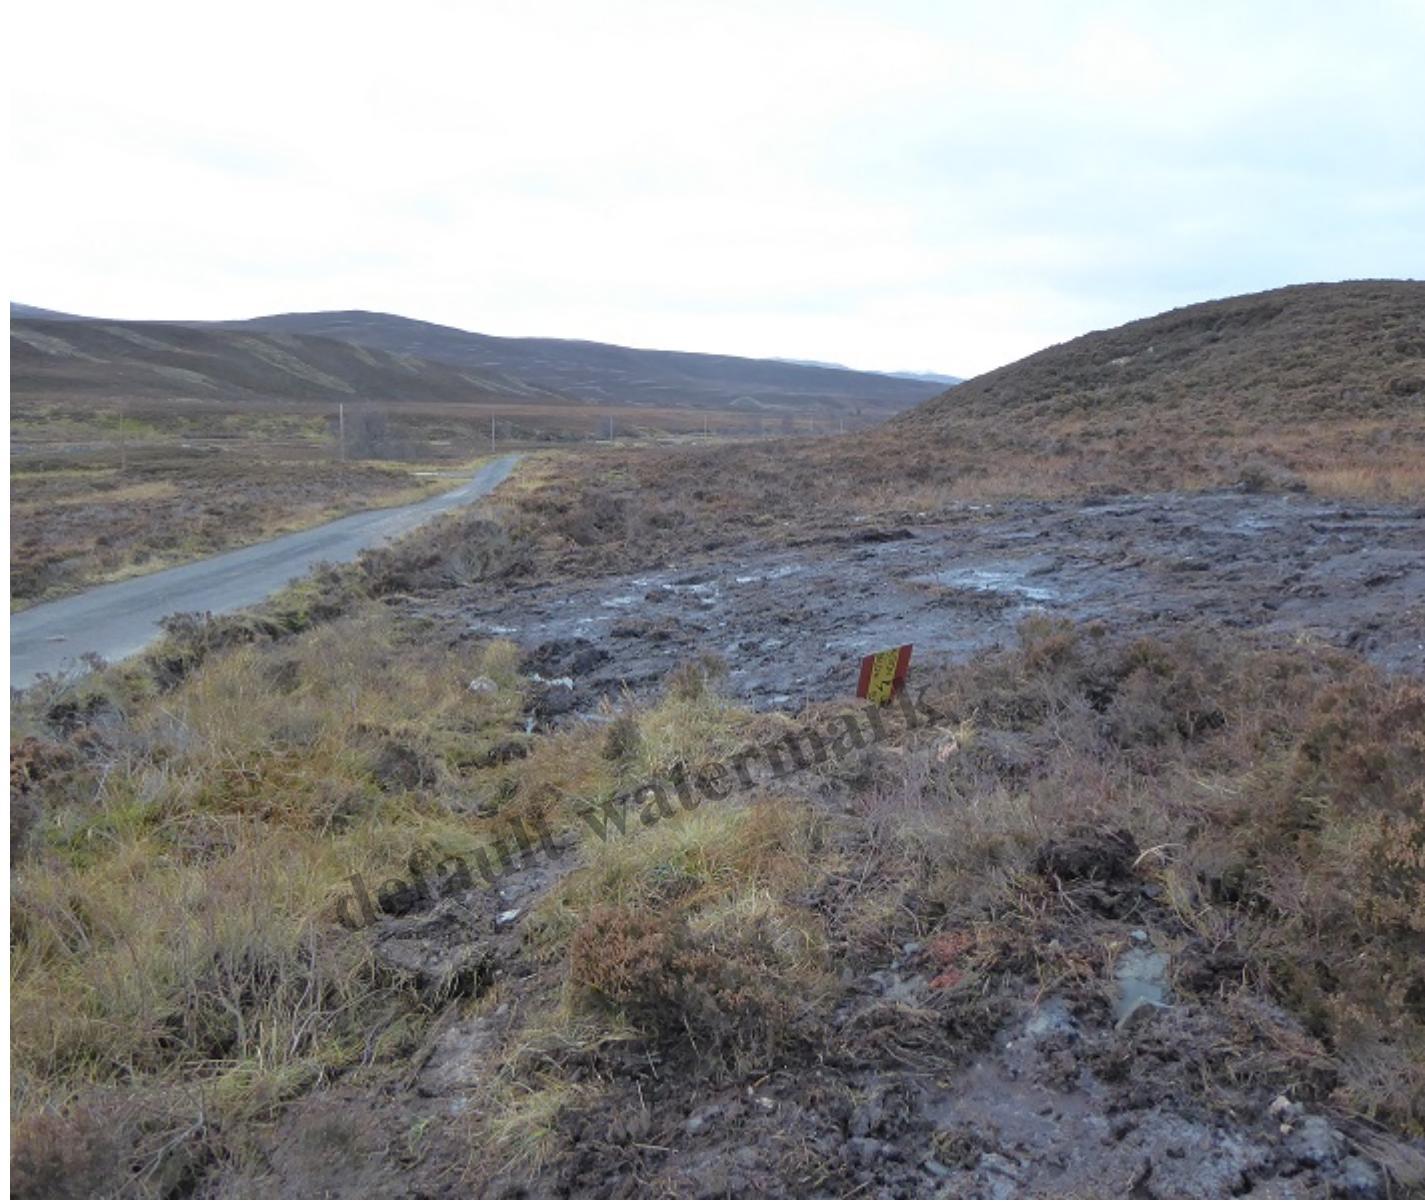
The worst area of ground disturbance/destruction of vegetation on moorland

I then came across the patch of very disturbed ground in the photo above. I was unable to ascertain the cause of this – it may have been a consequence of the land being very boggy – but in the context of several kilometres of buried cable it just served to illustrate in general how well the work had been done and the potential of using mole ploughs.

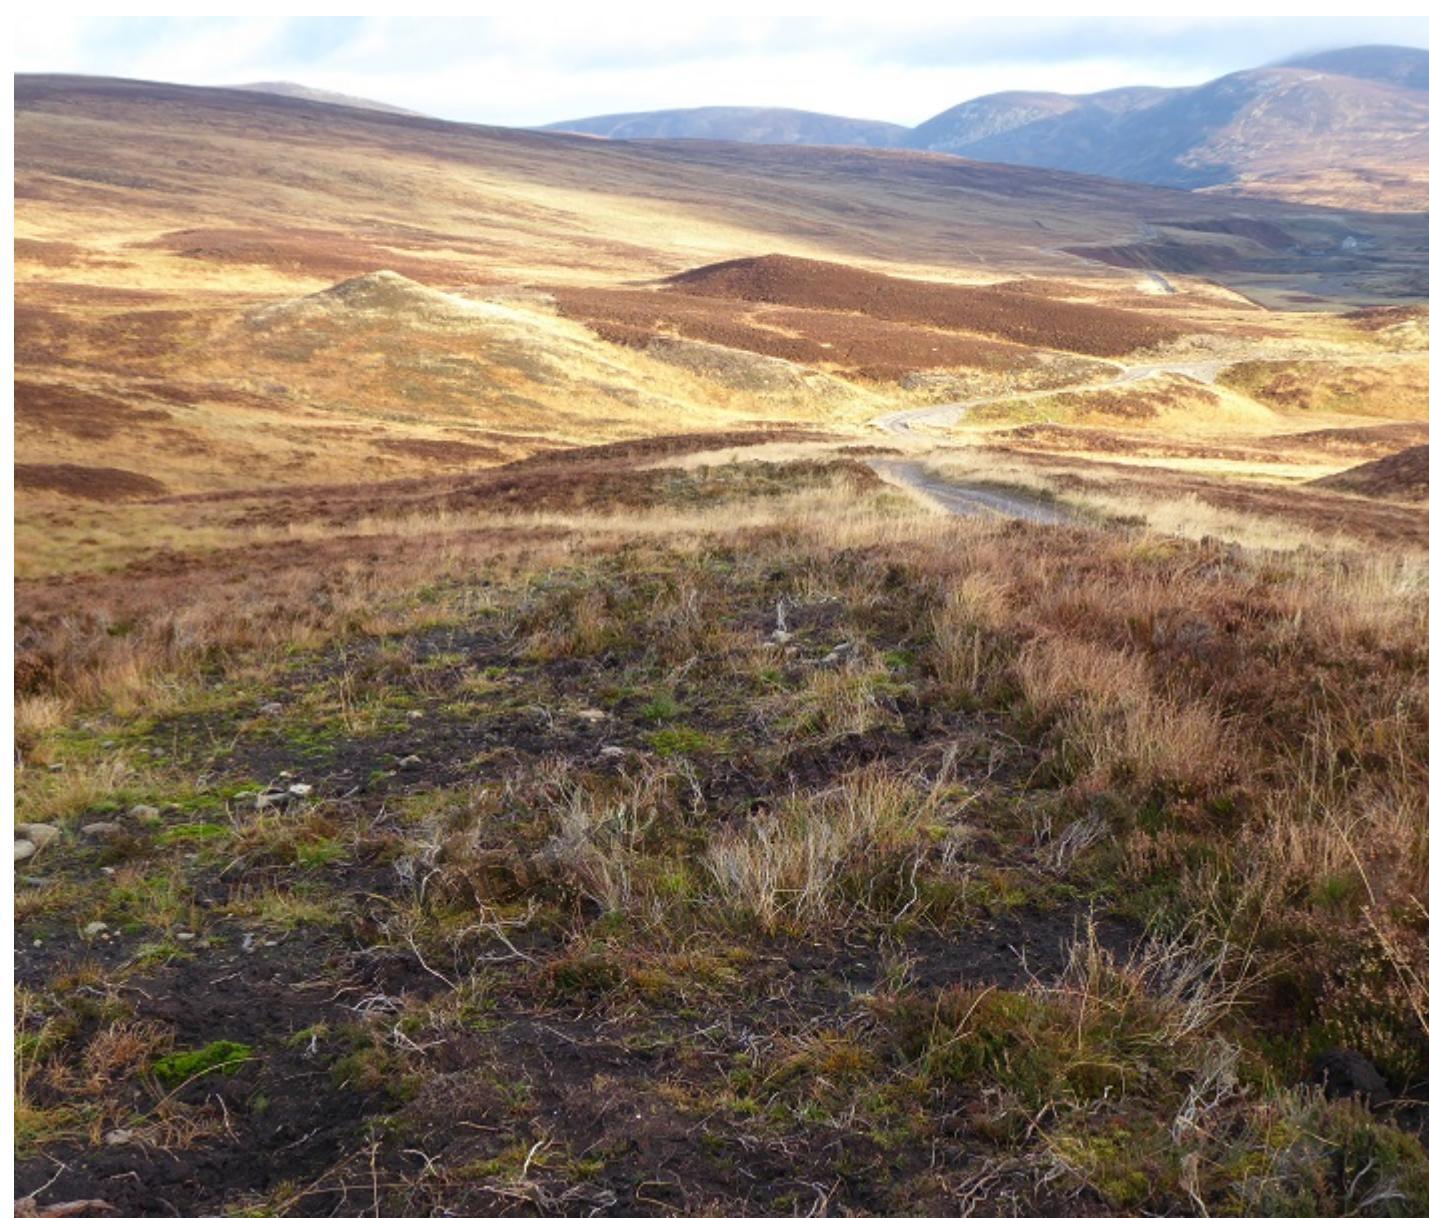
The line of the Glen Bruar power cable runs along the line of disturbed vegetation on the left of the repowerhouse which you can just see top right

The advantages of using the mole plough can be seen by comparing the powerline burial in Glen Tromie with that to the new Glen Bruar scheme. While parkswatch has given extensive coverage to the Glen Bruar pipeline restoration above the powerhouse, below it several miles of new electric cable was required to connect it to the grid. The work for this was generally to a high standard – and hence I have avoided comment – but the methodology used was to excavate a ditch, bury the cable and then refill it. Despite the care taken, over two years on the line of the cable is more visible than that in Glen Tromie two weeks after the work finished. The lesson, I believe, is that burying cable with a mole plough, if done well, does significantly less damage that any methods that involves removing vegetation, excavating a ditch and then trying to restore this work.

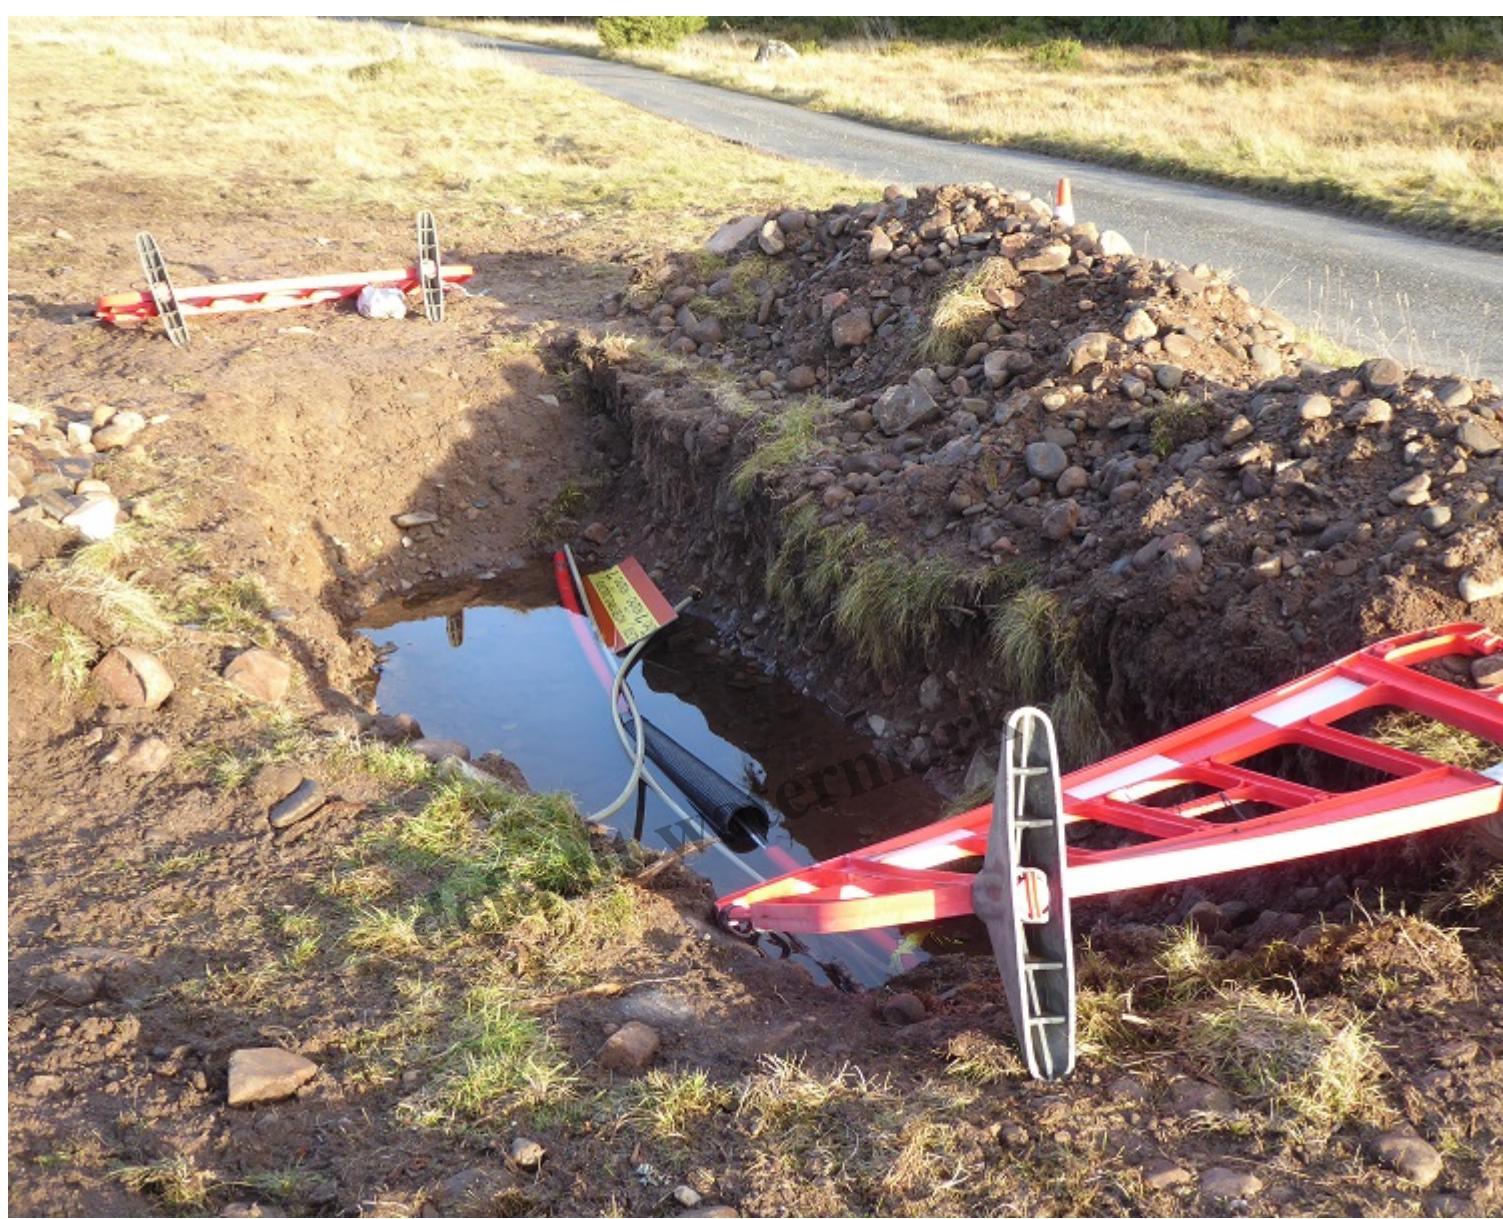
I had seen one example of excavation in Glen Feshie – the hole appeared for connection purposes. It is very difficult – and incidentally far more labour intensive – to restore the ground caused by such digging. Compare this to the impact and work involved in using a mole plough. Thomas MacDonell told us, if my memory is correct, that it had taken just five days to bury the cable in Glen Tromie and, from I saw, very little further work or monitoring will be needed.

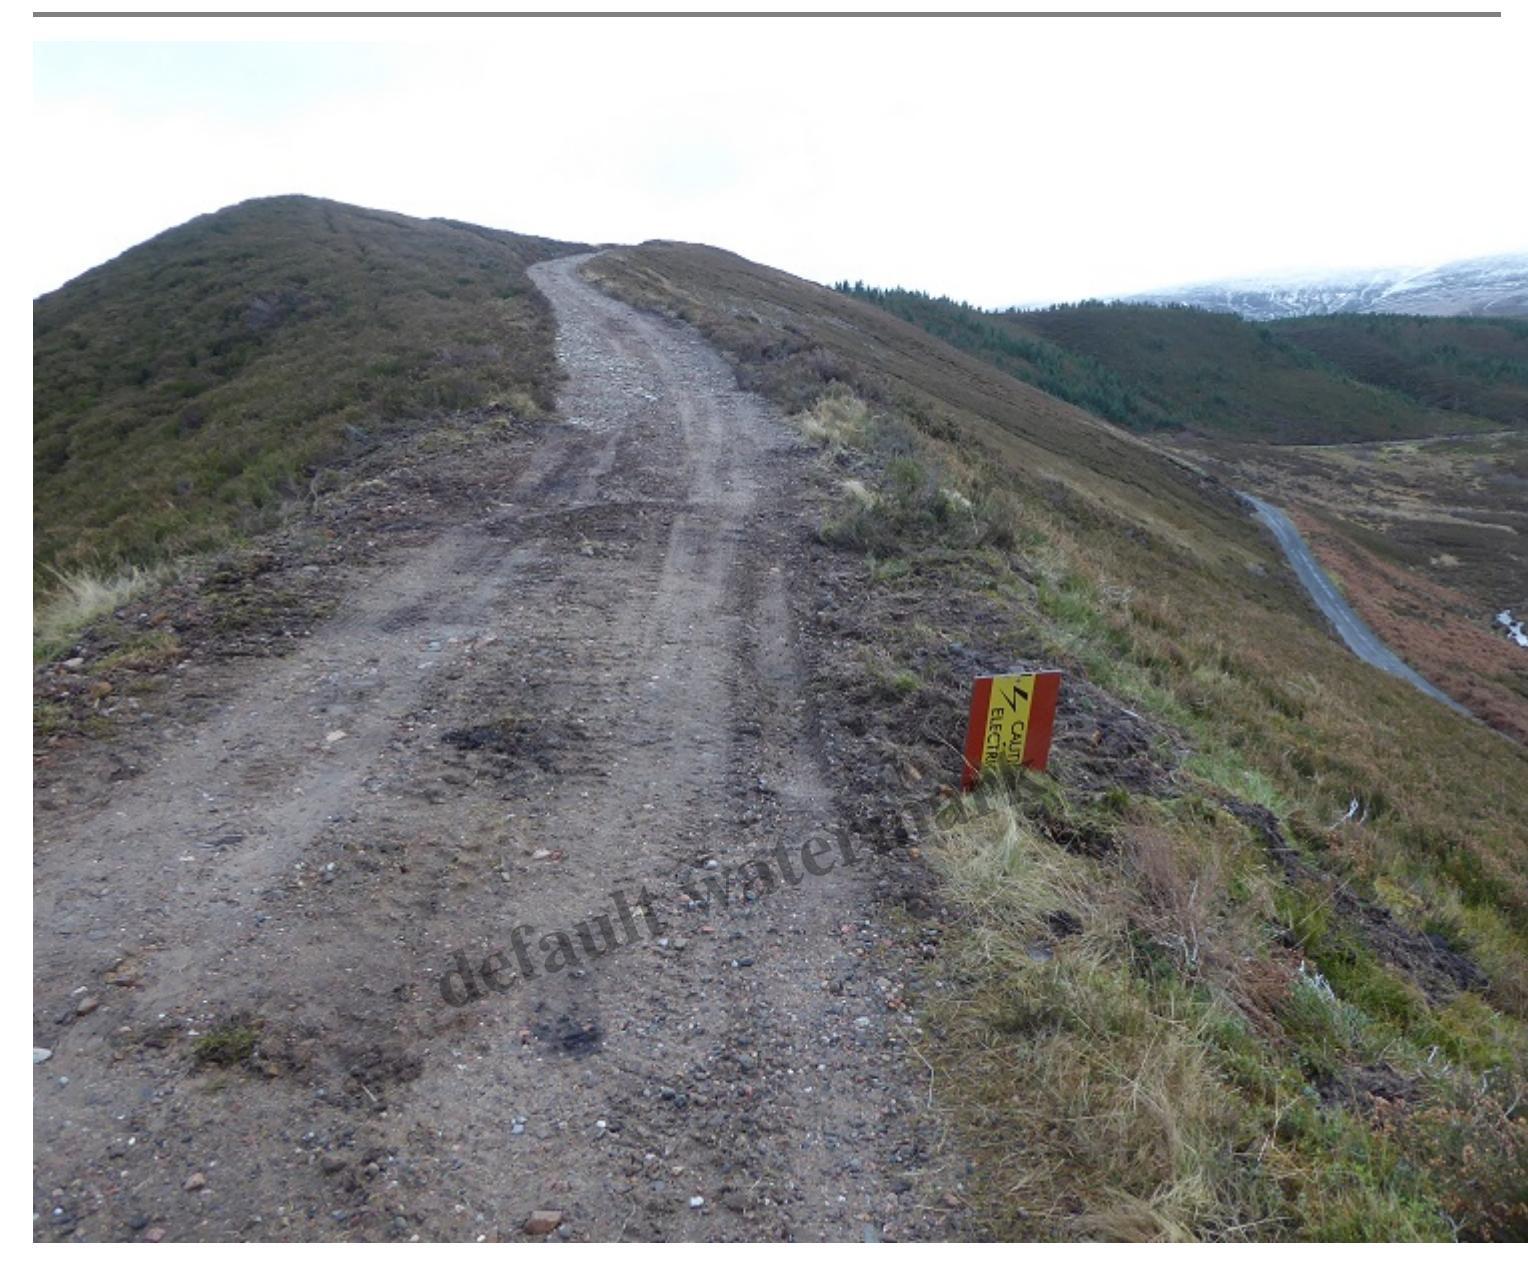
Sign marking where cable crosses the track leading up to the upper Allt Bhran hydro intake – the track below the moraine leads to the Gaick
