Landslips and the Nature Emergency – the A83 is just part of the problem

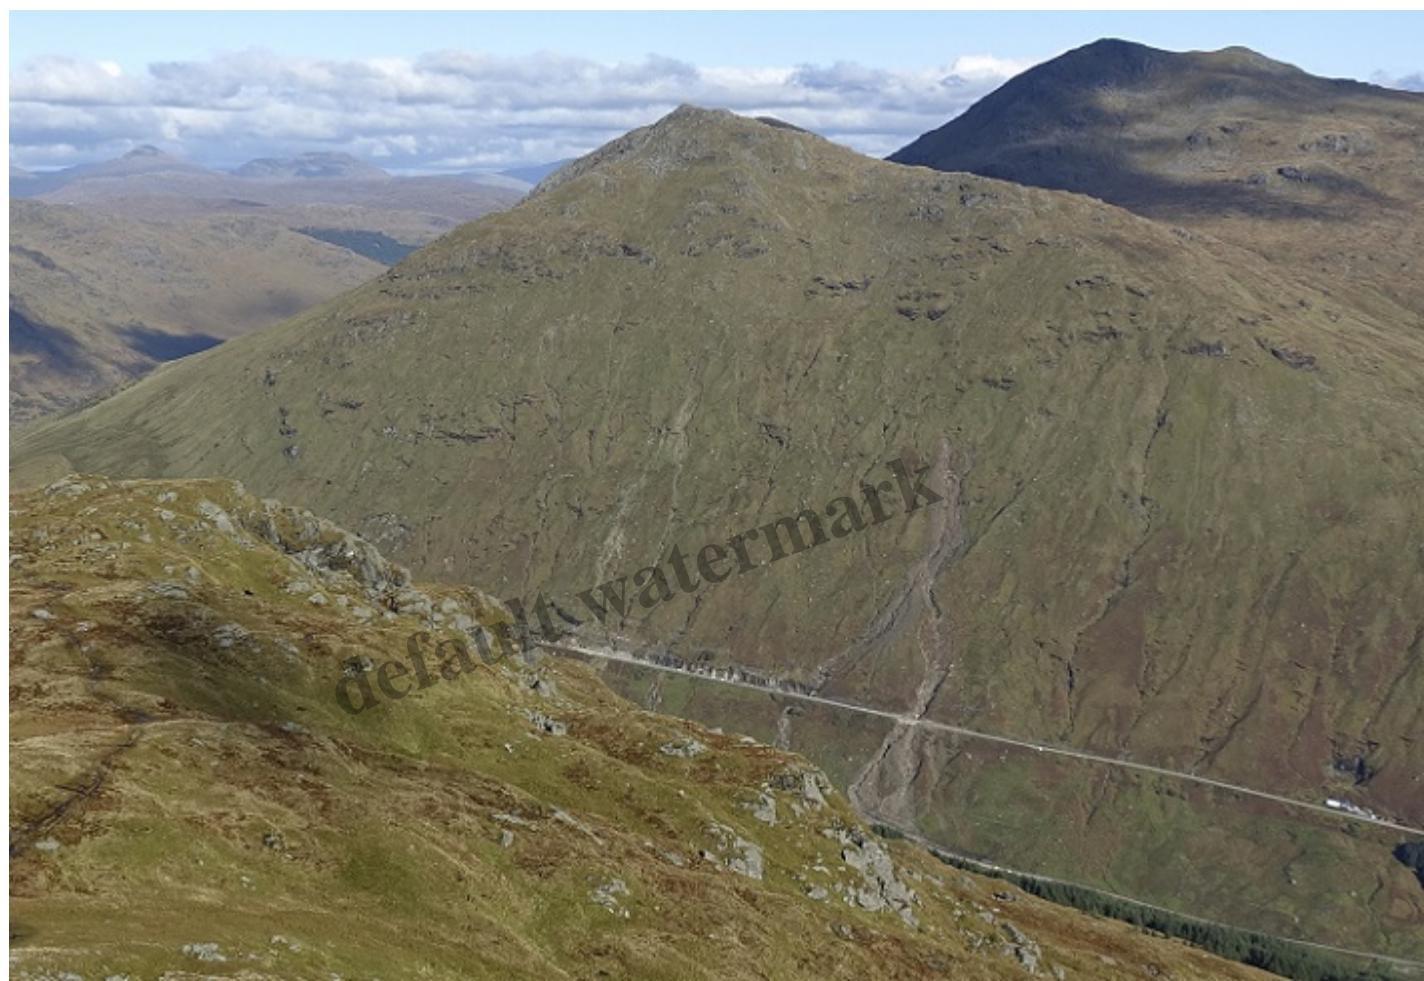
Slopes of Beinn Luibhean and A83 from Ben Donich Autumn 2020 – a huge volume of material still t go. Photo credit RP.

In both landslips, what struck me was how small the scar on the hillside appeared compared to thearea of ground affected. Just think of the amount of material and the damage it could do if the wholehillside went. Unlikely around Loch Katrine perhaps, because of the angle of the slope and because the hillsides are broken up with rocky outcrops and trees. But Beinn Luibhean, above the Rest and Be Thankful (top photo), is a different matter.

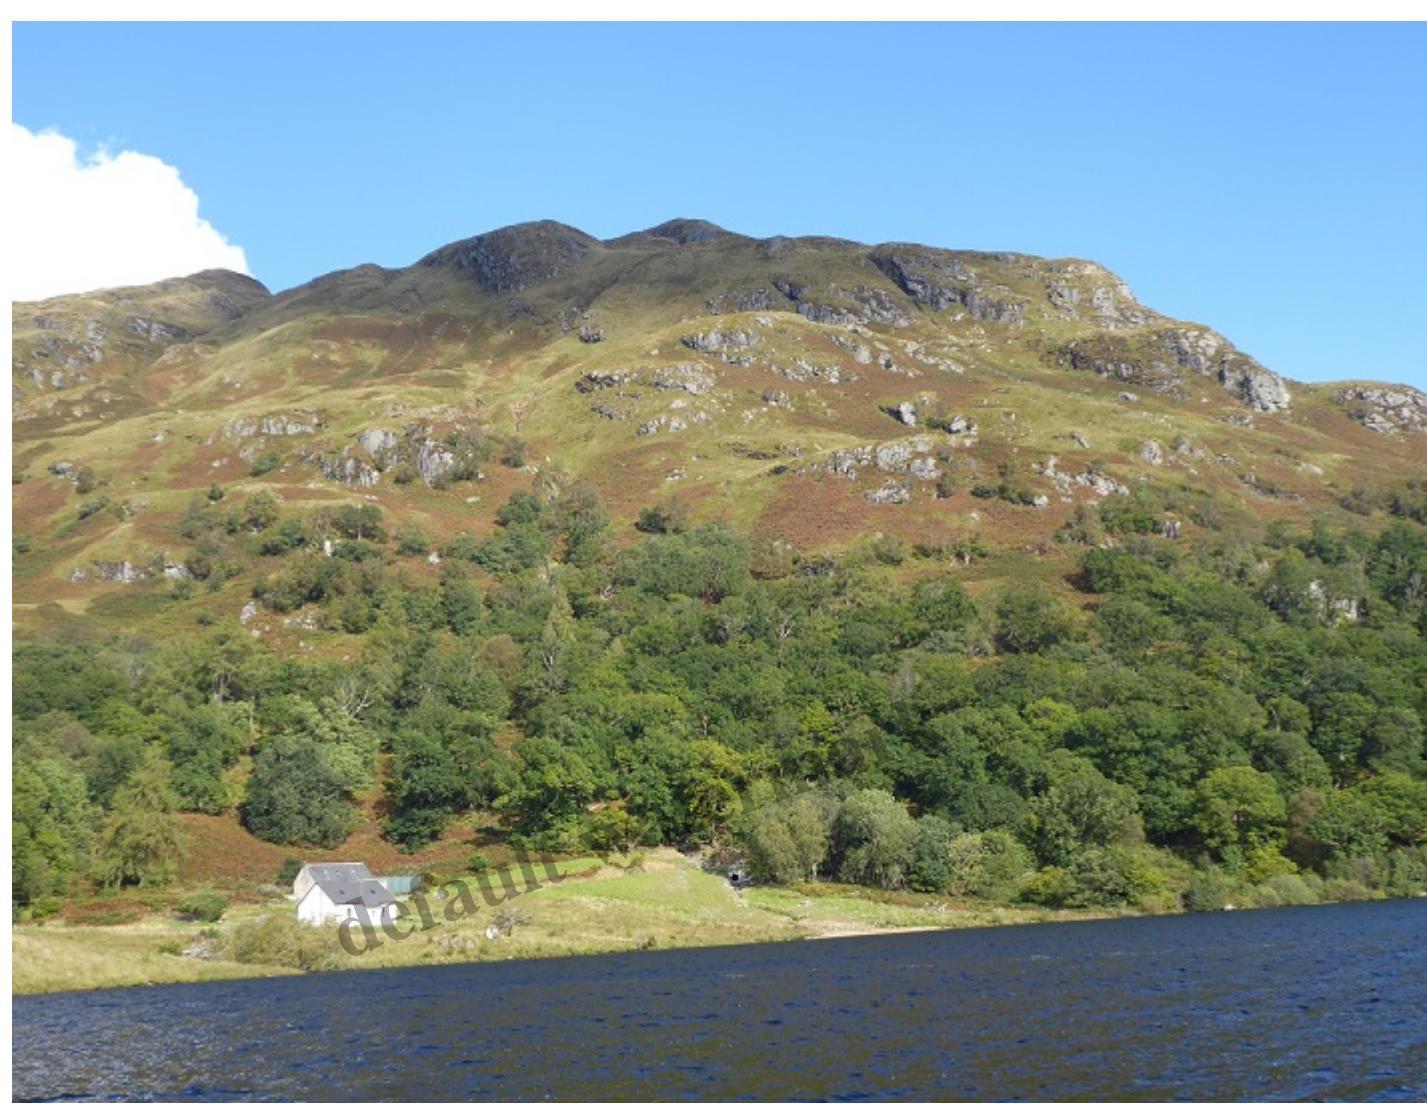
The landslip followed the gully line to the right the buildings, with bare patches just visible below skyline and debris reaching the shore below the trees

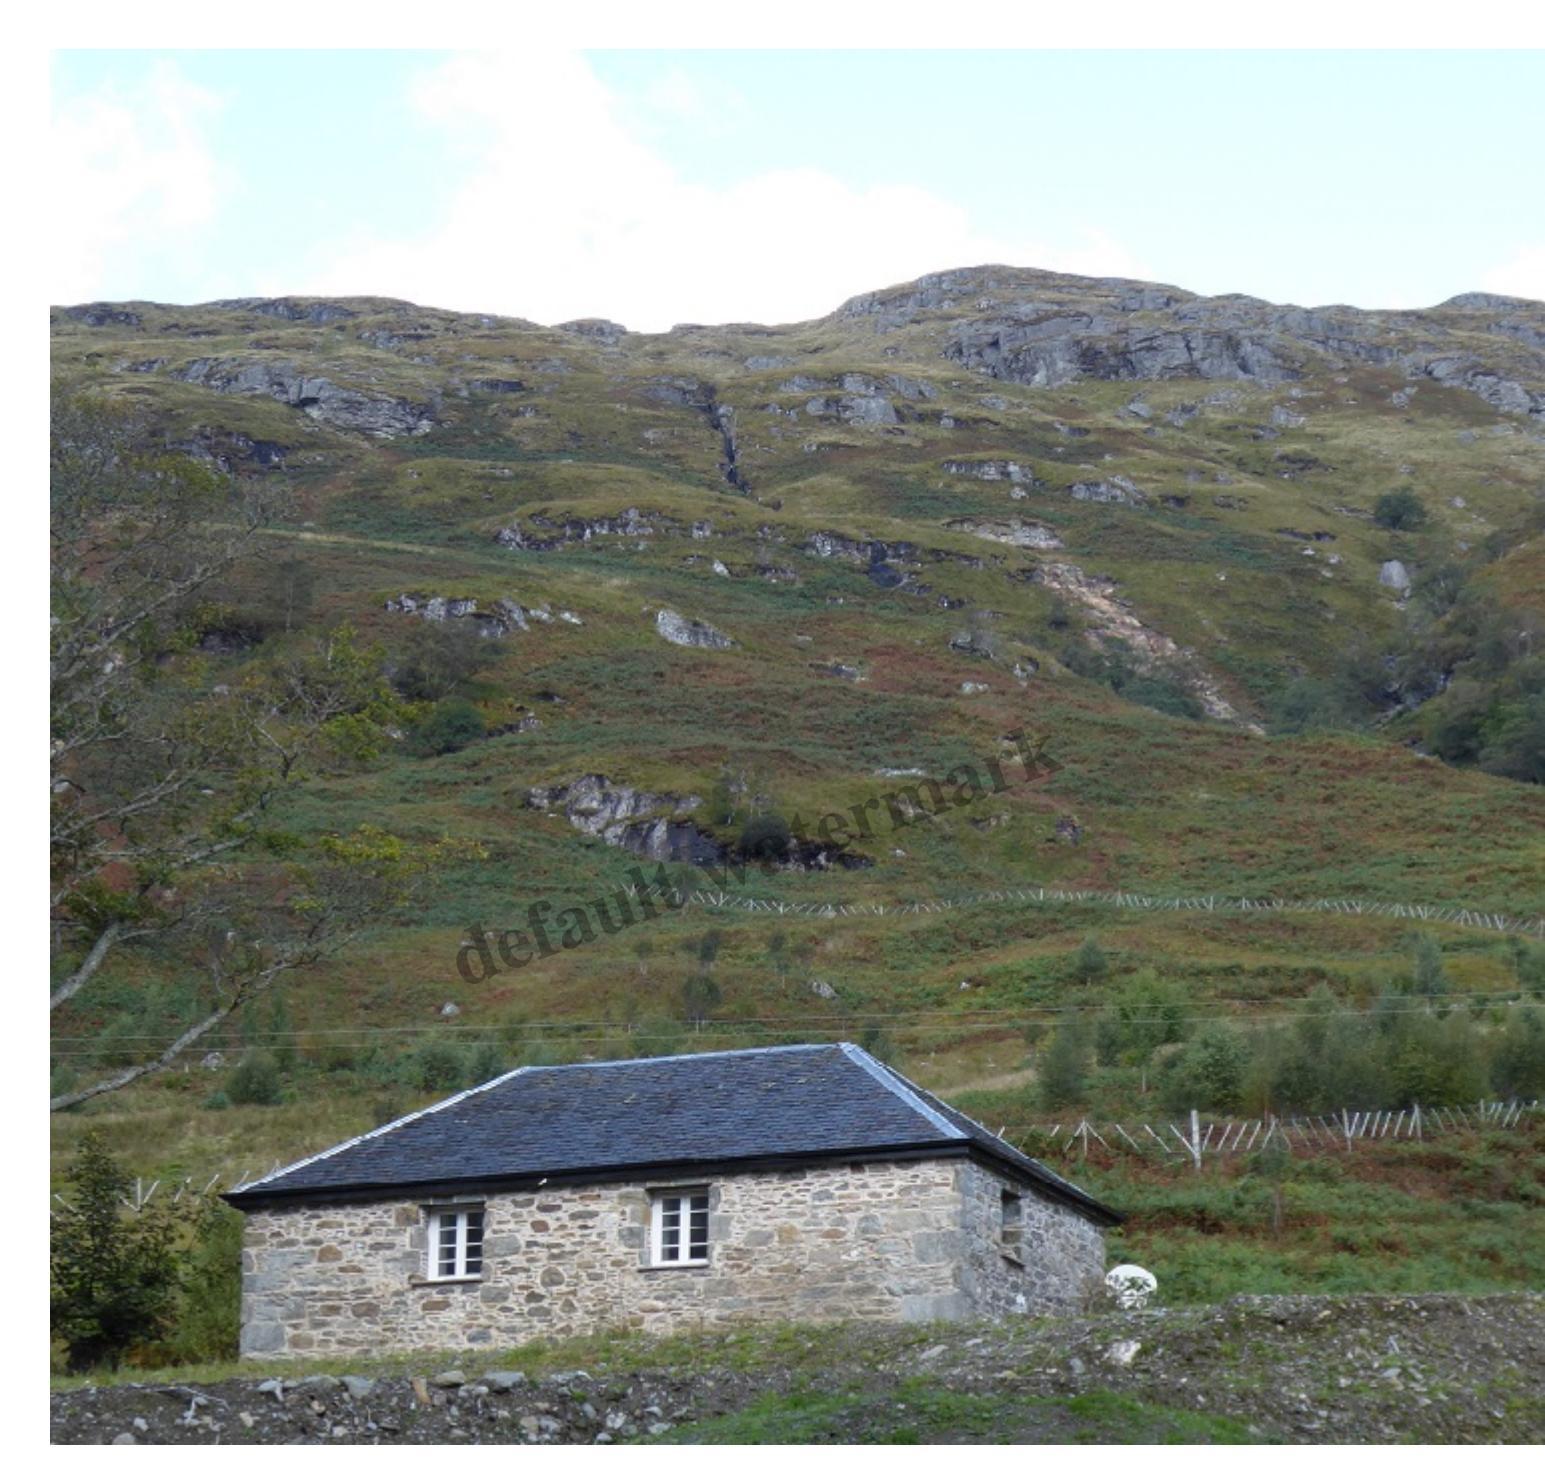
While the area around has now been restored by Scottish Water, debris from the landslip on this hillside piled up behind the house to its eaves. It must have been extremely frightening for the people staying there. Had the landslip moved fast like an avalanche, it would have probably destroyed the house. The debris moved slowly, however, giving time for people to escape.

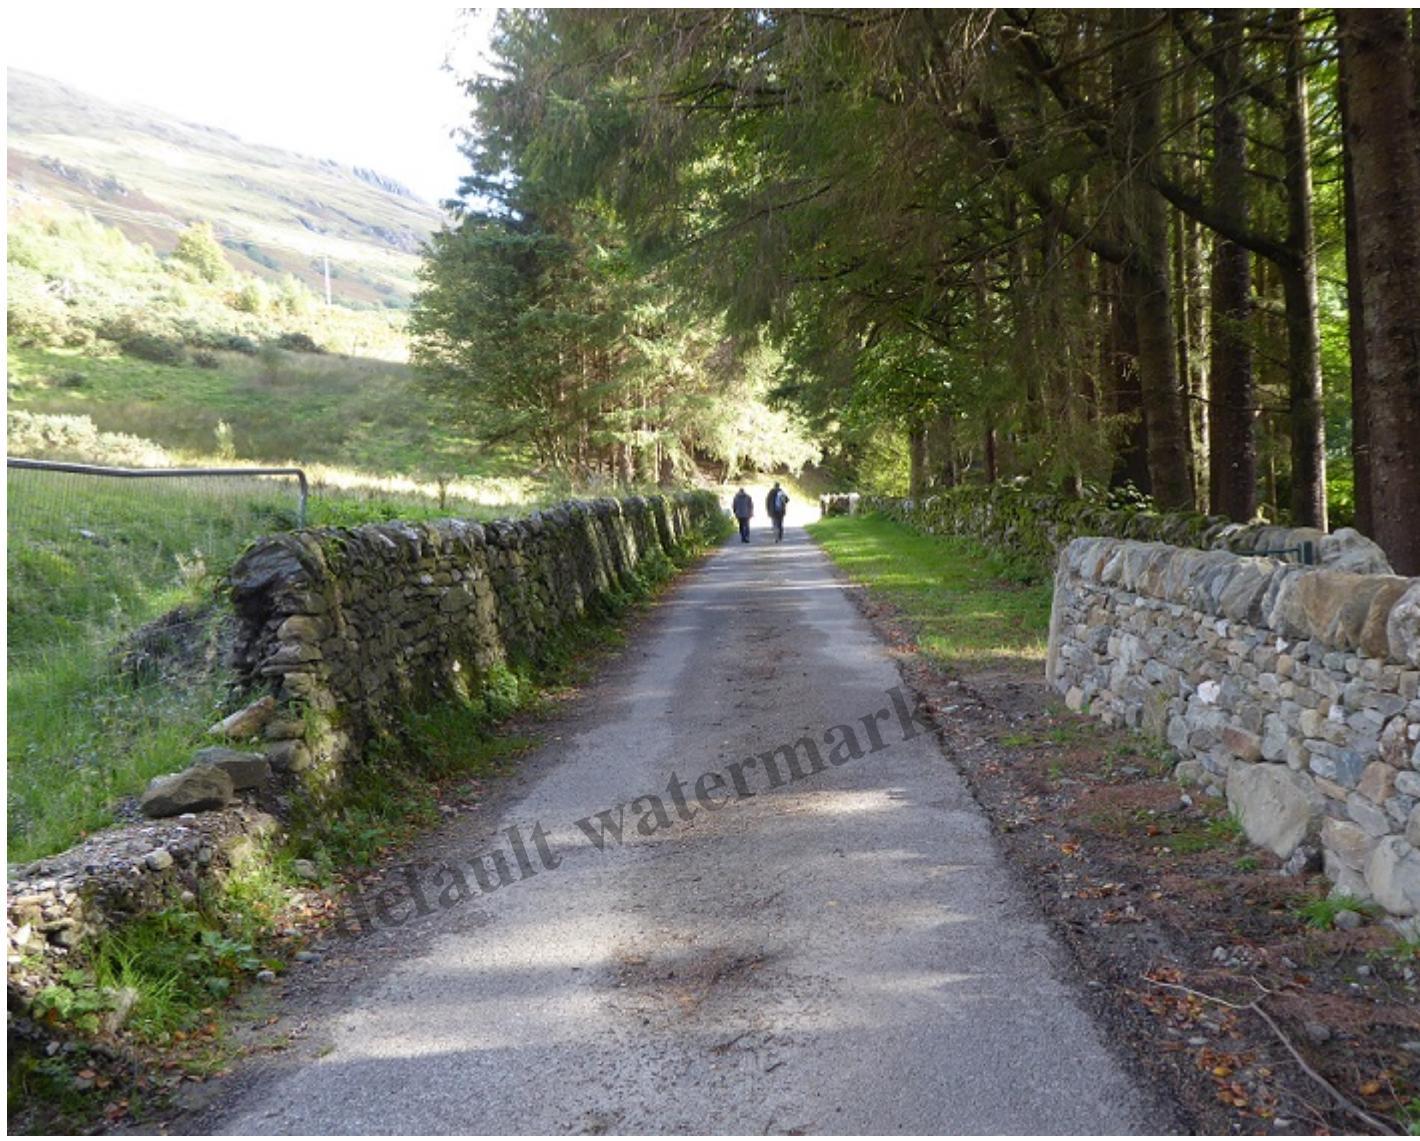
The road below the cottage in top photo, with demolished wall on left and new wall on right

Though slow, the landslip was powerful enough to carry away two dry stane dykes.

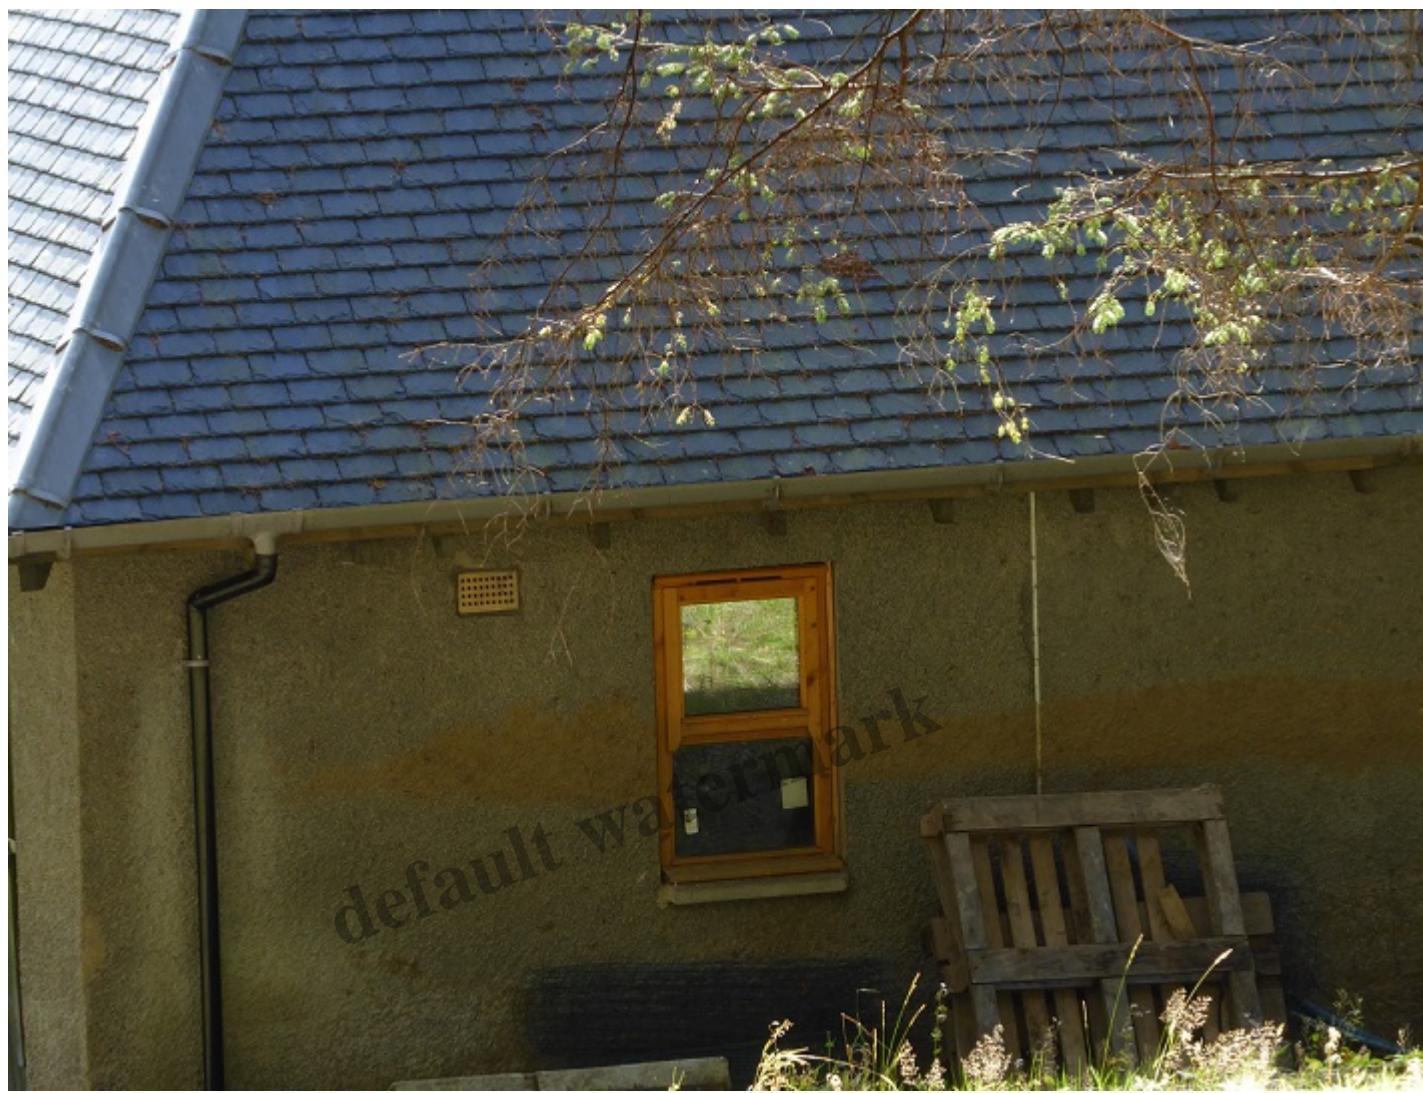
The brown line marks the height of the debris which piled up against a lower building

All the people staying at Glen Gyle had to take refuge in Rob Roy's old house, the only building unaffected. I understand the other buildings are unlikely ever to be used again – they have become uninsurable – and Scottish Water has been negotiating with their owners to buy them up. The threat of landslips has made most of Glengyle too dangerous to live.

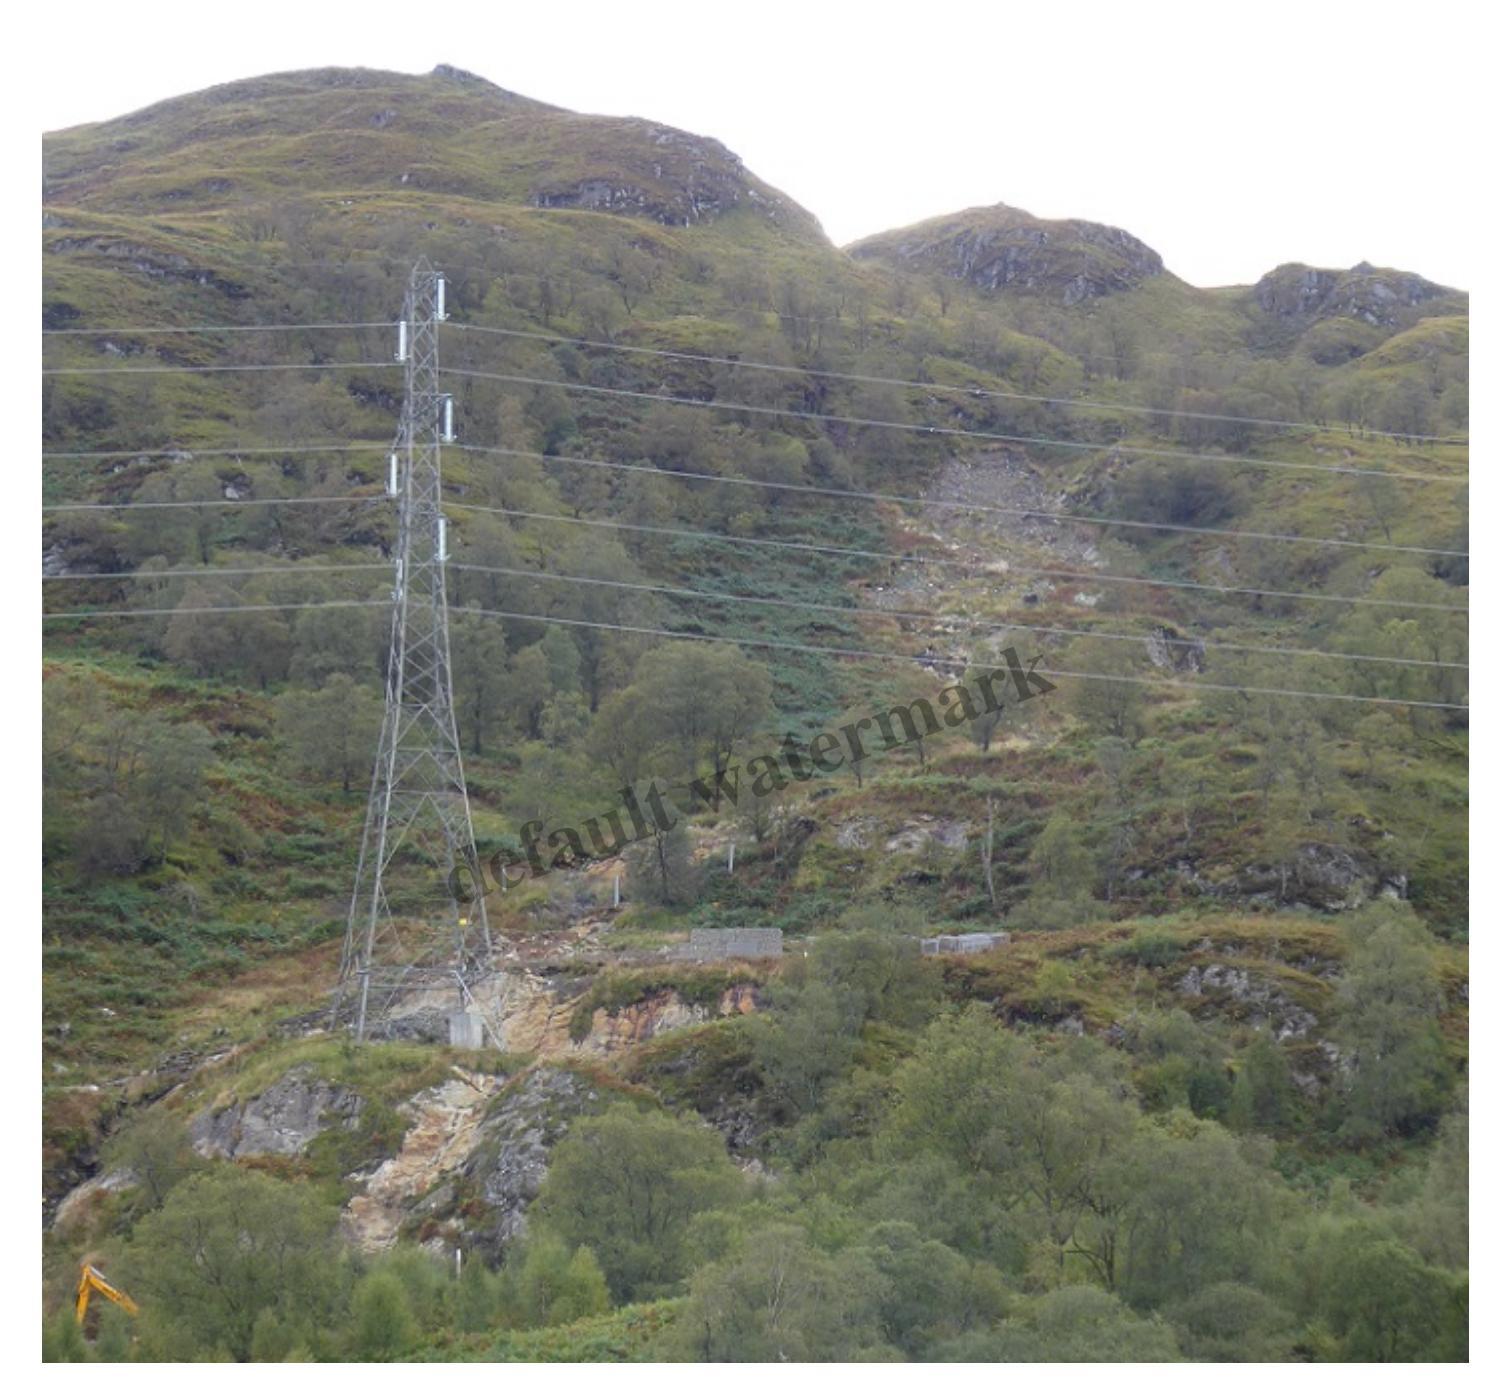
Had the landslips further round towards Stronachlachar actually toppled the powerline, that would have had a major impact on the national grid and we would have heard a lot more about it. As it is, it has taken more than a year to fix the damaged tower.

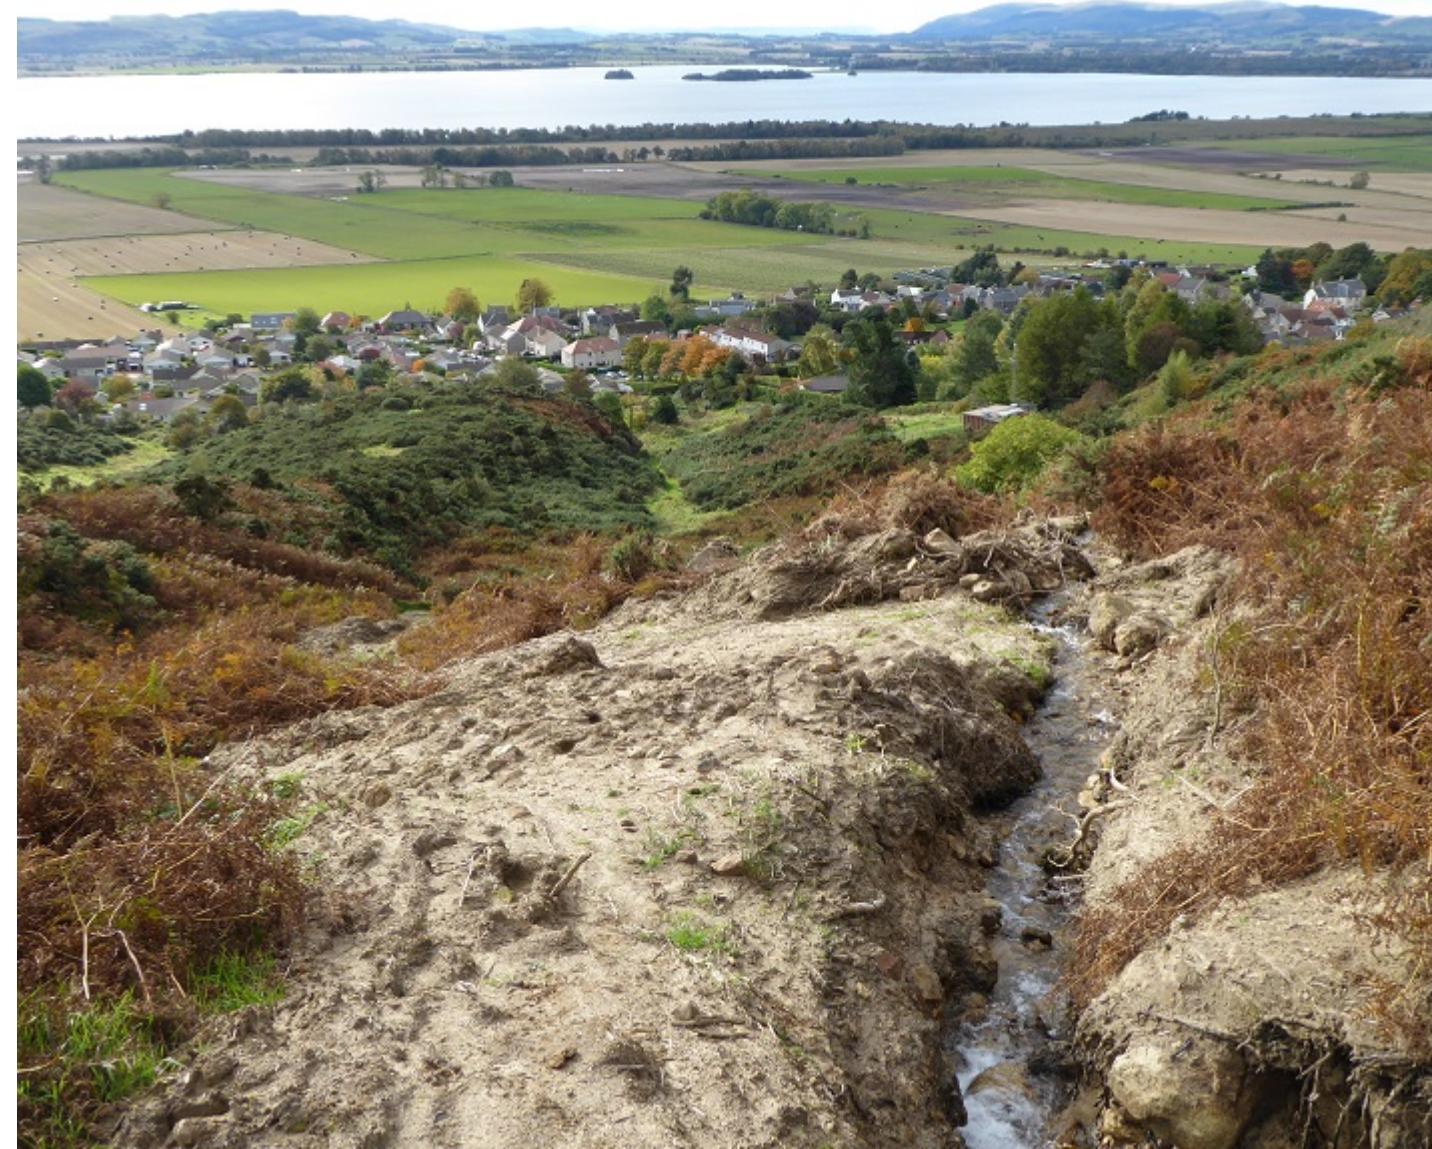
The risks posed by landslips are a Scotland-wide problem

View down landslip from above the village of Kinnesswood, with Loch Leven in distance

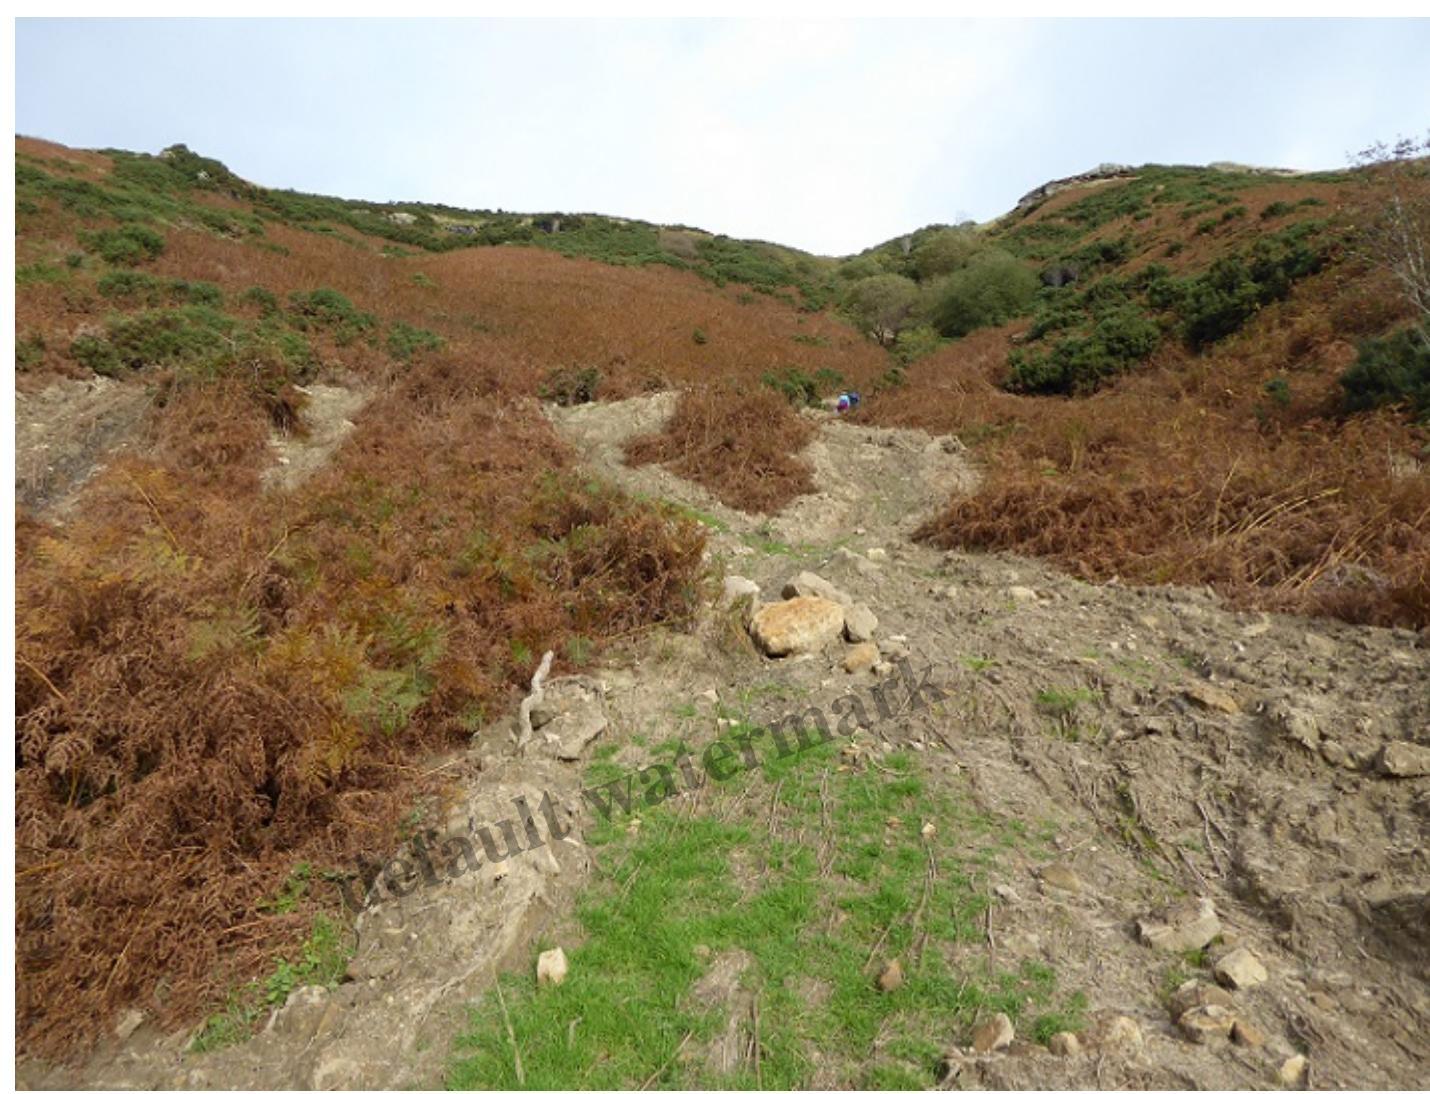
The landslip started just above the trees

Below the trees, the landslip gathered a significant amount of material and spread out like an avalanche. An interesting question is whether trees lower down might have limited its progress. In this case the landslip followed the line of the burn and its banks, so even if it had been much bigger and reached the village, it would probably have flowed through it.

Trees won't in themselves prevent landslips, as the photos here and in previous posts show. There are hints though (second photo) that woodland may help contain landslips. We know too that woodland helps hold back water which is what triggers most landslips in Scotland. The development of a scrub zone would have slowed and limited the volume of water flowing down the hill, potentially reducing the number of landslips triggered above the current tree line and in woodland on the lower slopes. That is not possible at present at Loch Katrine, Glen Falloch or many other parts of upland Scotland due to high deer numbers.

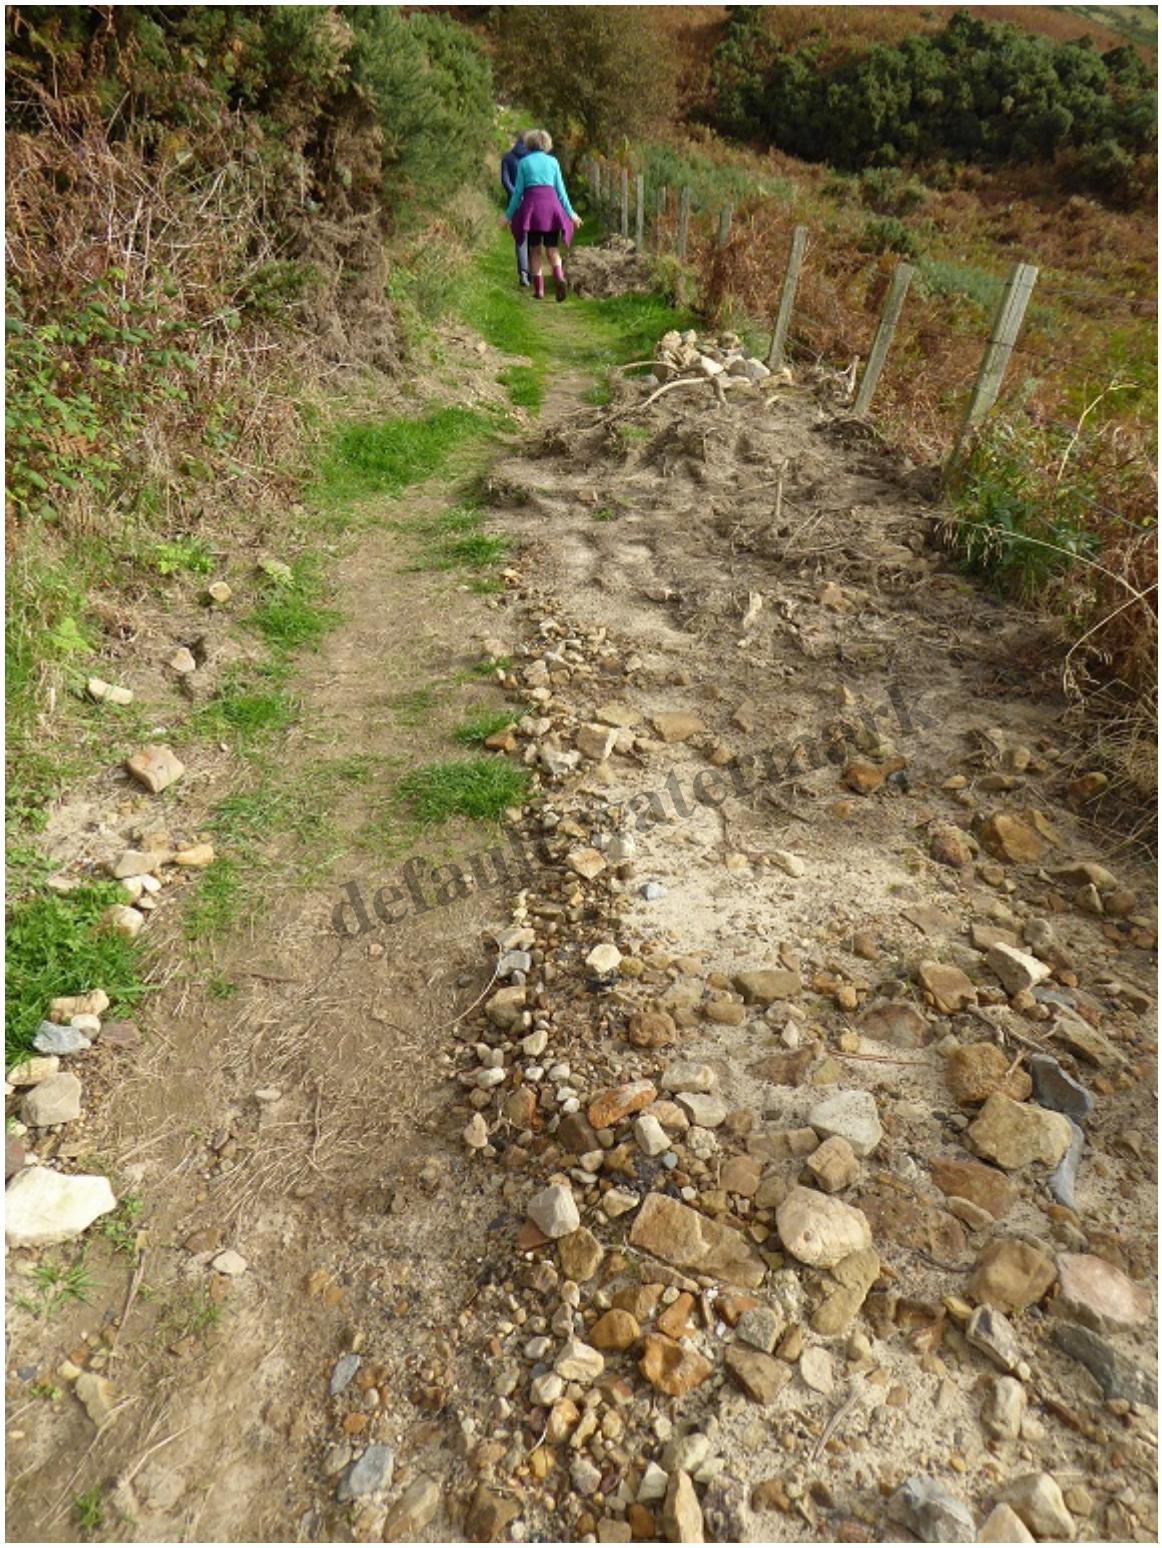
Footpath, partially cleared

I wouldn't, however, have liked to have been on the footpath.

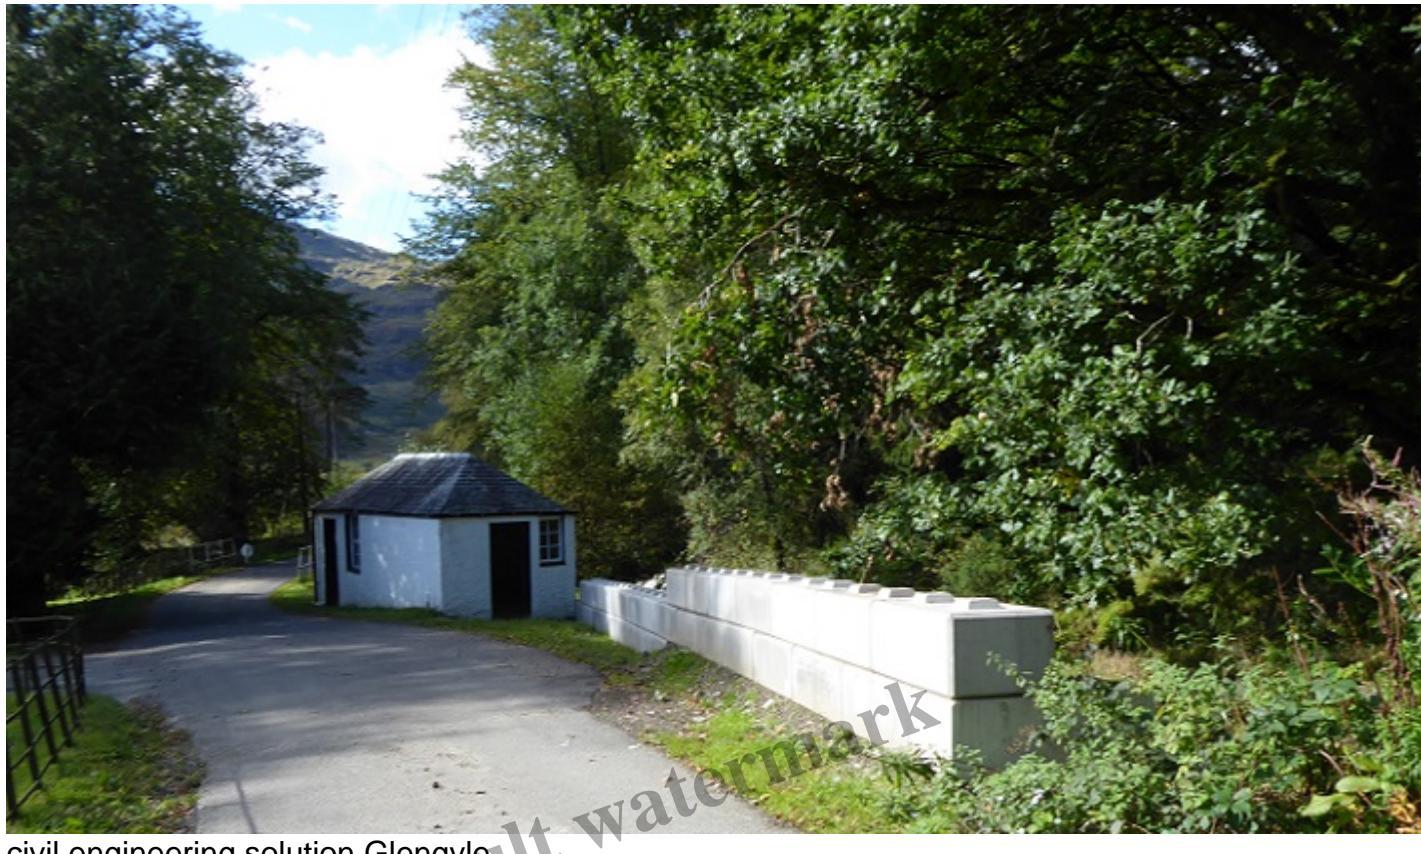
civil engineering solution Glengyle

Alongside understanding the risks, we need to develop nature based as well as civil engineering solutions to mitigate them.
