The state of the Cairngorms (5) – environmental catastrophe and the funicular

Storms and construction work

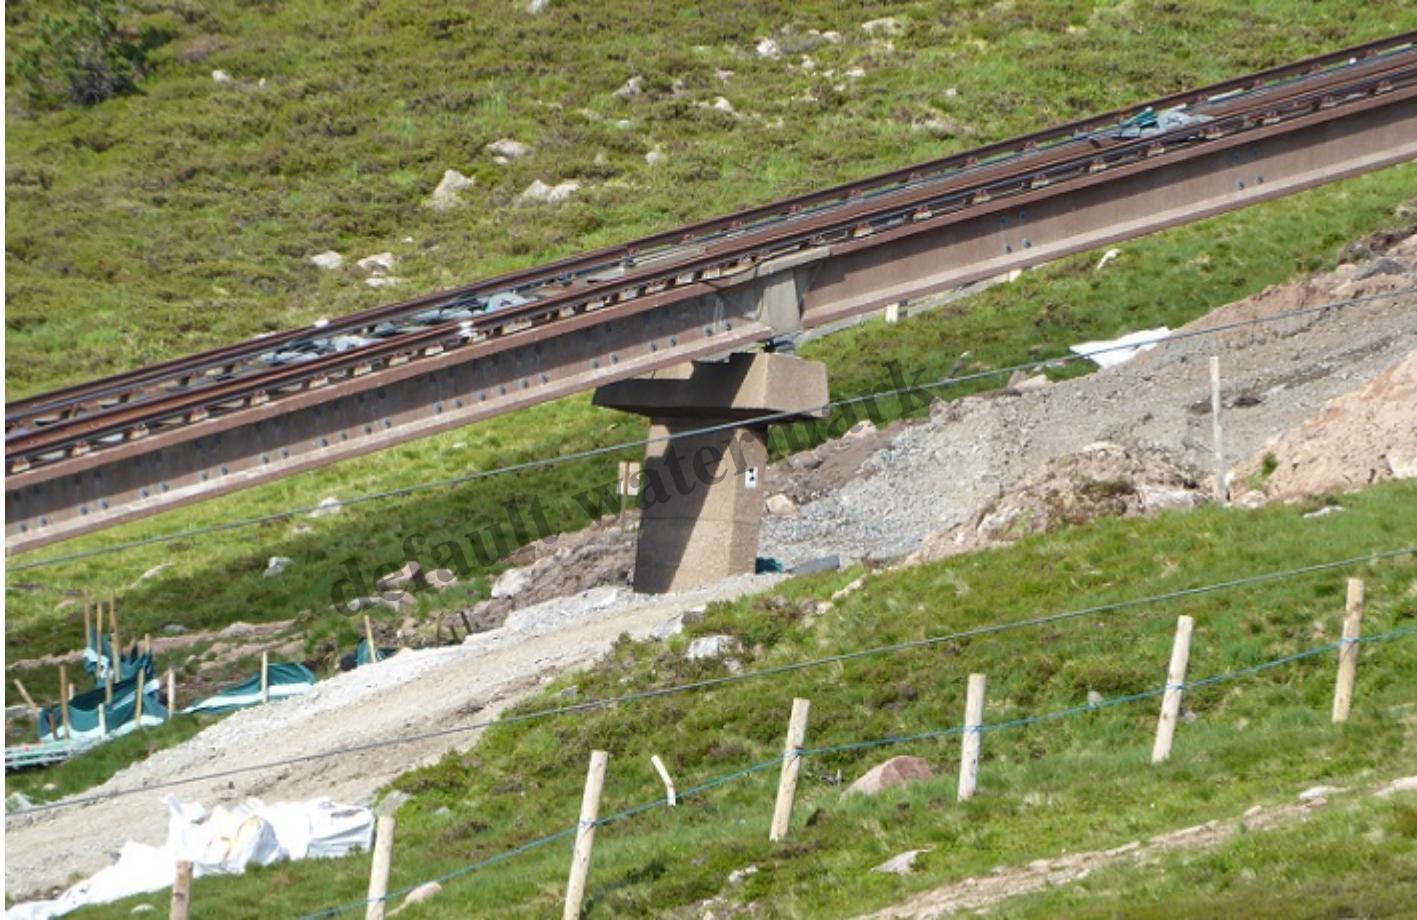
The funicular construction works 14th July, a few days after the intense rainstorms which affected parts of Speyside. Photo credit Louise Brimelow

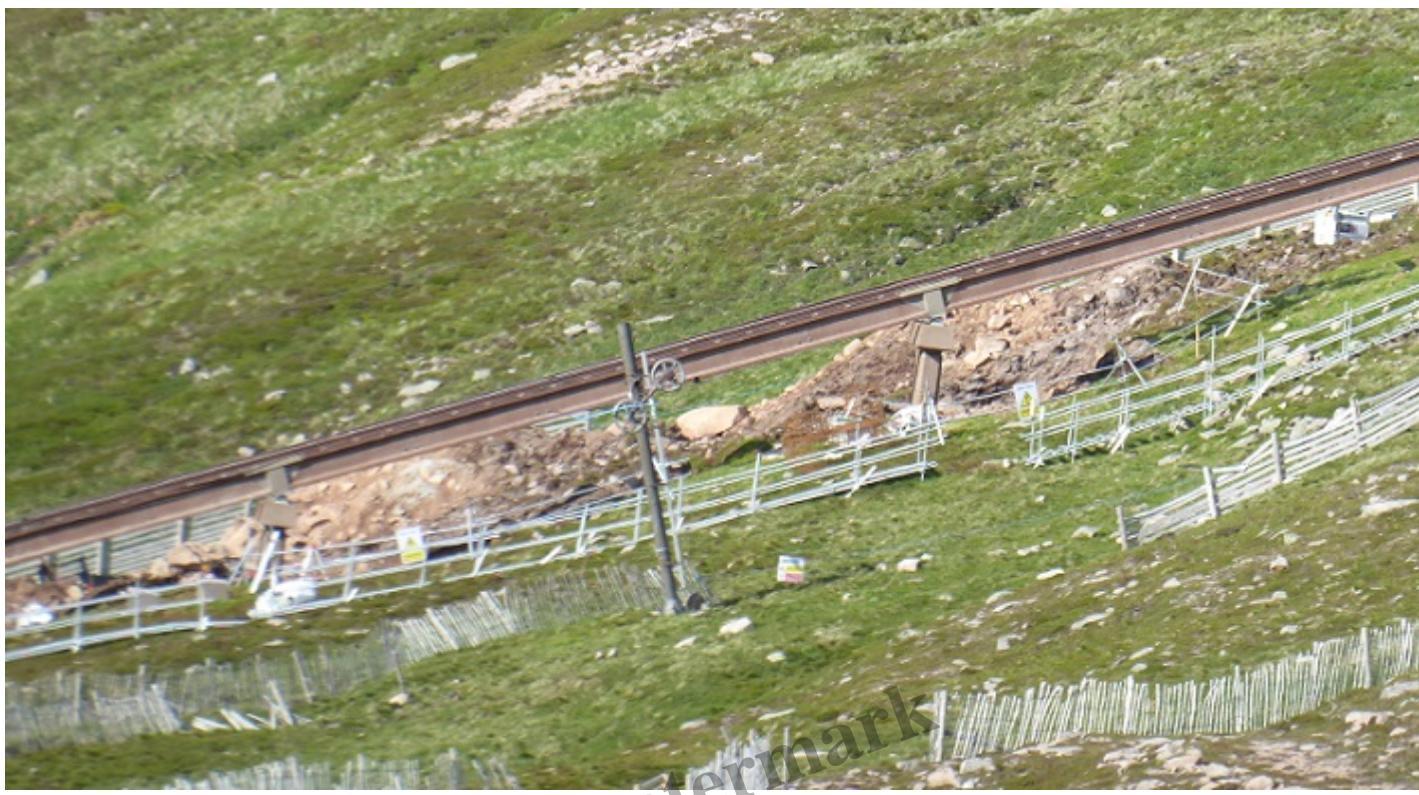
Two weeks ago there were heaps of excavated material all the way up the funicular:

Photo credit Louise Brimelow 14th July.

Whatever the merits of repairing the funicular, heaping piles of excavated material and imported material all the way up the construction site *at the same time* is not a sensible idea in a mountain environment. The work should have been phased. By luck Highlands and Islands Enterprise may get away with it.....unlike those developers in Japan.

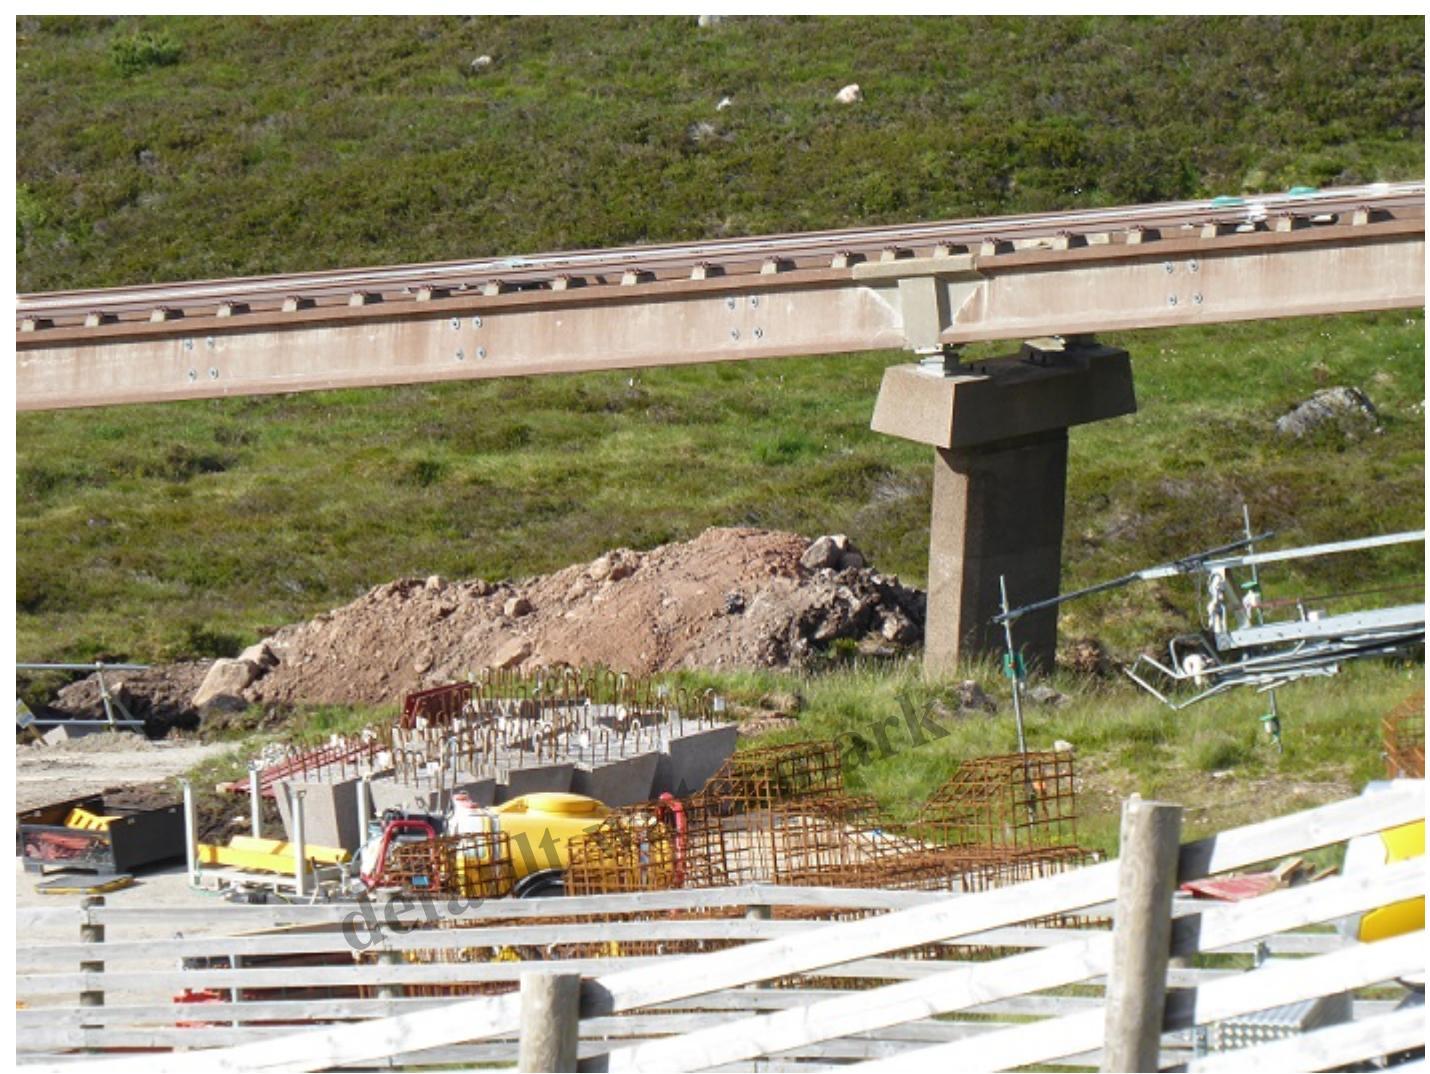
Lower down a heap of excavated material had been placed downhill of a pier and beneath the beams supporting the rails – apparently to protect peat – where it would have been offered some protection against rain. Photo Credit Louise Brimelow.

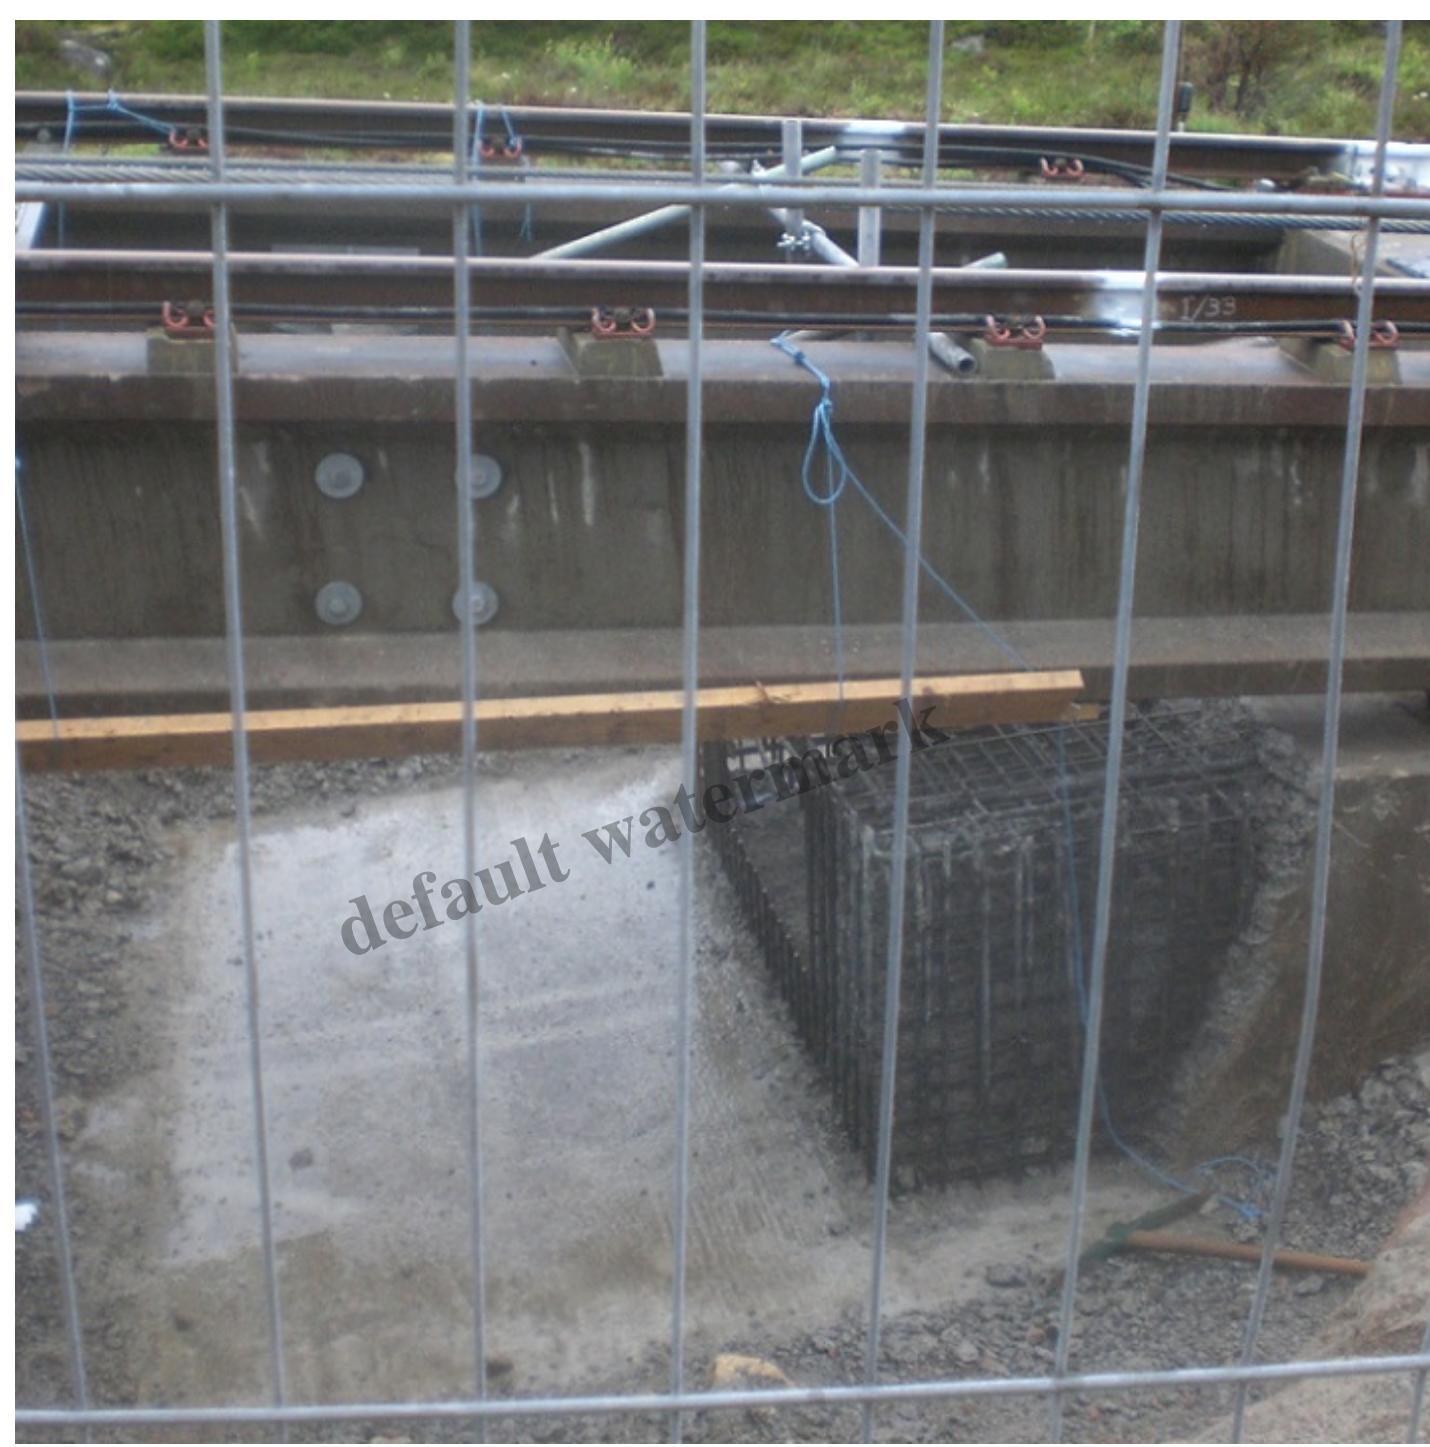
Anchor block extension. Photo credit one of my Cairngorm companions

The amount of concrete – 900 kg of CO2 is emitted in the fabrication of every ton of cement – being added to the funicular to prop it up and stop it sliding downhill is considerable.

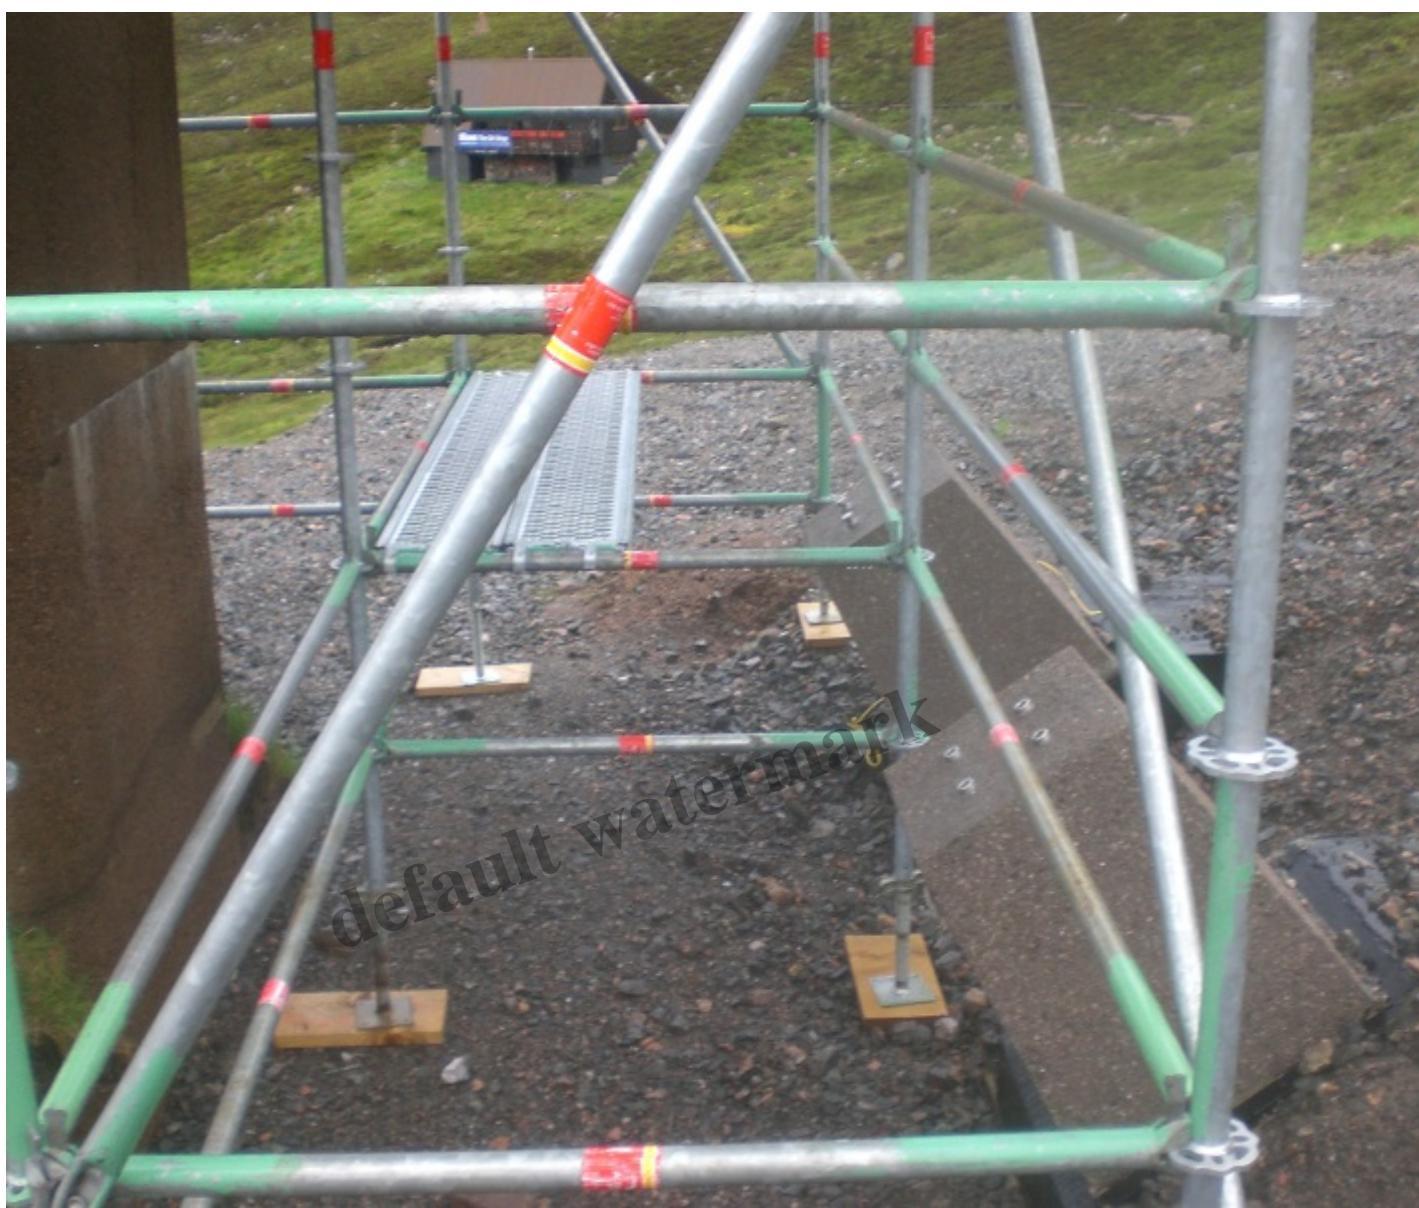
While only the pre-constructed blocks which will support the metal props will be visible once construction is complete, below they are supported by much larger blocks of concrete. Photo credit my Cairngorm companion.

As well as the concrete, significant quantities of imported aggregate have been used in the construction. Together they have altered what remained of the natural granite based soils around the funicular and will change the drainage patterns, with unpredictable consequences.

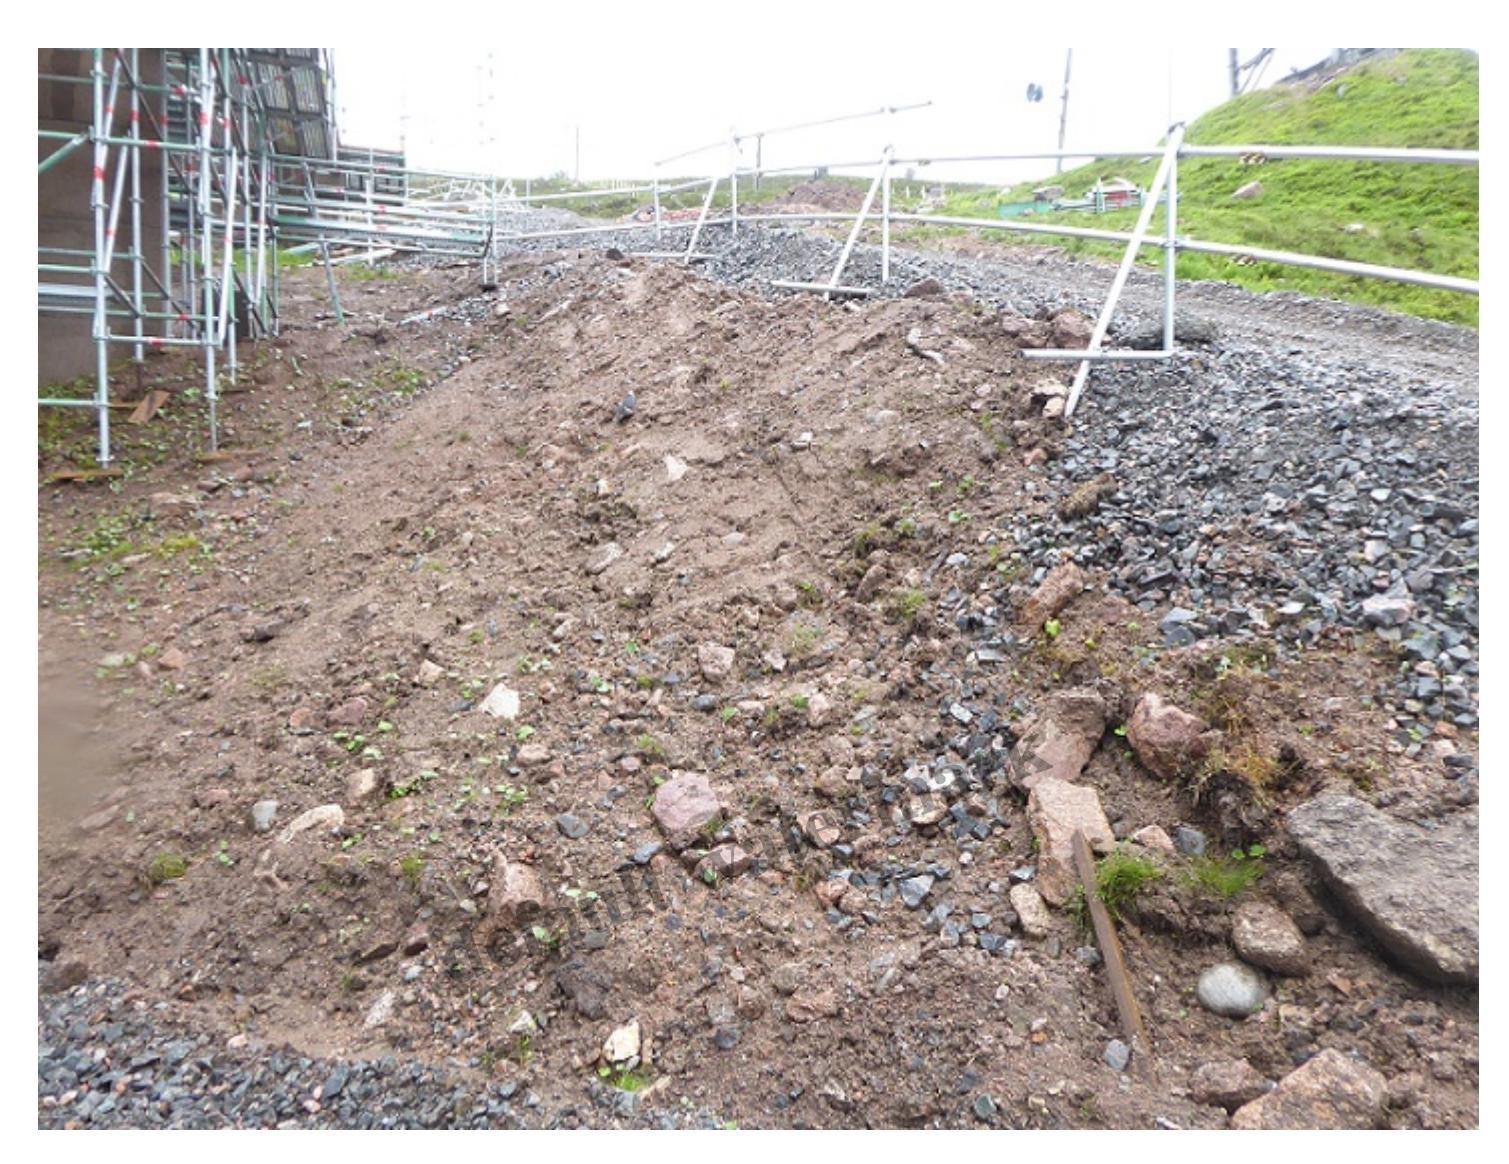
The planning application claimed that the original funicular construction tracks above the mid-station which had been restored would be uncovered and re-used. This always was nonsense. What the photo shows it that Balfour Beatty has been allowed to bring in imported aggregate to surface a new "temporary" access track. It is hard to see how this can ever be removed – it is spilling all over the mountain – and its still not clear what will be done with this and all the surplus material displaced from the pits. Spread it around, perhaps, and hope for the best?

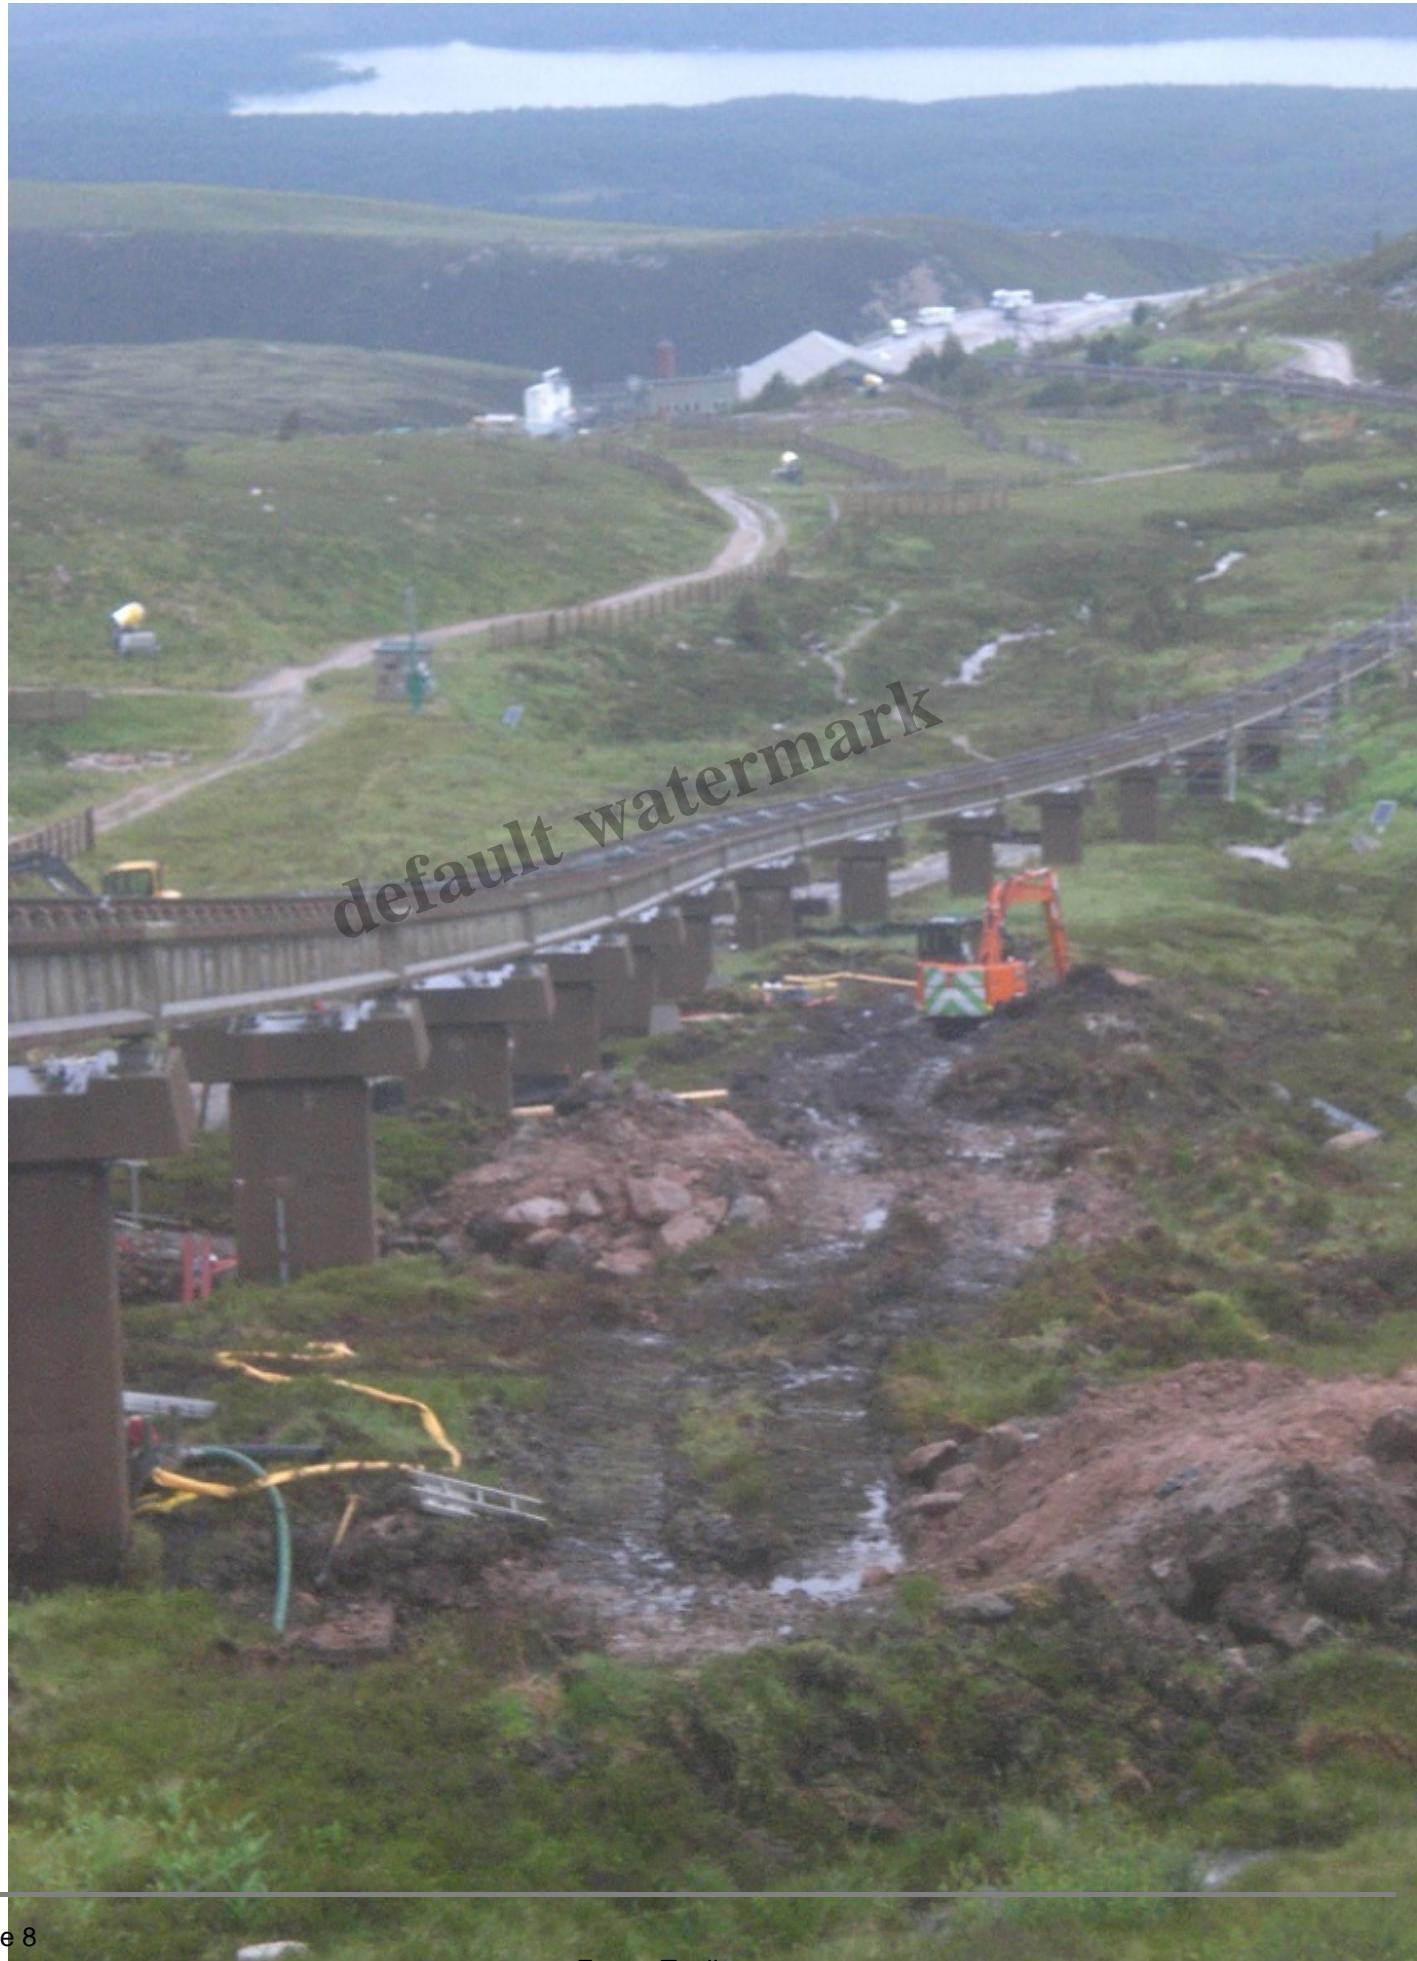
No signs of the ground being protected, the peaty turf (centre foreground) is not being stored properly while large quantities of excavated material have been dumped on peaty vegetation outwith the construction corridor. Photo credit my Cairngorm companion.

"SUSTAINABLE PEAT MANAGEMENT: SEPA welcomes the utilisation of existing tracks where possible and acknowledge that there is little scope for mitigation in terms of reducing volumes of excavated peat with regards to the proposed new pier supports [yet more carbon emissions]. However, there appears to be scope for further mitigation in relation to the new temporary tracks proposed with a significant volume of peat estimated to be excavated for these in table 3 of the Outline Peat Management Plan and SEPA therefore request that all temporary tracks where peat would otherwise be excavated comprise of geotextile or plastic track matting unless there is a significant technical reason why this is not feasible". (Extract from the CNPA Committee Report on the Planning Application).

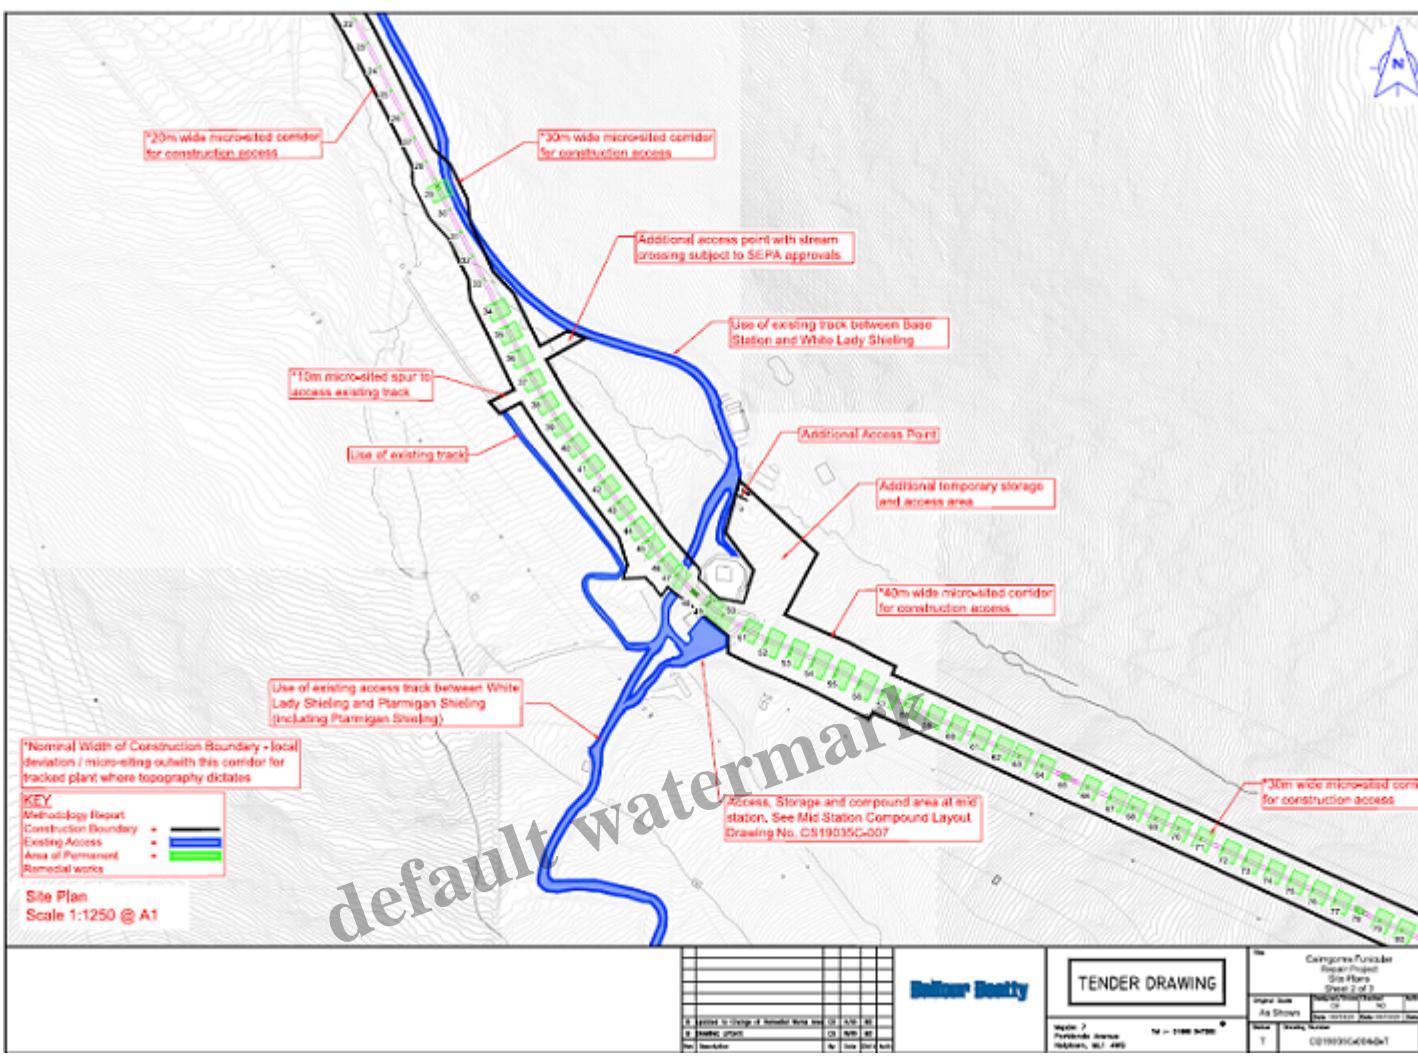
The construction corridor outlined in black, 20m at the top and 30m for the rest, apart from 6 piers above the mid-station. The shieling, outlined in grey, and mid-station are just below centre in the pla

- 20m where new bearings and pier strengthening was required (generally lower down the hill top left in map above);
- 30m where new props were required to strengthen the piers which were toppling over (generally from 10 piers below the mid station to the funicular tunnel);
- 40m for the six piers above the mid-station; and
- a few section where where there were projecting access spurs and storage areas.

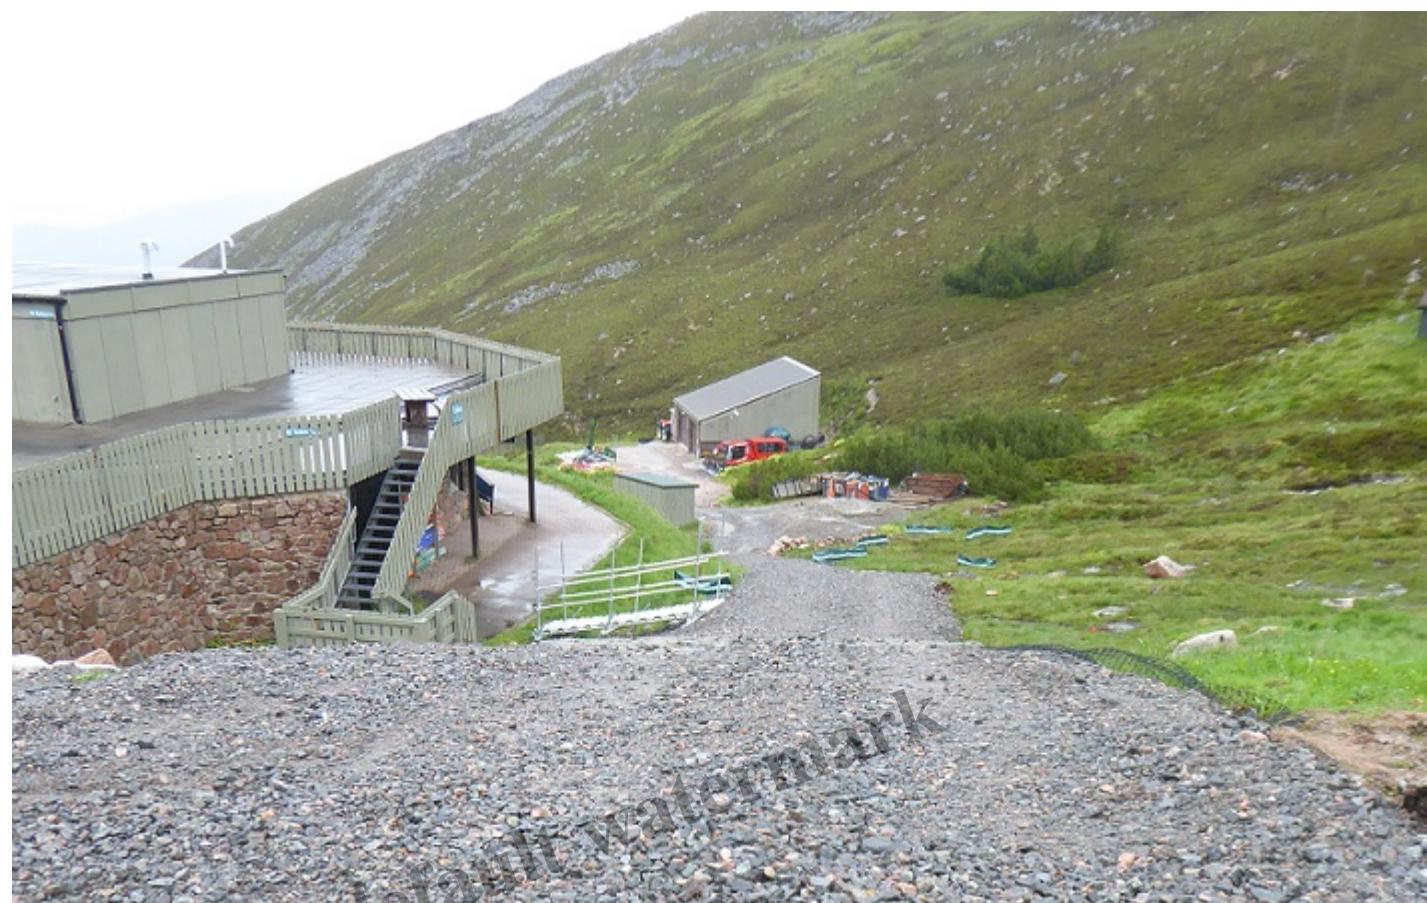
The temporary storage area above the shieling, marked as lying within the construction site appears mostly unused albeit an enormous new track has been constructed..

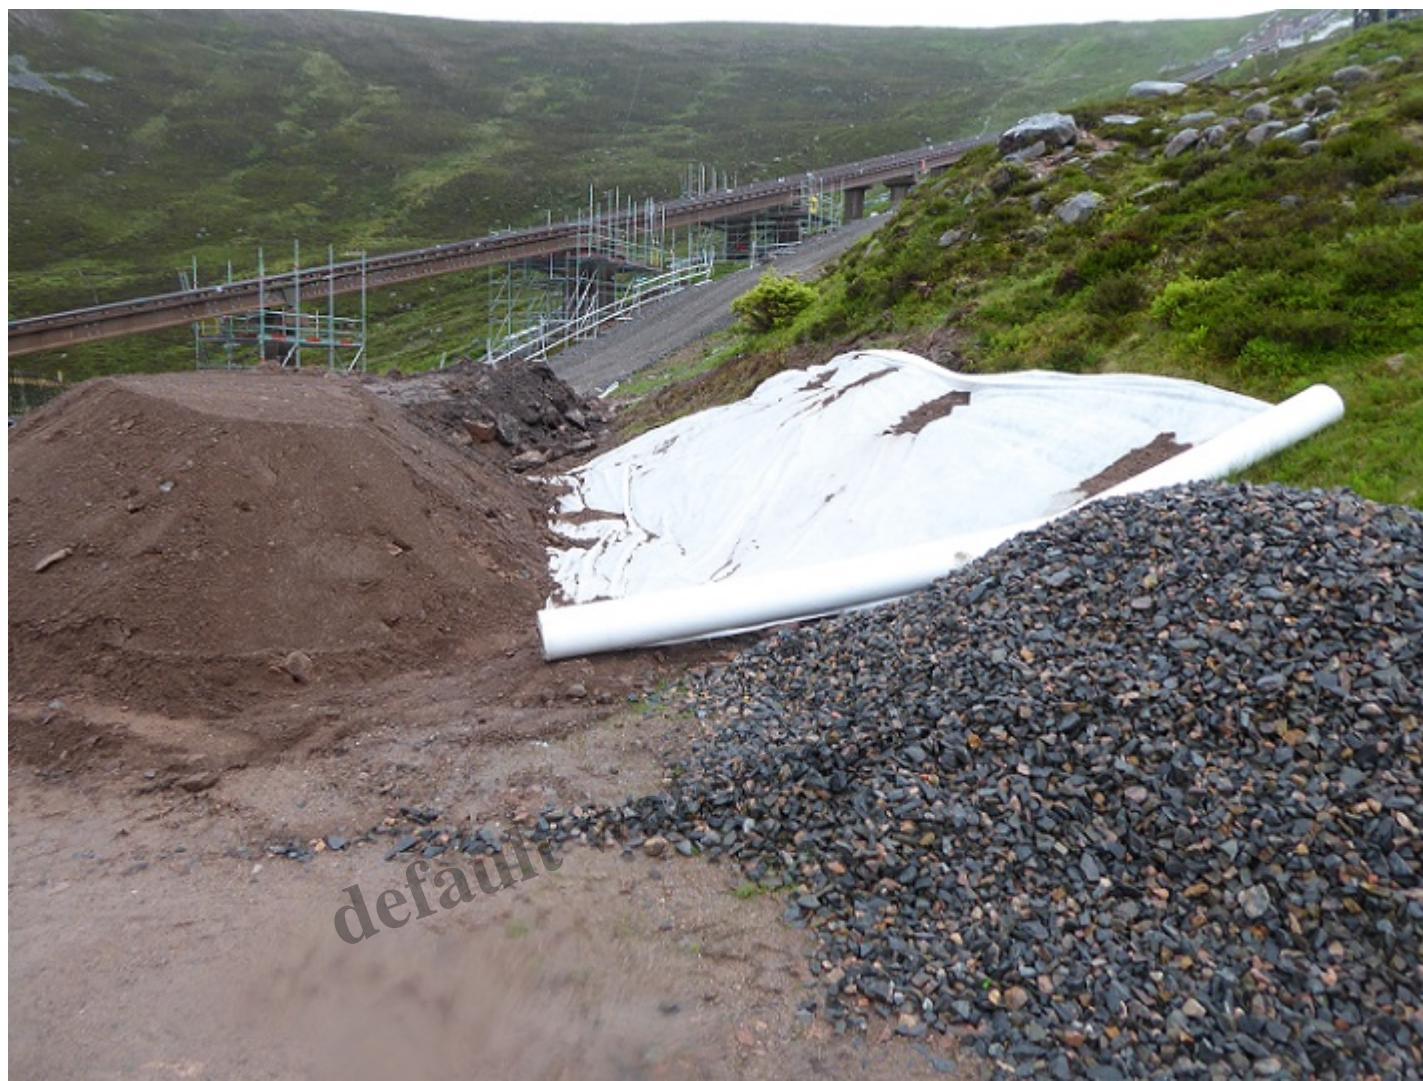
These piles of sand and aggregate, together with the sheeting, lie outwith the construction area, the shaded blue area in the plans above

To their credit, the Scottish Environment Protection Agency in their response to the planning application had queried the construction site area and noted *"that should the construction site area be over 4ha, a Construction Site Licence (CSL) would be required."* That never appears to have been followed up by the CNPA.

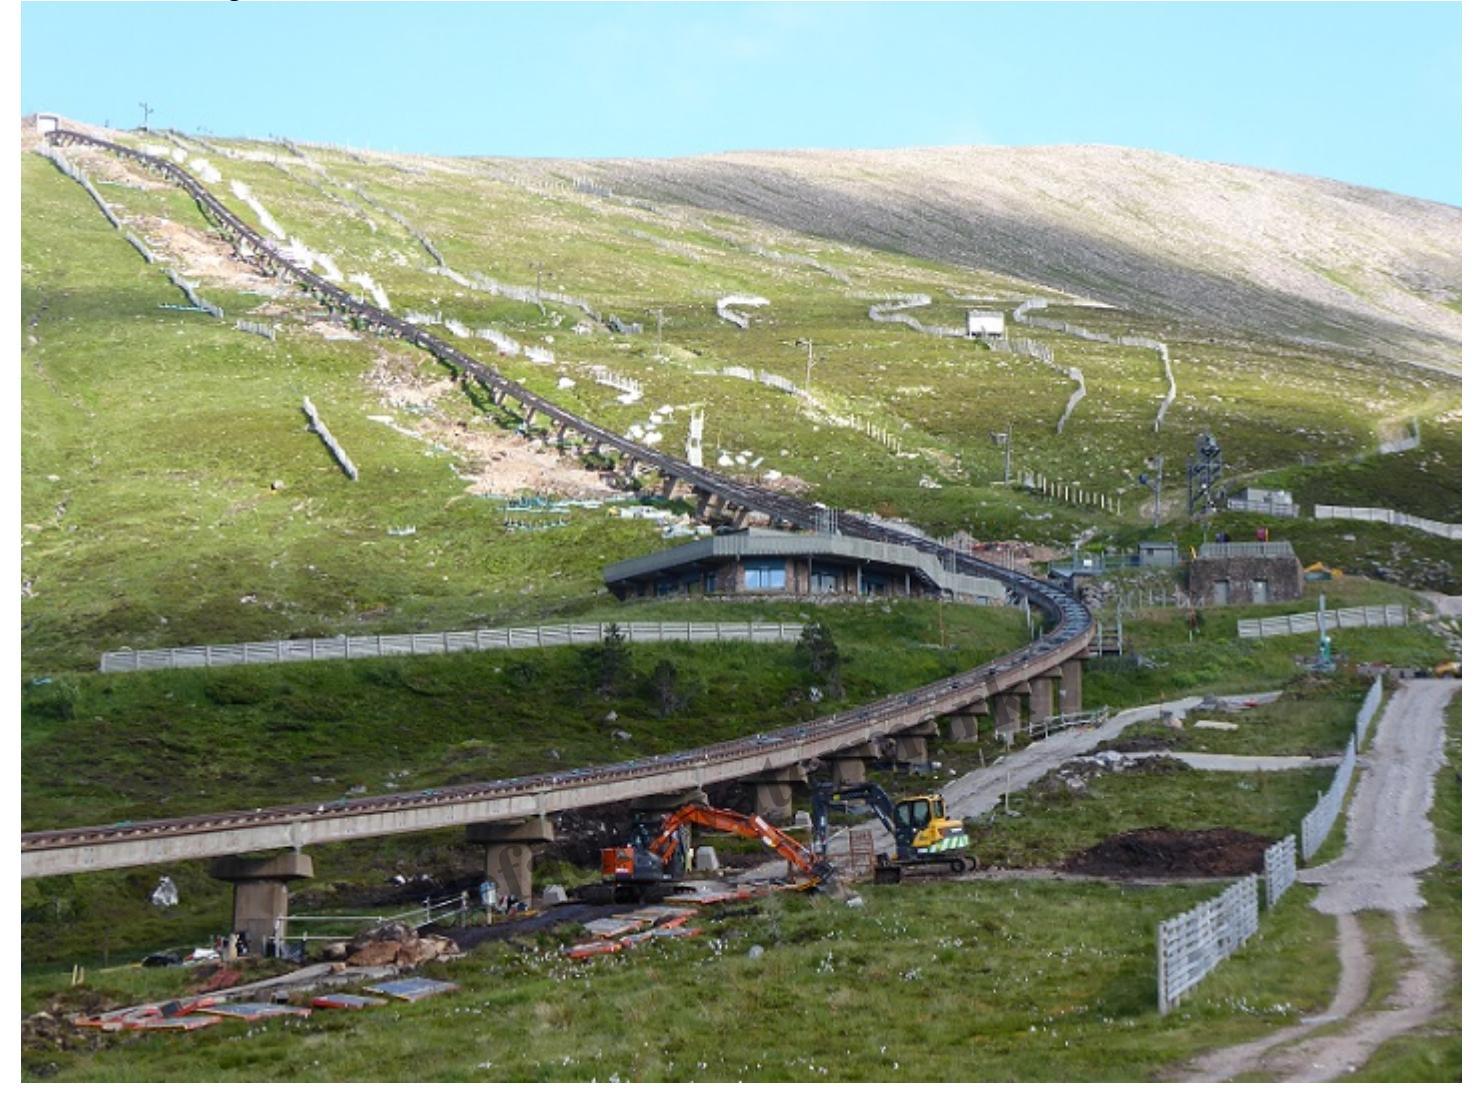
Evidence of work impact on areas outwith the construction corridor, by the heap of soil/peat lower right and higher up the mountain the construction has clearly affected an area more than 30m wideSo why didn't the Cairngorms National Park Authority insist the construction corridor was first sized and then marked out properly? Why has it since not taken enforcement action o this and other issues (like failure to store vegetation)? It was quite predictable that, given their record, HIE and Cairngorm Mountain Scotland Ltd would make little effort to ensure planning conditions were kept, so why weren't CNPA Planning staff out on site each day?
