Landslips, flooding and riverside tree planting in Balquhidder – tackling the source of the problems

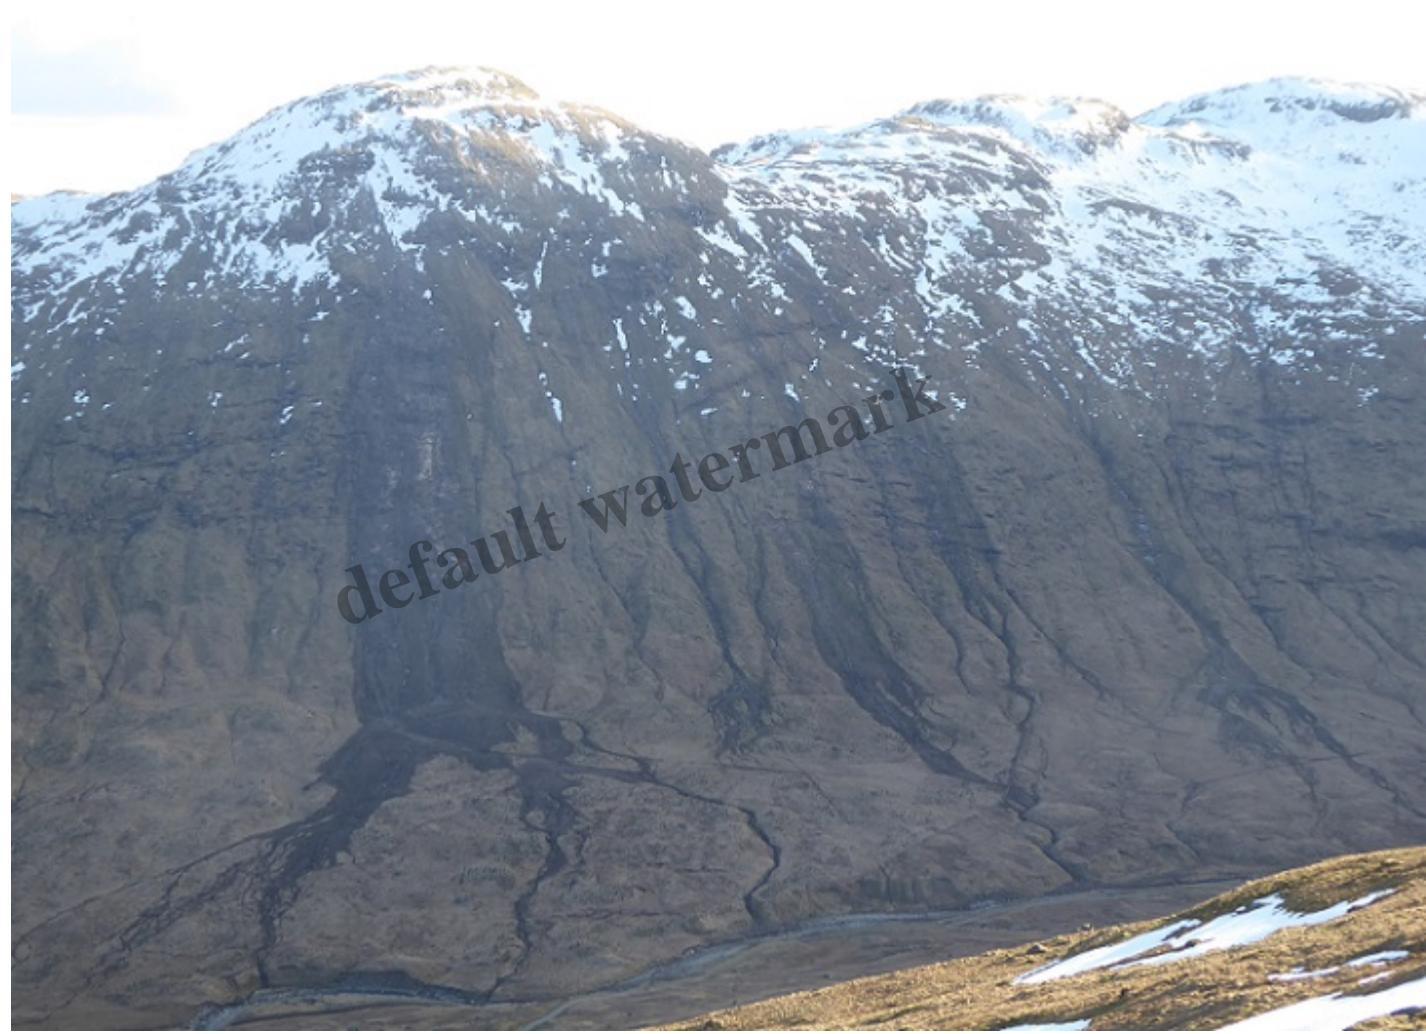
Landslips on Stob an Duibhe March 2020

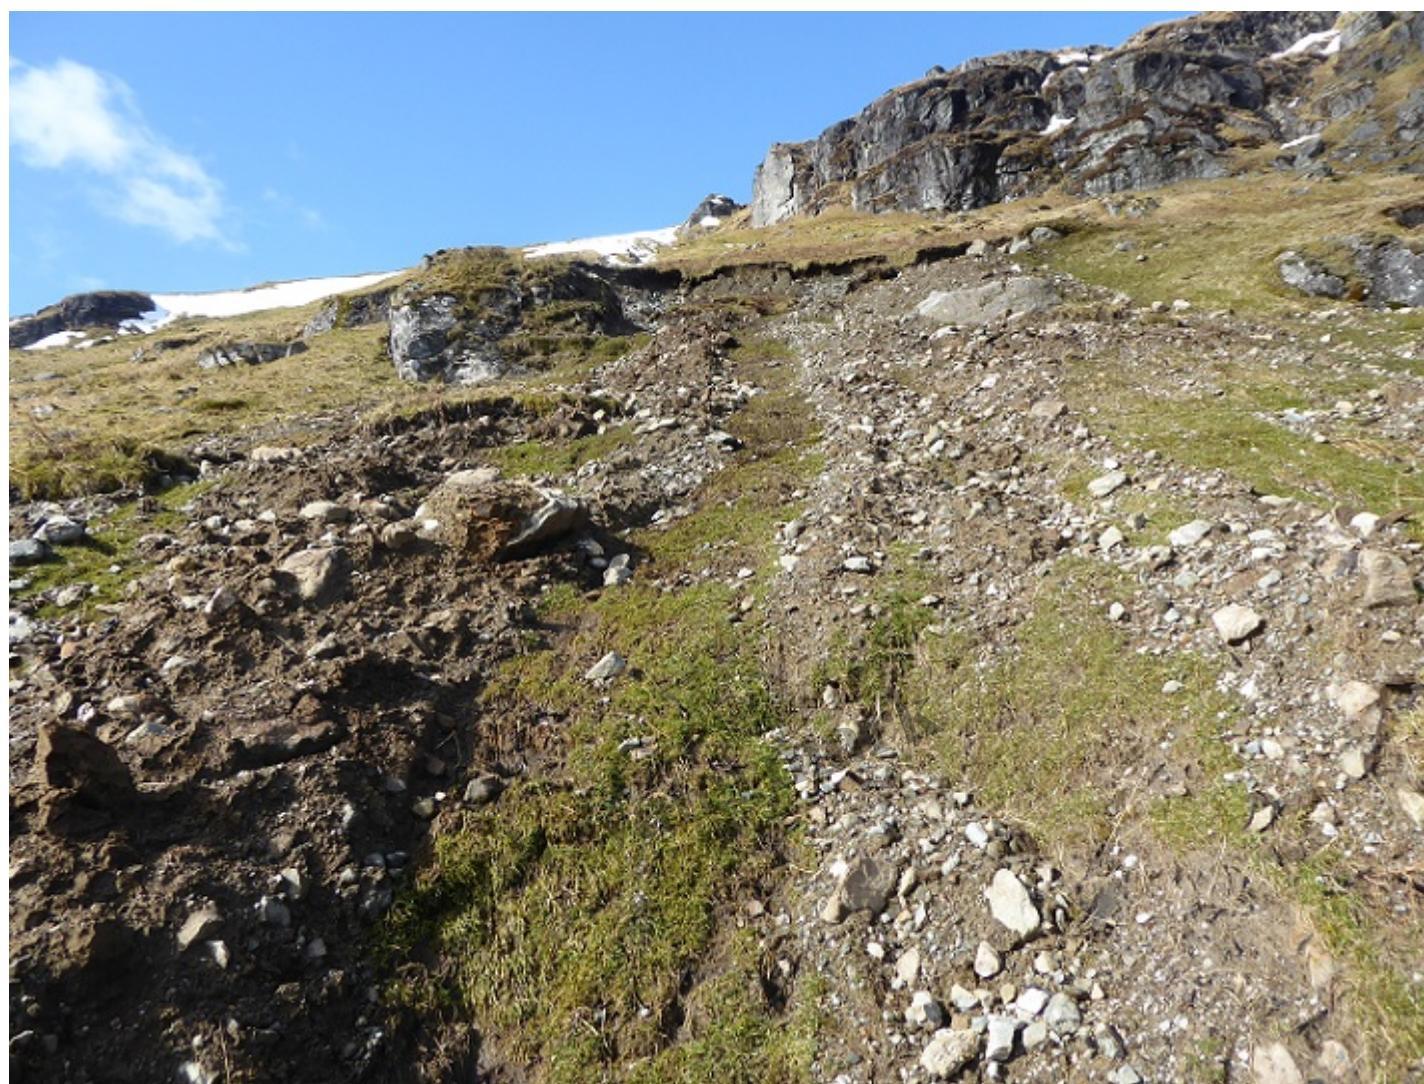
Landslip on south slope of Beinn a Chroin. Note how the volume of water has washed clean a strip down the centre of the landslip. March 2020.

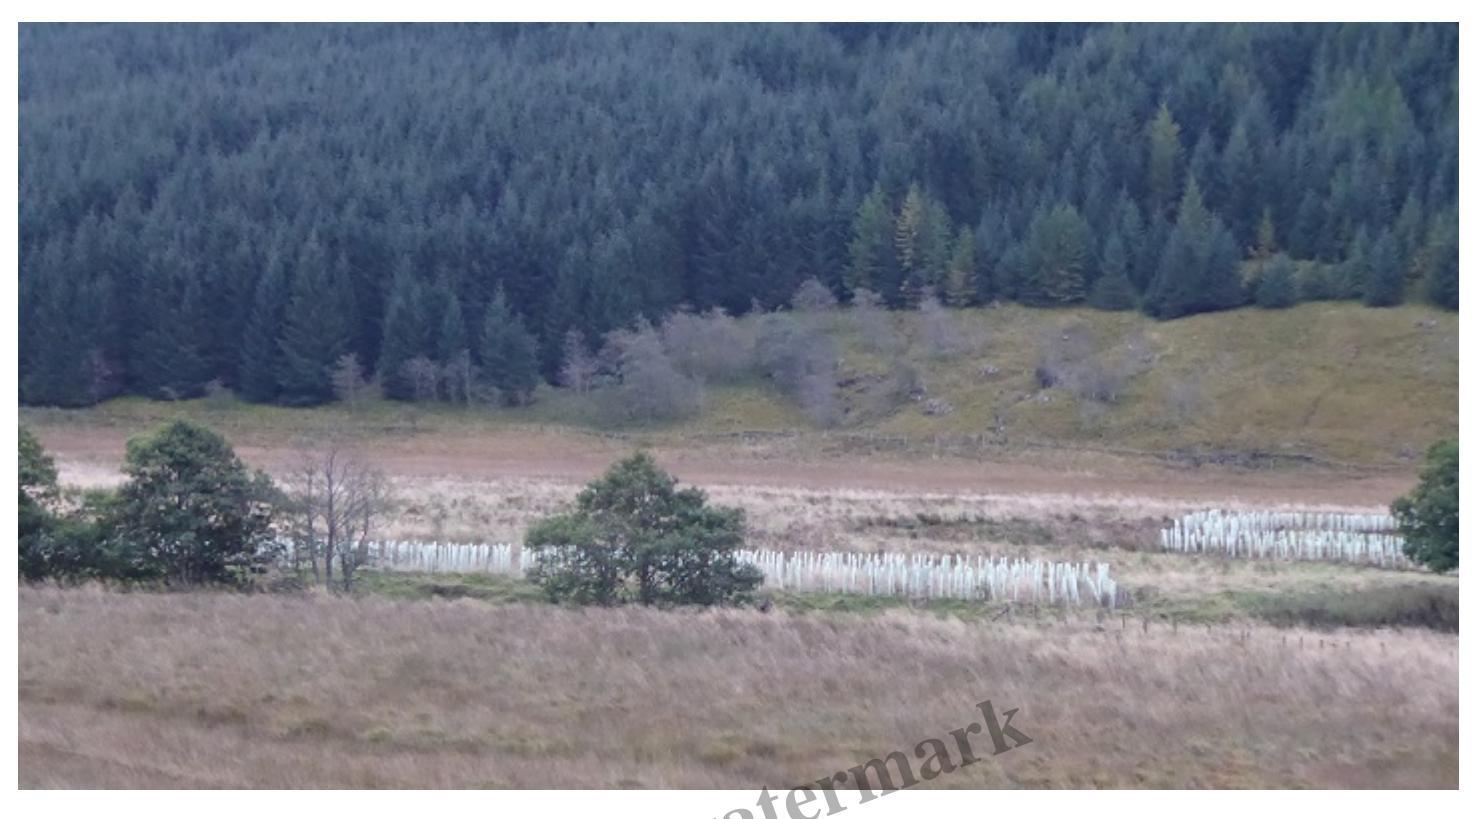
We were greeted by a forest of plastic tree tubes on the flood plain just before the road end at Inverlochlarig which the Loch Lomond and Trossachs National Park Authority (LLTNPA) had boasted about back in March (see here). The photo illustrates how the LLTNPA has paid no regard to the landscape, carbon emissions – plastic is derived from oil – or how it is killing wildlife in our rivers and seas.

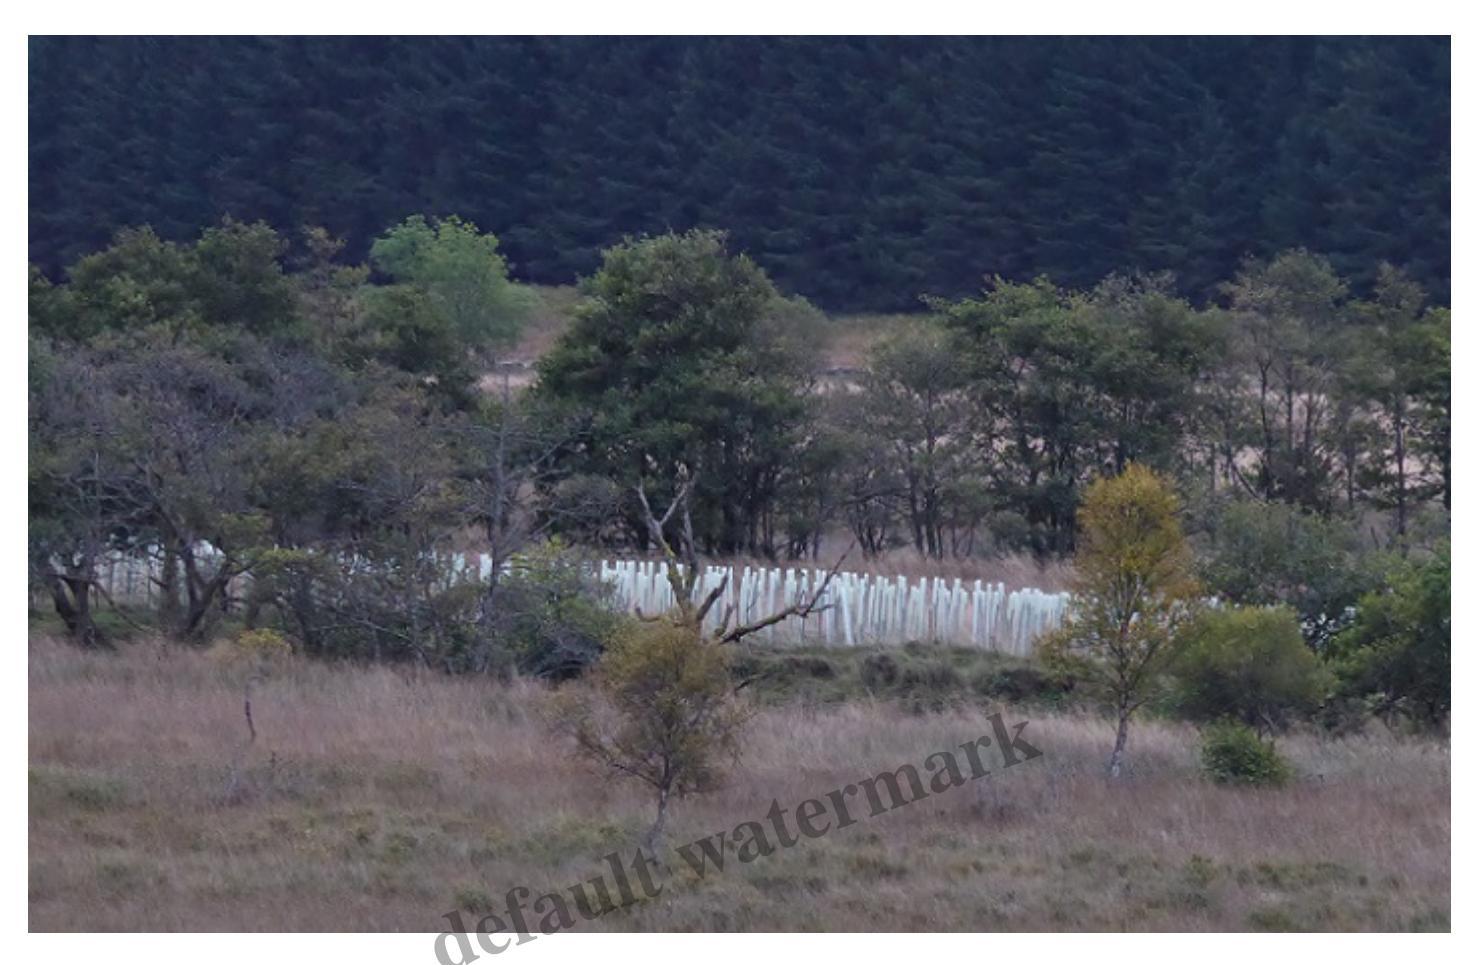
The LLTNPA stated the purpose of this tree planting was to improve river habitats by creating riparian tree cover. This photo shows it was completely unnecessary and a waste of public funds. There are already lots of trees along this section of the River Larig and these would regenerate naturally if given a chance.

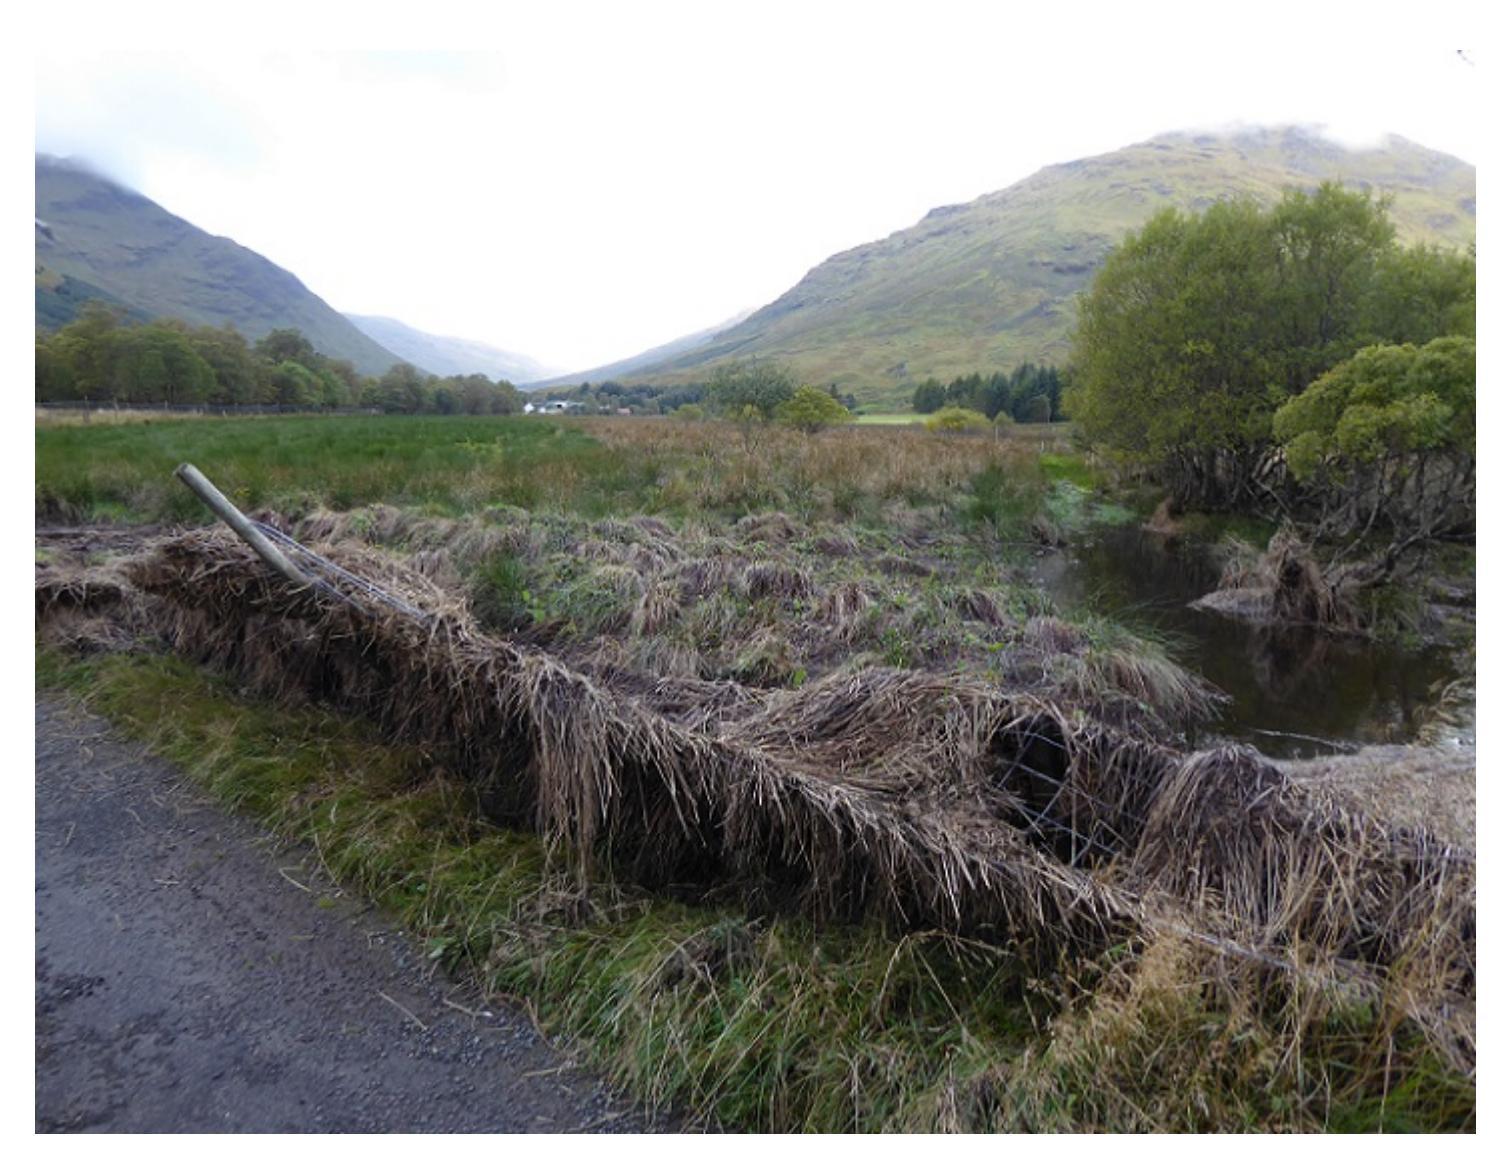
Just 50m beyond the car park, we came across evidence that the rain on Friday had been sufficient to cause significant flooding

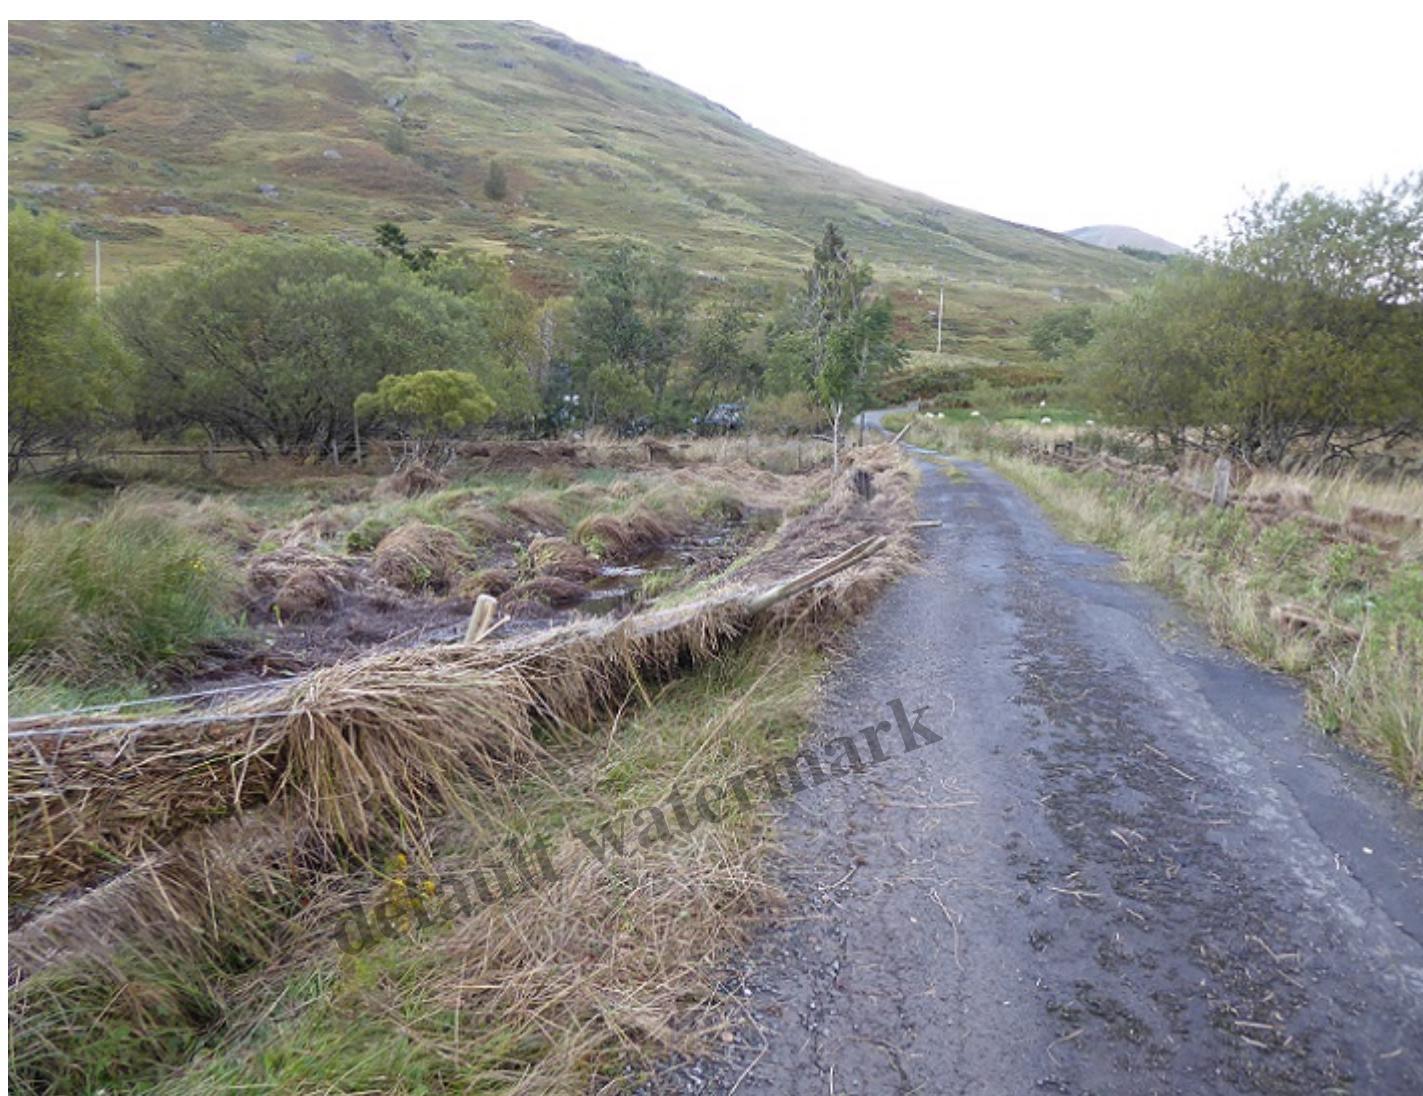
Looking back towards the car park. You can just see some of the sheep which were scattered over the hillside beyond in significant numbers.

Even small scale damage like this will have caused significant cost to the landowner

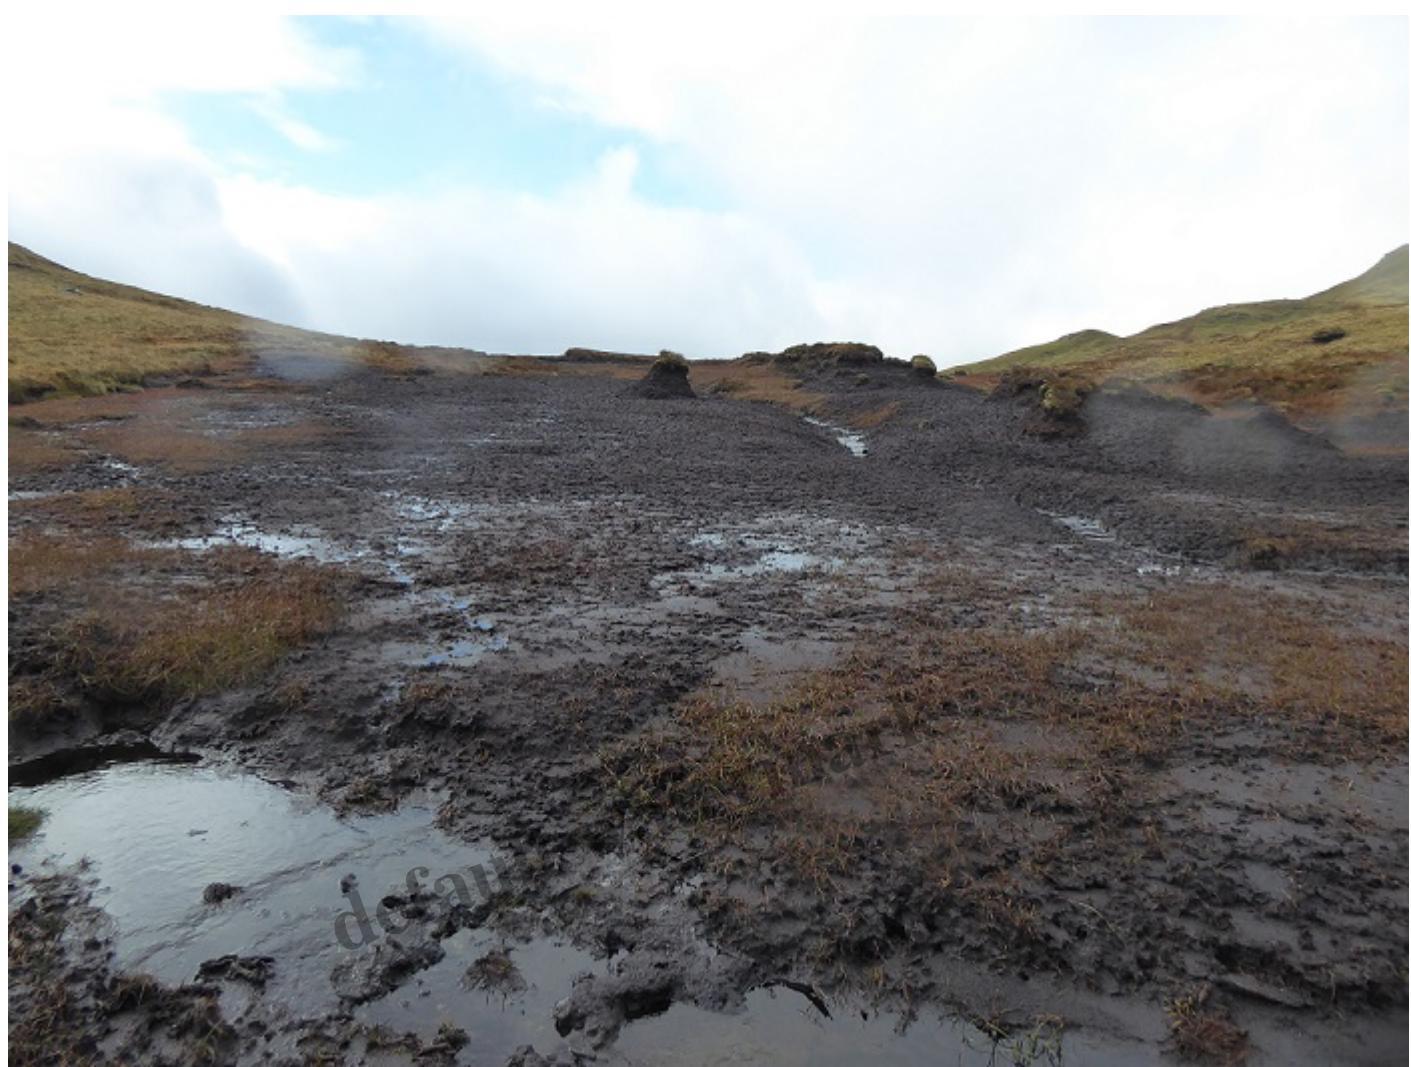
Eroded peat on the undulating south east ridge of Stob a' Choin. The height of the hag in the distance is an indication of the former height of the bog and how much carbon was stored here. Note the animal hoof marks visible in the foreground and the watercourse on the right, both of which are causing the erosion.

This and other areas of degraded peatland between Balquhidder and Loch Katrine could be helping to absorb rainfall which has been triggering landslips on both sides of the watershed. This particular area would appear need very little restoration work to start functioning again as a bog. If grazing levels were reduced, the flat areas would quickly re-vegetate with cotton grass. The other main intervention that would be required would be to block up the water course and create bog pools.

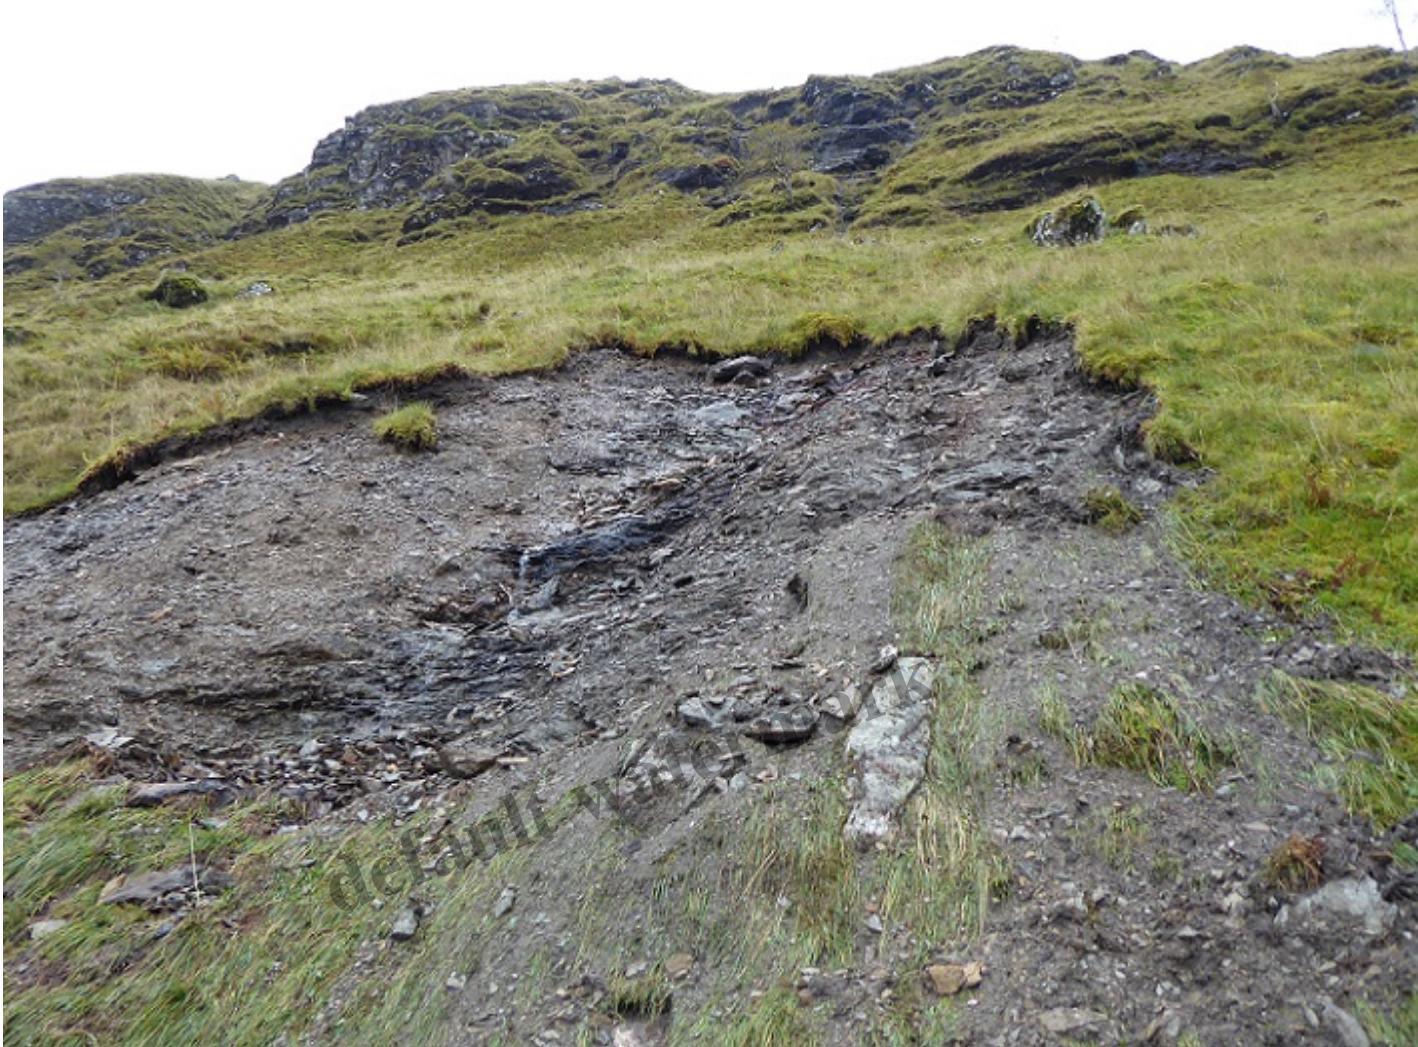
The flattened vegetation and smaller debris, which was soft and unconsolidated, indicates that this landslip was only days old.

A small watercourse was visible below the crag above the landslip which then disappeared under the vegetation. It appears that the volume of water flowing down this underground burn triggered the landslip exposing the burn once more.

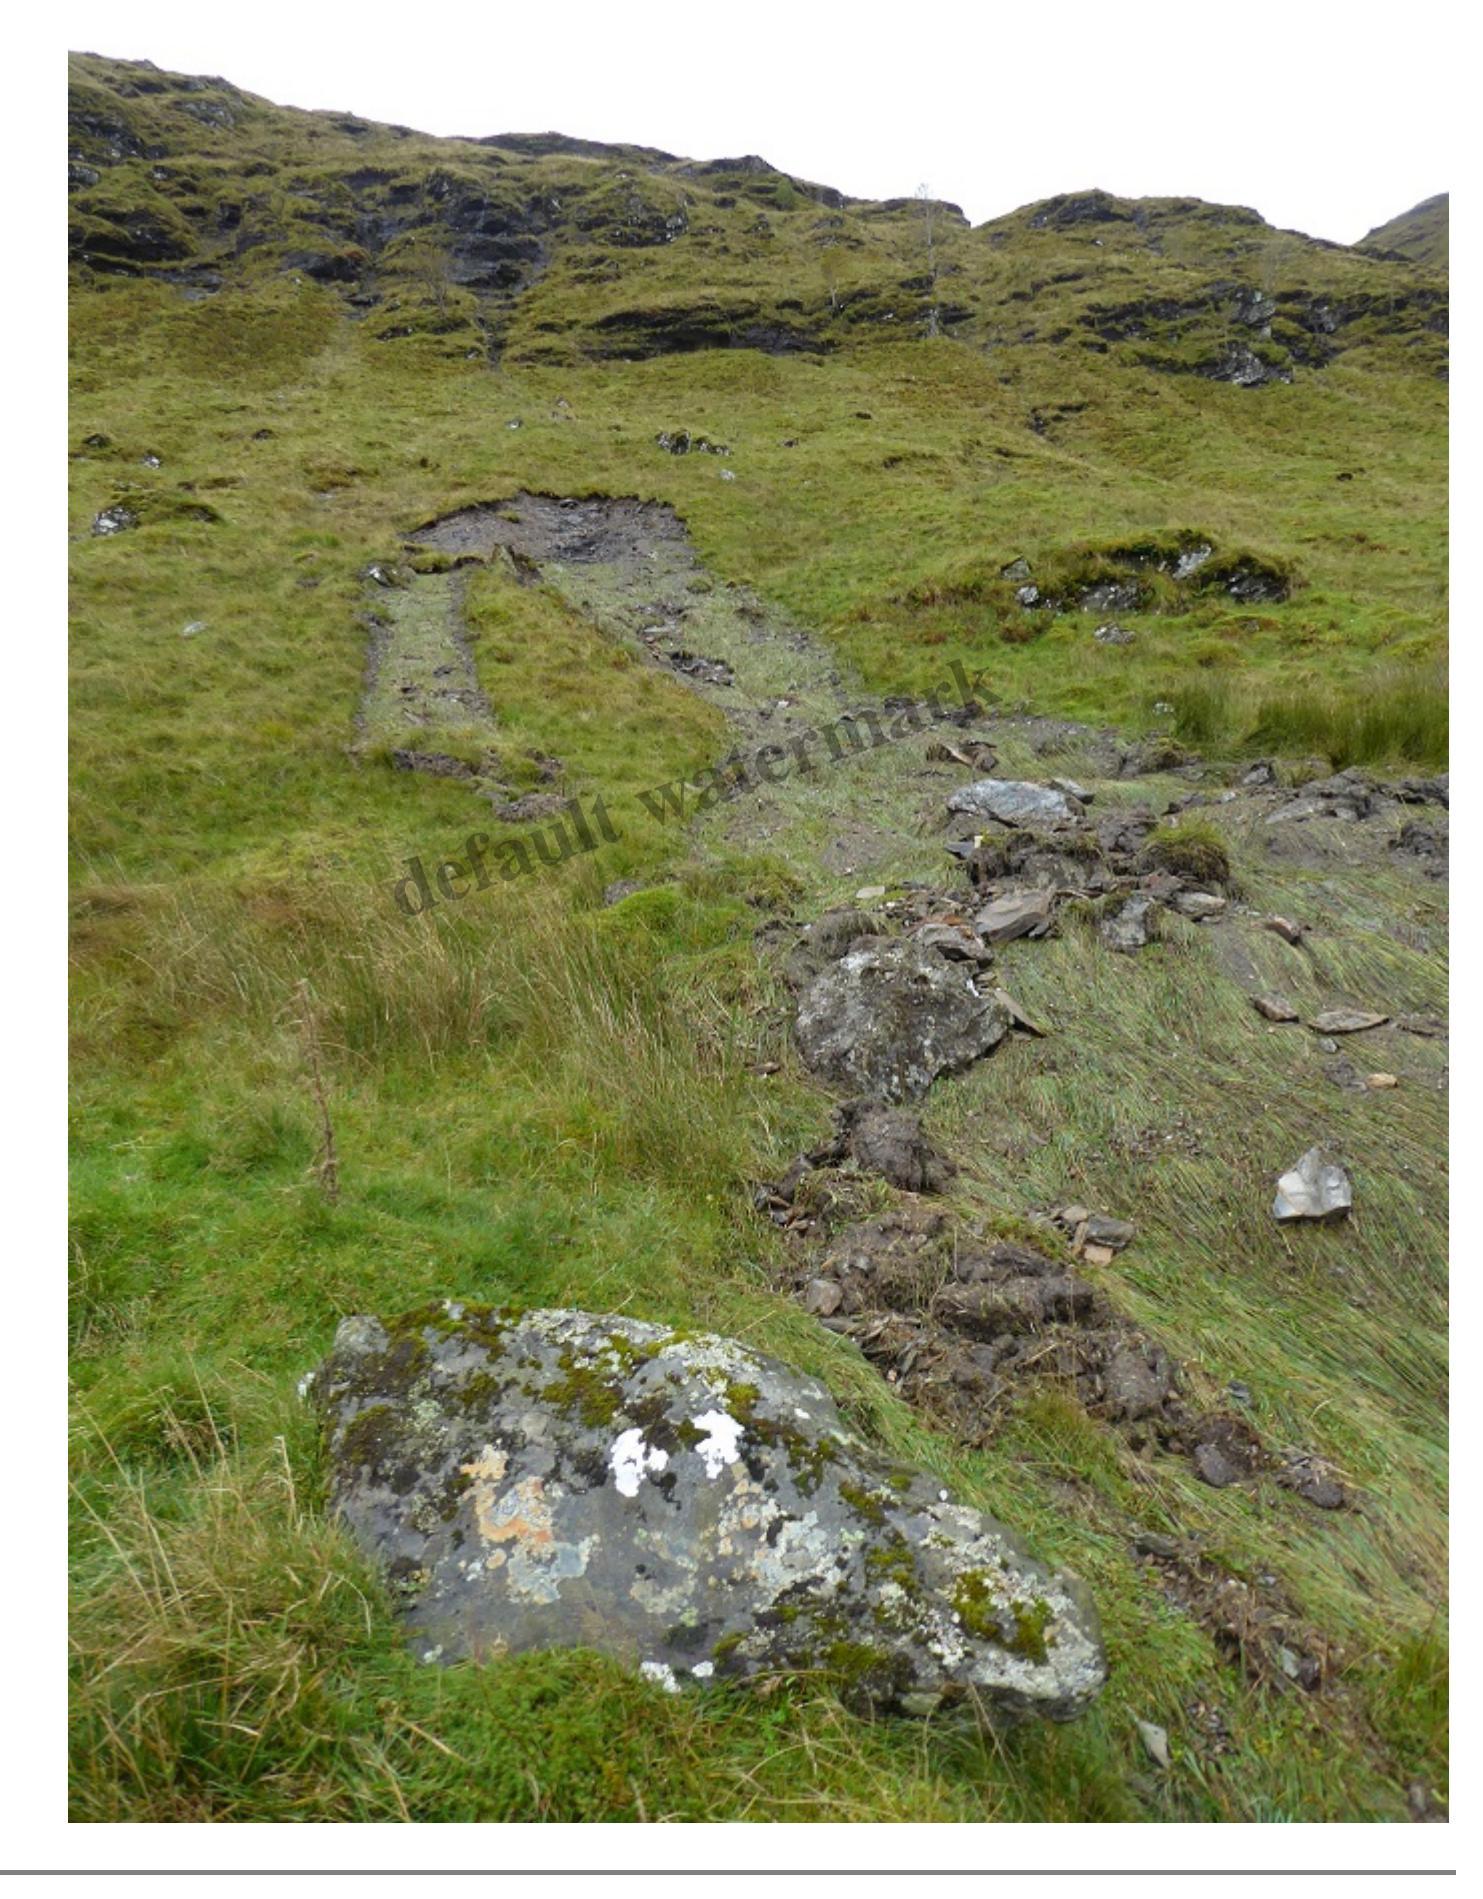
### Top section of landslip.

There was also enough water running down the hill to allow these blocks to slide over the vegetation without causing it significant damage

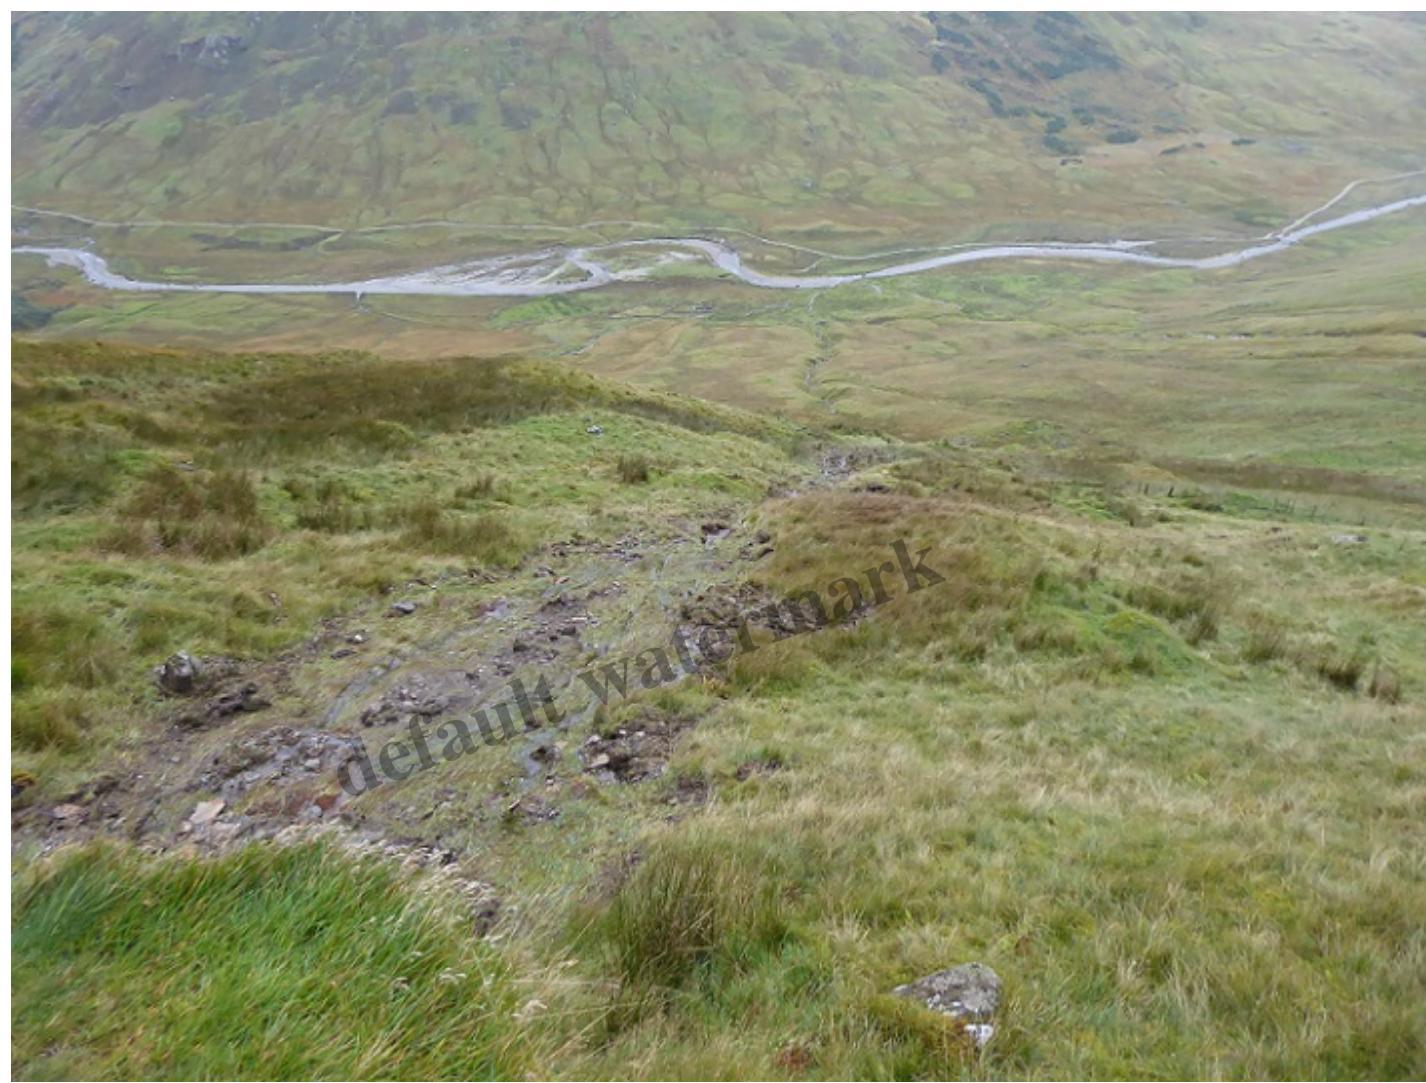
Looking down from near the point where the previous photo was taken

The landslip continued scattering debris for several hundred metres down the hillside

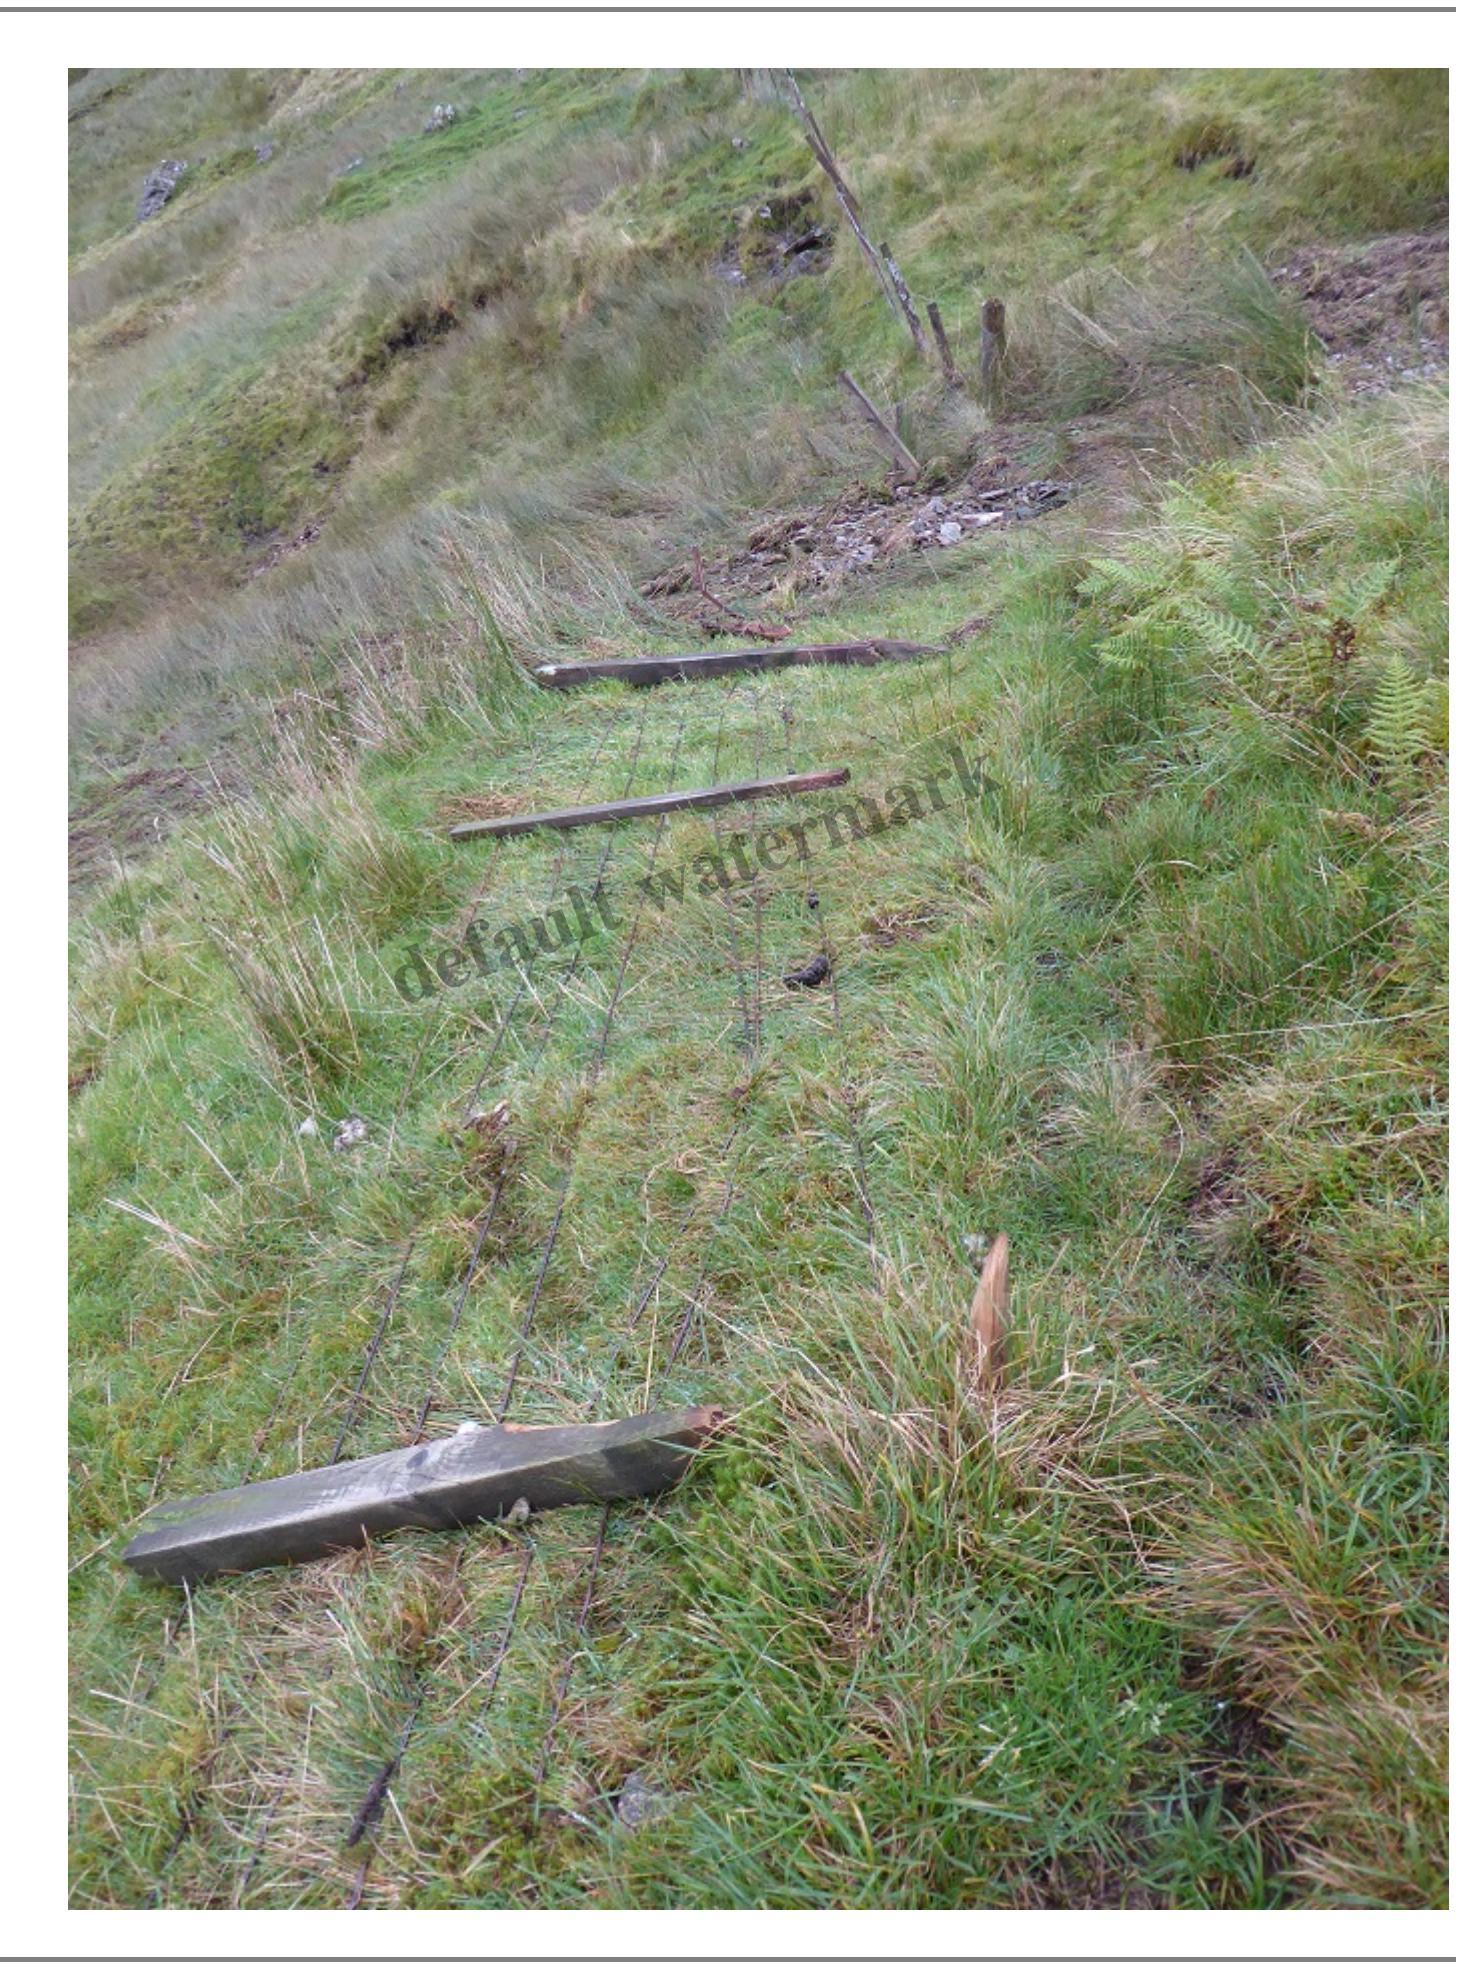
Note the projecting spear of wood to the right of the post in the foreground

The force of the water and the debris it was carrying was sufficient to flatten this stock fence well below and snap one its posts in two – more costs for the estate

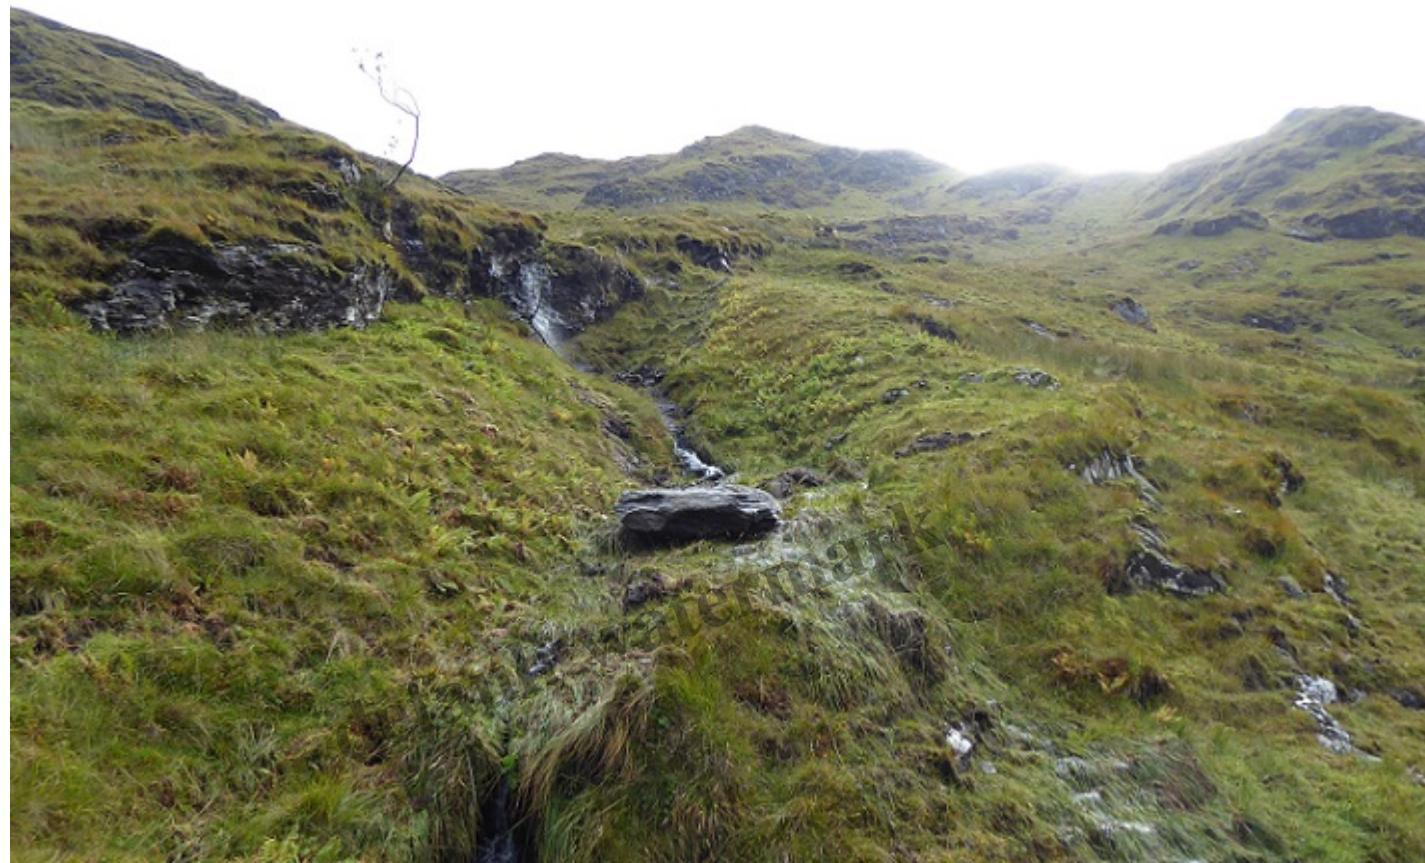
The course of the landslip is visible to the right of what is now a small waterfall.

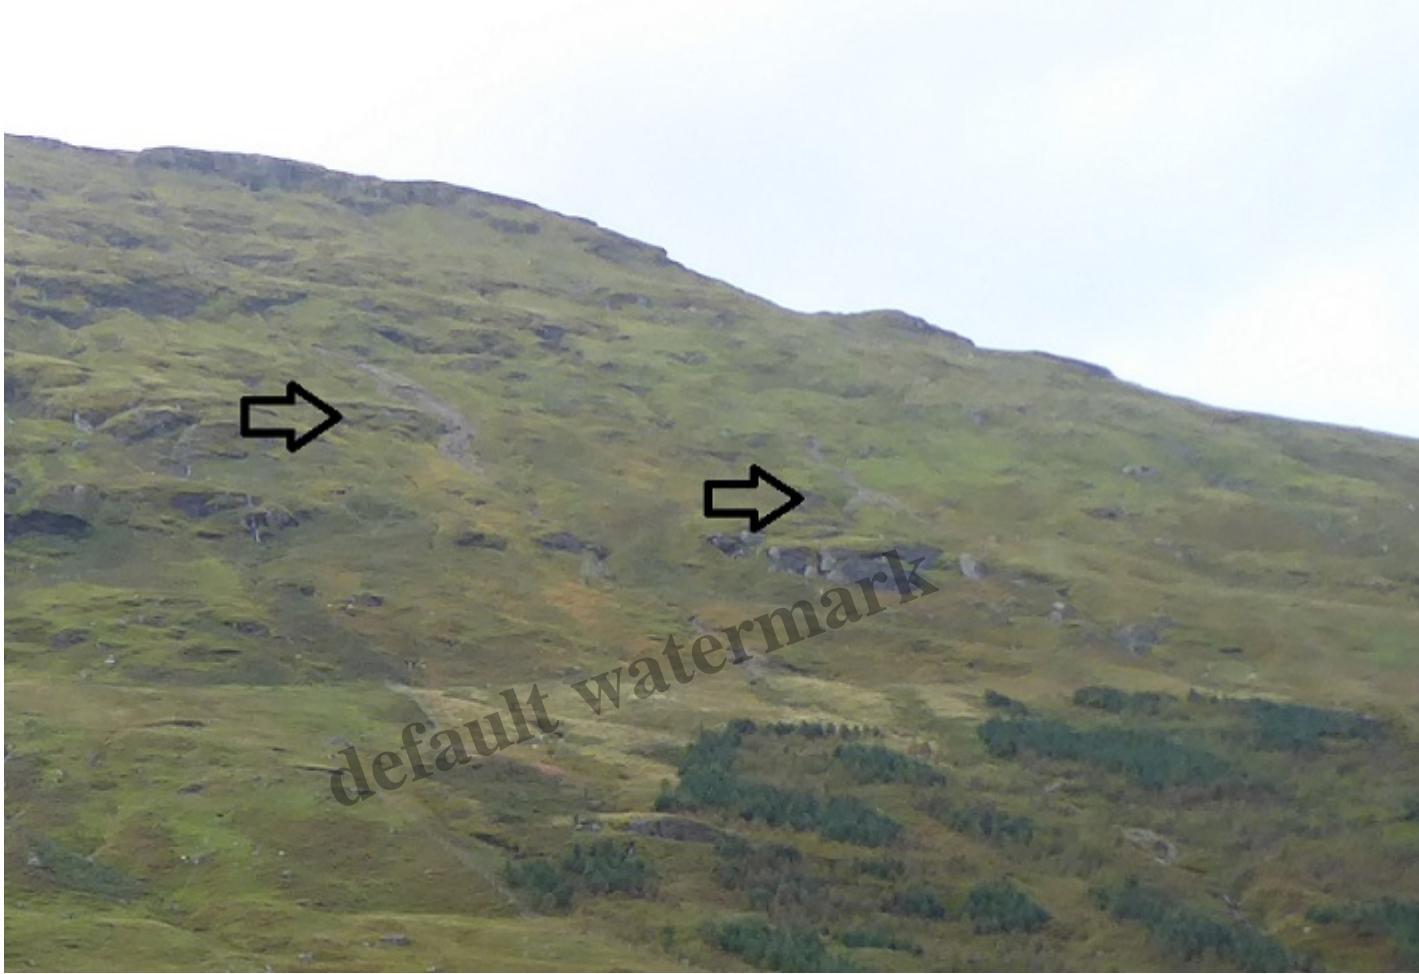
Note how the landslips are above the native woodland plantation, an illustration that we need to sten flow of water much higher up the hill
