Landslips, flooding and riverside tree planting in Balquhidder – tackling the source of the problems

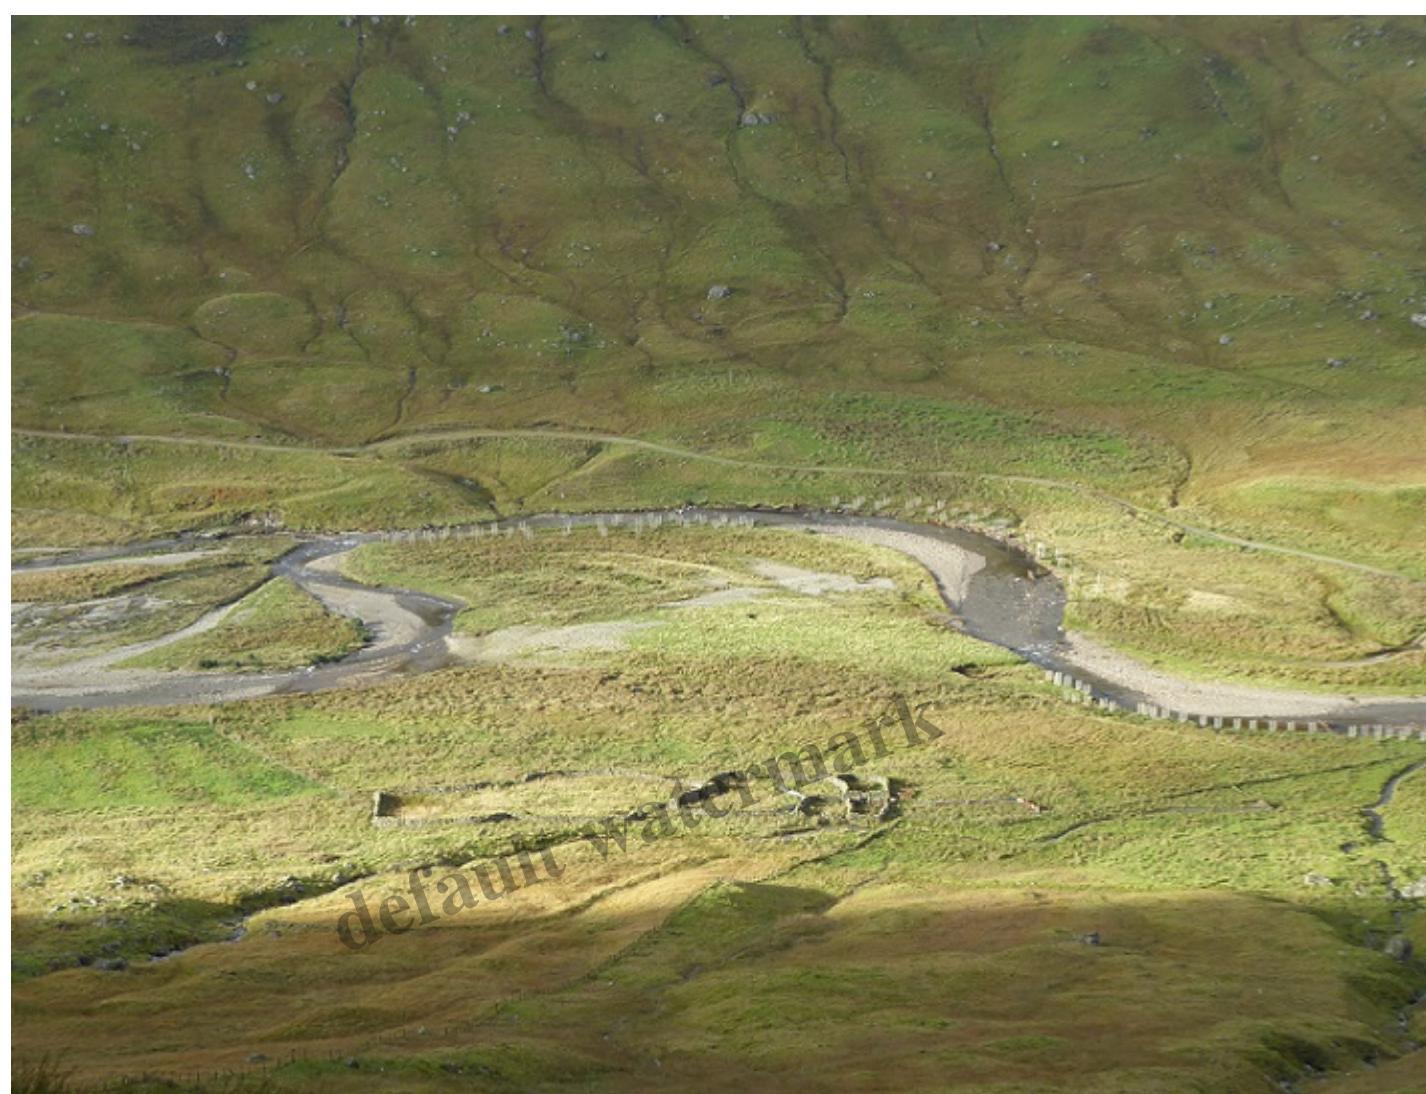
Part of the postage sized planting above Inverlochlarig Farm. Note the many watercourses on the fa side of the glen. Once rainfall gets into these the water flows rapidly down the hill

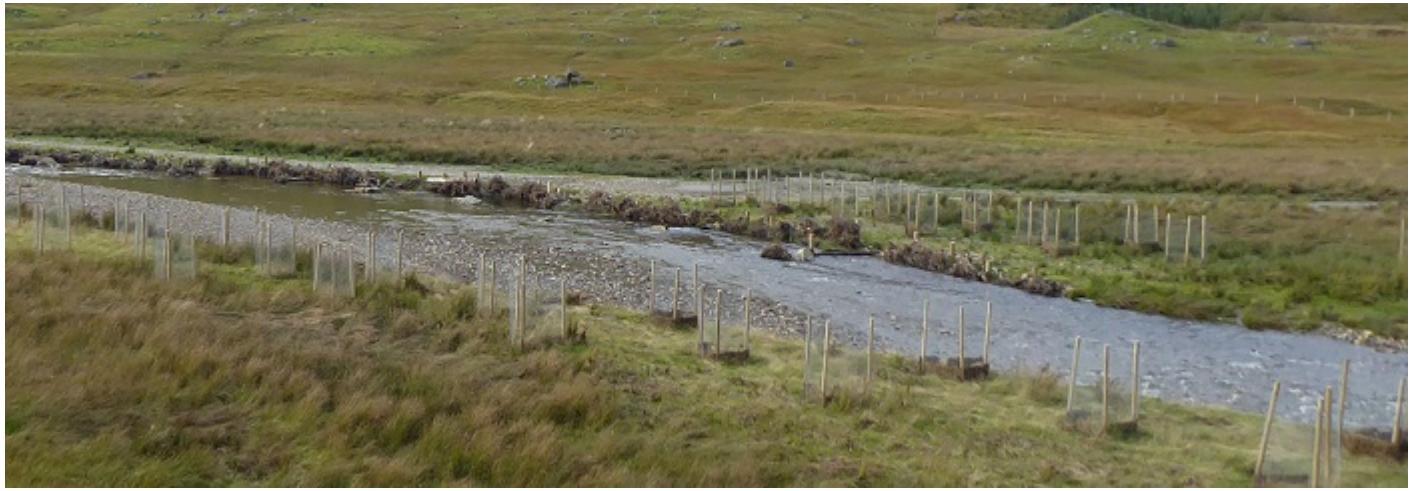
Works to stabilise the river bank visible left of centre

Some of the enclosures, particularly where broadside on to the flow of water, had taken quite a battering in the flood.

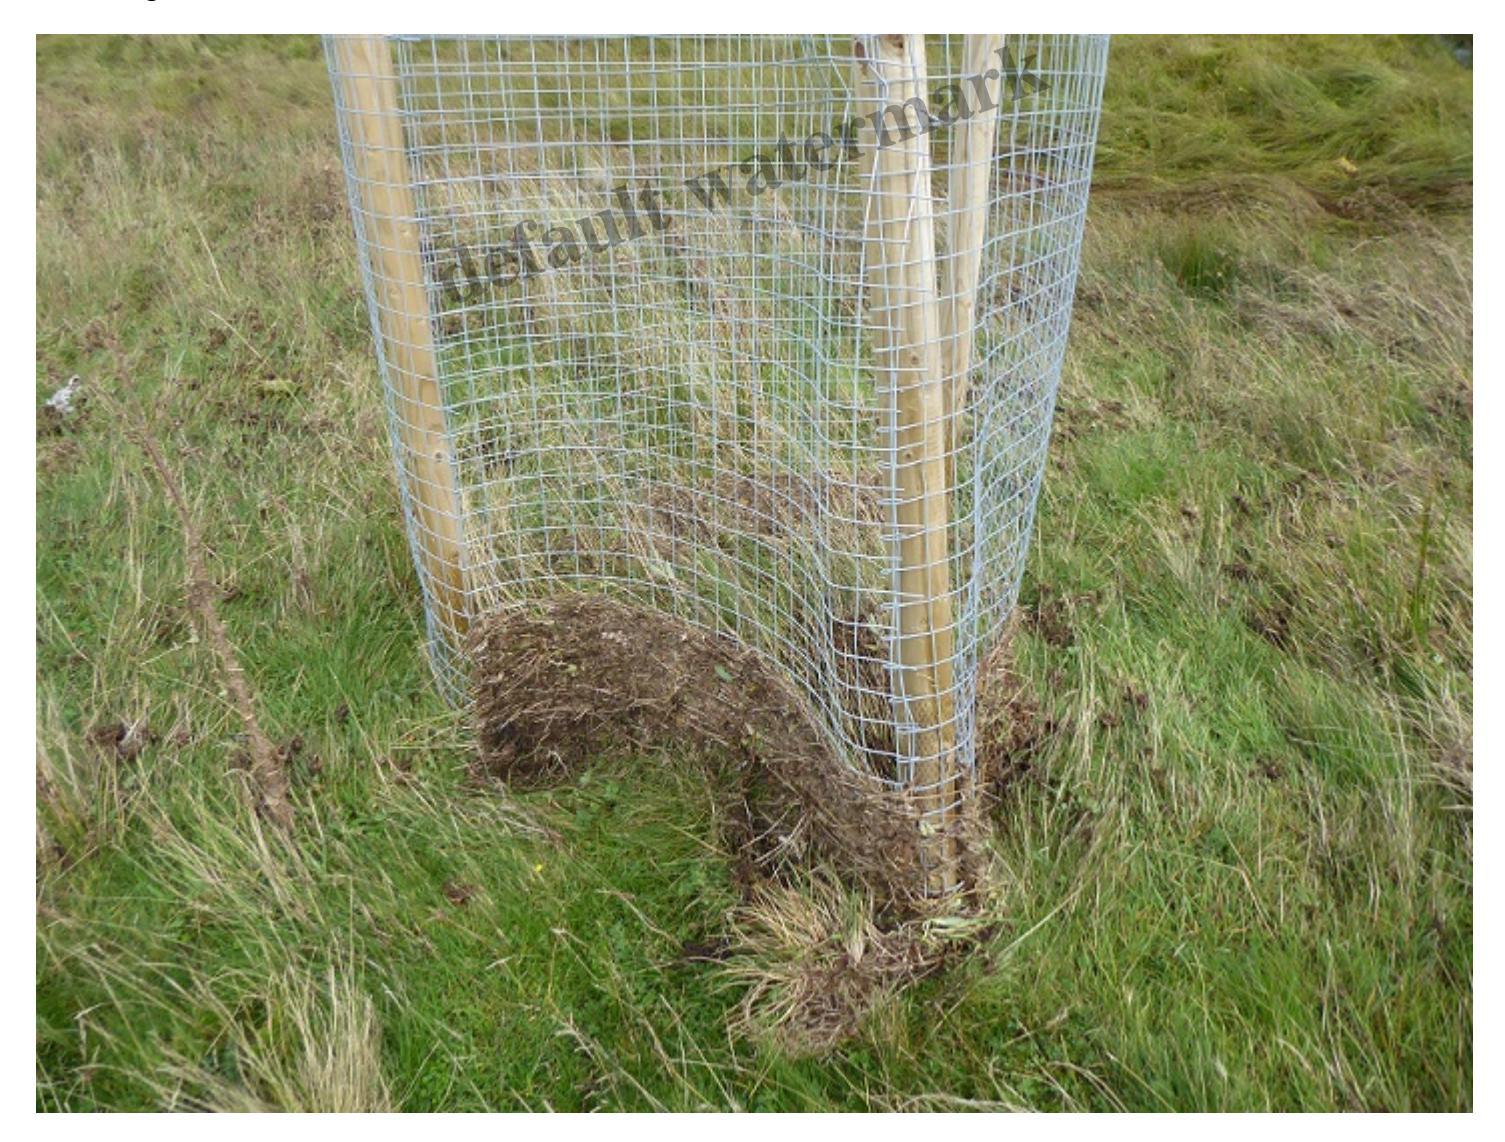
While there was no tree surviving in this enclosure, the way the wire serves to catch the vegetation probably helps to protect the trees and reduce the chances that they will be uprooted by the force of water or chopped or crushed by flood debris (though alder have evolved to survive such challenges). A larger flood, however, might destroy the enclosures and the trees with it.

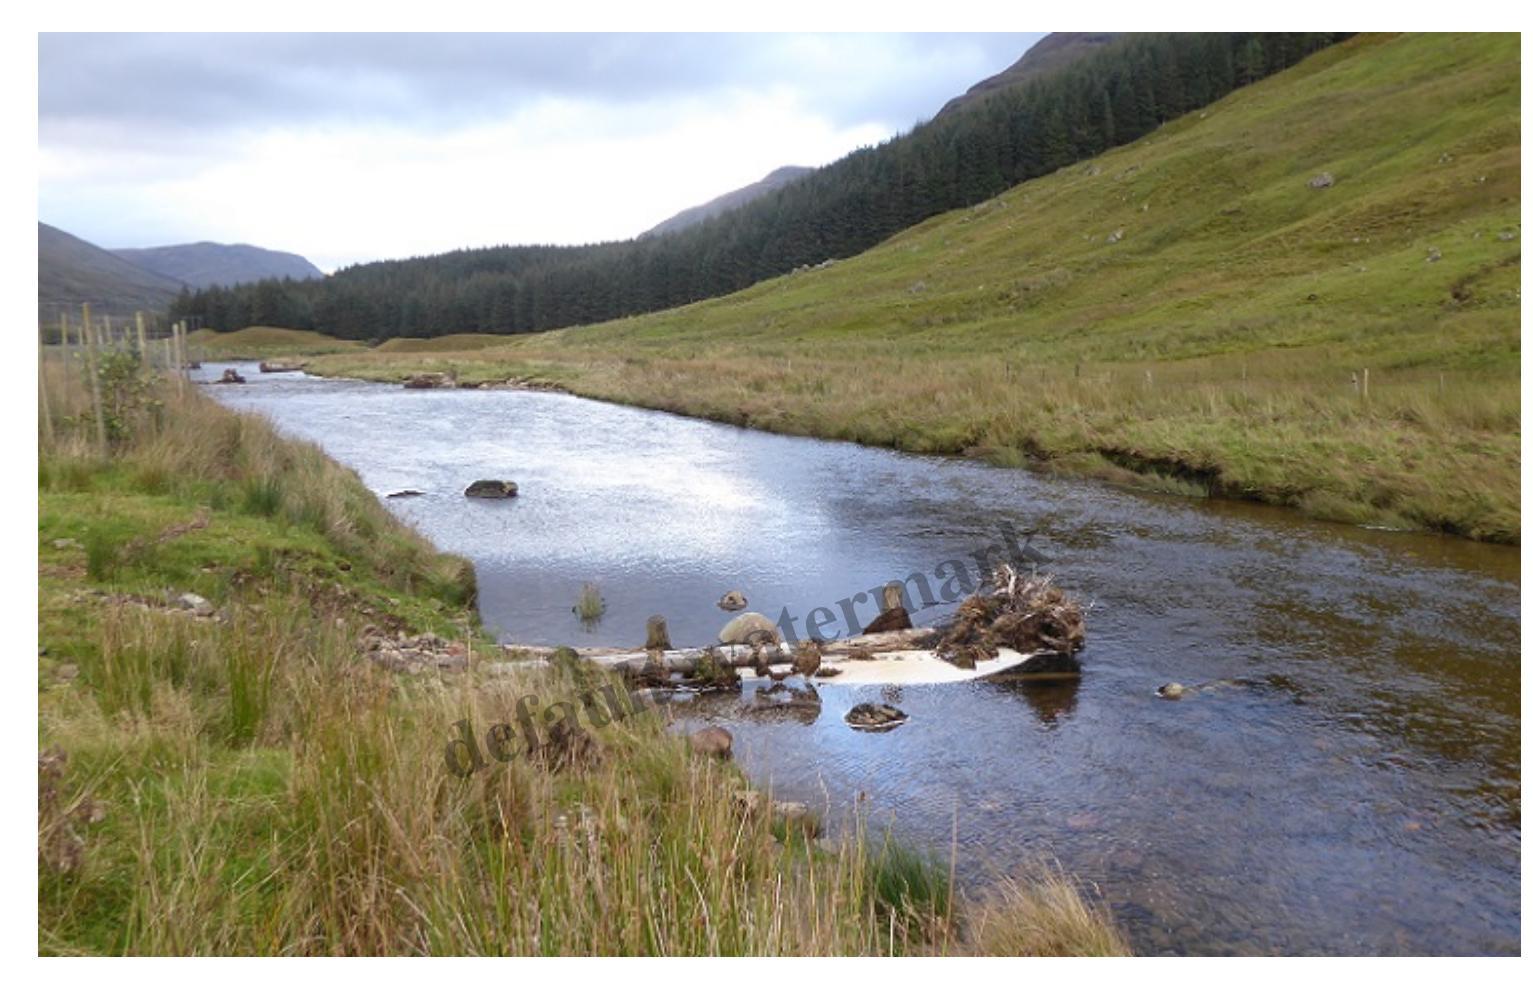
Placing tree trunks across rivers is now quite fashionable in conservation circles. While it serves to hold back some debris, potentially creating spawning beds for fish, in a flood it is likely to quickly bank out so that water and debris flow over the top. Neither in-river works like this nor planting trees is likely to reduce flood flow significantly.

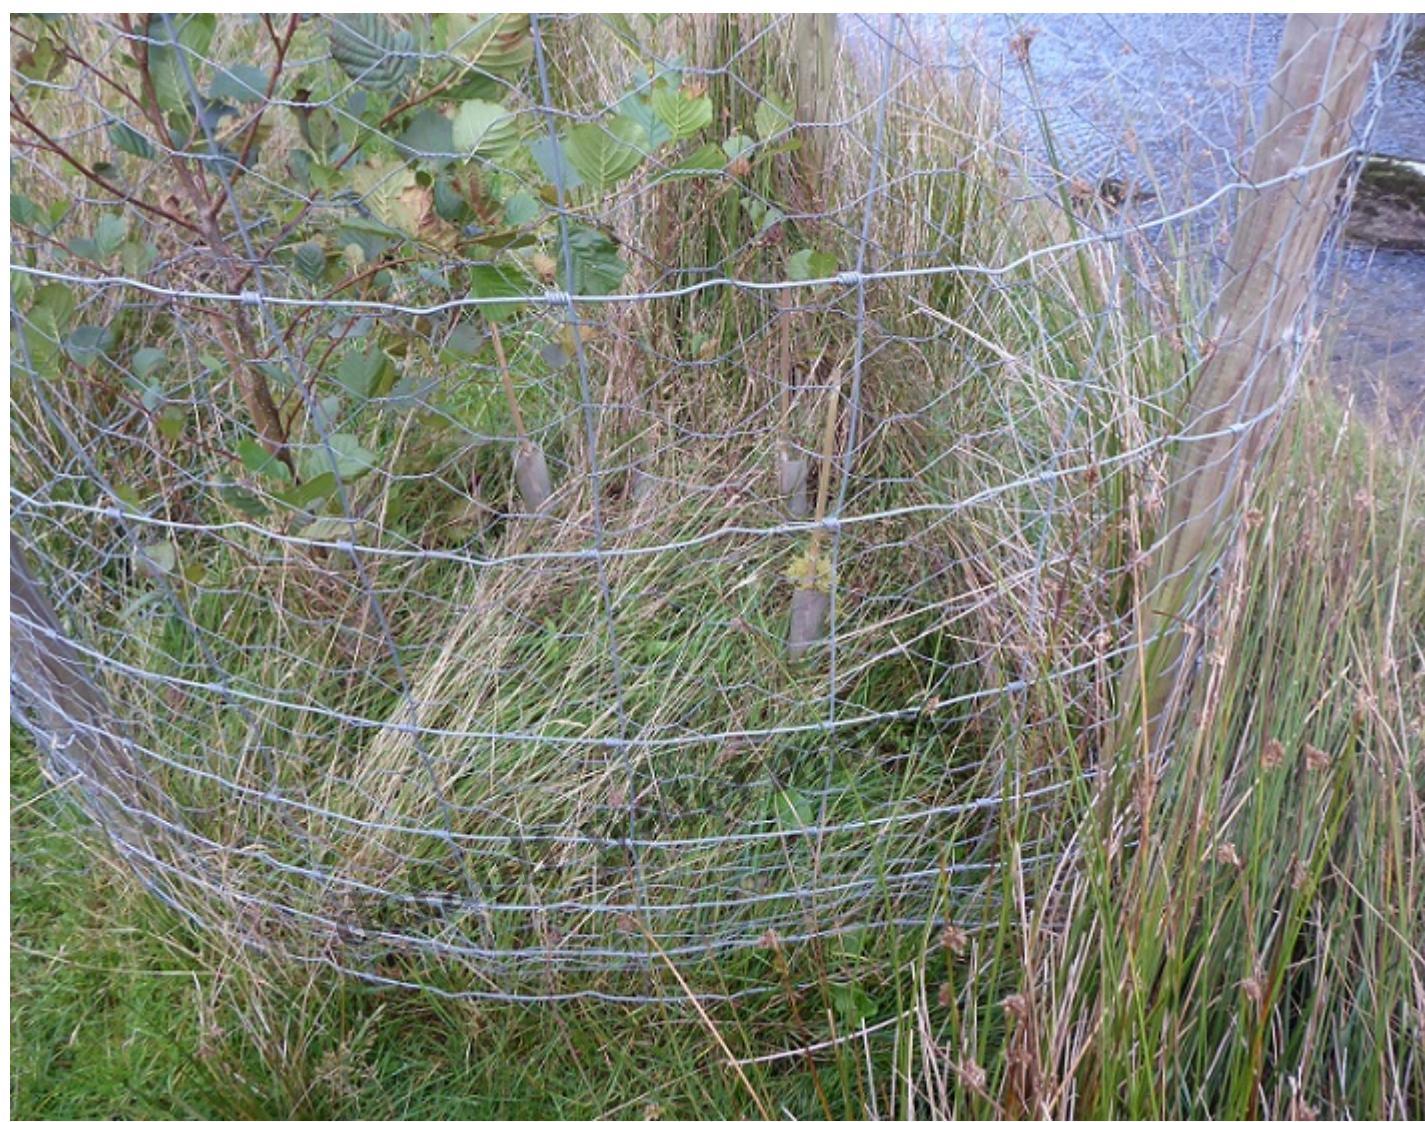
The trees in about half the tubes in this enclosure had taken – note the moss filled tube on the right. The wire netting makes it very difficult for anyone to remove the redundant tubes and reduce the amount of plastic that may end up in the river.
