Lessons from abroad – the impact of climate change on the natural environment

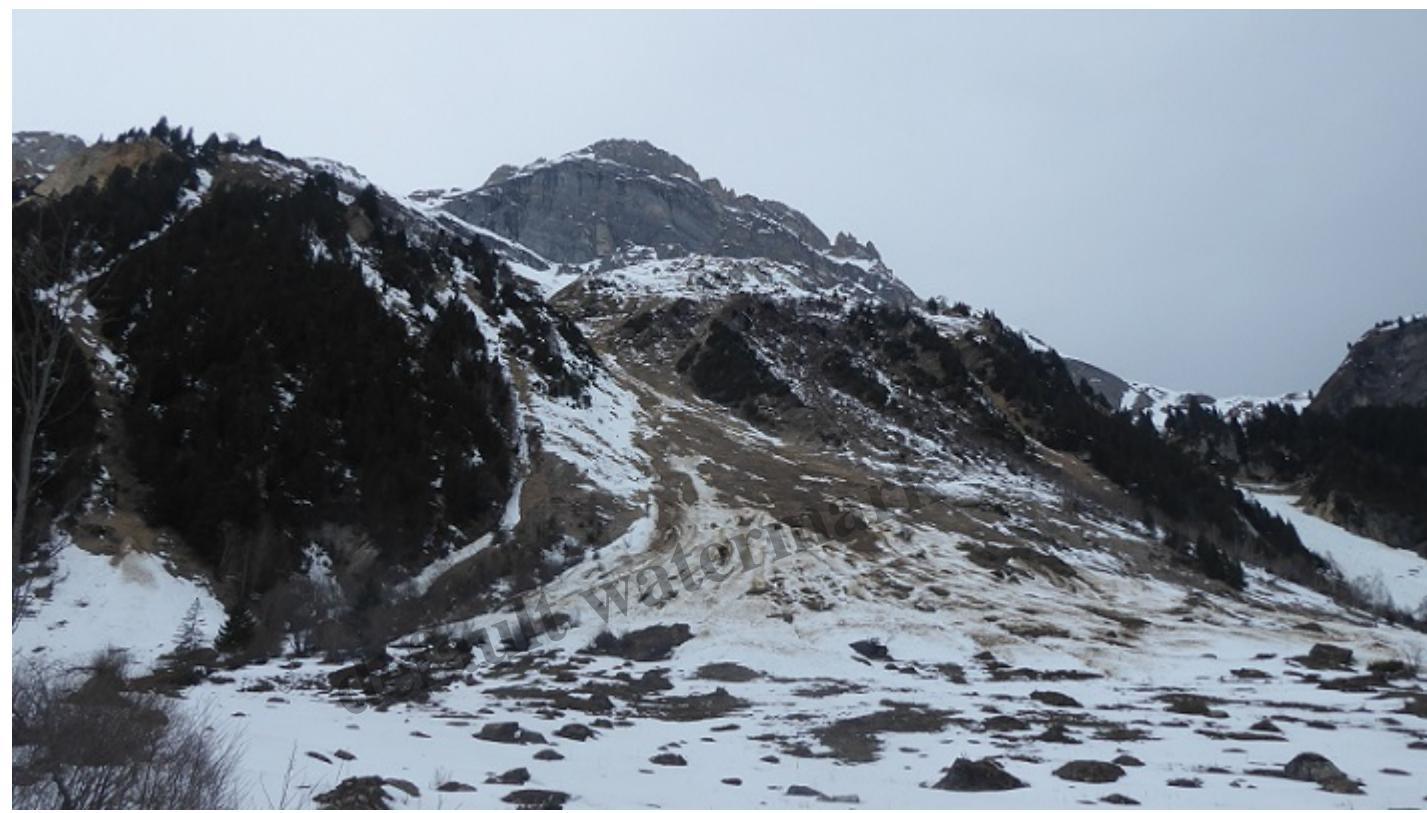
Slopes – just outside the National Park boundary – swept by avalanches

Skiing back down into Pralognan from the Refuge de Peclet Polset I was struck by the extent of the apparently bare ground created by avalanches on the western side of the valley just north of Petit Mont Blanc.

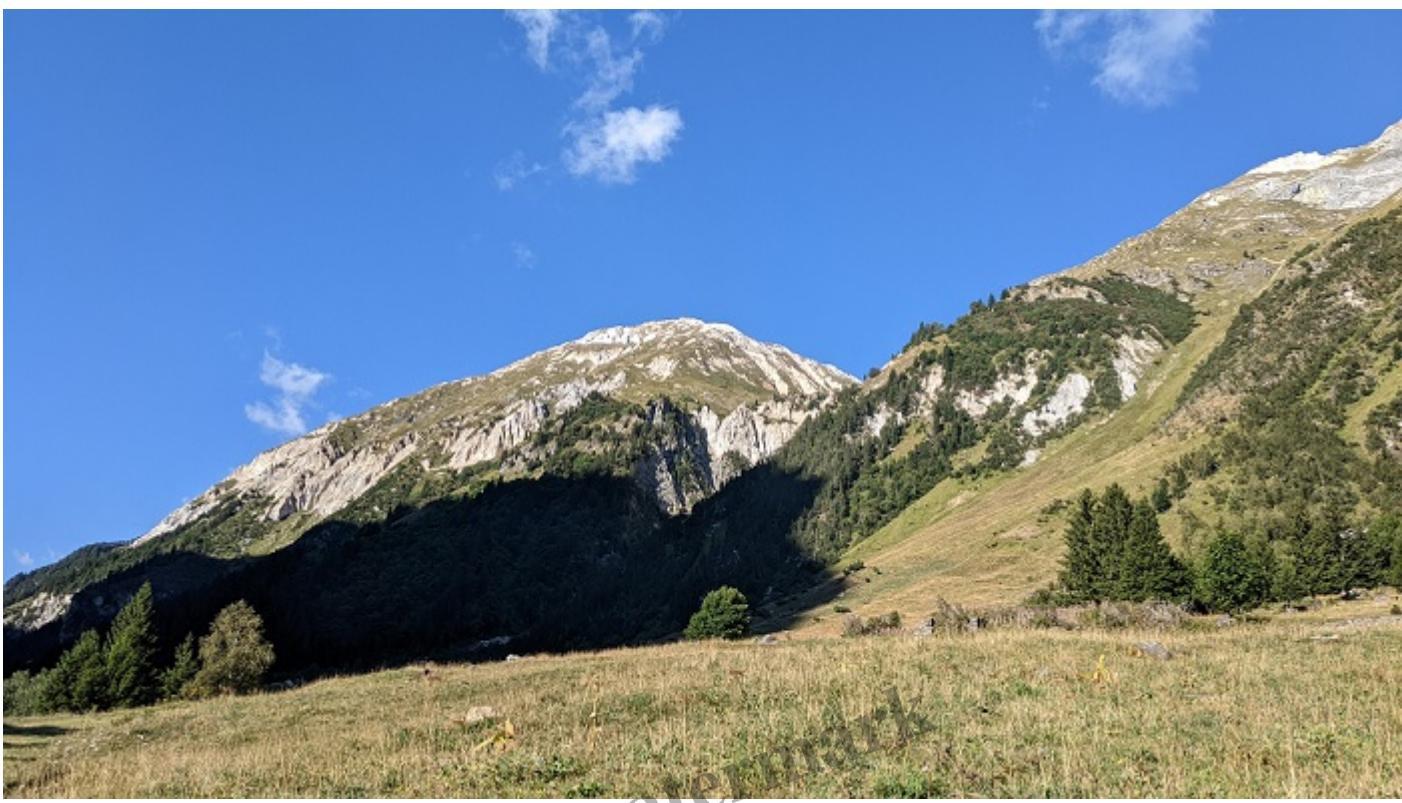
Petit Mont Blanc August 2022 with the bare the slope featured in the photo above on the right

The same slope last summer was free of trees and clearly regularly swept by avalanches but the parched ground vegetation appeared intact. While slopes denuded of vegetation by avalanches or landslips can recover quite quickly, it appears that it has been the recent avalanche activity this winter that has been responsible for creating areas of bare ground. Those areas, however, are not quite as extensive as might appear from a distance:

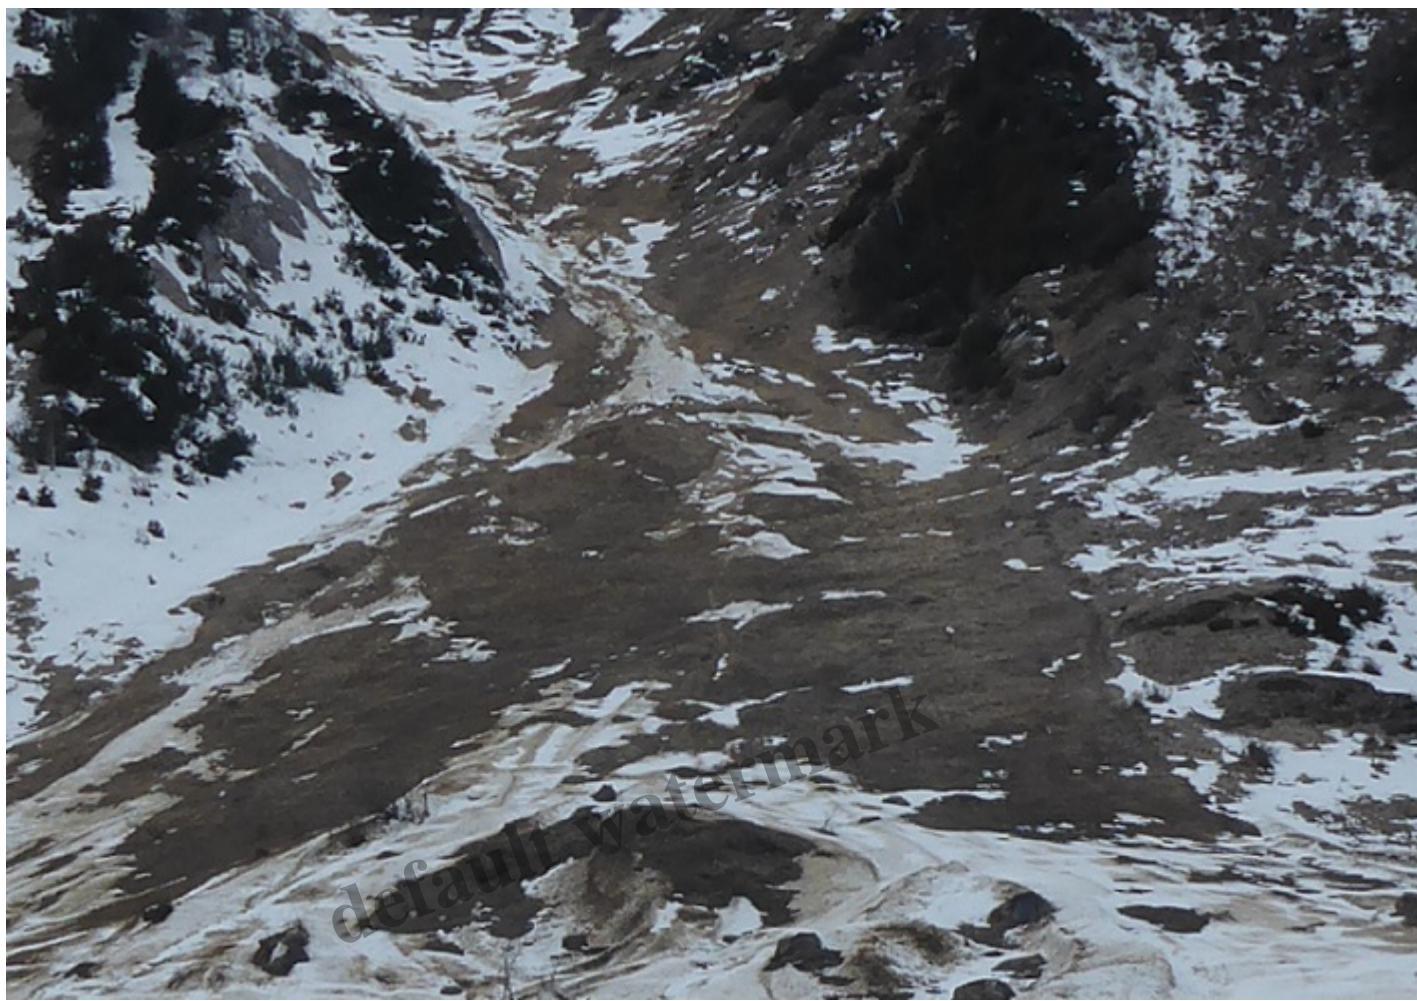
Note how there are more trees in the gap between conifers on the right which is also subject to avalanche activity.

A close up of the main avalanche fall line shows that significant areas of ground vegetation has survived, while more may be concealed under the soil brought down by the avalanche and water subsequently. Still, although some vegetation is still clinging on, the dirty snow tells a tale – the plants and trees on this slope are now subject to serious erosive forces.

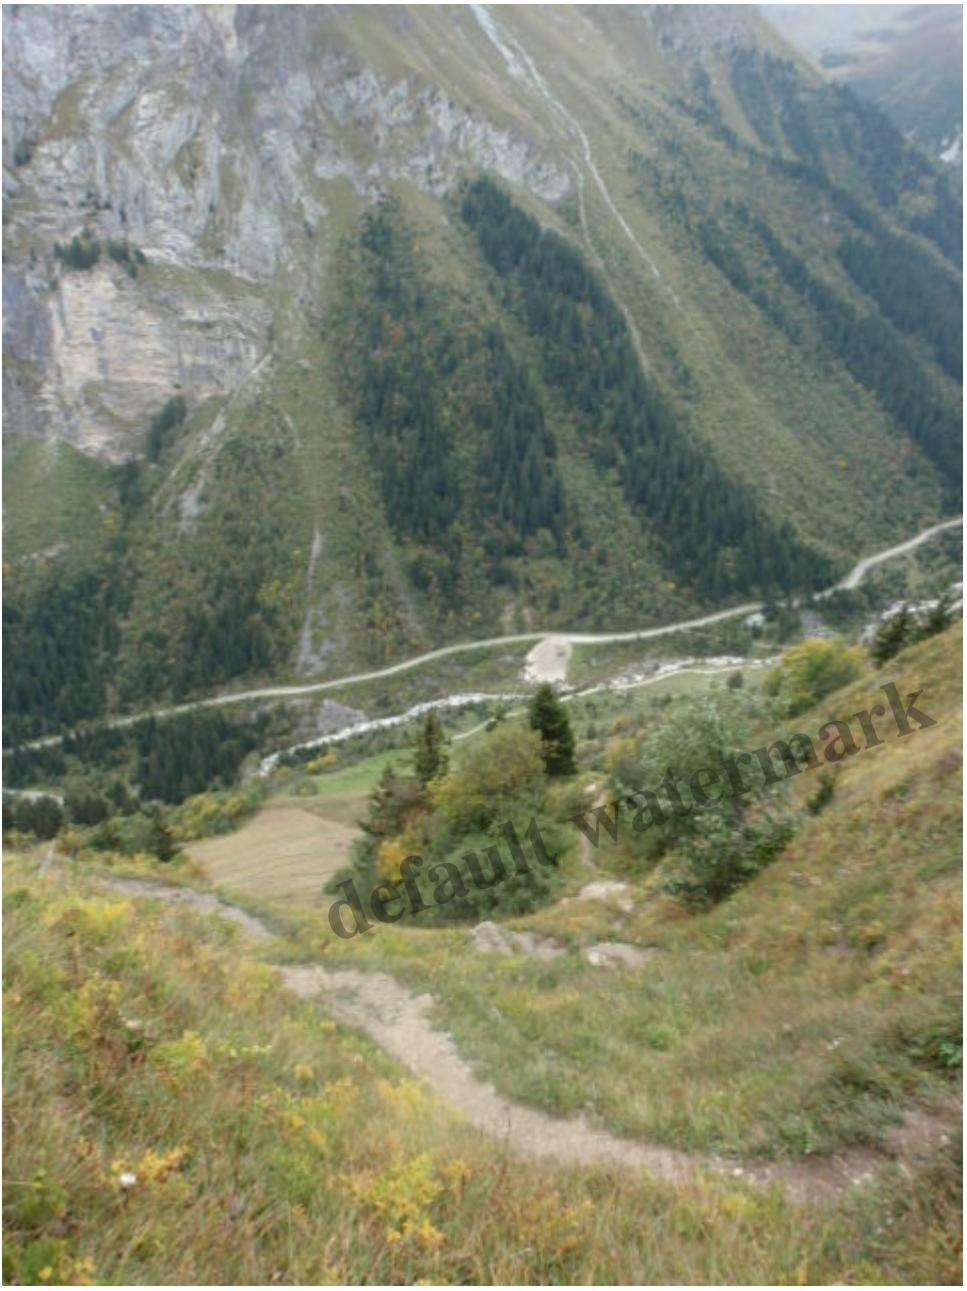
Looking down the Petit Mont Blanc path in 2010.

Back in 2010 the avalanche lines through the forest on other side of the valley were obvious. But what is also striking from this photo is how those avalanche lines were covered with smaller trees and the apparently healthy state of the vegetation by the path.

Green alder is a small tree that thrives where avalanches cut through alpine forests, as it bends under the weight of snow. The presence of other trees, however, suggests that though regular, avalanches were not that frequent and the interval between them gave time for the ground vegetation to recover.

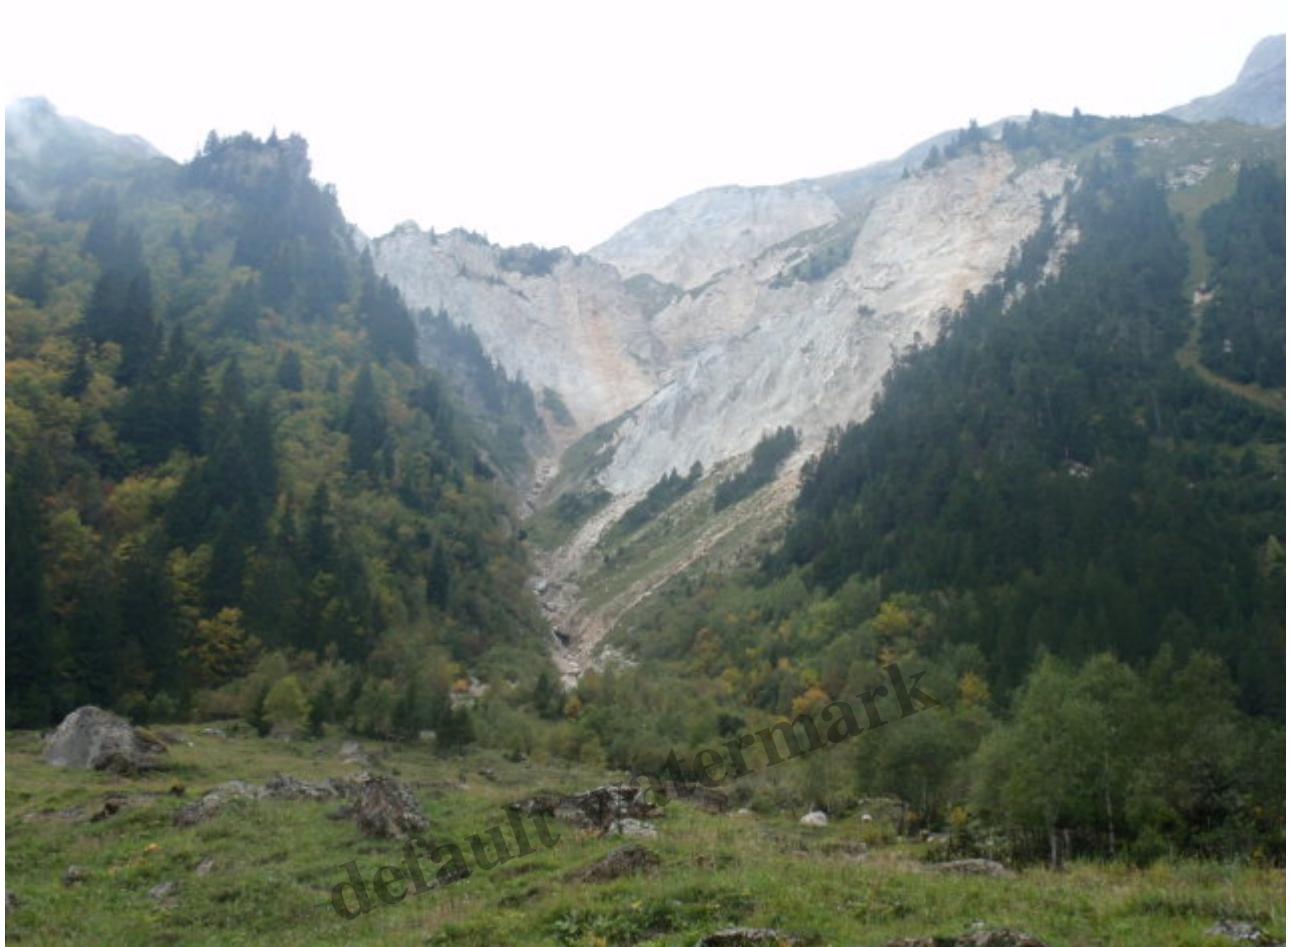
The gorge taken by the Petit Mont Blanc path September 2010

Note the densely wooded areas on either side of the stream and the two small blocks of conifers growing on the steep slope below the slabby cliff in the centre of the photo.

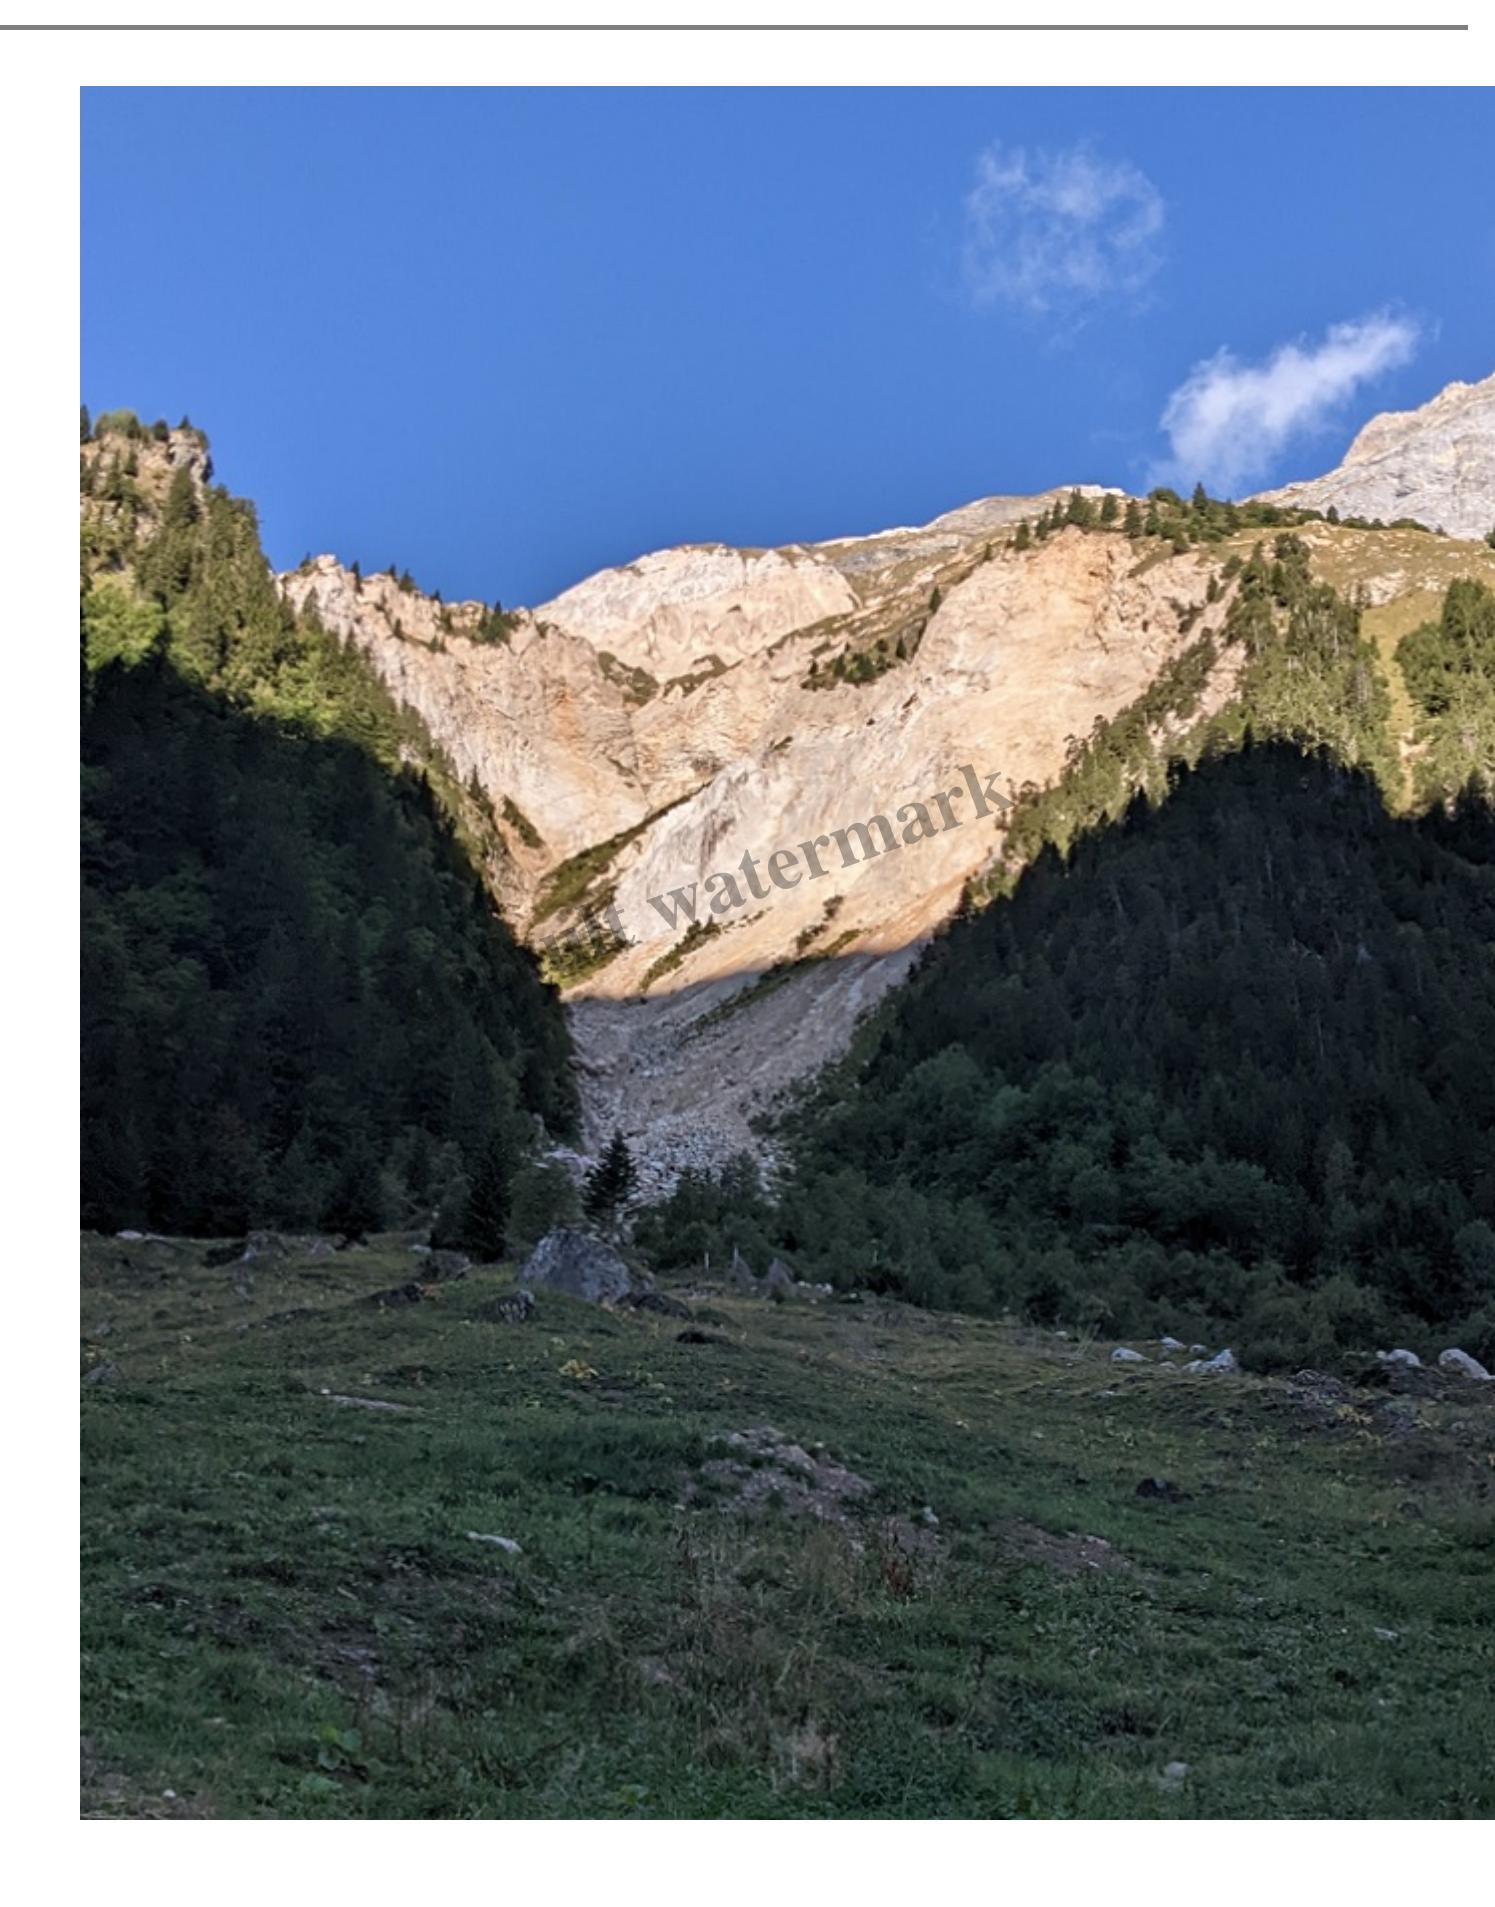
The gorge taken by the Petit Mont Blanc path September 2022

Thirteen years later, the two elongated blocks of conifers below the slabby cliffs had been considerably reduced in extent while the vegetation below them had completely disappeared and been replaced by rock rubble.

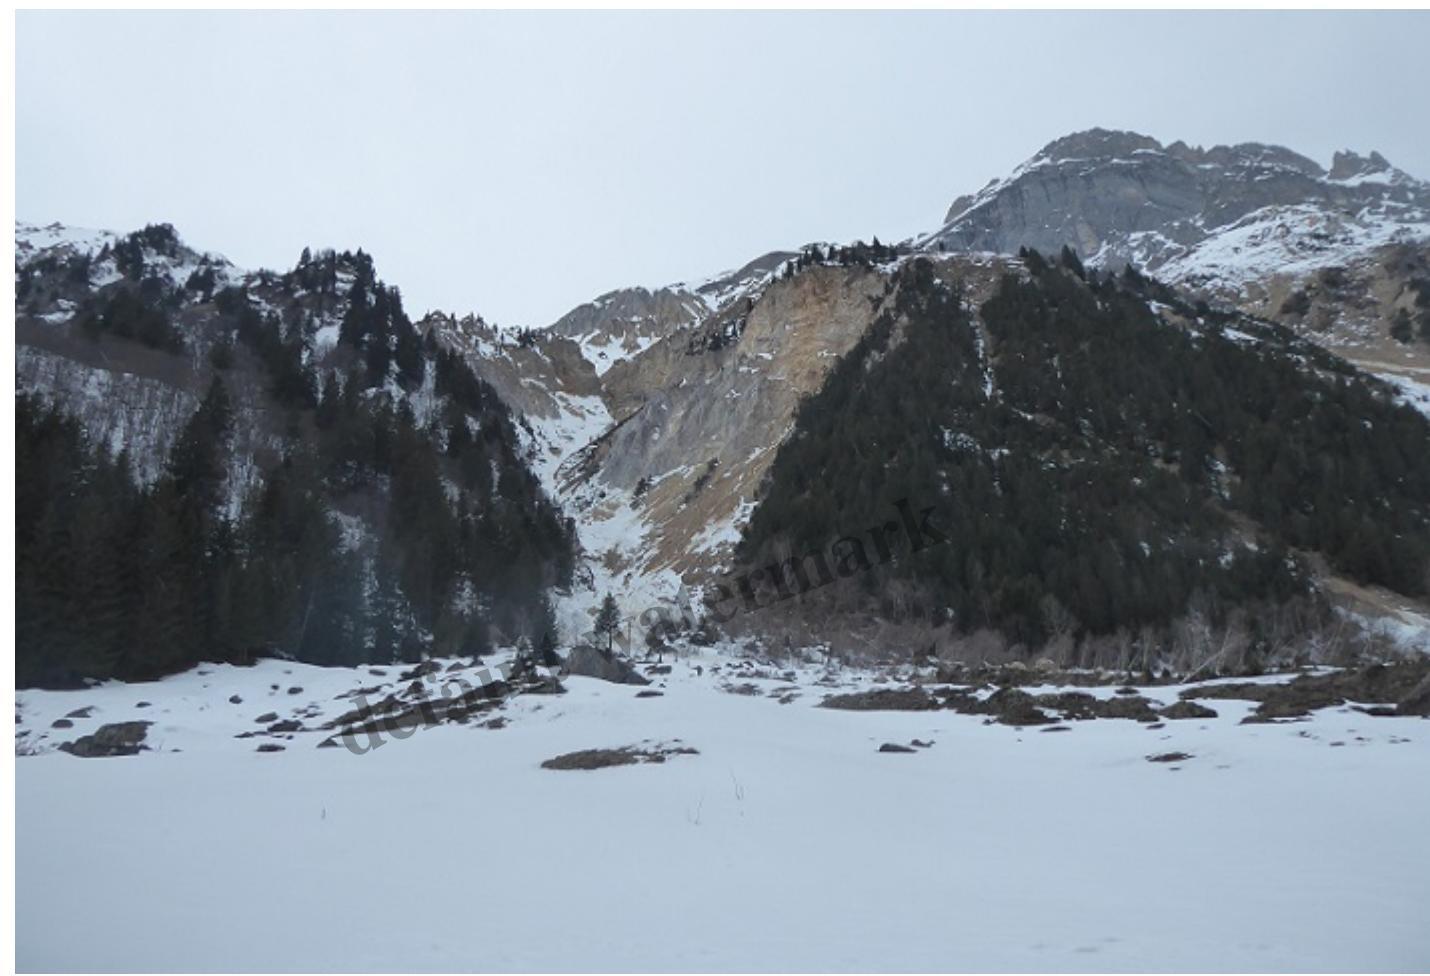
The gorge taken by the Petit Mont Blanc path in March 2023.

Six months later the two elongated blocks of conifers below the slabby cliffs appear to be on their last legs while an avalanche or avalanches has swept through the block of deciduous trees knocking many over. In addition it appears the slopes to the left of the gorge may be less tree covered than they were 13 years ago.

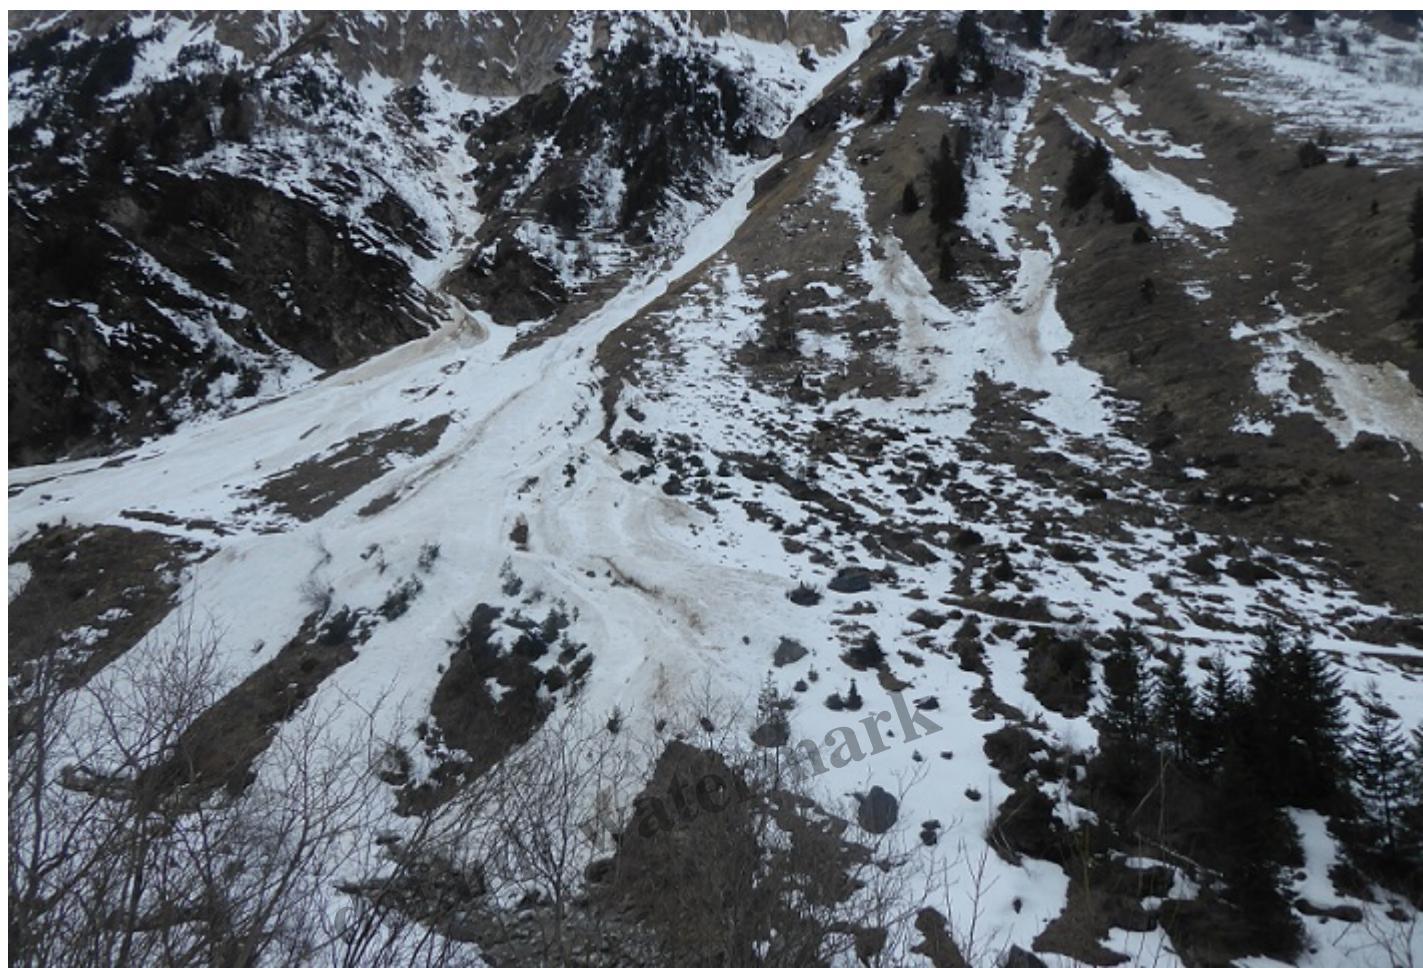
Wet snow avalanche trails. Wet snow avalanches move more slowly and shorter distances than dry snow avalanches.

What appears to be happening is that on these slopes there have been more avalanches and these have been steadily denuding the vegetation cover.

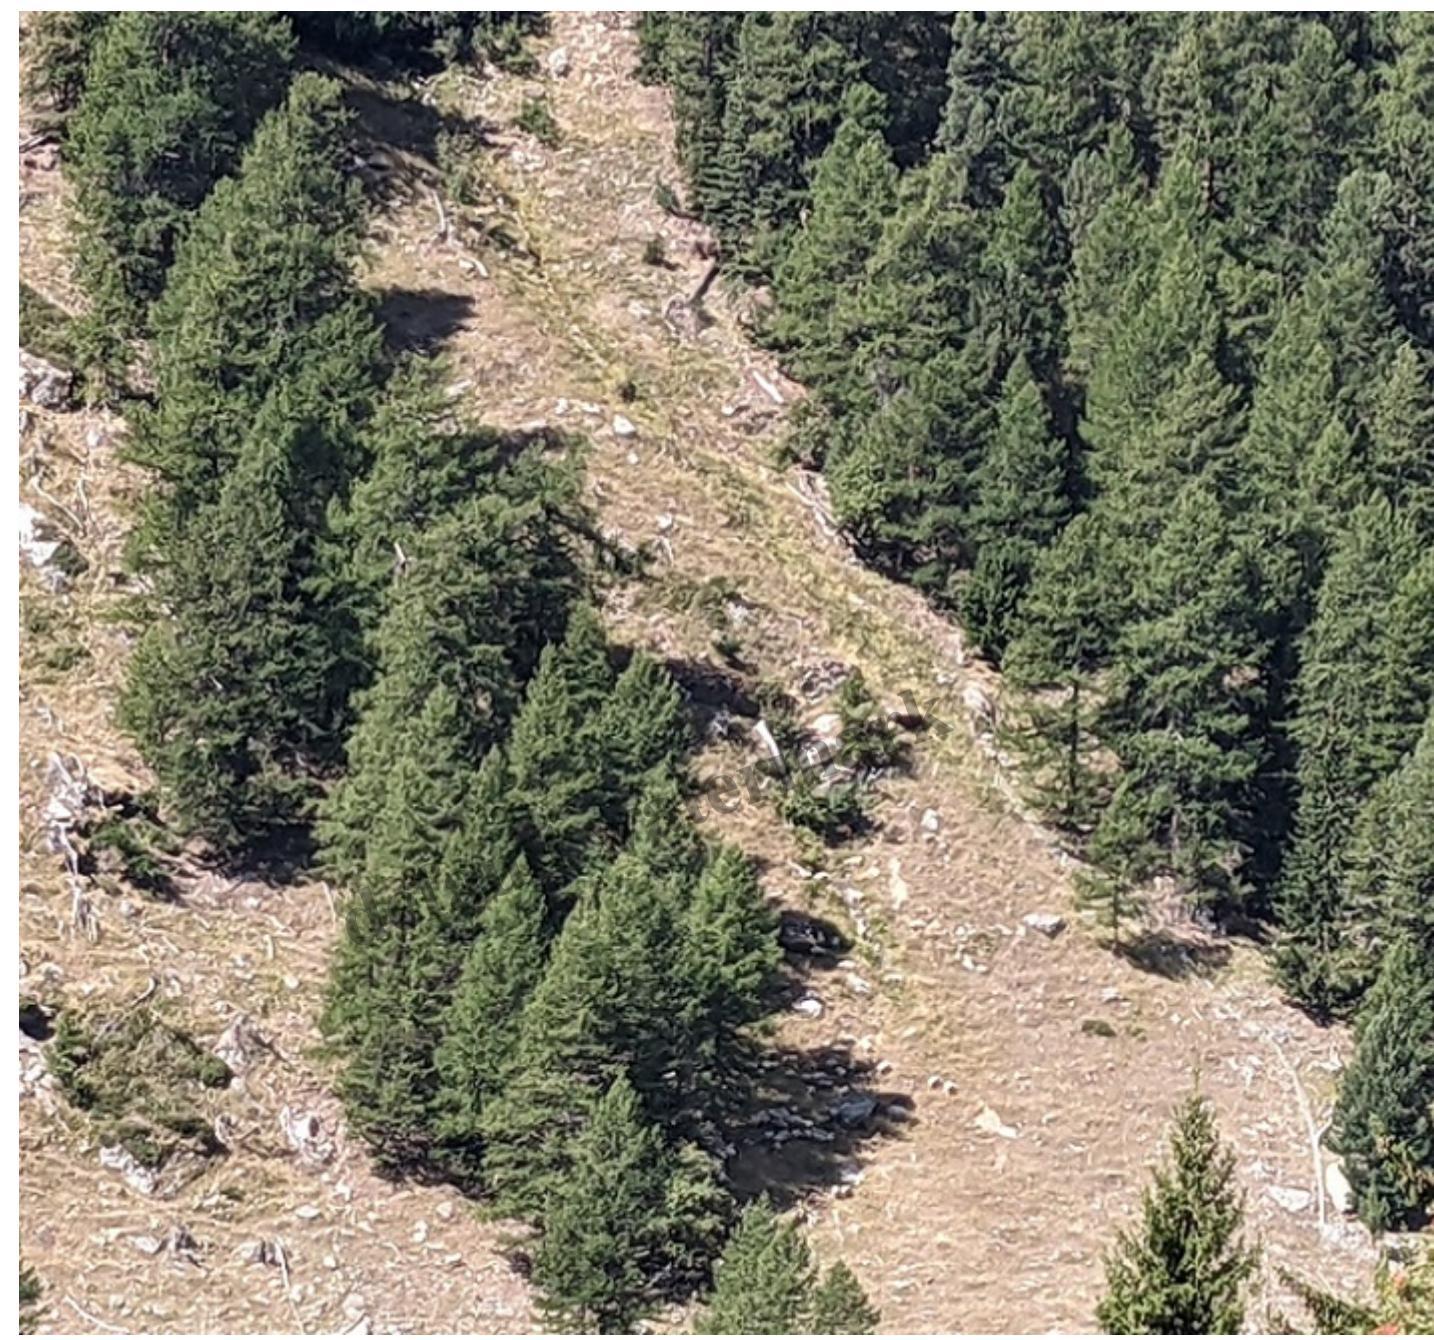
Avalanche trails through the trees on slopes parched by drought

Warmer winters and drought in summer is creating another vicious circle: as trees die from lack of water in summer, there will be even less to hold back the wet snow avalanches in winter.
