Some questions HIE needs to answer about the safety of the Cairn Gorm funicular

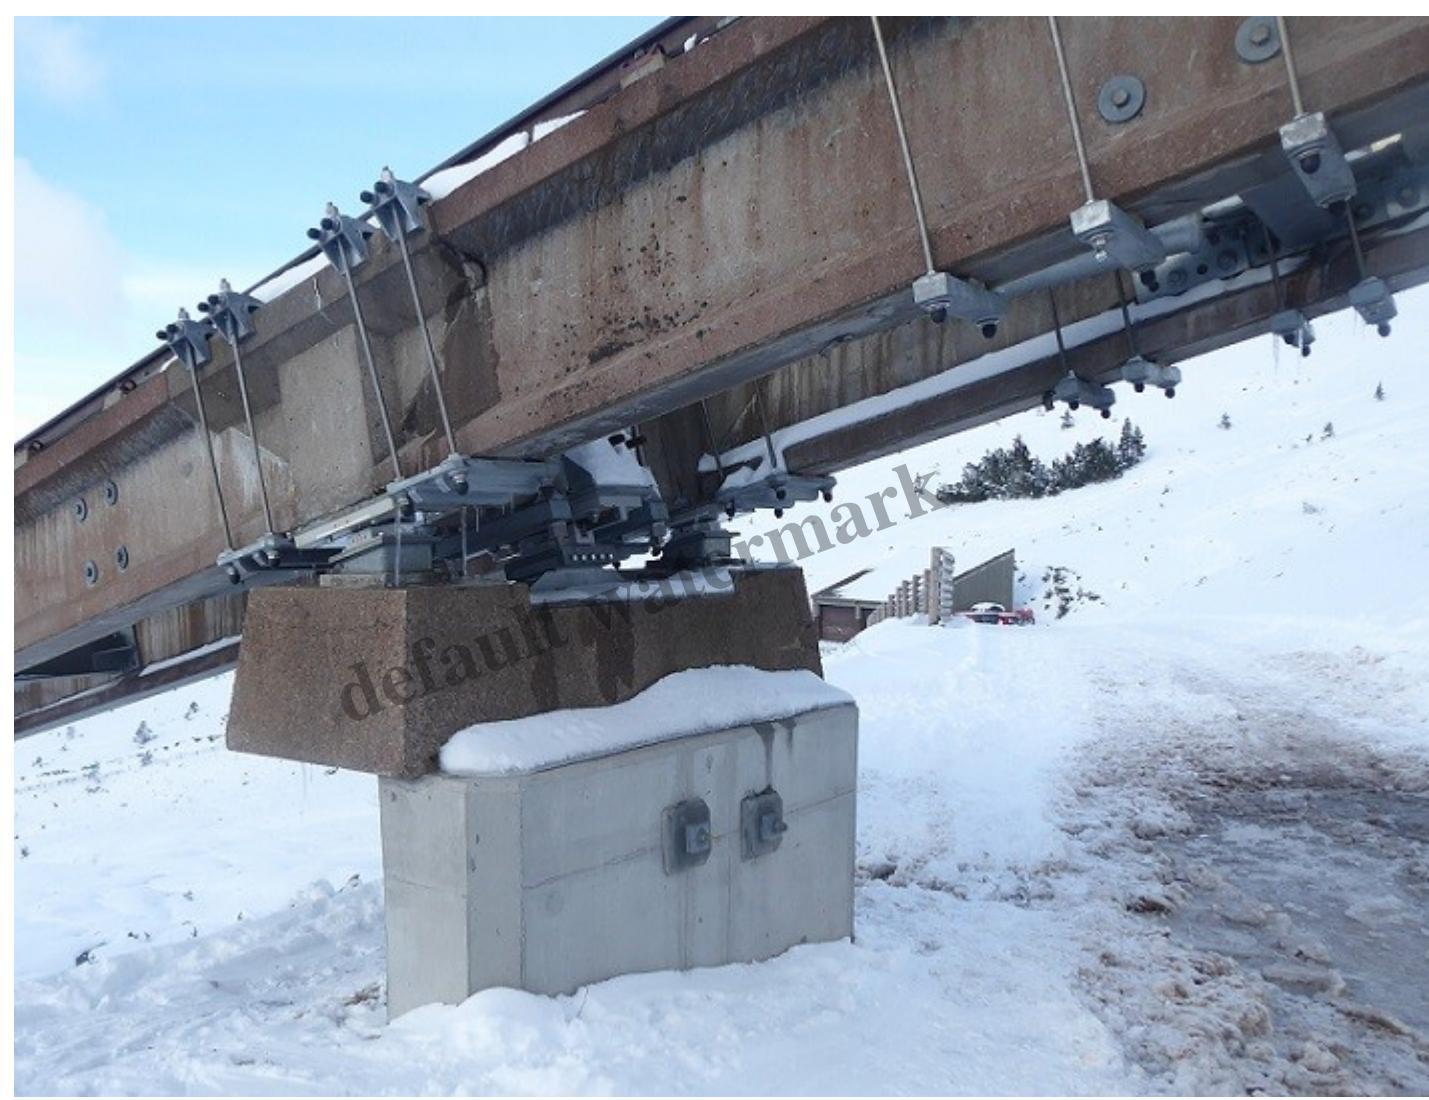
Pier below shieling with new concrete collar and metal braces on the "I" beam

(a) That the concrete "I" beams are not strong enough for the length of the span (I was made aware of this by a person with 36 years experience in this line of work). This would appear to be confirmed by the steel work around the "I" beams (see top photo), although HIE has never explained the reason for this;

(b) Related to this, the COWI report of December 2018 stated "The precast beams are reinforced but not <u>pre-stressed</u>". I am grateful to an academic lecturer in railways for informing me that the minimum depth for a concrete "I" beam which is not pre-stressed should be 8cm for every 1m length. That means the safe depth of the "I" beam is therefore  $8 \times 18 = 144$ cm not the actual 80cm! This figure may be for current standards and not those from 1999 but the conclusion is that after the funicular failed all the beams should either have been replaced or strengthened along their whole length in order to comply with today's standards.

One option to do this would be to use a Carbon Fibre Reinforced Polymer wrap, as explained by this company:

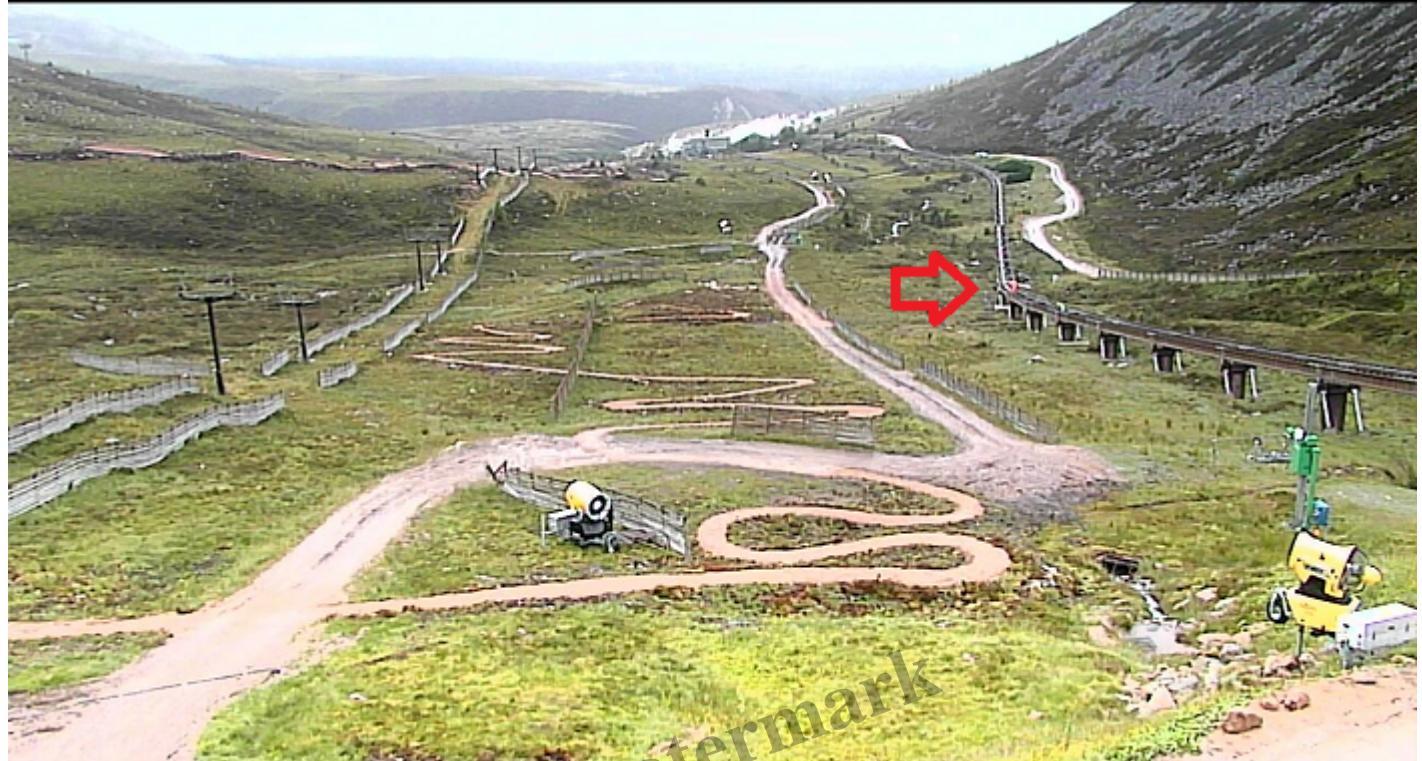
Two people working on the funicular structure on a Thursday evening

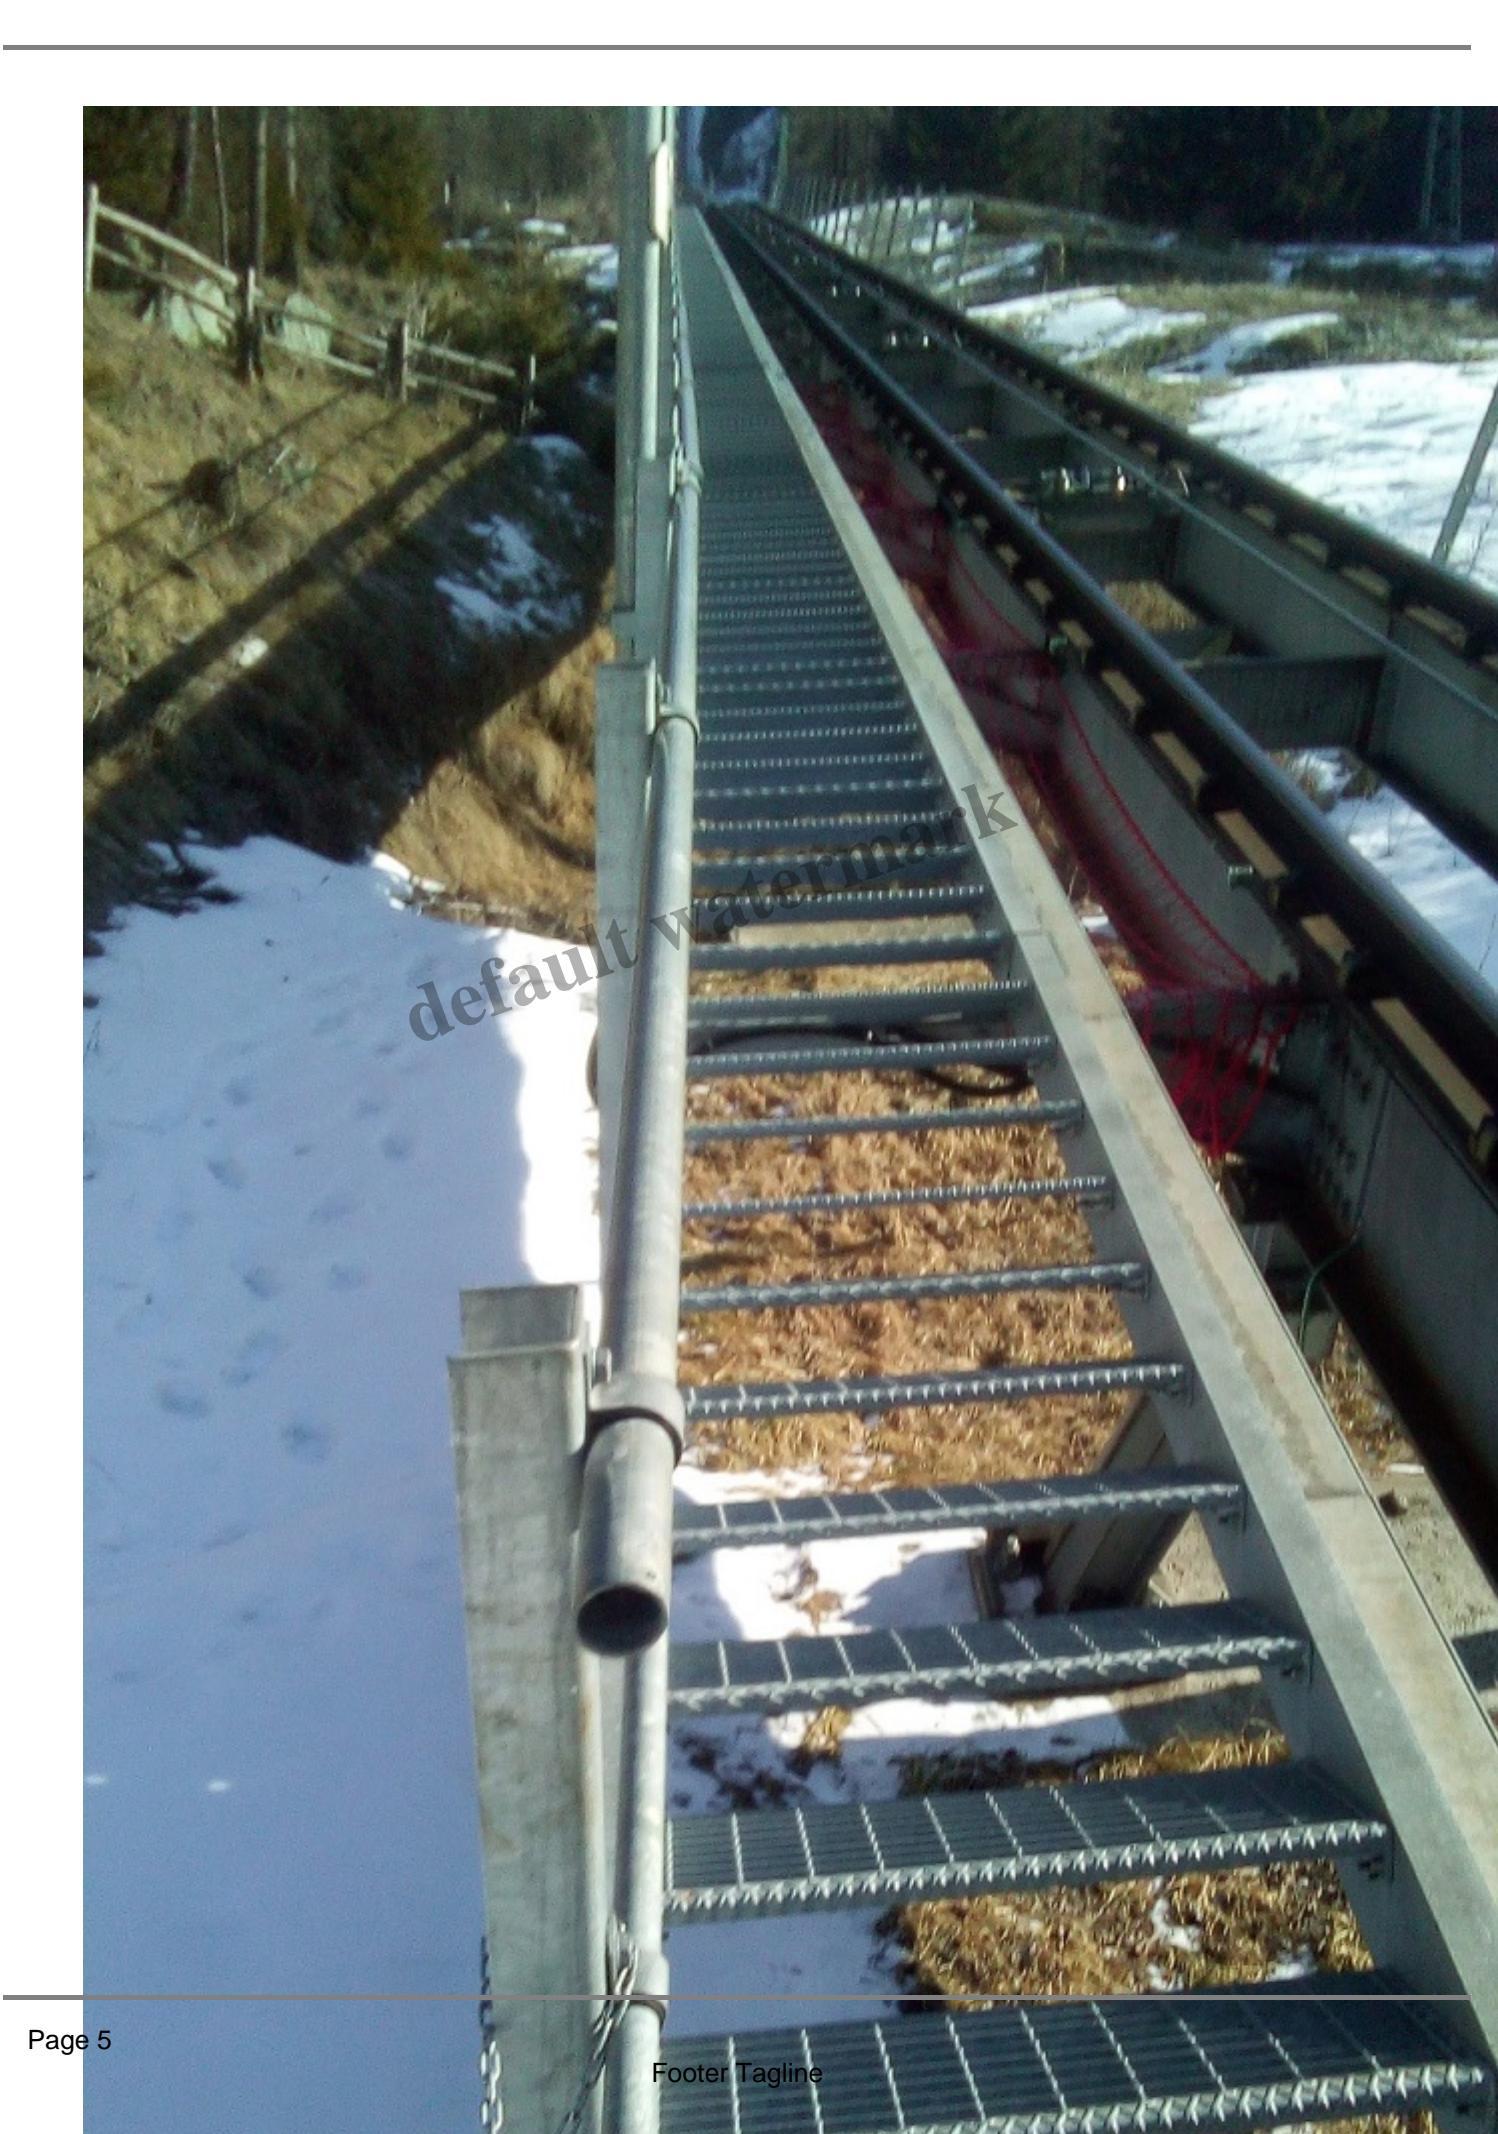
Walkway alongside the Frachey Funicular in Champoluc showing what an escape walkway should look like

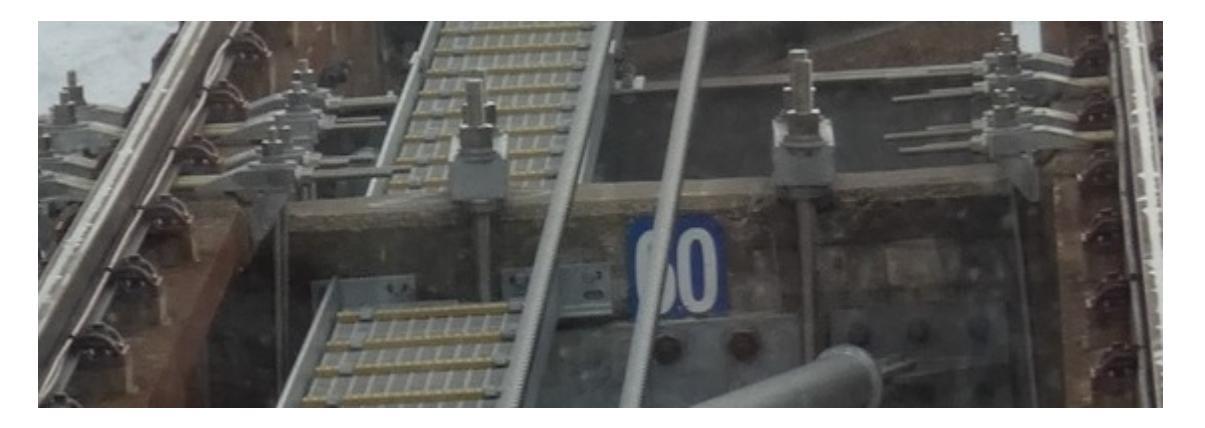
What has now been installed on the Cairn Gorm funicular, a walkway between the tracks, may be acceptable for maintenance but is completely unsuitable as an escape route in case of breakdown as there is no access to the walkway from the train. Therefore if stranded, customers and staff would be stuck!

The views of the HSE suggest the re-opening of the funicular should not have been approved as there appears to be no means in place for safe evacuation of passengers. Should the funicular now be closed until the HSE agree that a safe means of evacuation, for both staff and passengers, is in place?
