Extreme rainfall and landuse – more lessons from the flooding and landslips in Cowal and Glen Kinglas

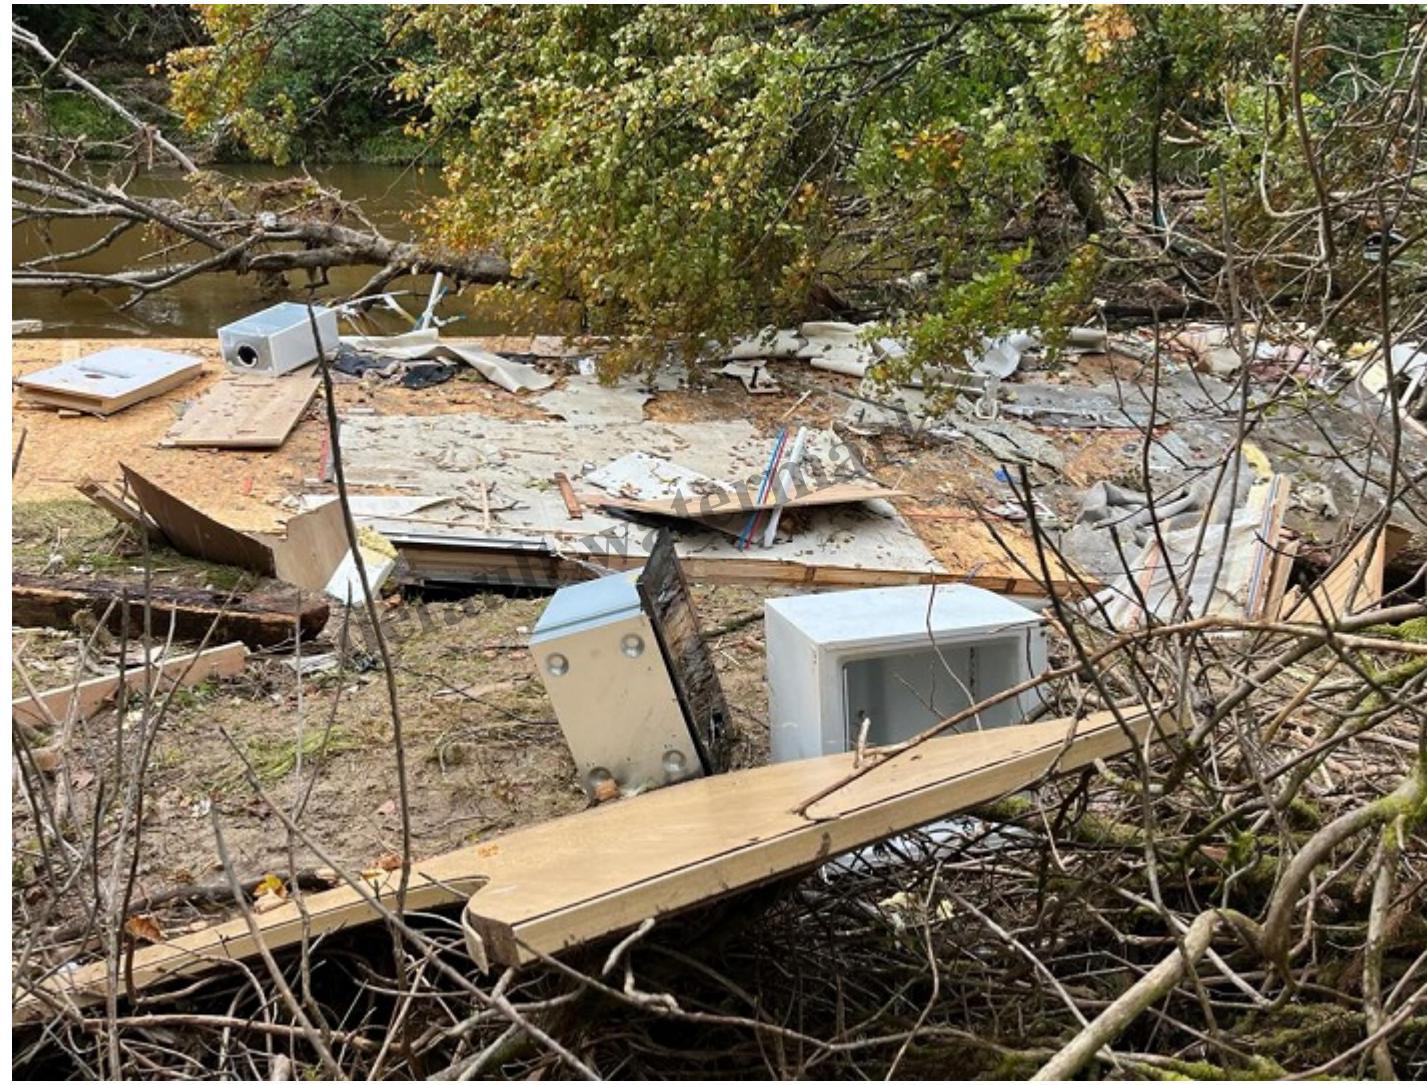
Flooded holiday park detritus in the River Eachaig. Photo credit parkswatch reader.

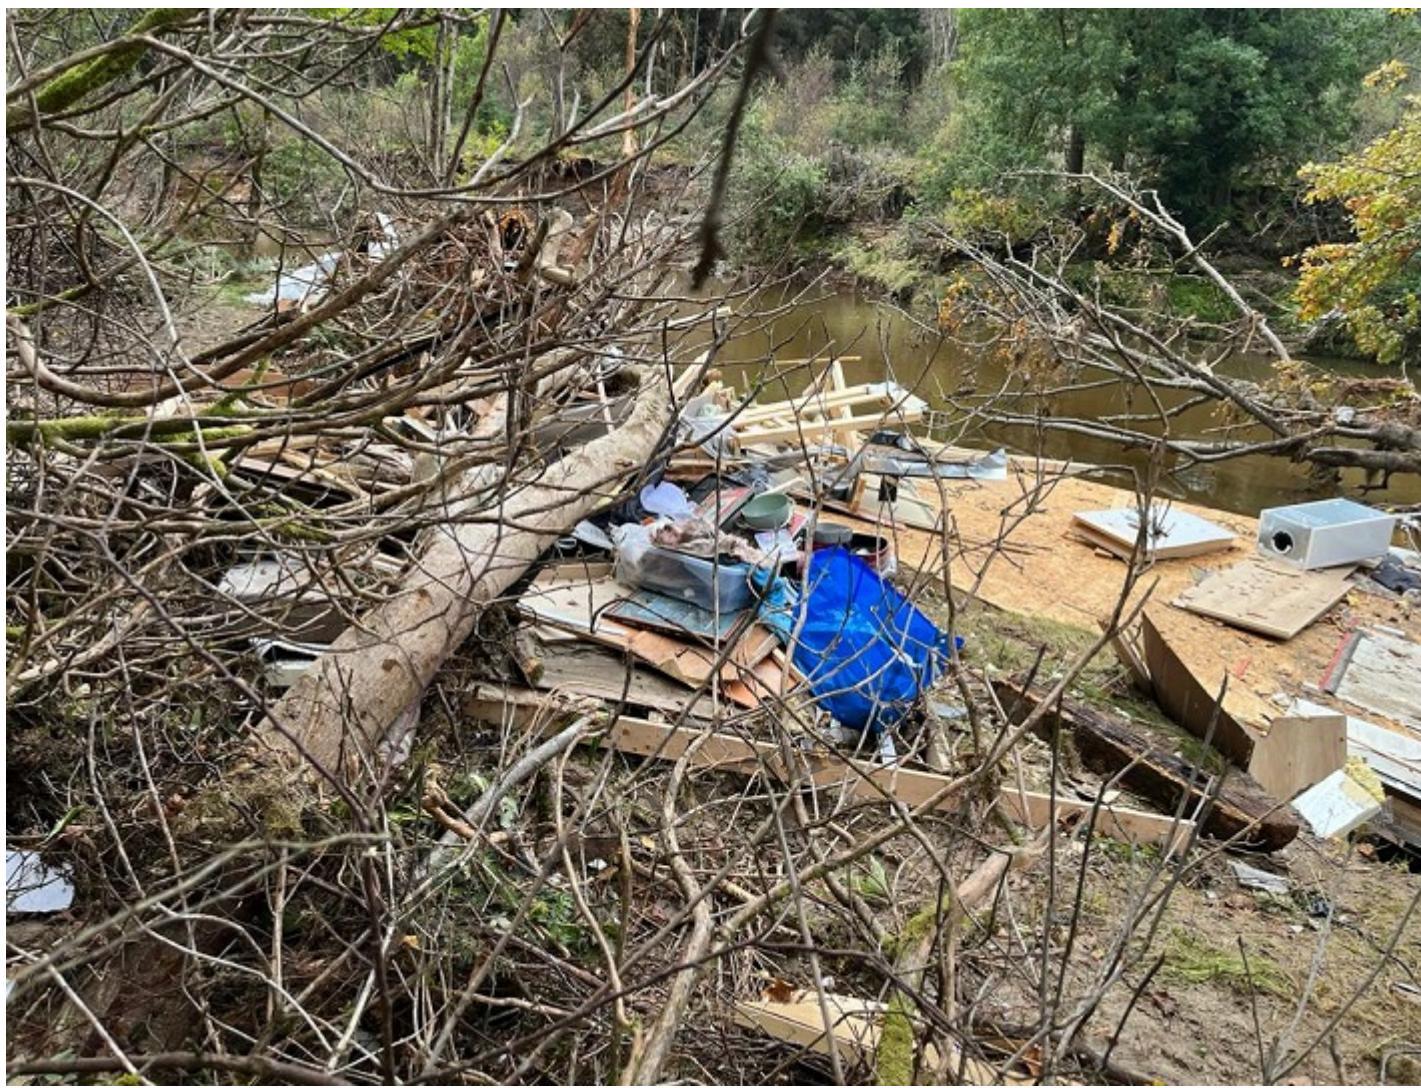
Another view of the same detritus on the River Eachaig. Photo credit PW reader.

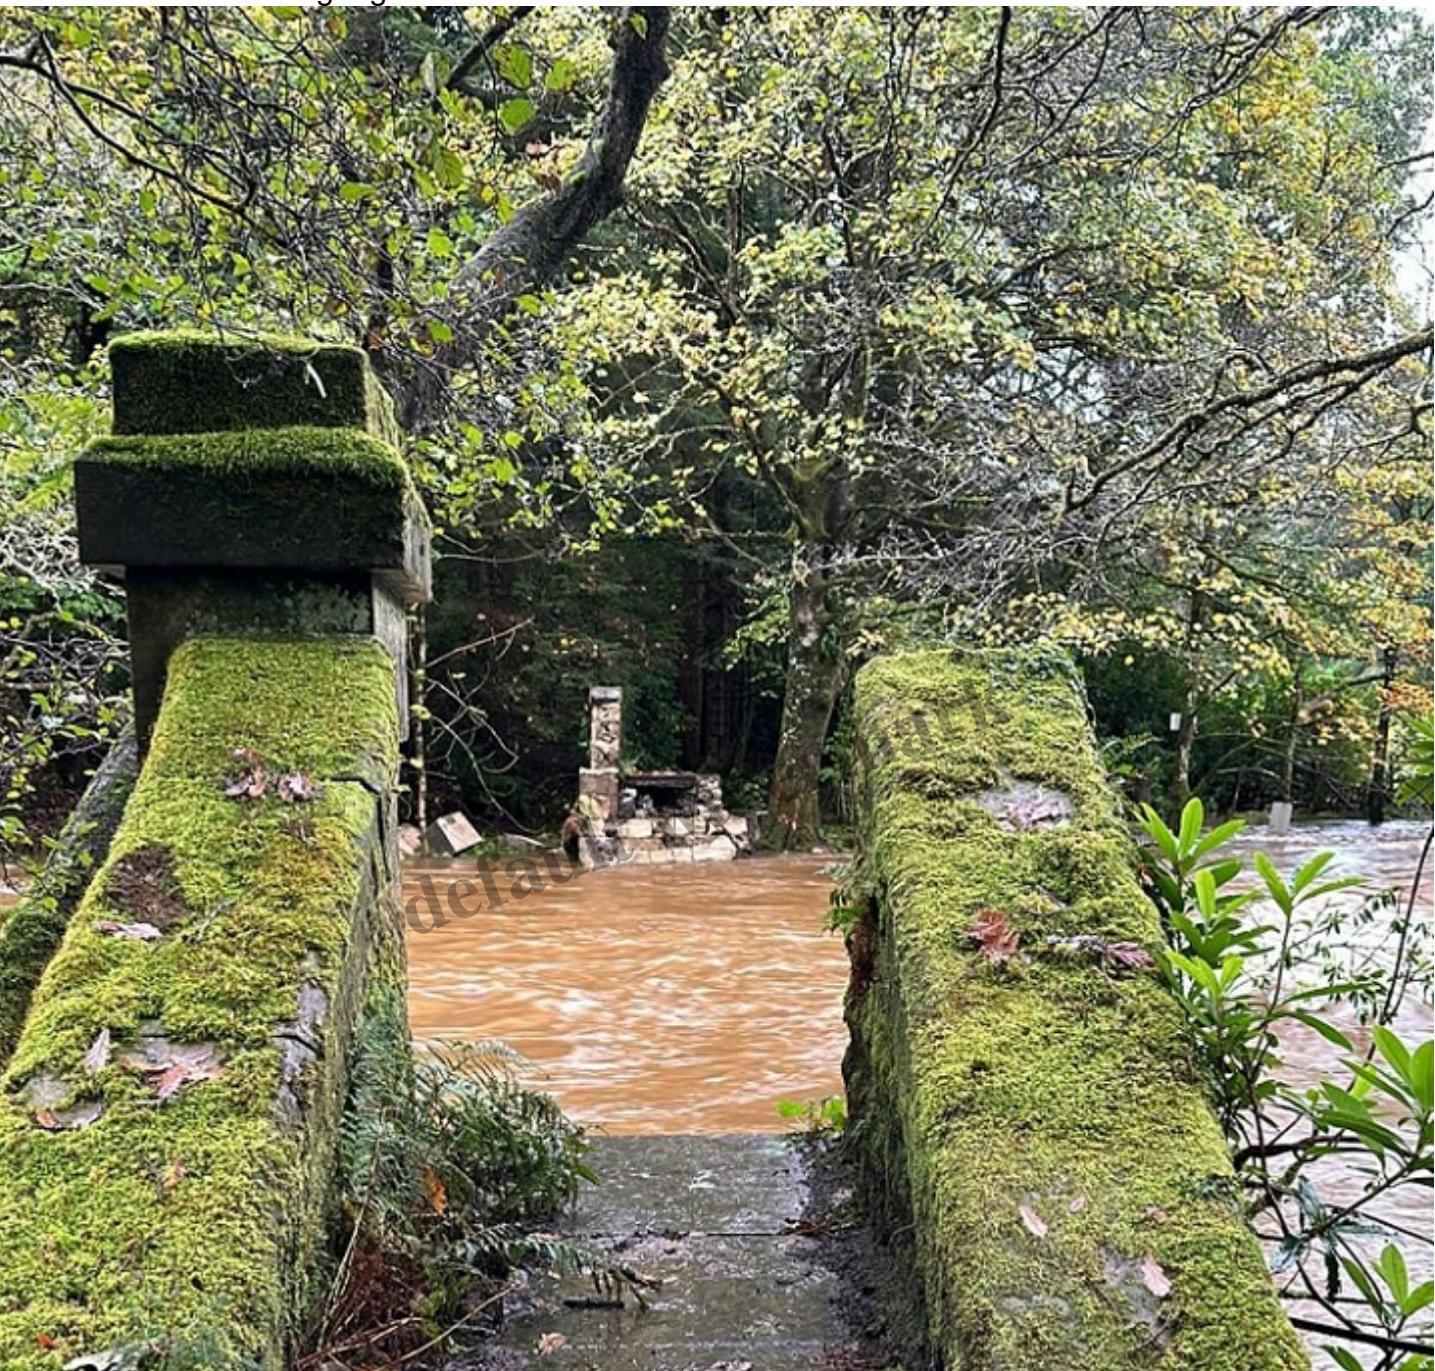
The listed pedestrian bridge at Benmore Gardens was swept away. Photo credit Parkswatch reader. The rainfall that was brought to Scotland by Storm Babet was far more restricted in extent -my thanks to a reader who alerted me to the excellent Met Office report (see here). However, it caused record rainfall in Angus (which had just two weeks earlier received the sixth highest rainfall ever recorded for the area). Like the report for 6th/7th October, however, it is not detailed enough to explain variations of rainfall within river catchments such as the 80mm SEPA recorded at Gella Bridge in upper Glen Clova. The important point here is that if 150mm of rain had fallen at Gella bridge, as appears to have happened just to the south, the water levels in the River South Esk at Brechin, which exceeded all previous records, would have been far far higher.

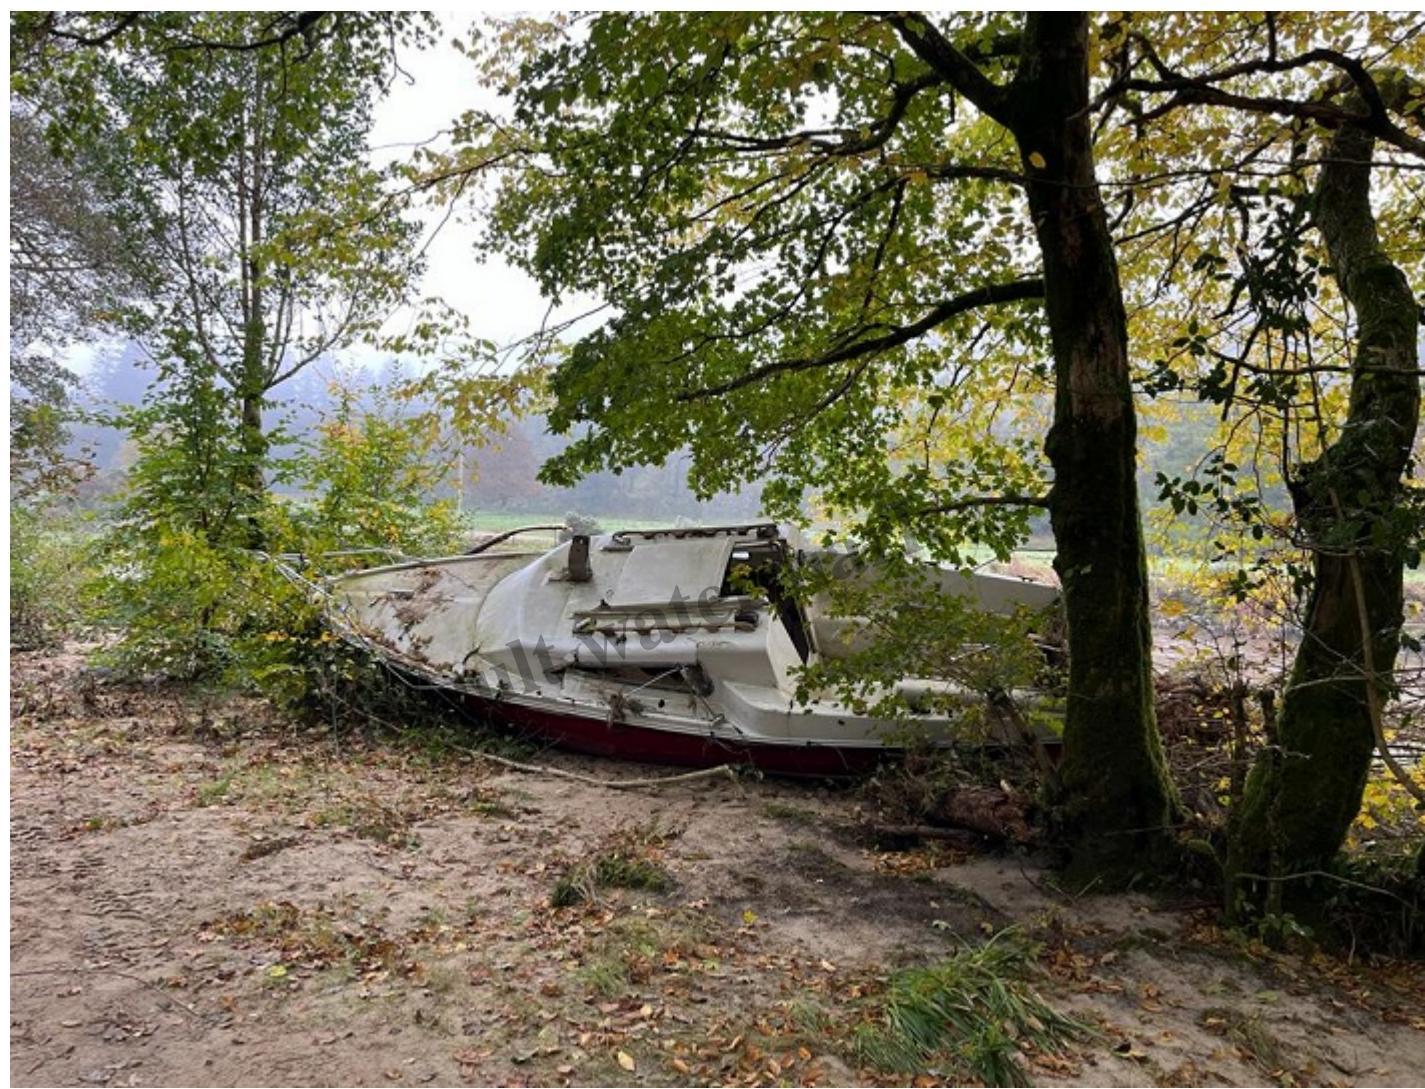
Boat apparently washed down the River Eachaig from Loch Eck. Photo credit Parkswatch reader

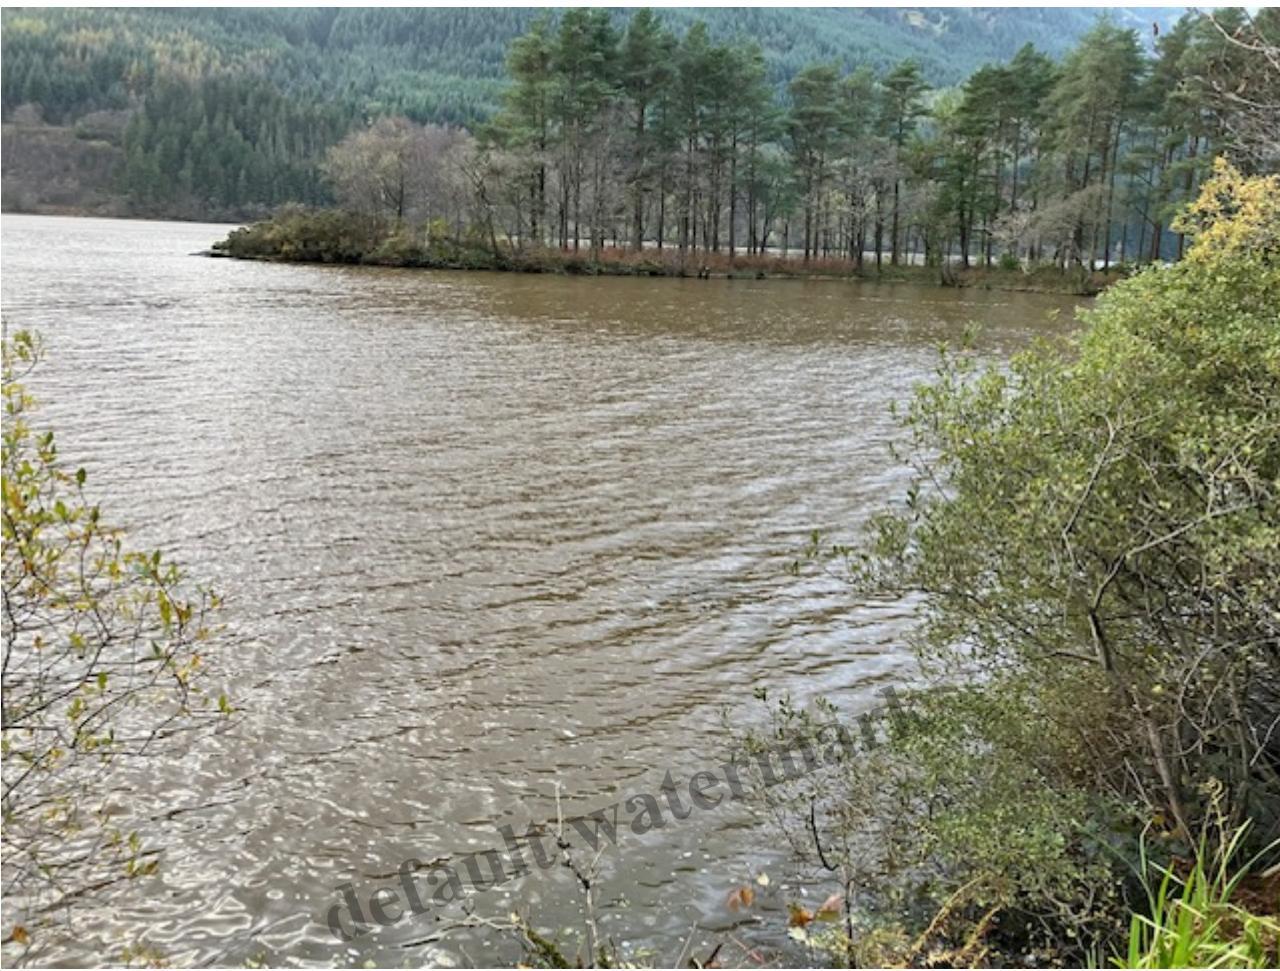
Loch Eck 20th October. Photo credit Nick Halls

Eleven days after I had visited Lock Eck, its waters were still brown, filled with sediment. There are two public interest questions here, where did the soil come from and why, and, what impact will all this sediment have on the (rare) wildlife in Loch Eck?

How then could so much sediment end up in a loch surrounded by trees? One possible explanation is that the flood plain along the River Cur was seriously eroded by the deluge and washed sediment into the north end of Loch Eck and this then spread 10km down the loch. Another possible explanation is that industrial forestry practices have helped undermine the stability of the steep slopes around Loch Eck which would normally have been helped by being planted by trees.

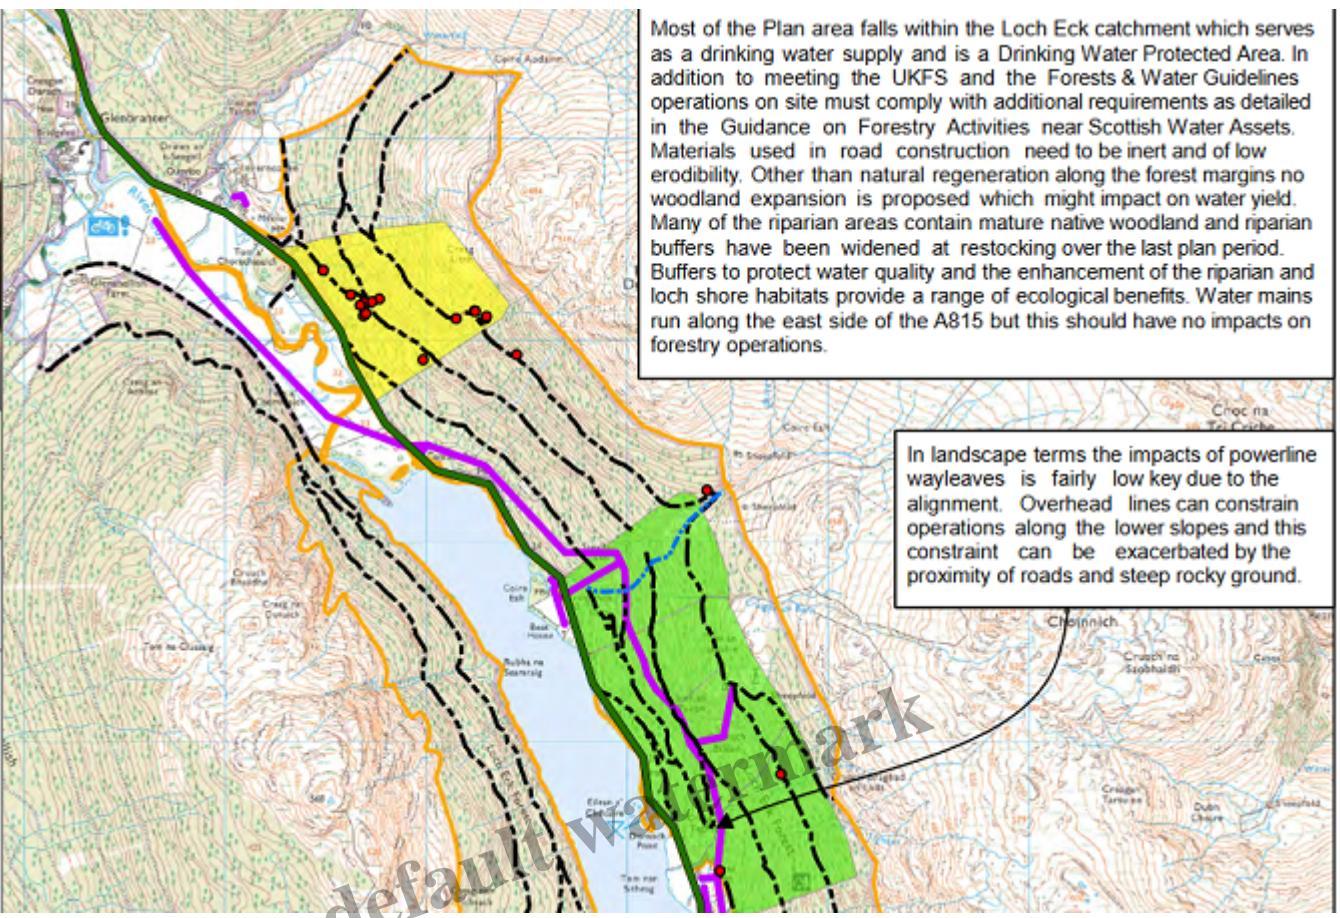
Red dots = recorded landslips. Map credit FLS Loch Eck Management Plan approved in 2020

The fact that most of the recorded landslips are by forest roads could be because they are easier to spot but it could also be because those roads were helping to cause the landslips. Add to that the clear-felling that has been taking place around the loch, which involves heavy machinery churning up the soils, and it appears quite possible that FLS' management of the land may be responsible for much of the sediment in Loch Eck.

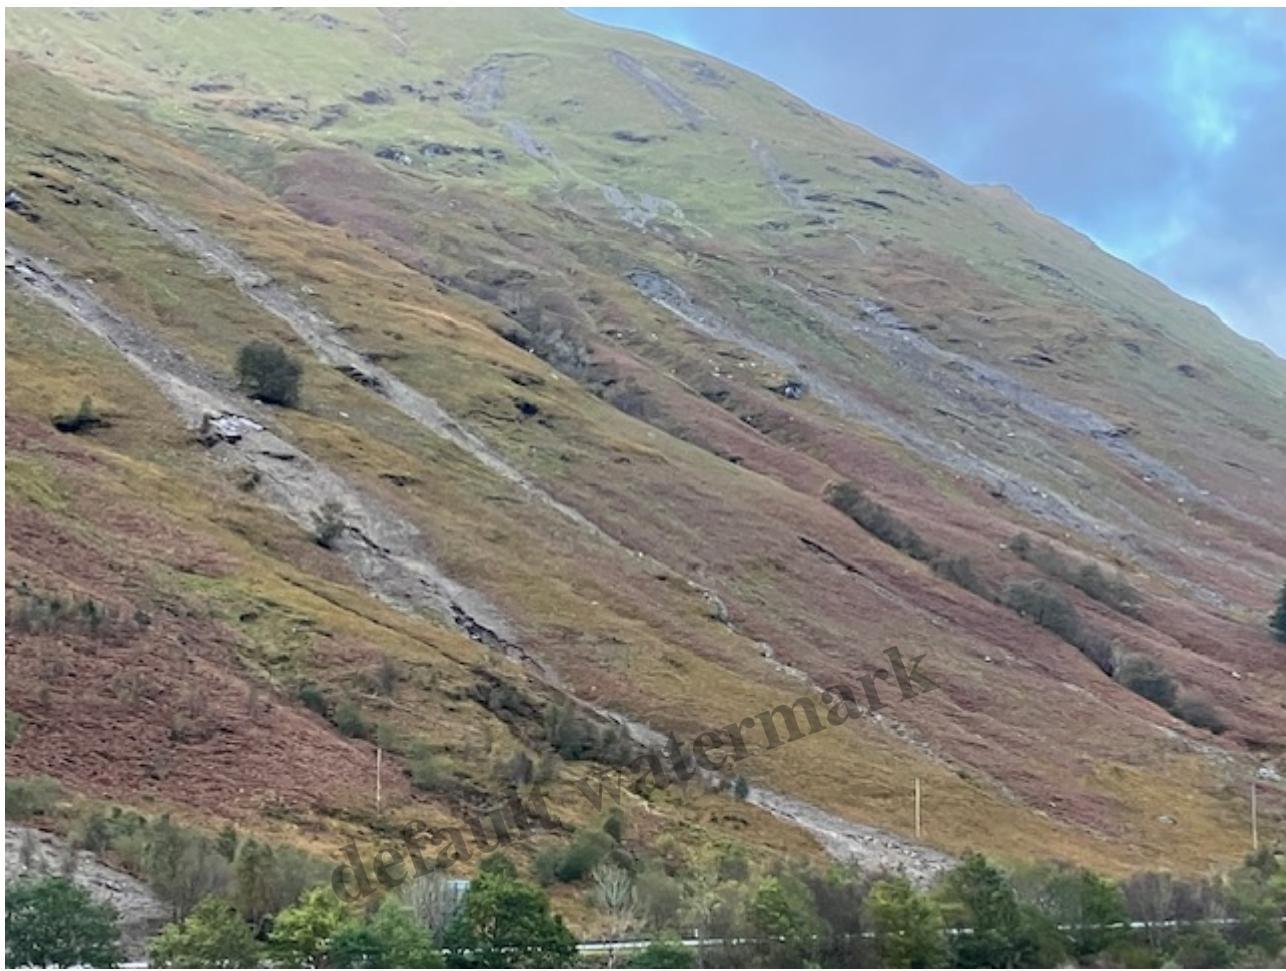
Landslips Glen Kinglas. Note the sheep grazing the slopes. Photo credit Nick Halls

Over in Glen Kinglas, just outside the National Park boundary, there have been significantly more landslips than the eight BEAR reported as reaching the road. This reinforces the case for creating a comprehensive data base of landslips in Scotland in order to properly assess risks to infrastructure. Knowing about the landslips that don't hit the road is as important as knowing about those that do.

Meantime the fact the owner of the Strone Estate, Tom Turnbull, who is also chair of the Association of Deer Management Groups, is still grazing (or allowing someone else to graze) sheep on these slopes should to my mind be treated as criminal, an offense against the public interest. The fact that the Scottish Government is subsidising him to do this through greening payments – as I explained in my last post – appears even more criminal.

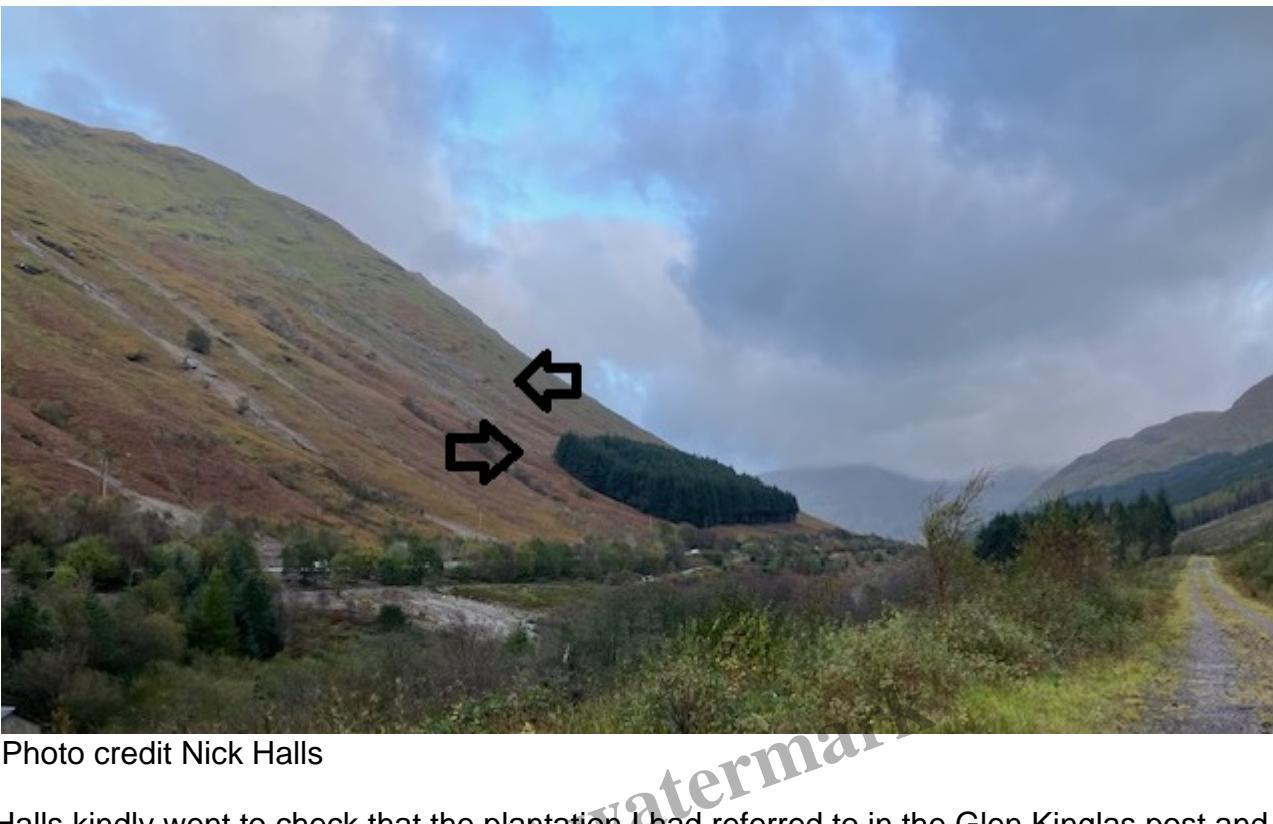
Photo credit Nick Halls

Nick Halls kindly went to check that the plantation I had referred to in the Glen Kinglas post and which had been granted a felling license by Scottish Forestry was still there. I had commented how stupid it was that Scottish Forestry would even consider granting felling licenses on landslip prone slopes. Nick's photo proves the point. It shows two landslips above the trees.

That evidence should be sufficient to prompt Scottish Forestry to undertake an immediate review of all felling licenses for trees on steep slopes vulnerable to landslips.
