## Why has the destruction at Cairngorm happened?

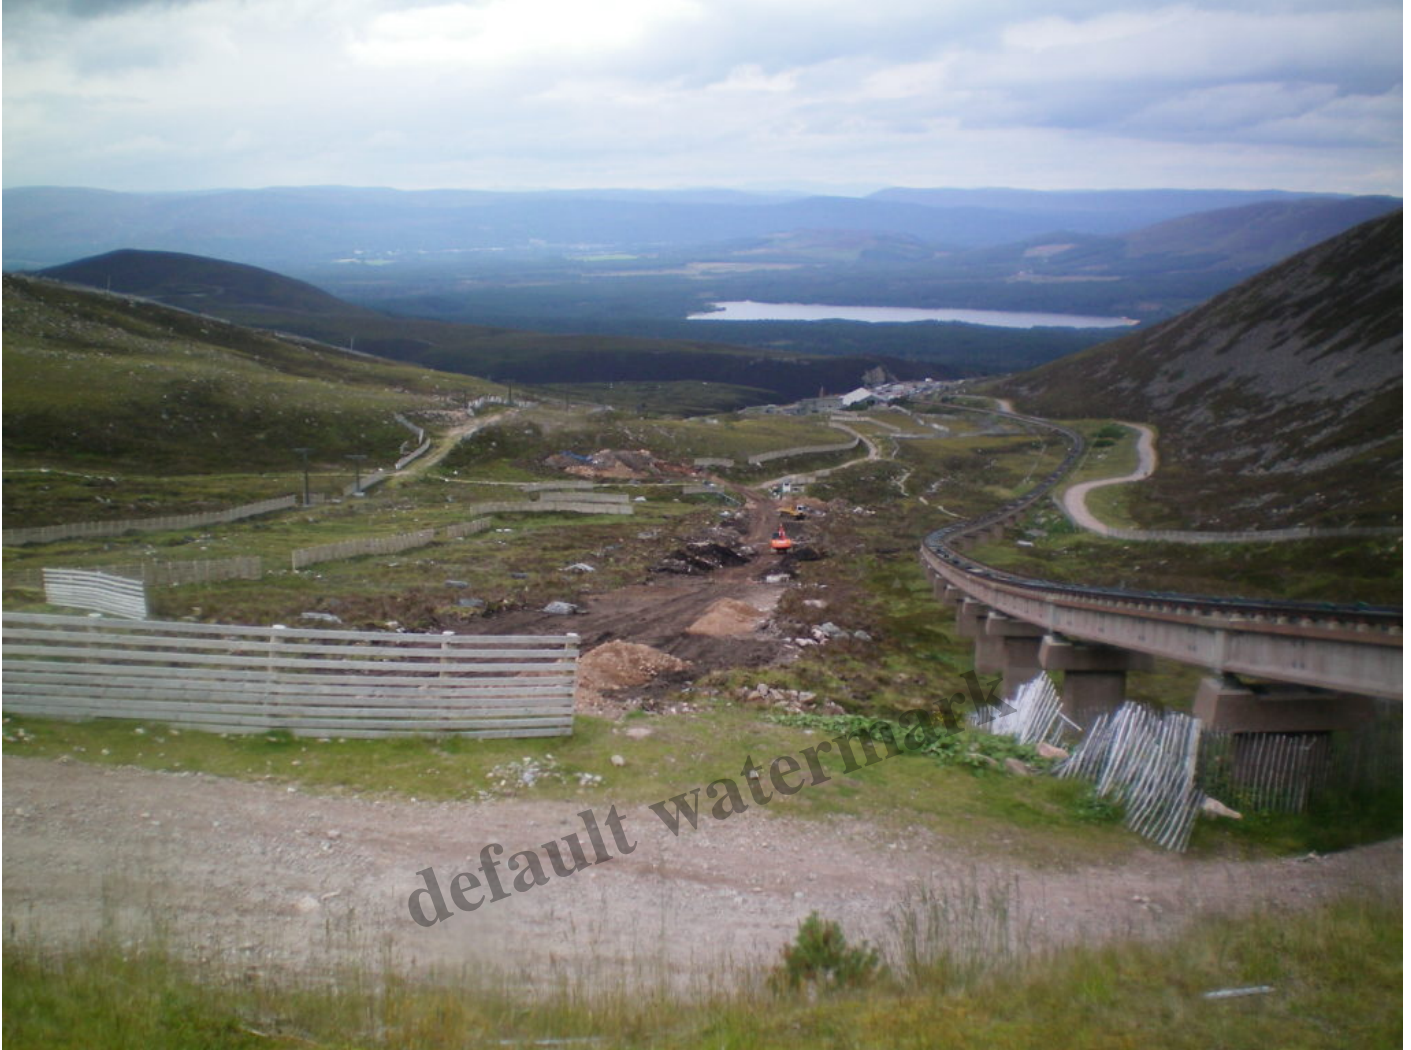
I am not sure the planner appreciated just how much soil and boulders would be shifted

Shifting and storage of soil and boulders was not mentioned in the Method Statement – a huge pile can be seen centre background outwith the area granted planning permission

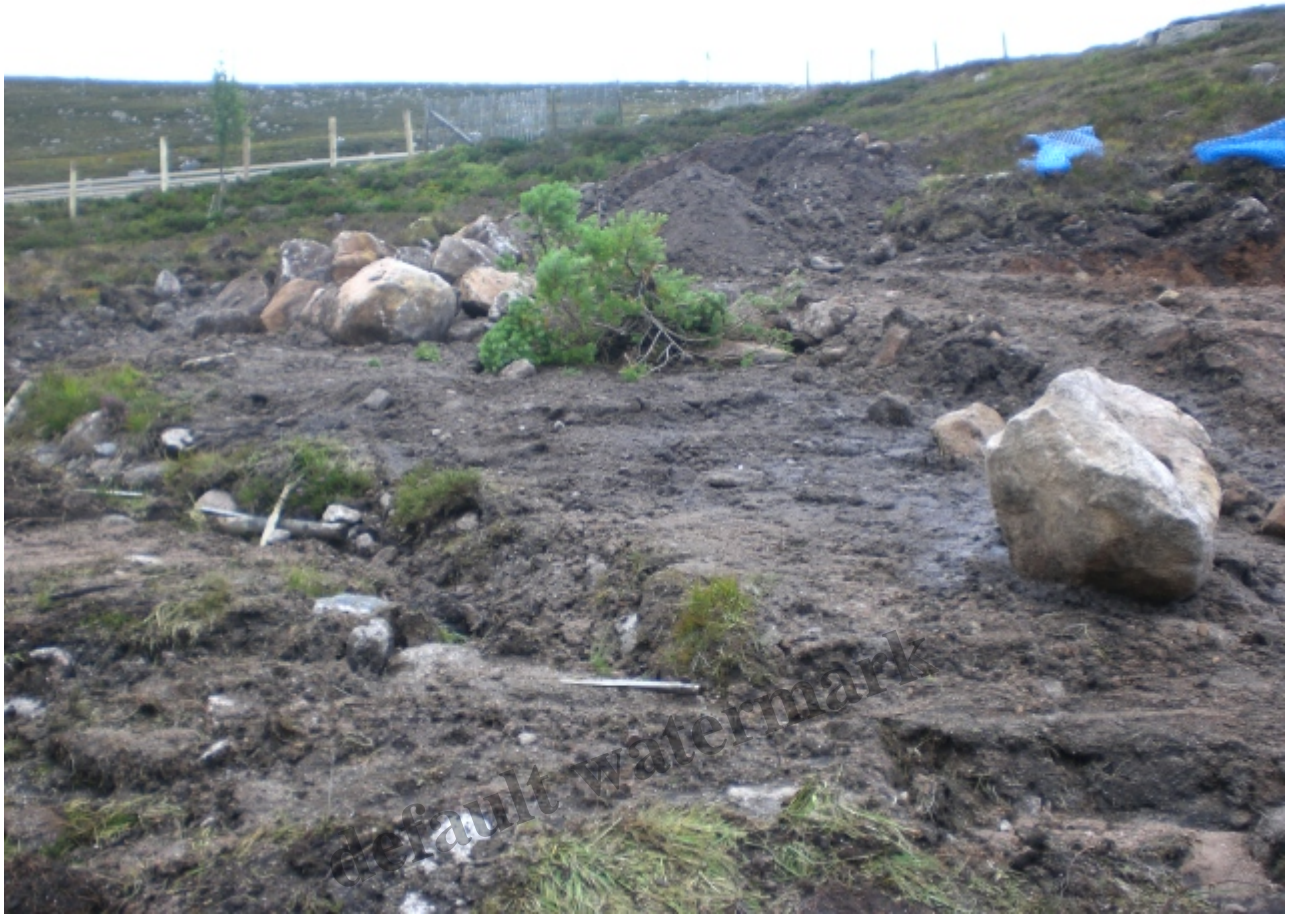
The Method Statement did not say what would happen to boulders that impacted on the “reprofiling” of the slope Photo credit Alan Bratney

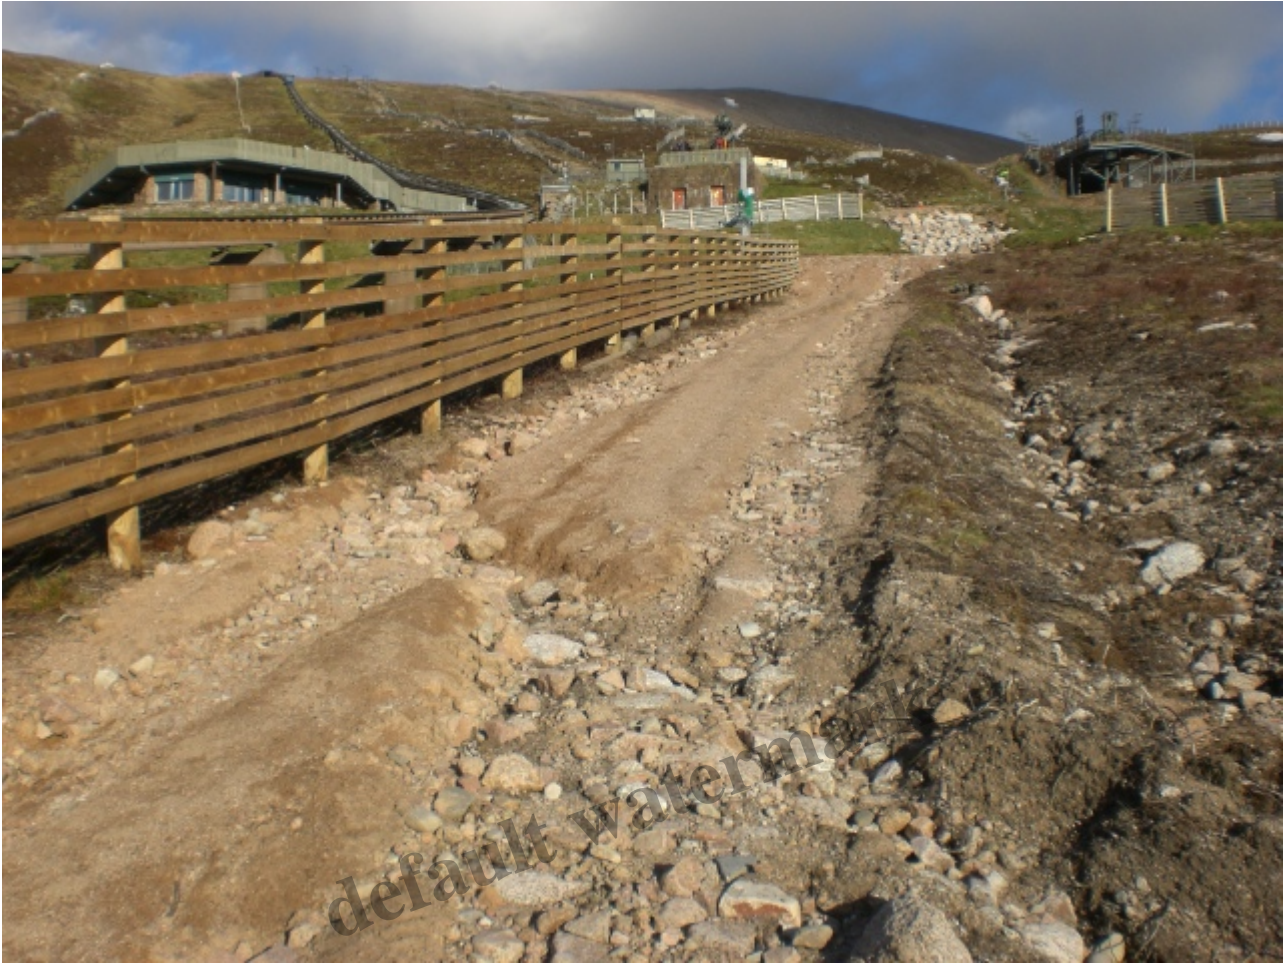
The new bulldozed track

There was no reference to a new bulldozed track in the planning application – a clear breach of planning requirements  
George Paton

a full and public apology for what has happened and take a lead in re-instating the bulldozed track and repairing the other damage, I believe they are no longer fit to own the ski area.

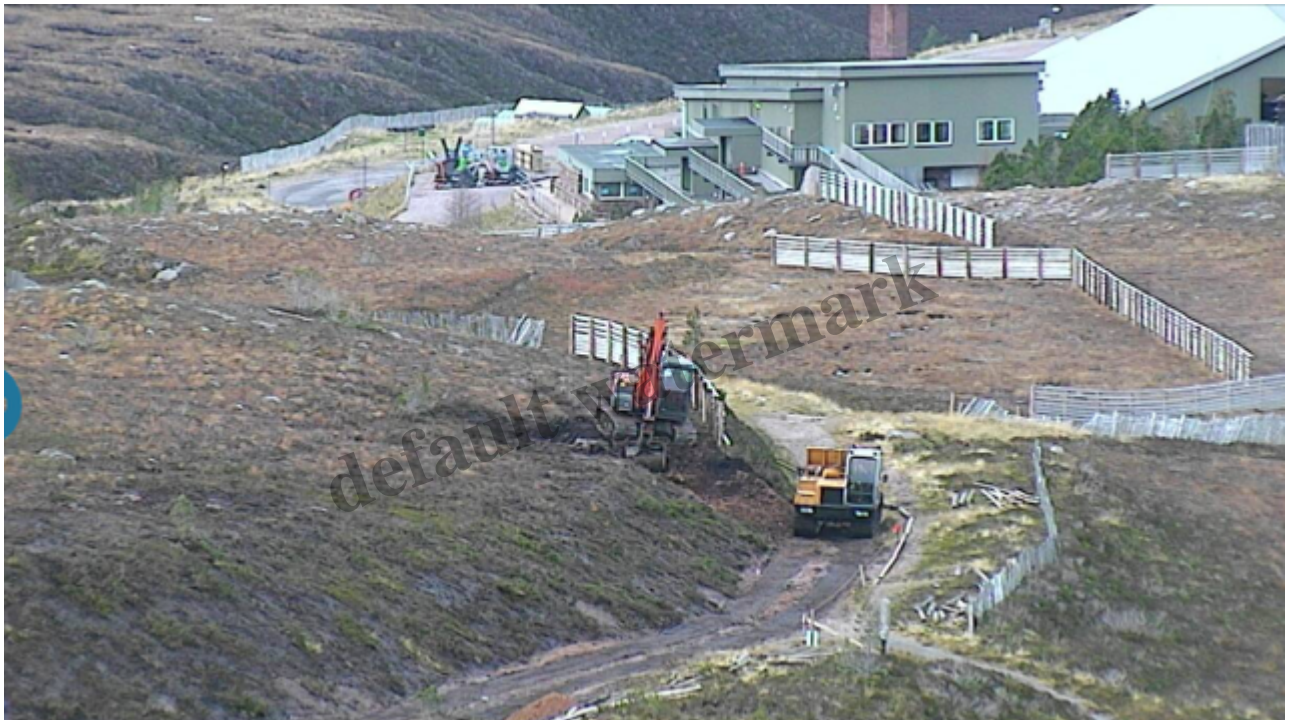
Work undertaken outwith the area granted planned permission

Working taking place on the bank below the shieling ski tow – the planning permission did not cover this area  
credit George Paton

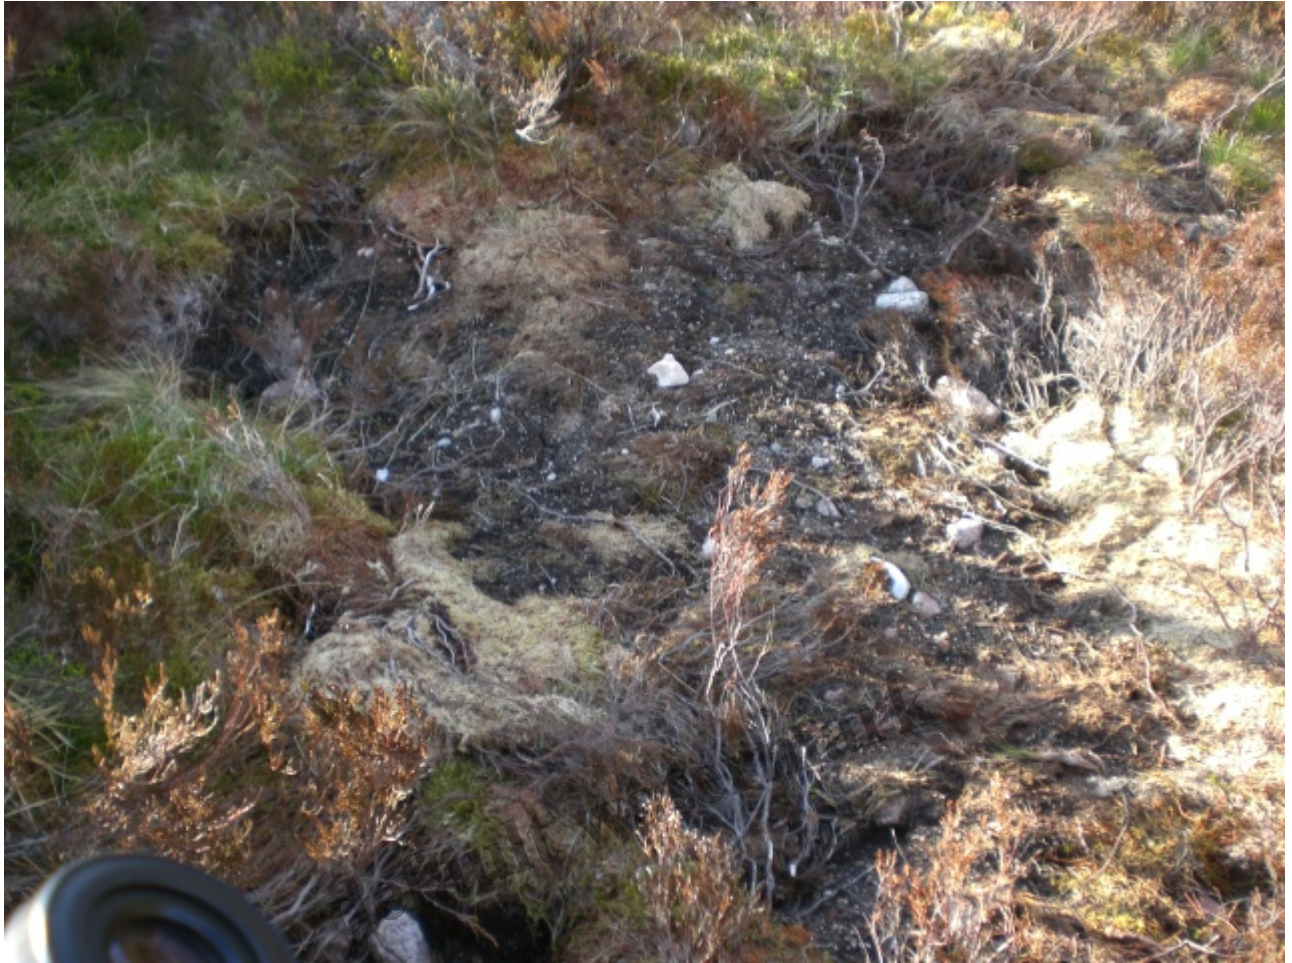
A hole excavated by a digger outwith the area granted planning permission – it appears the contractors were short of vegetation (implying they had not stored turf in the manner specified) and tried to address this failure by taking vegetation from elsewhere. There is no mention of this in the Method Statement and it is also clearly outwith the planning permission granted

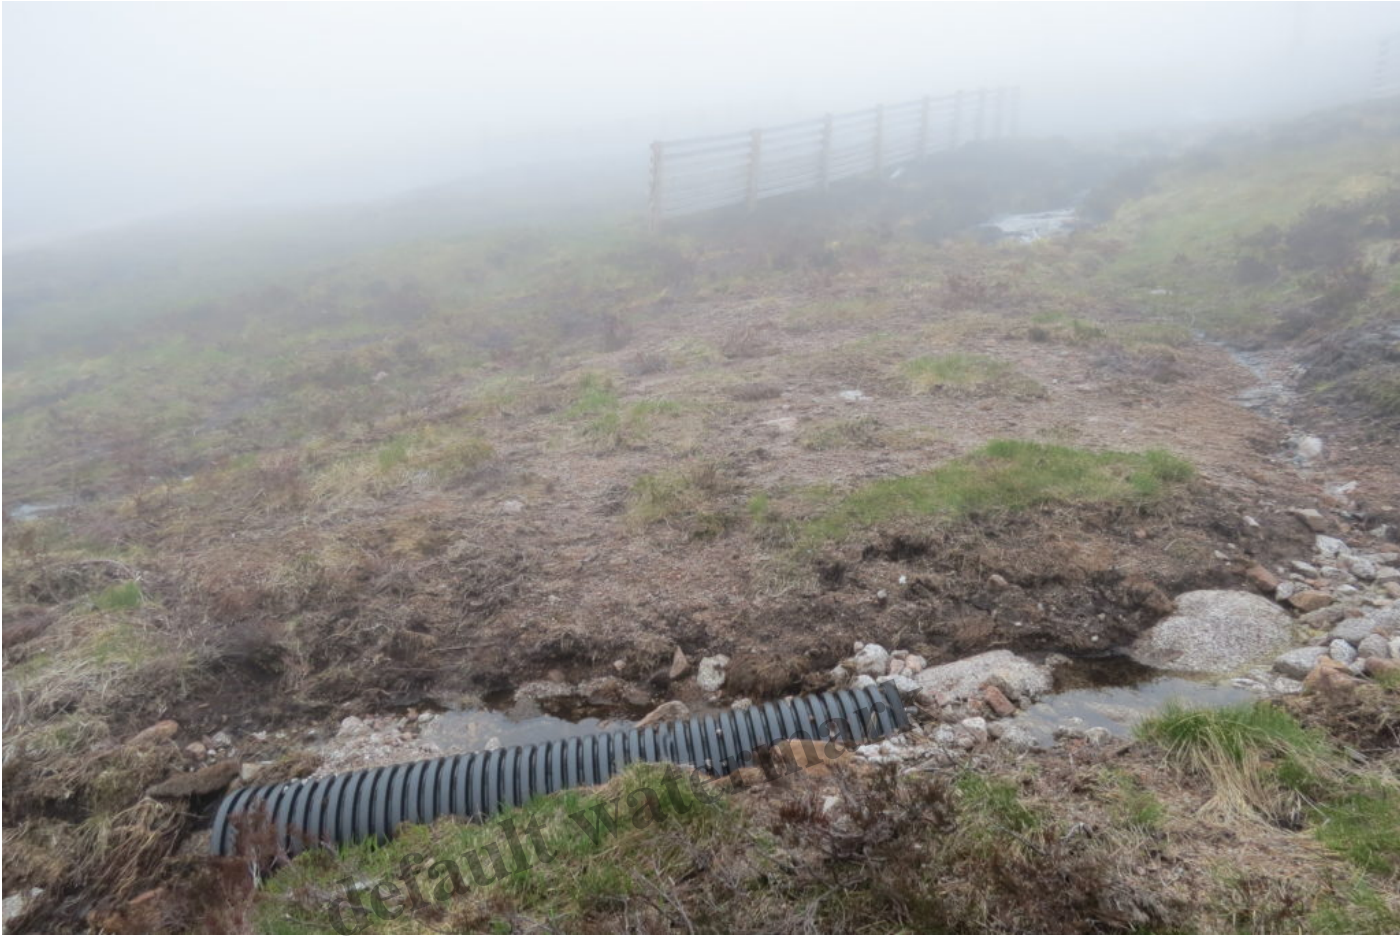
The contractor has failed to finish off the new culvert let alone in the manner specified

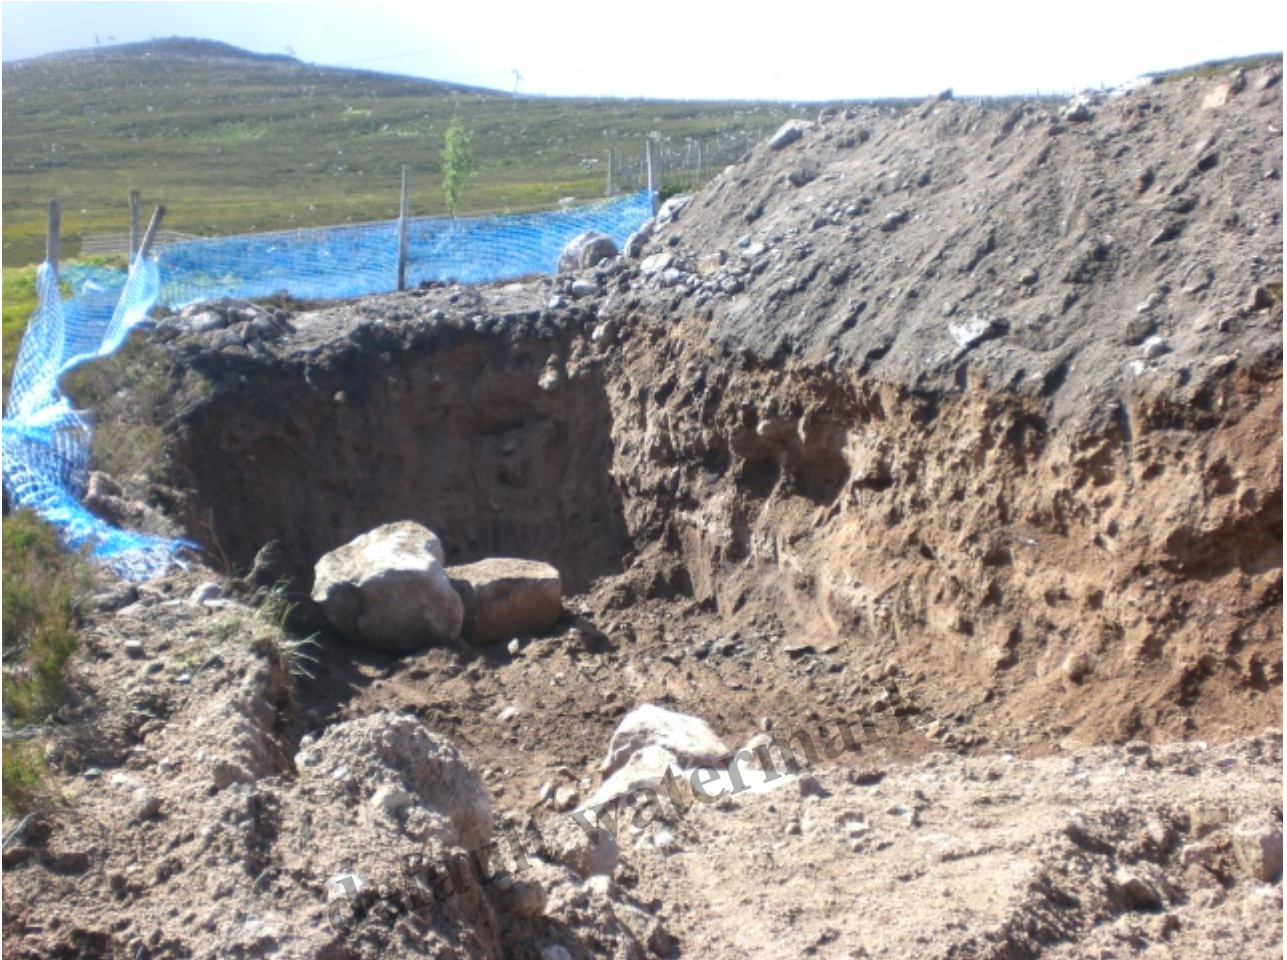
And there is the question of whether this pit was covered by the planning permission?

Pit into which soil, peat and boulders was later dumped Photo Credit Alan Bratney
