The continued destruction and lack of care at Cairngorm

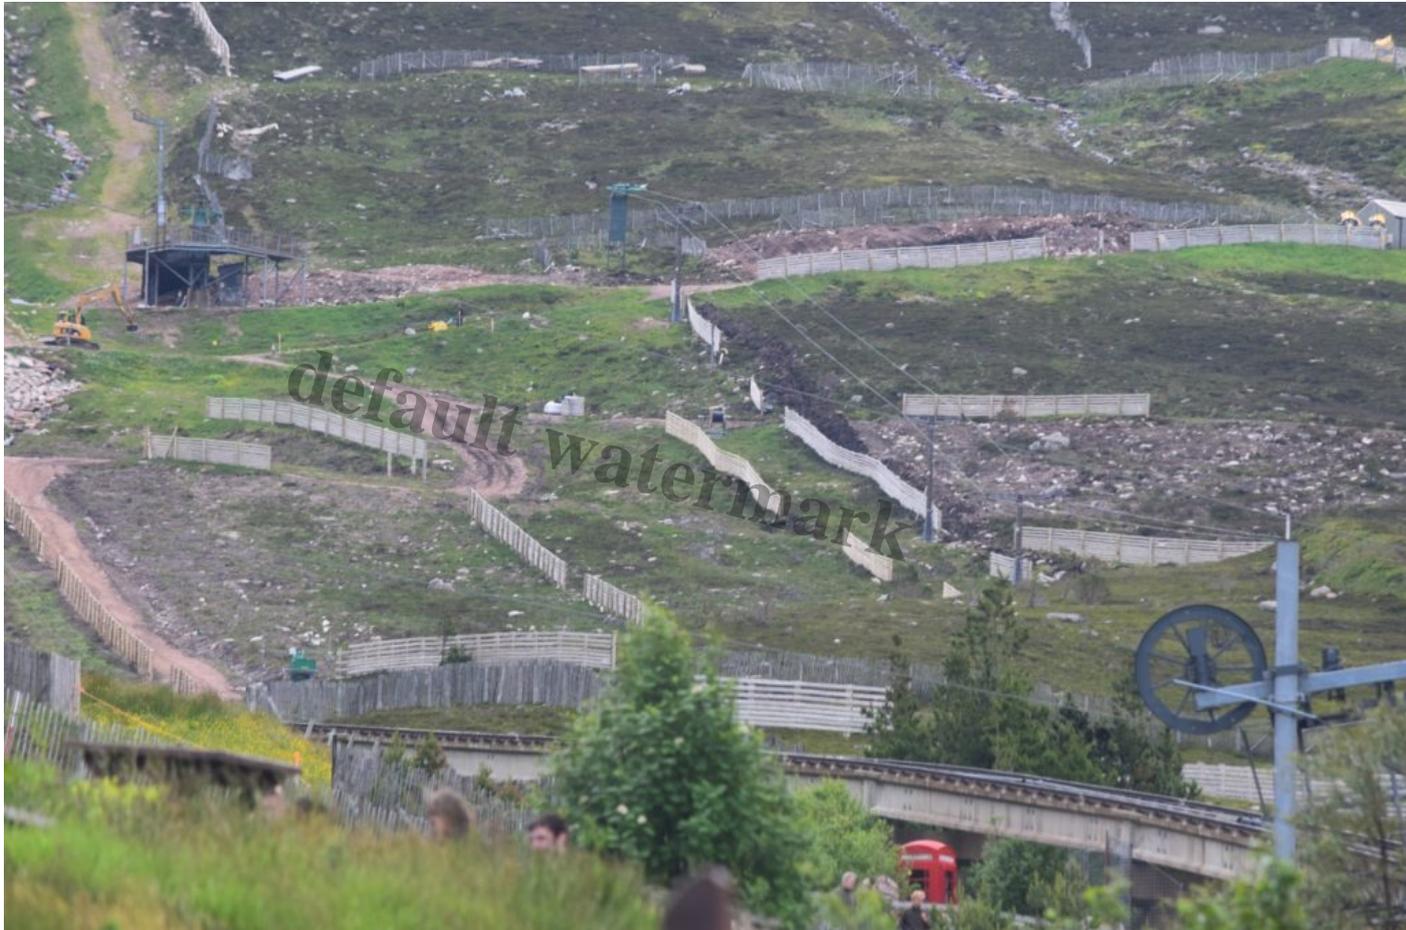
An illustration of the extensive 'works' at Coire Cas Cairngorm taken mid-July
Photo credit George Paton

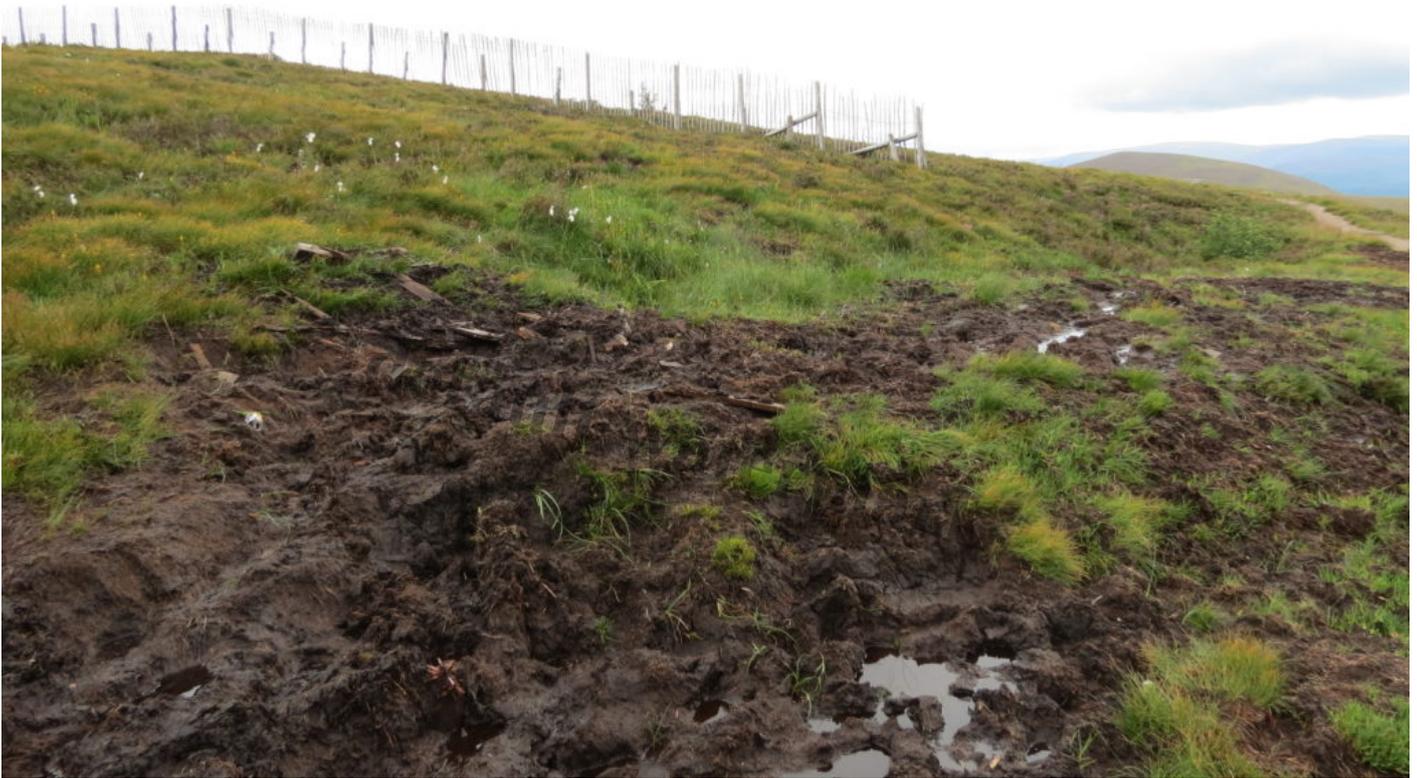
Much of the rubbish by the start of the Car Park T-bar and Coire Cas path, featured on parkswatch, has been removed but if you look carefully you can see its a job half done â?? plenty of scrap wood middle left.

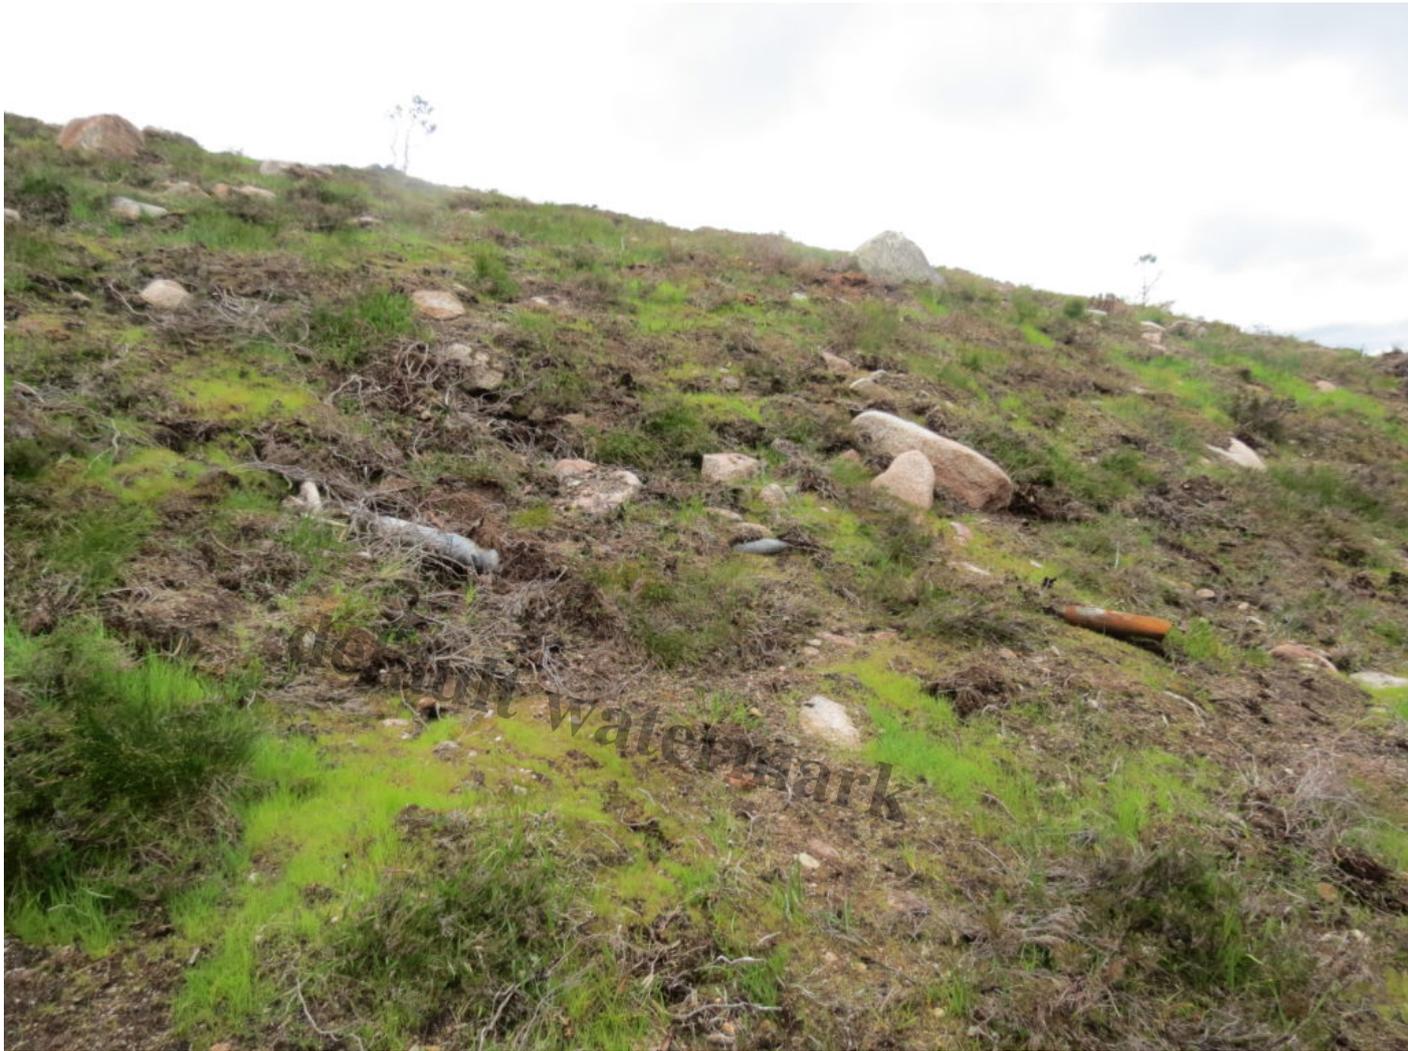
Bits of old piping left in ground that has been re-seeded (bright green) on the bank where work was done without planning permission.

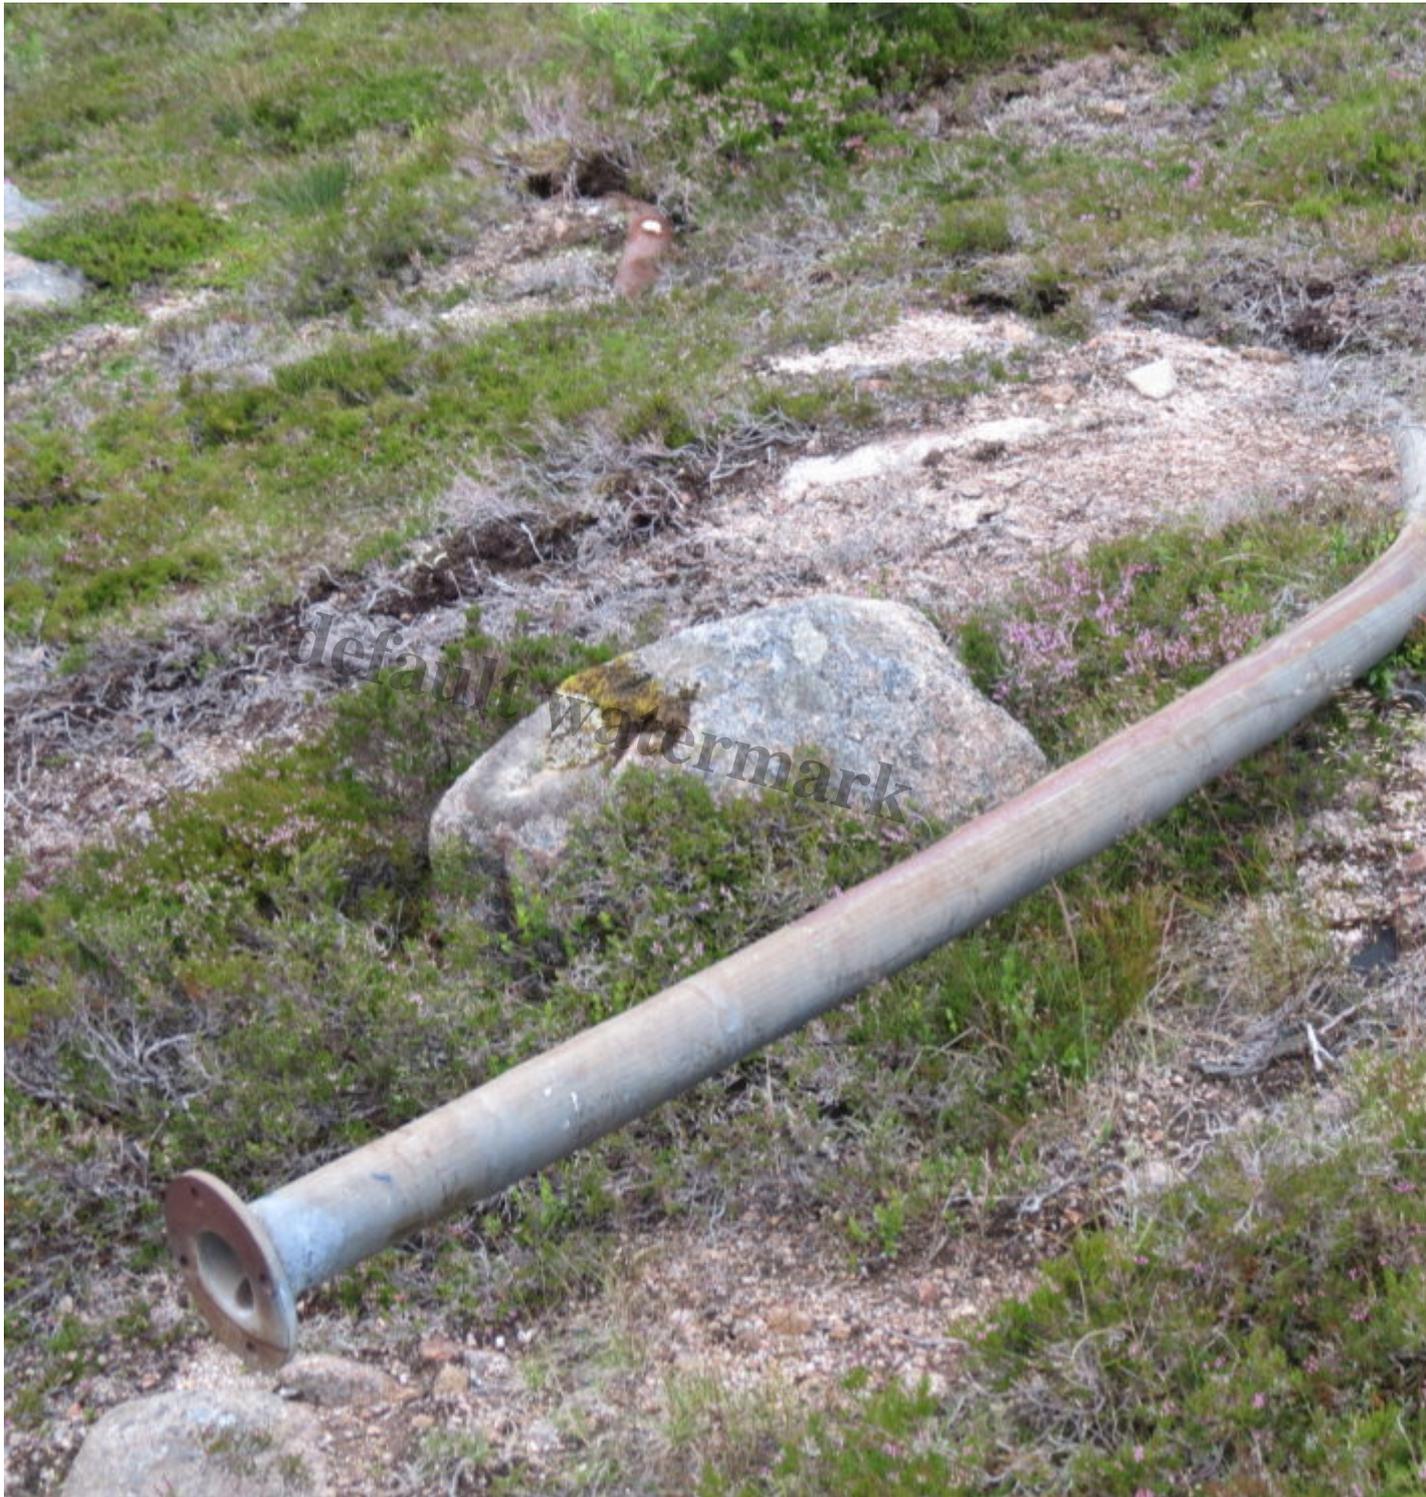
This section of the old pipe is even more obvious but is just outside the "re-landscaped" area

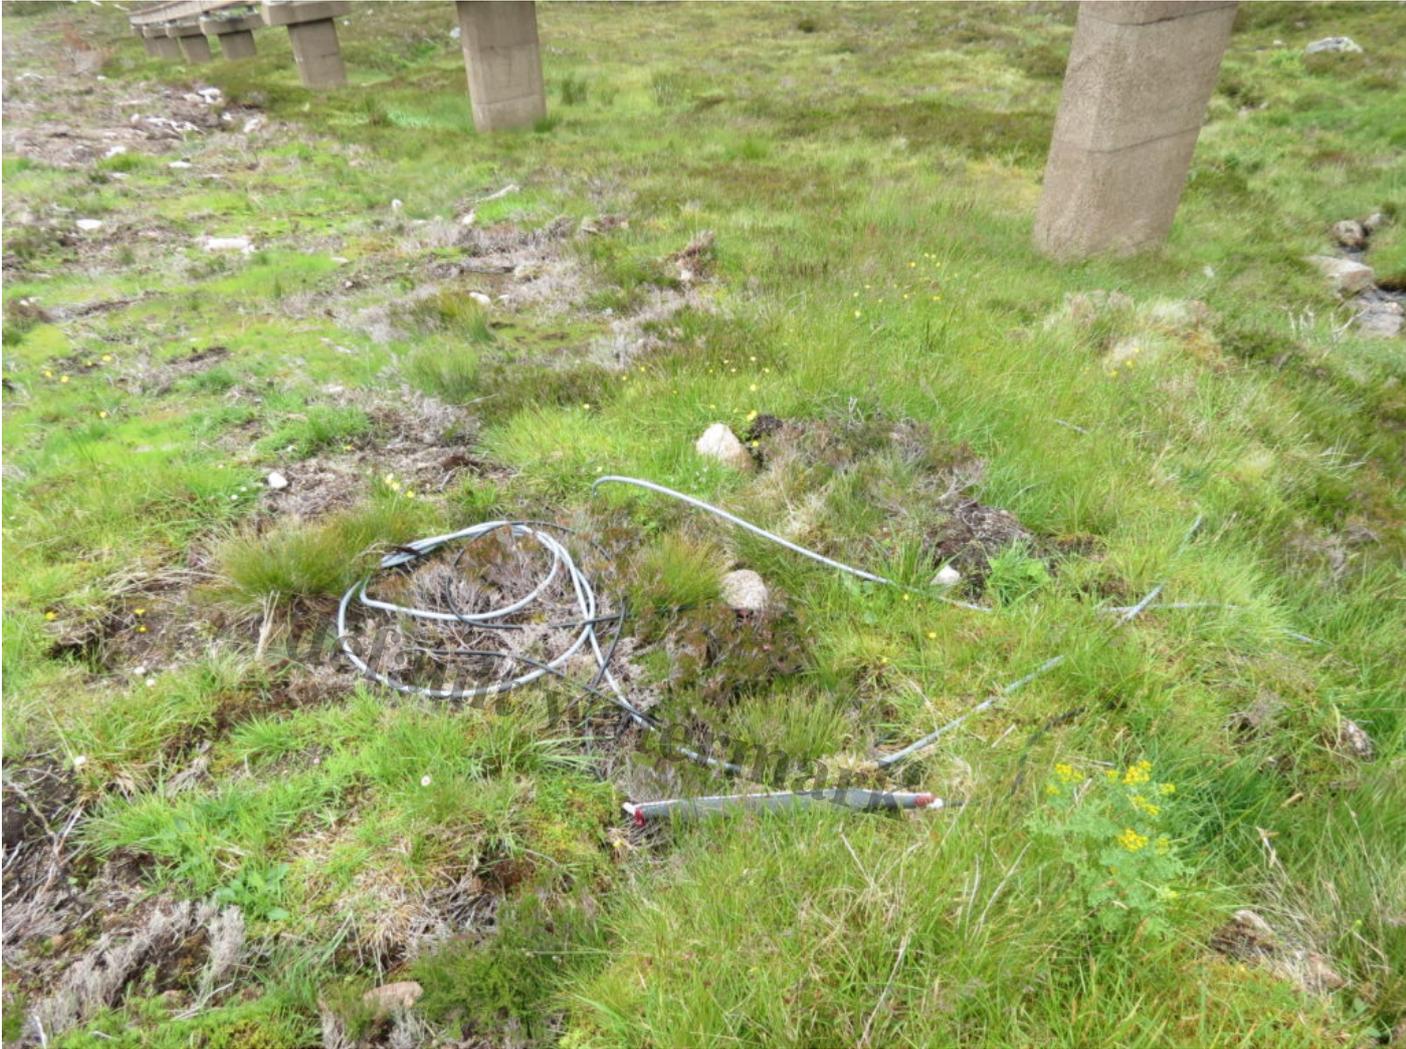
Rubbish left by funicular stanchions on the edge of the reprofiled shieling poma slope that was granted planning permission

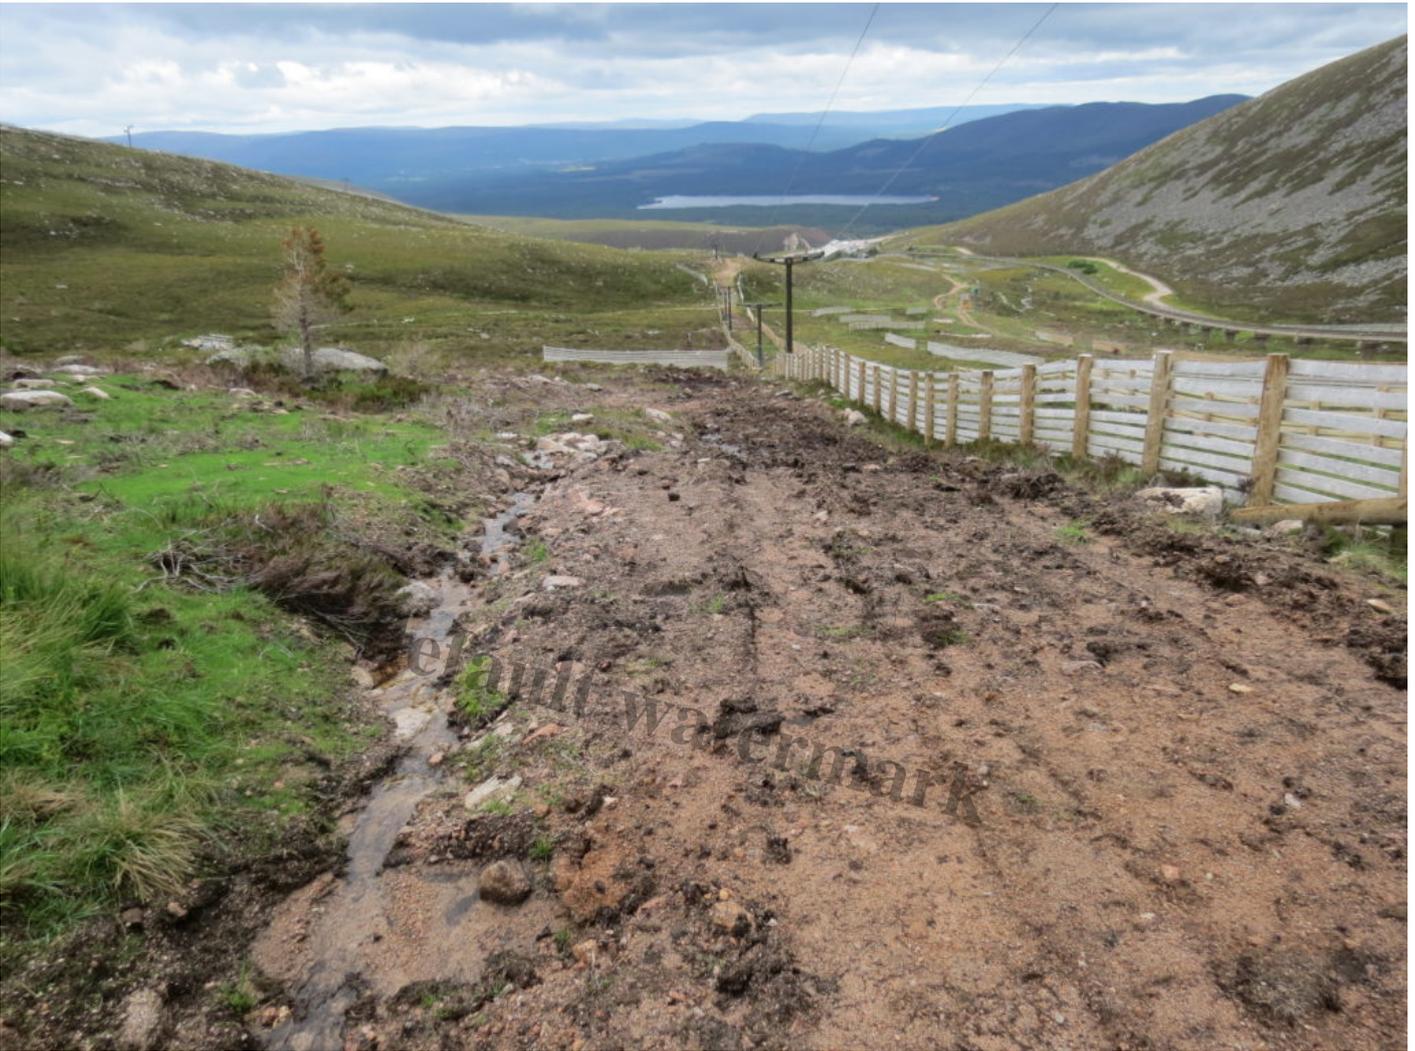
When Natural Retreats stated they had completed restoration of the car park T bar uplift track â?? which did not require planning permission â?? they made no mention of the upper part of the tow where the cable follows the other side of the fence. The restoration work here is far from impressive but it appears vehicles are using this to access the area of land in the far right lower middle section of the first photo â?? for a purpose that I have not yet established. Just what have Natural Retreats and HIE been up to here?

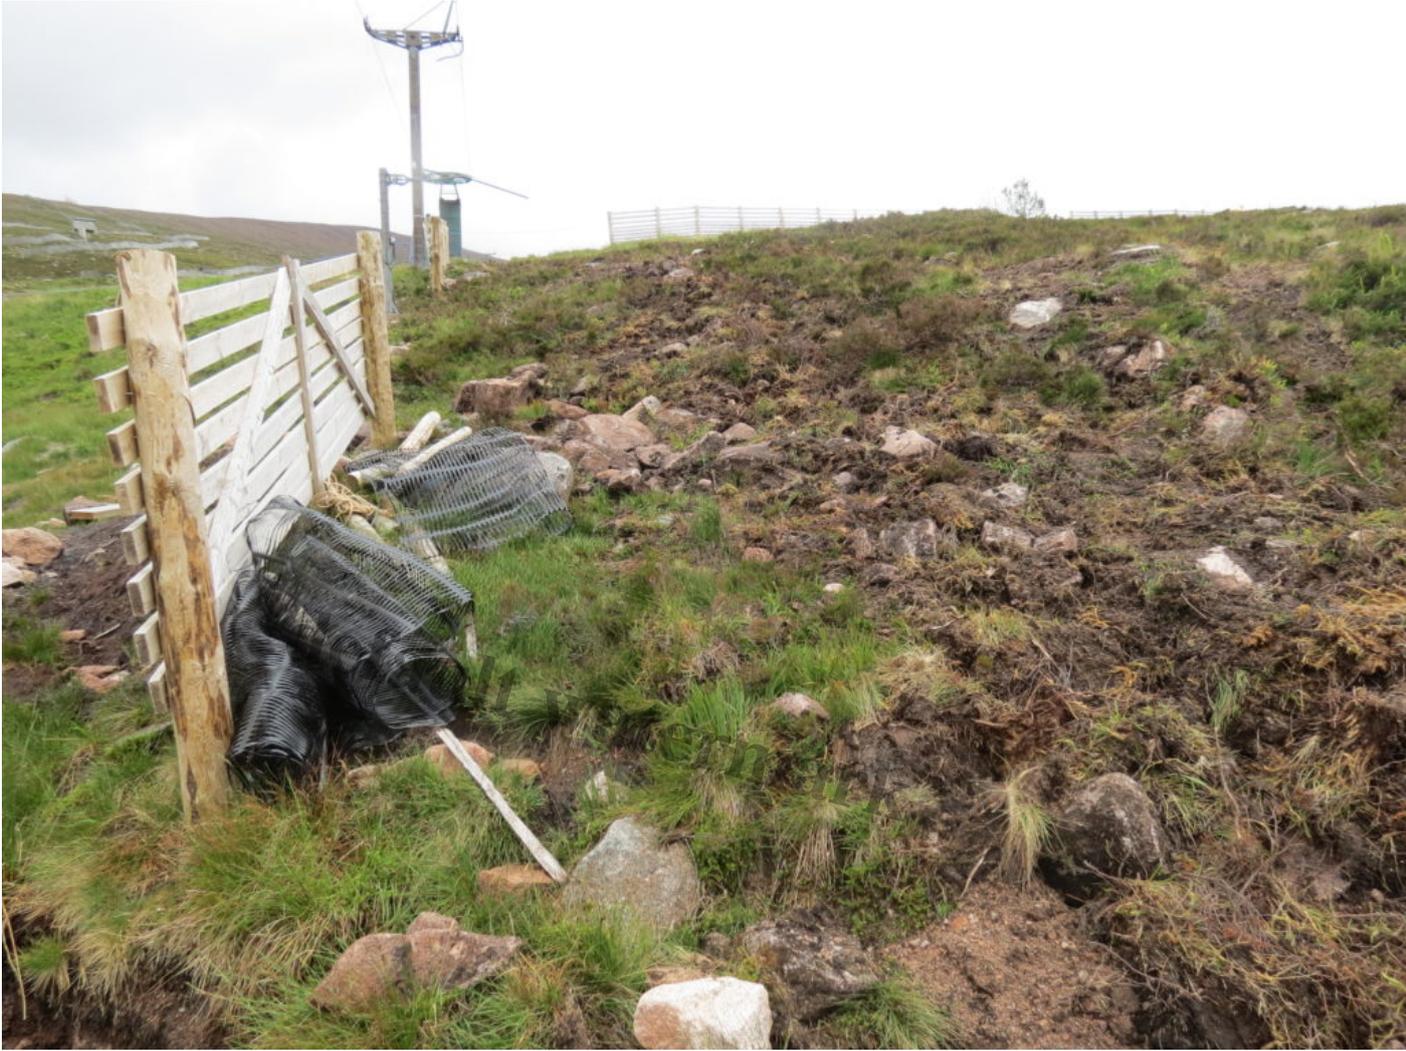
The “re-instated” ditch at the top of the Car Park t-bar a very similar photo appears on the Natural Retreats website and which they claim as evidence of re-instatement

Now, I am not an expert on restoration work but I do not understand what good practice this photo is supposed to demonstrate? Boulders that were once embedded or beneath vegetation are now lying loose above it and some no doubt will soon roll downhill while the drainage has been totally altered with lots of “pockets” for water to accumulate.

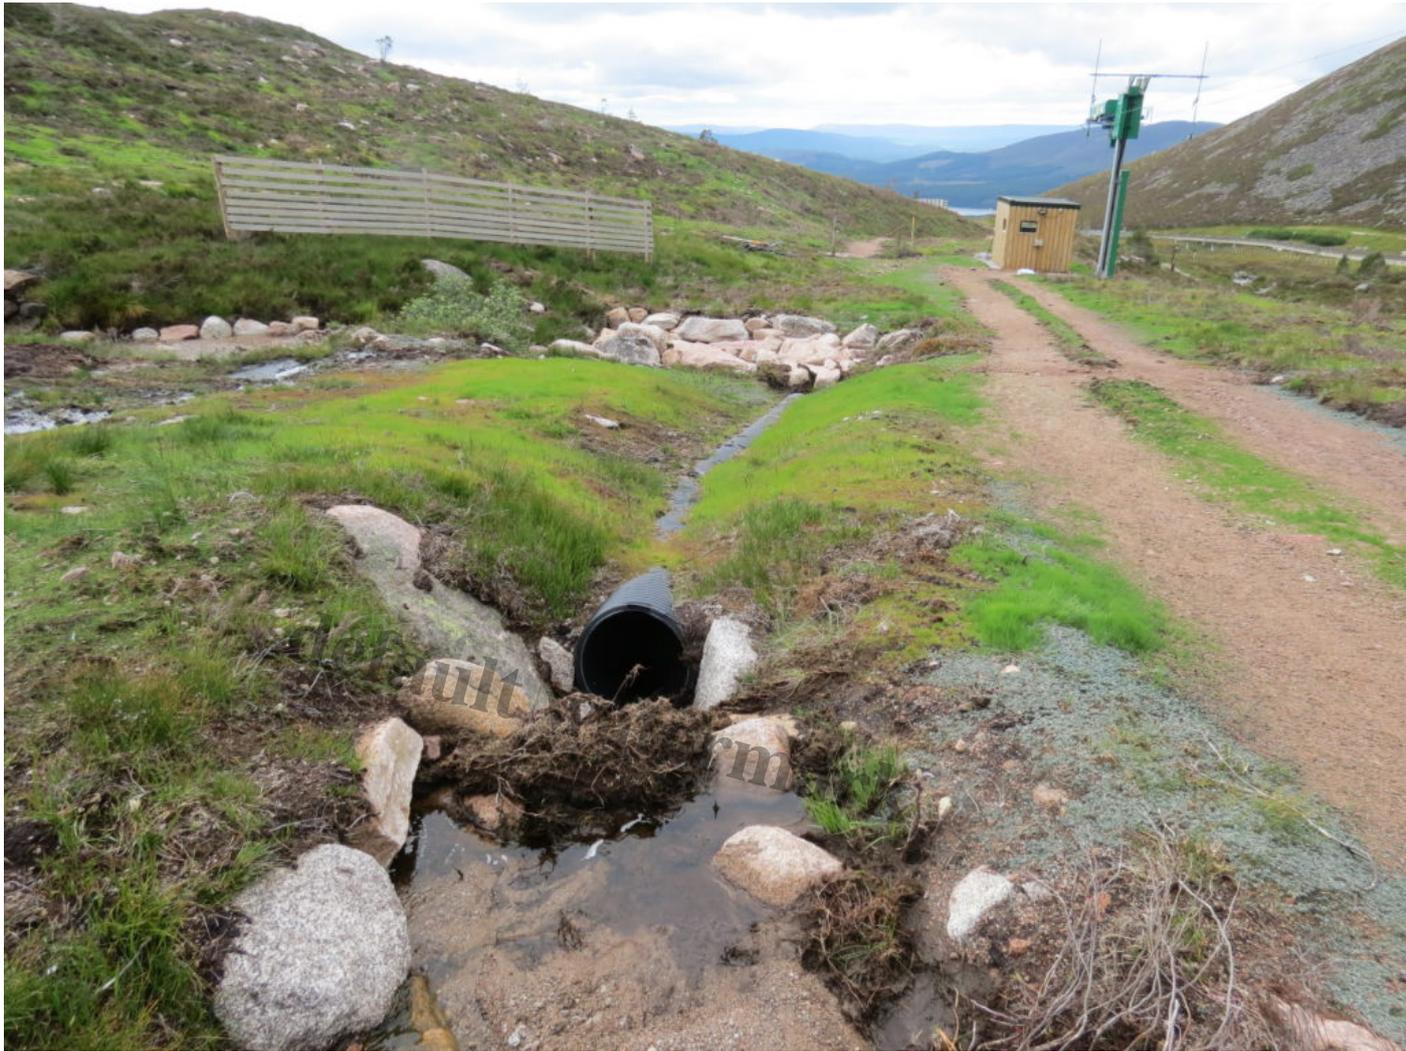
One of two unfinished culvert on the edge of the Sheiling Poma ski slope – there are three culverts in all, only two of which are referred to in the planning application

Yes, Natural Retreats has been re-seeding but not areas which were previously grassy as it claimed in the quote above. A planning condition for the sheiling poma was that Natural Retreats removed all the vegetation, stored it and then replaced it. The extensive re-seeding has been required because of their failure to comply with planning conditions and the bright green colour highly artificial, the result of the use of the blue/grey fertiliser you can see in the foreground. There was nothing about widespread re-seeding in this way in the planning permission but it is now needed because of their complete failure to observe planning conditions. My belief is that the Cairngorms National Park Authority should as part of enforcement require Natural Retreats to pay for montane scrub planting on the slopes in the background (which are not part of the piste) as a compensatory measure.

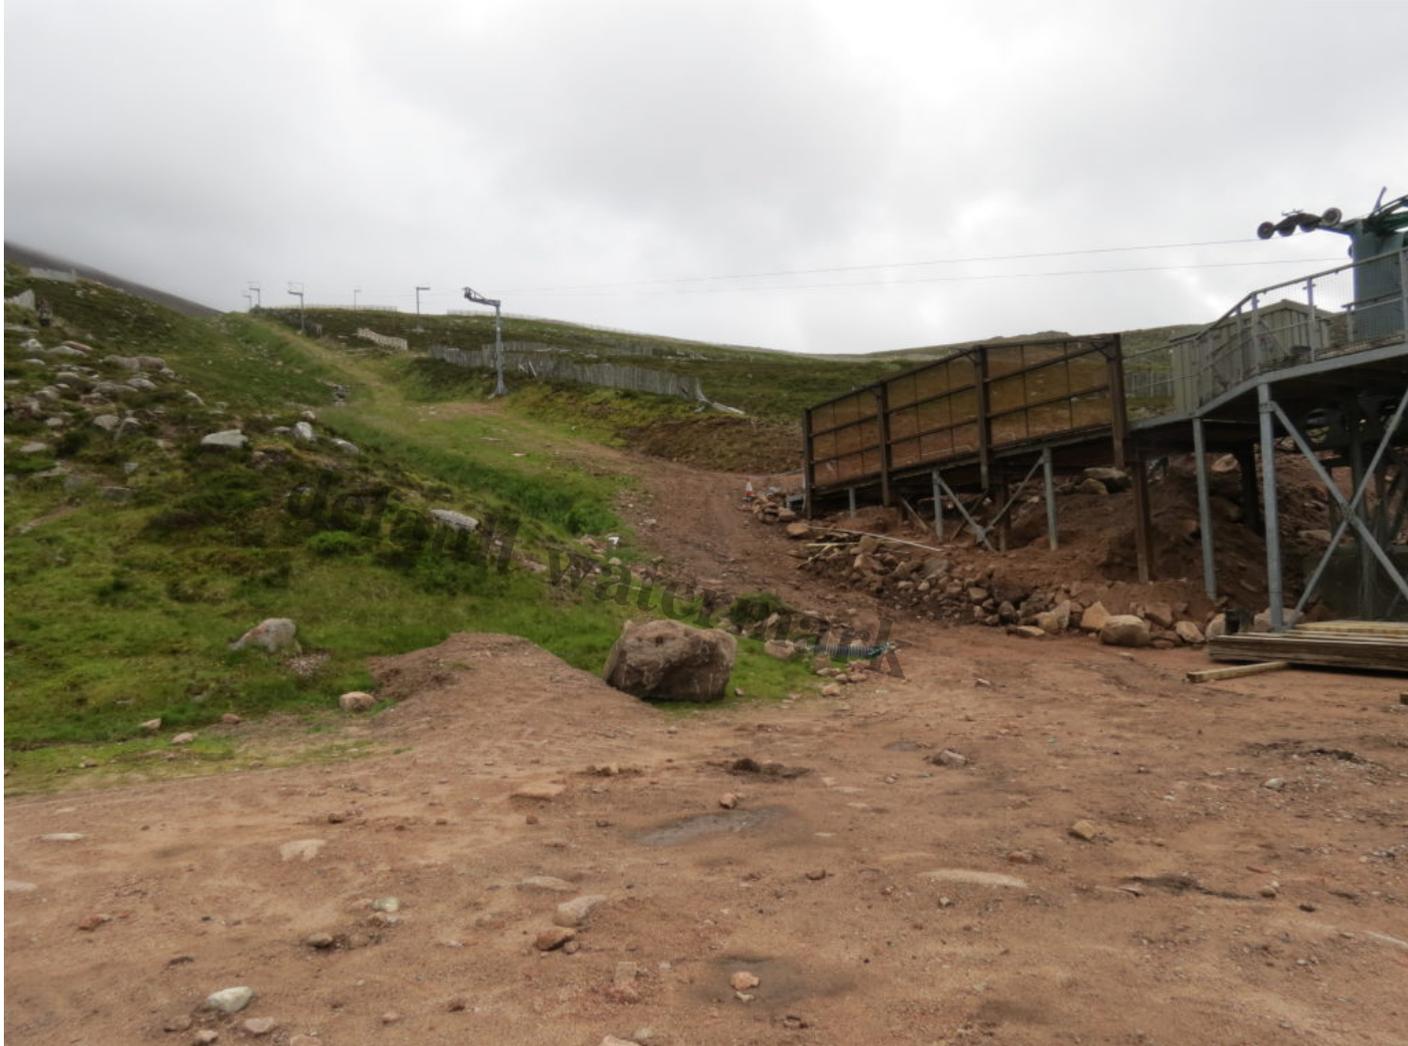
The new Cas Gantry, replaced last year – planning permission was waived because it was supposed to be an emergency (quite foreseeable because it had not been maintained) and works were supposed to be de minimis – ie so little that planning permission was not required.

Most of the spoil under the gantry previously featured on parkswatch is still there – you can judge for yourself whether this is –de minimis–. Is the spoil heap part of the –great success– that Natural Retreats claims to have had in –reprofiling– the old bulldozed tracks.

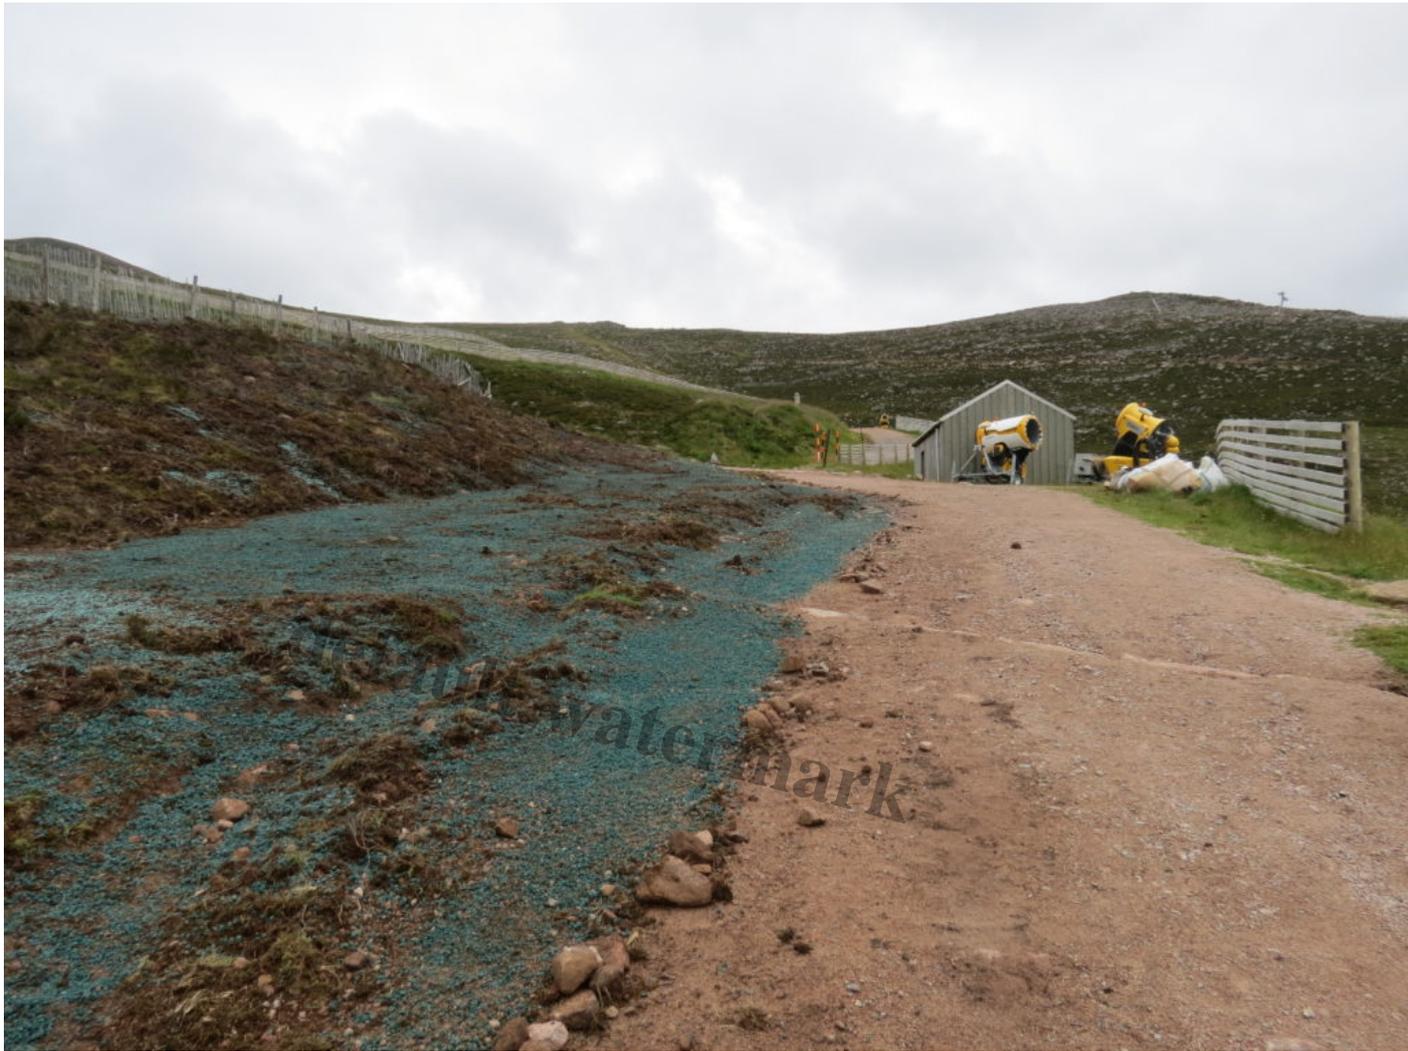
The track between the Coire Cas Gantry and the pumphouse at the bottom of the zig-zags.

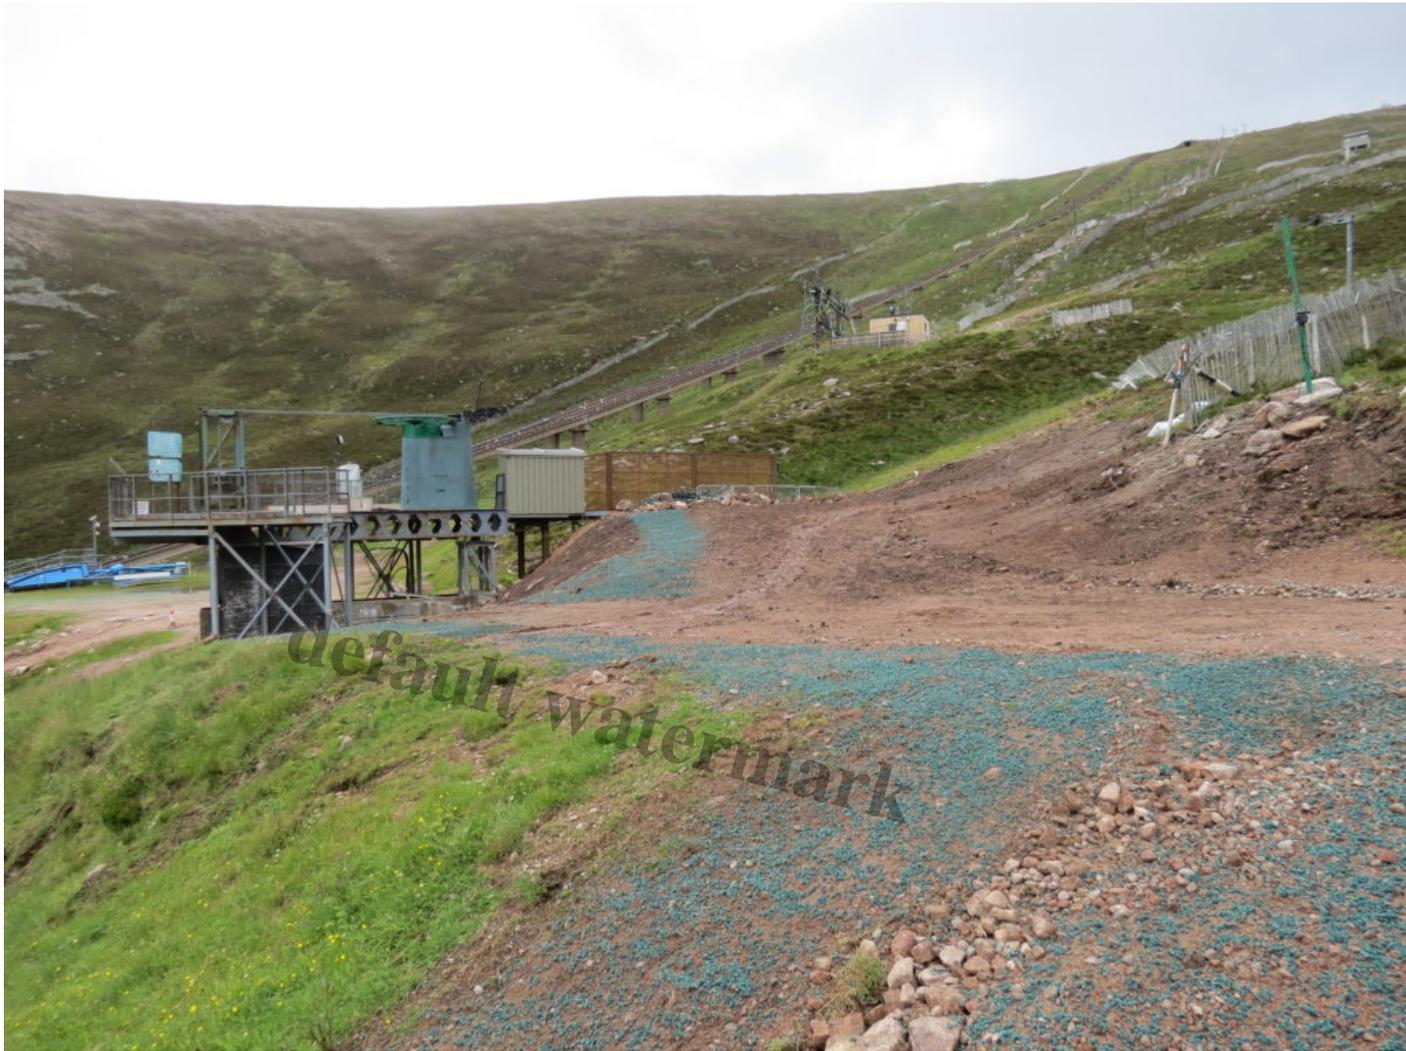
The track as it approaches the gantry with more reprofiled ground. There appears to have been no attempt to save existing vegetation.

The widening of the track at the bottom of the zig zags to the gantry was also allowed without planning permission on a ‘de minimis’ basis. It is likely to increase the speed of skiers just as they approach the top of the Car Park t-bar where other skiers are dismounting increasing the risk of accidents. The rationale in skiing terms for broadening this piece of track was highly questionable and is likely to increase the number of accidents. It raises more questions about Natural Retreats and HIE’s fitness to manage the ski area. As for Natural Retreats claims that the restoration has been a great success, again you can judge for yourself – at best I think one could say its far too early to tell.

- Second, HIE and Natural Retreats should pay for an independent ecological survey to document the extent of the destruction and set out options for restoration of the damaged areas (both the piste areas and the land outside these). I would like to see the land outside the pistes, including the banks, becoming part of a montane scrub project as a compensatory measure for the damage that has been done.
