## The CNPA is digging a deeper hole for itself at Cairngorm

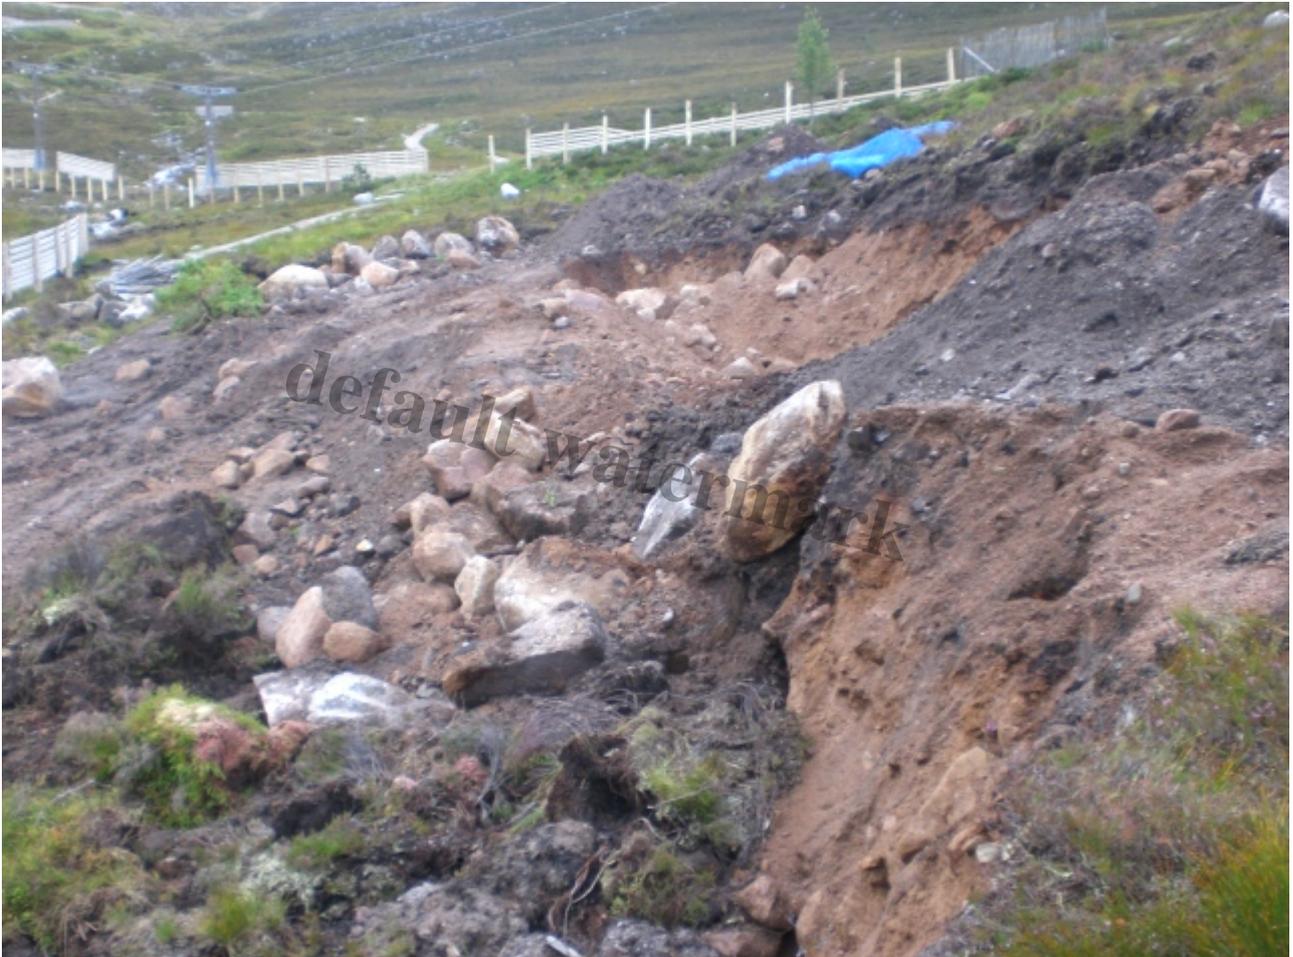
Photos of this hole and associated damage caused by Natural Retreats outwith the area granted planning consent was sent to Cairngorms National Park planners in early October a month after they were first alerted to the issues. Photo Credit Alan Bratney.

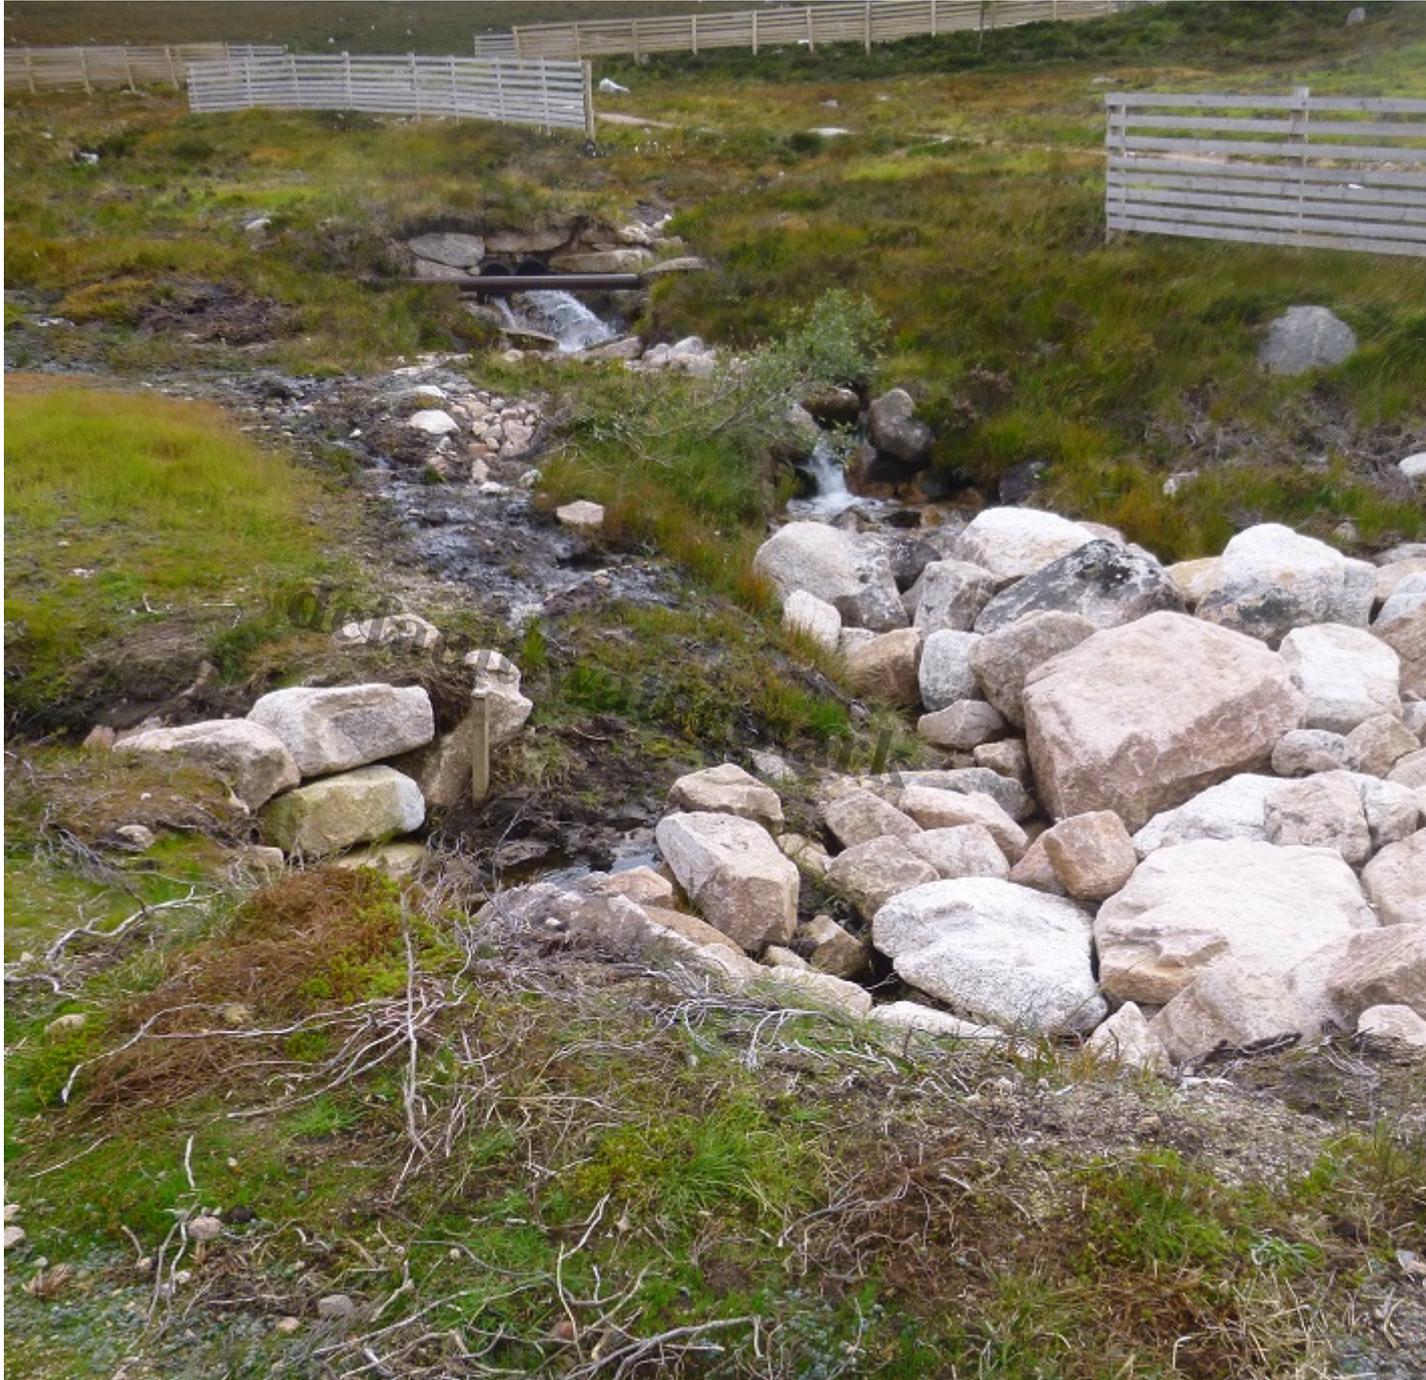
How does this fit in with the planning permission granted?

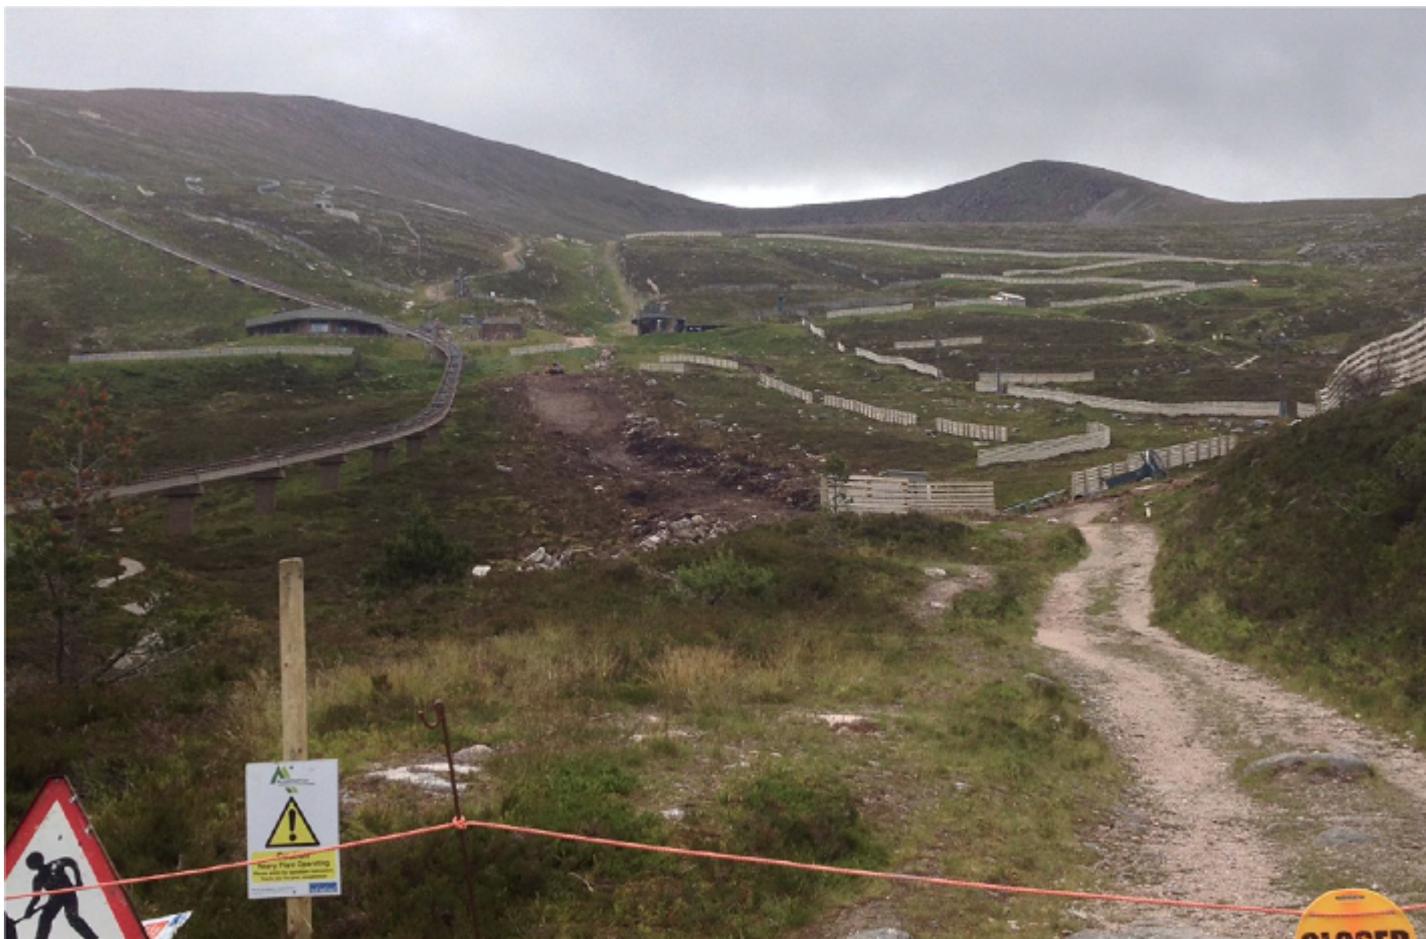
The bank on the right of the track was covered with vegetation when work on the Shieling Rope tow yet the CNPA claims it was eroding and appears to have used that claim as a justification for ignoring a serious breach of planning permission when Natural Retreats dug up this bank to make it look more natural (their words). Photo Credit Alan Mackay

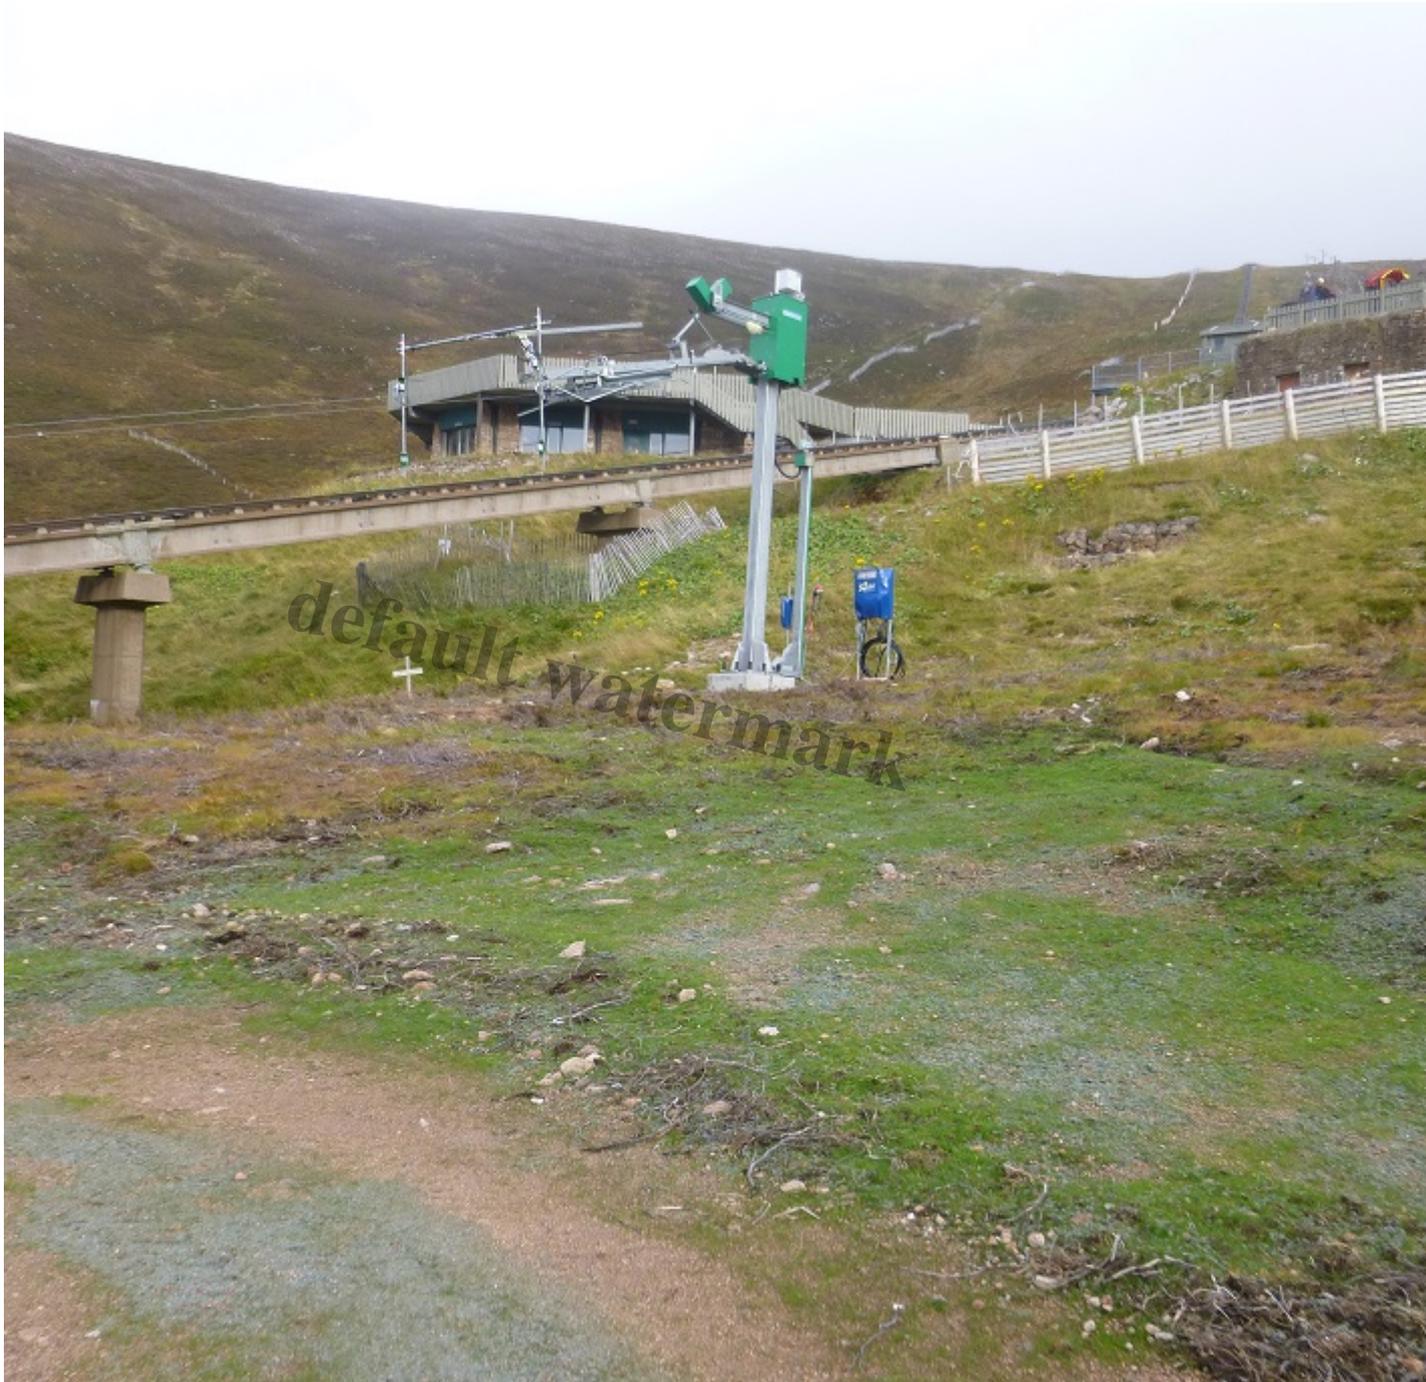
Extensive re-seeding near the top of the shieling rope tow showing how little vegetation restoration  
Credit Terry Smith

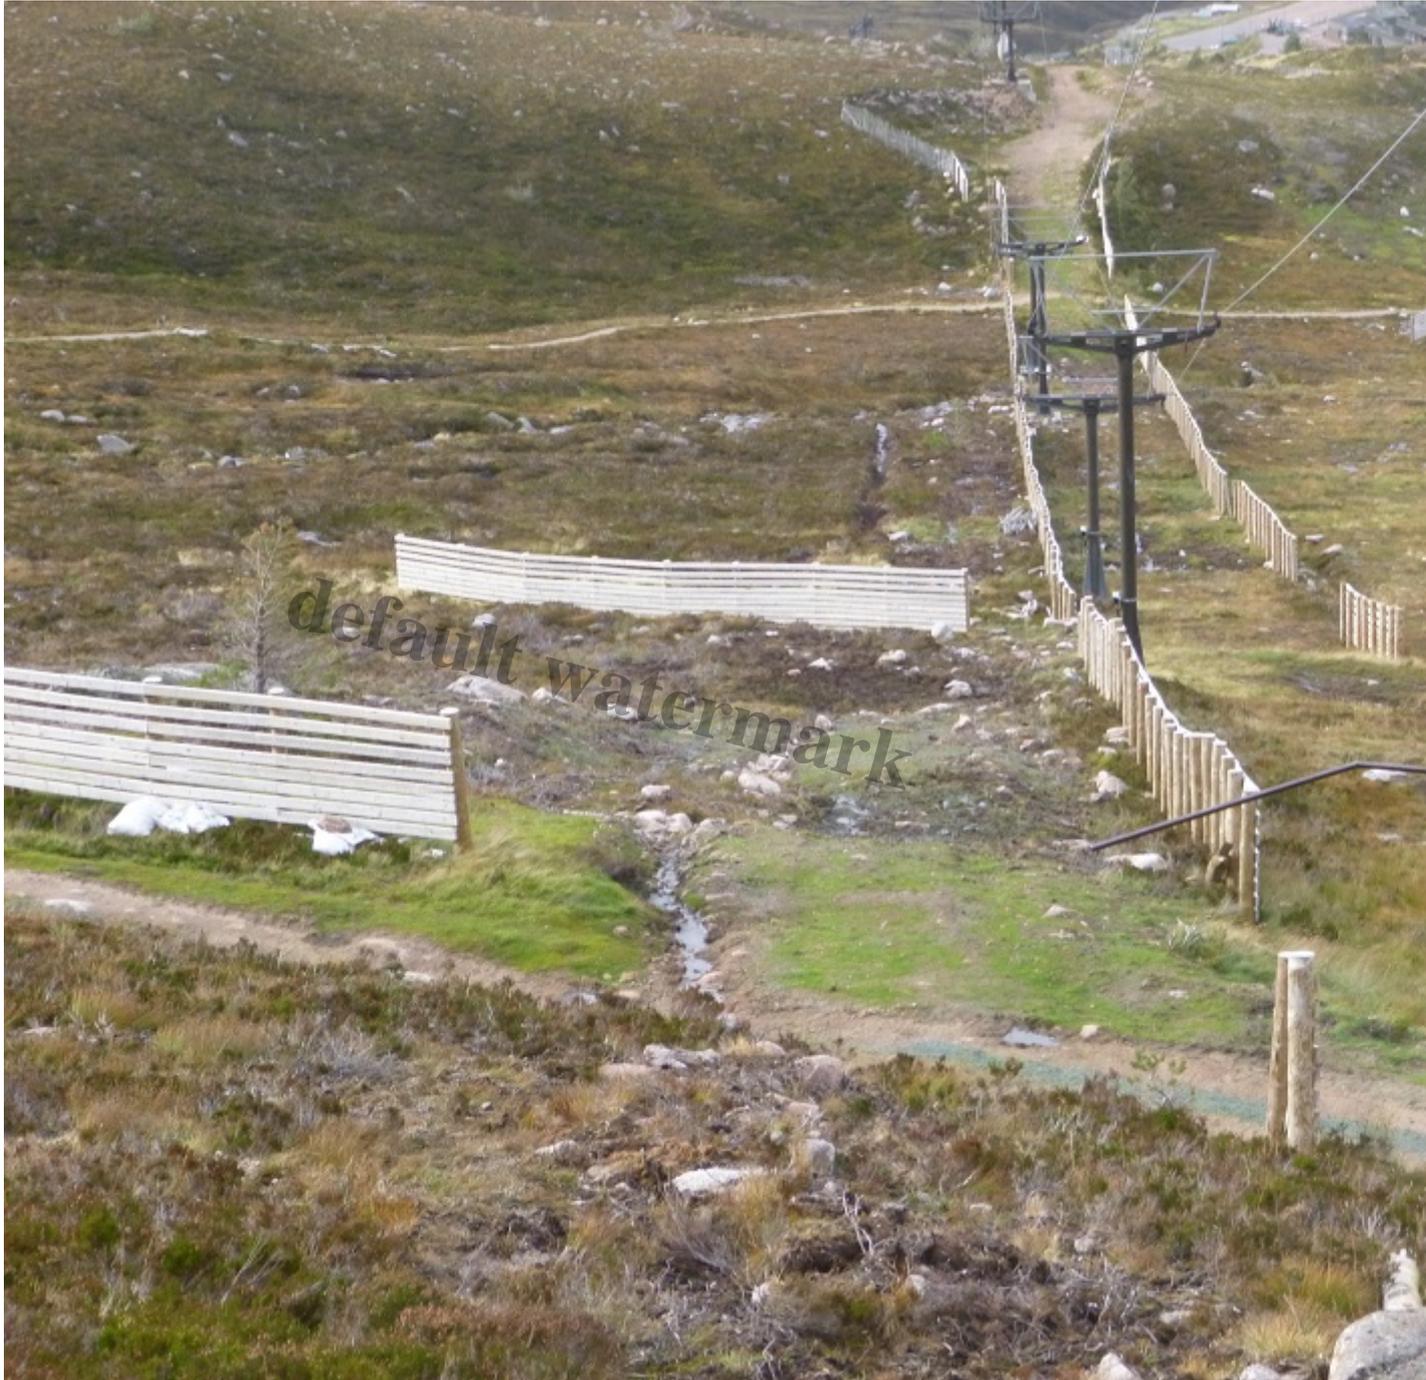
Re-seeding to the south of the car park t-bar well outside the zone granted planning permission. Par  
diggers working here â?? what were they doing and why? The re-seeding shows the extent of the da  
Smith

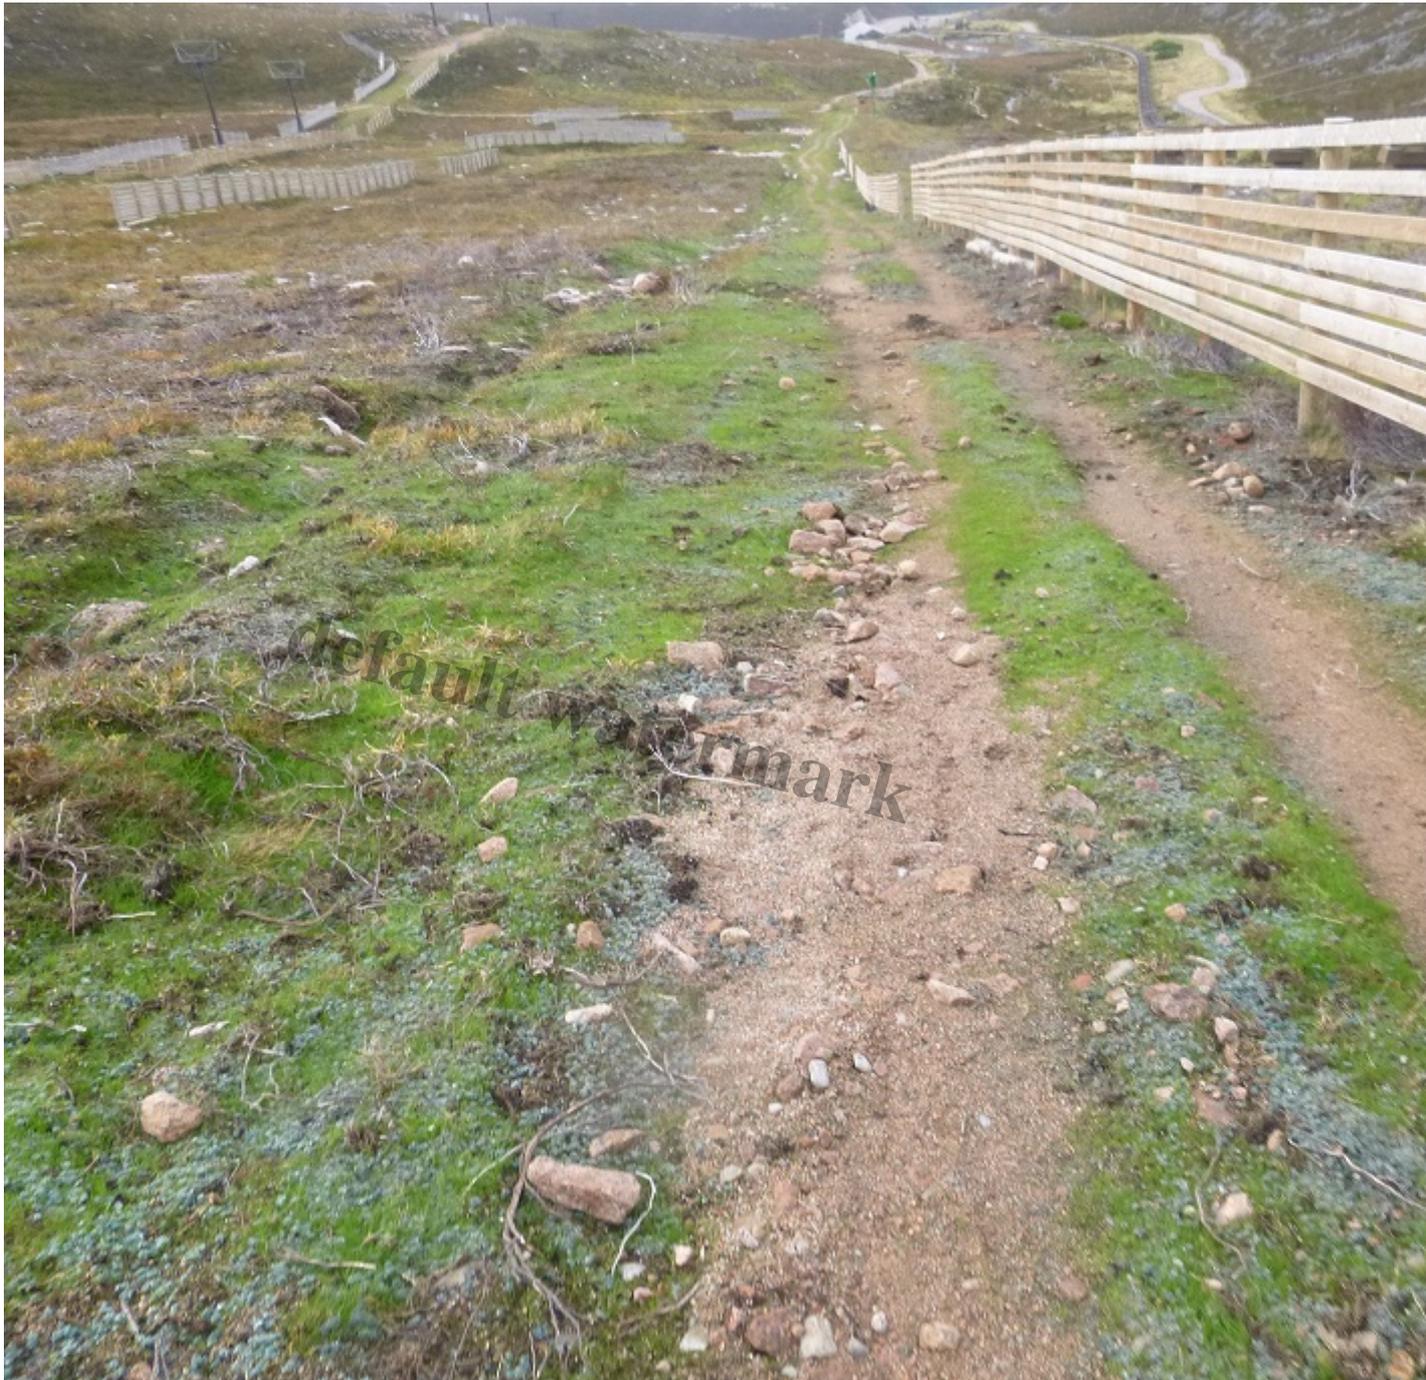
The steeper top half of the shieling track erodes each time there is a storm because its too steep and the track washes onto the surrounding re-seeded area Photo Credit Terry Smith

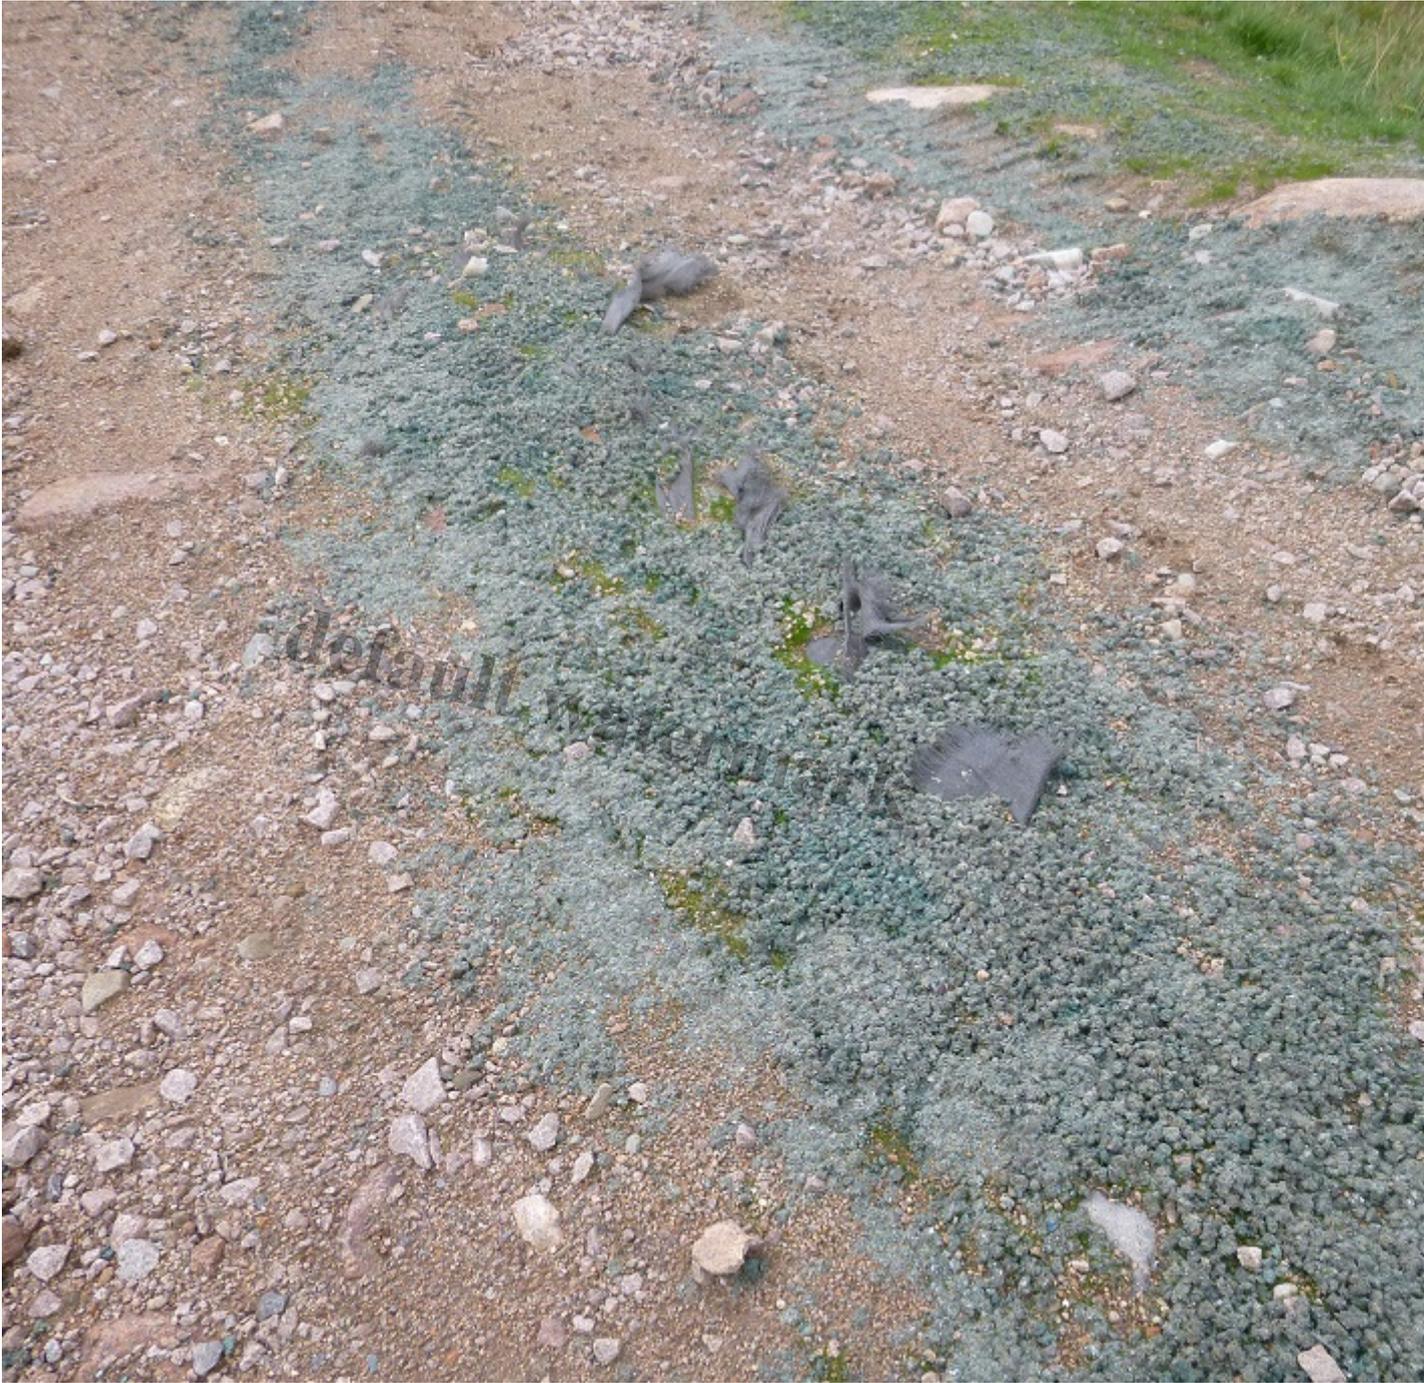
Is this high quality restoration work?

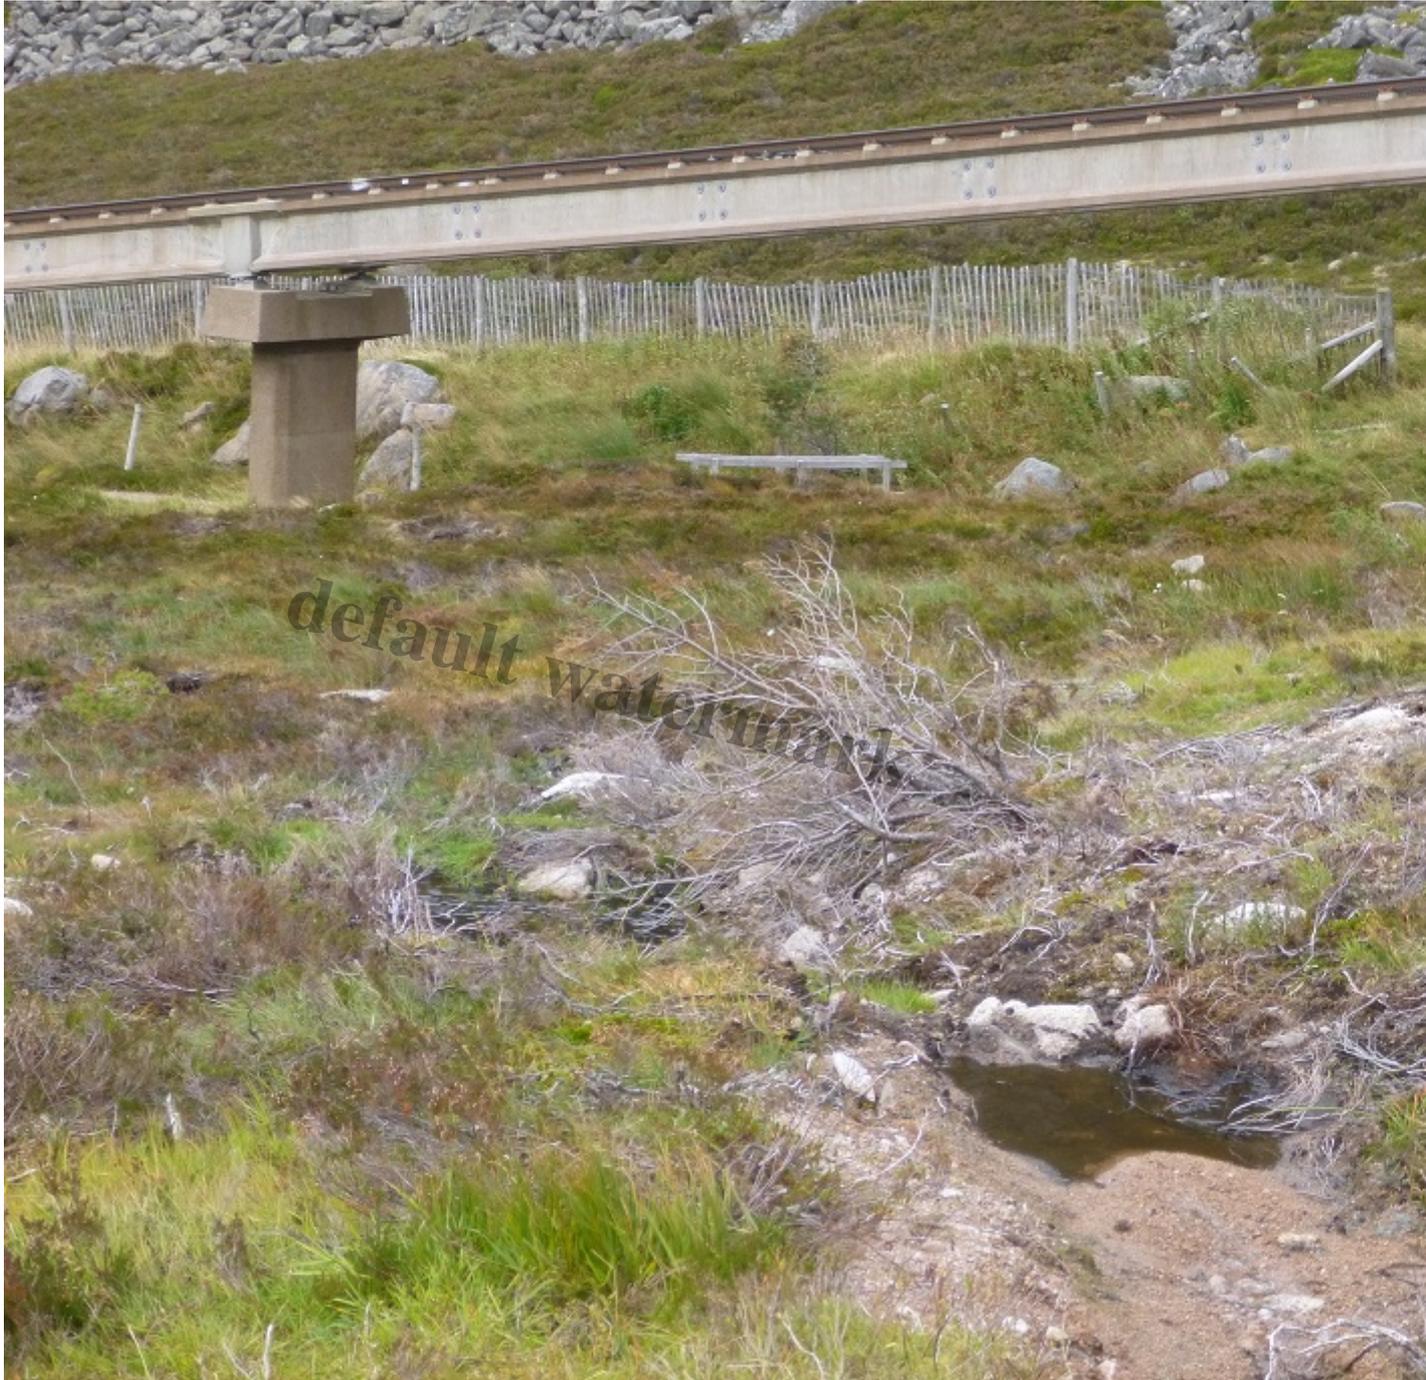
The ecological assessment makes no reference to the number of trees killed by Natural Retreats or out with diggers leaving holes across the bottom half of the slope Photo Credit Terry Smith

The one positive suggestion in the assessment is that “there is a good opportunity to plant Dwarf Willow, Birch and Scots Pine on the re-graded bank” but why only here? As I have argued previously, one way to compensate for the extensive destruction would be for the CNPA to require Natural Retreats to employ a properly qualified contractor to plant montane scrub across the area.

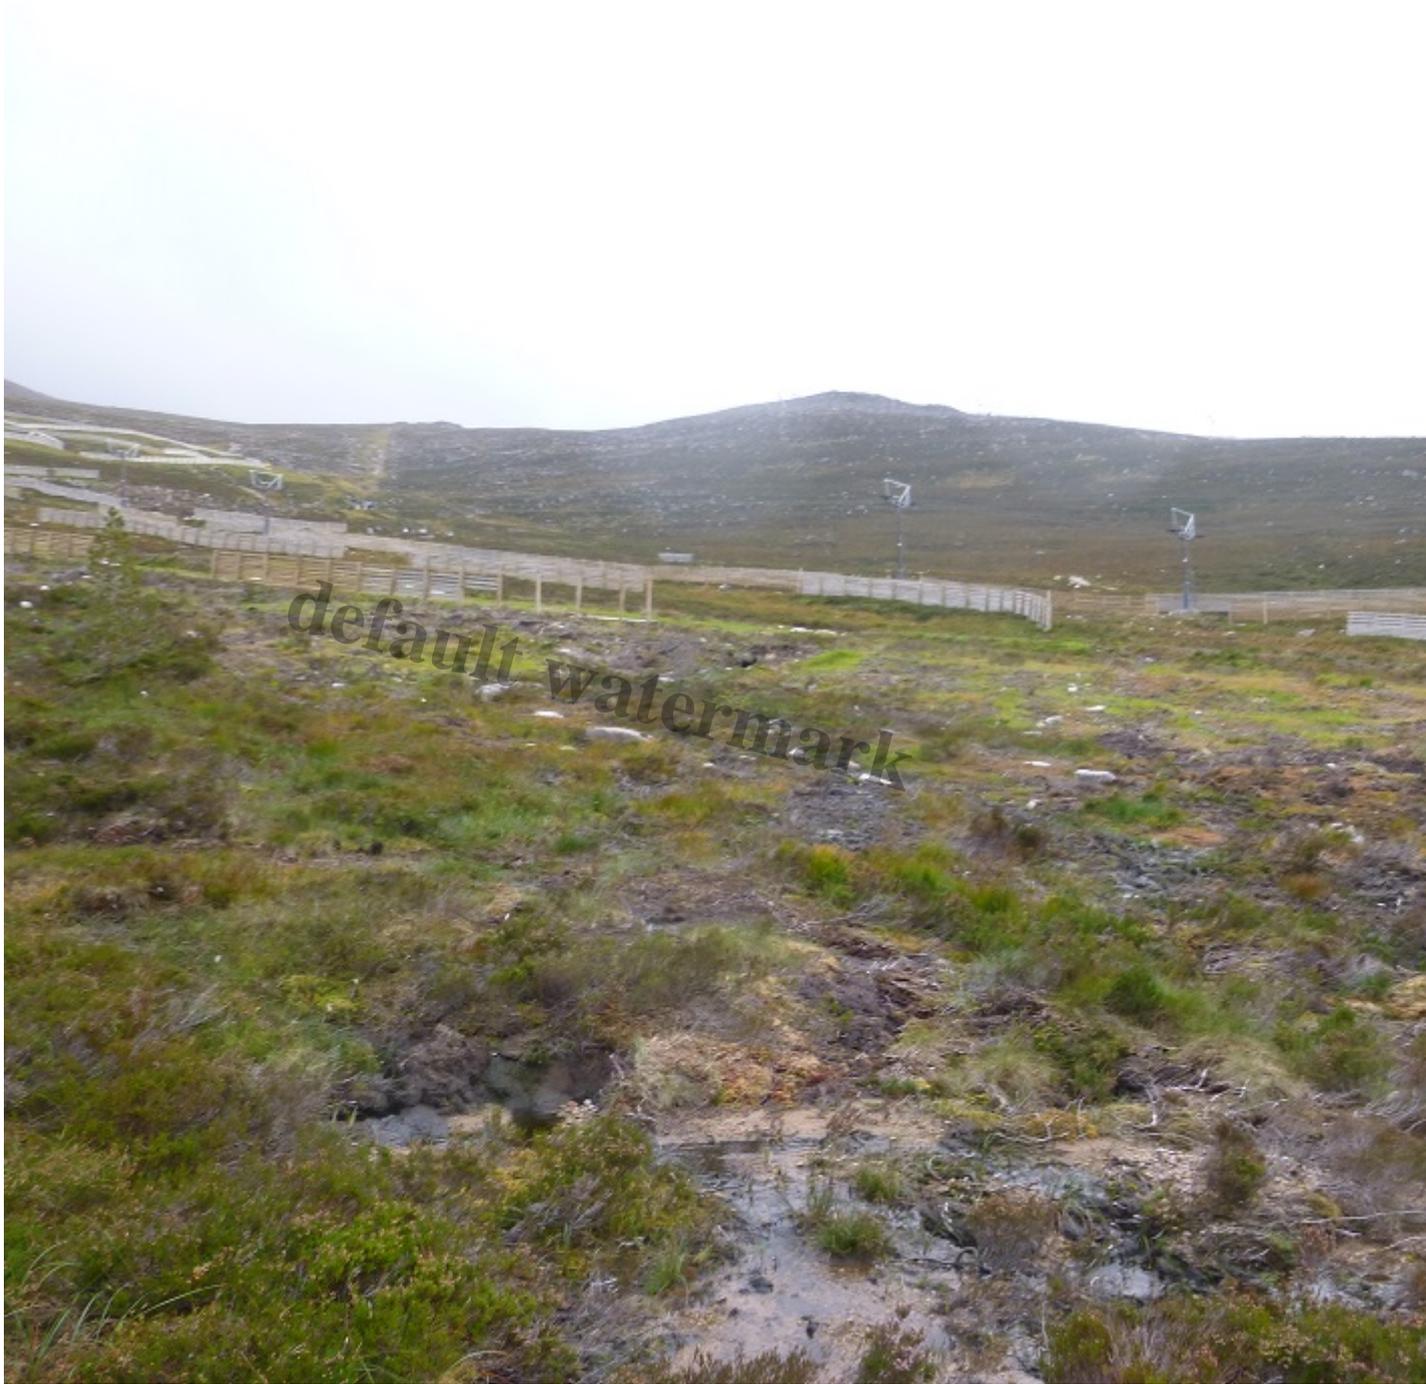
The ecological assessment contains no reference to the quagmire that has been created by diggers scooping holes out of the vegetation to “restore” the ski slope behind Photo Credit Terry Smith

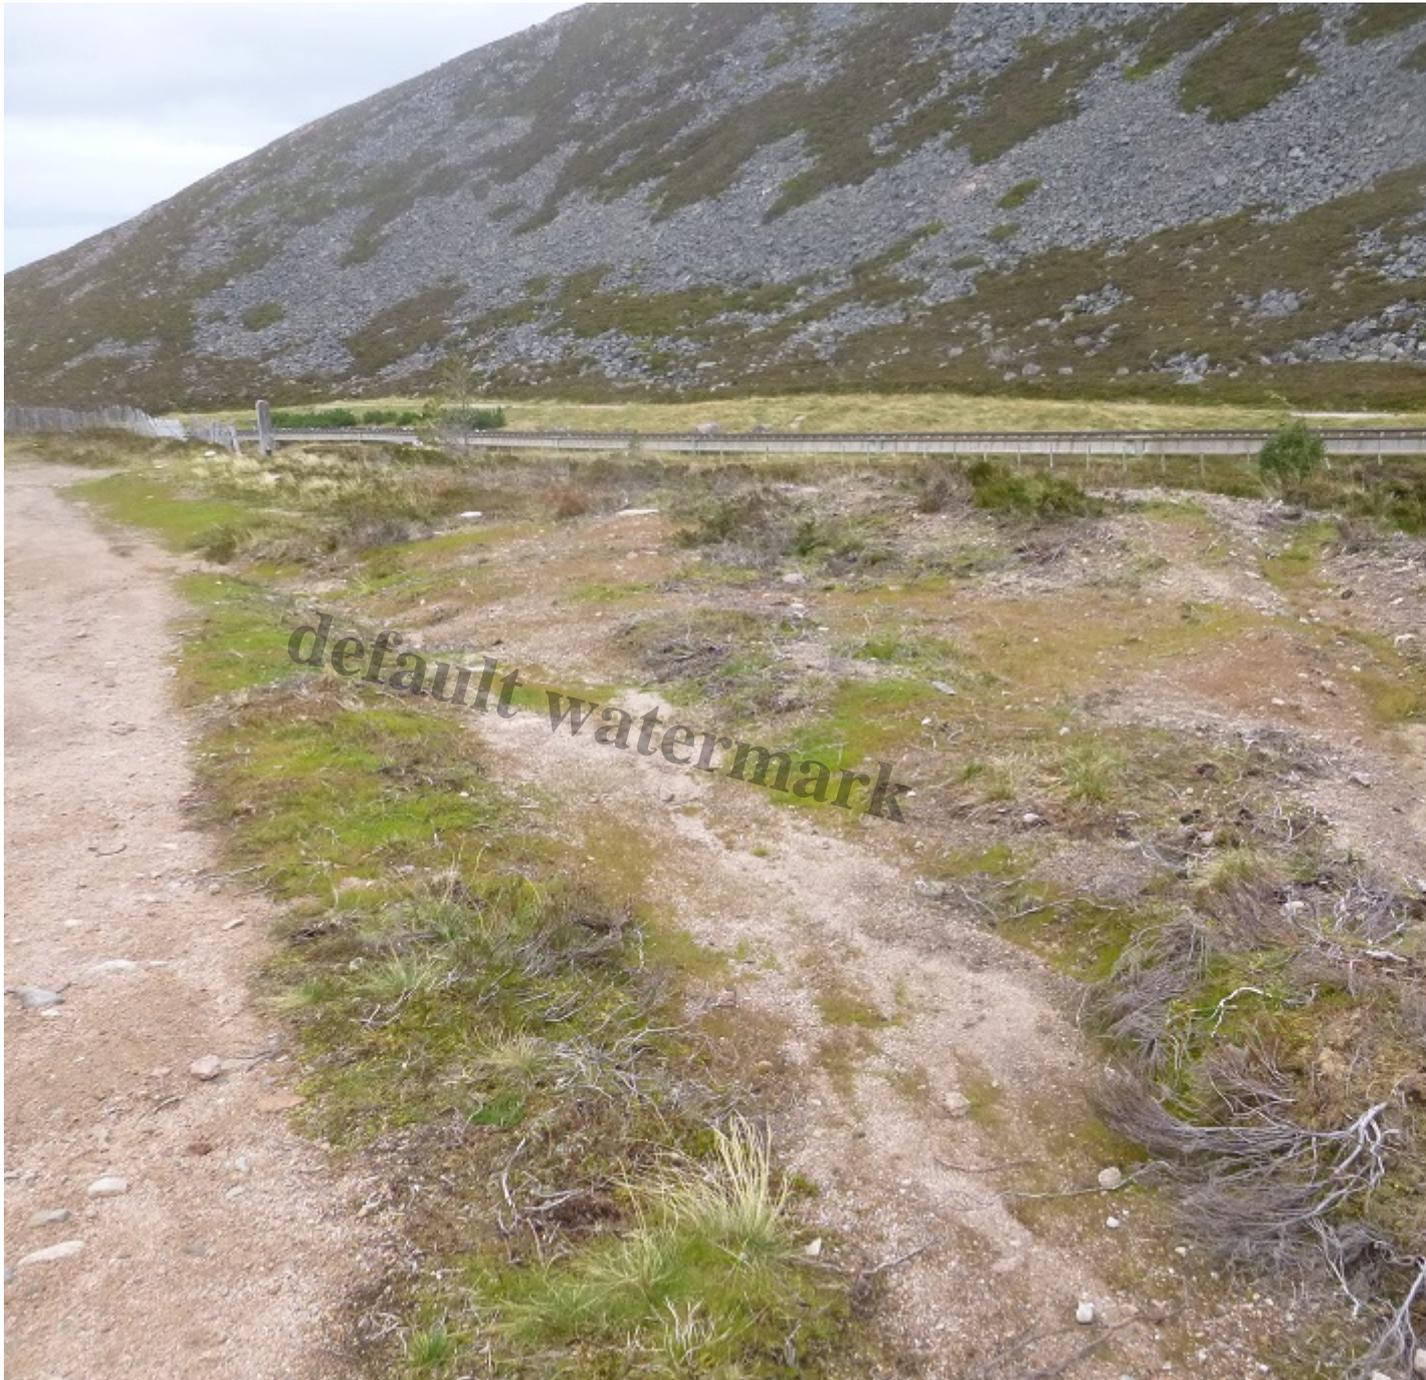
Th ecological assessment makes no reference to all the granite gravel that has washed off the lower surrounding ground. Again the extent of destruction of the vegetation is striking. Photo Credit Terry S
