The CNPA is digging a deeper hole for itself at Cairngorm

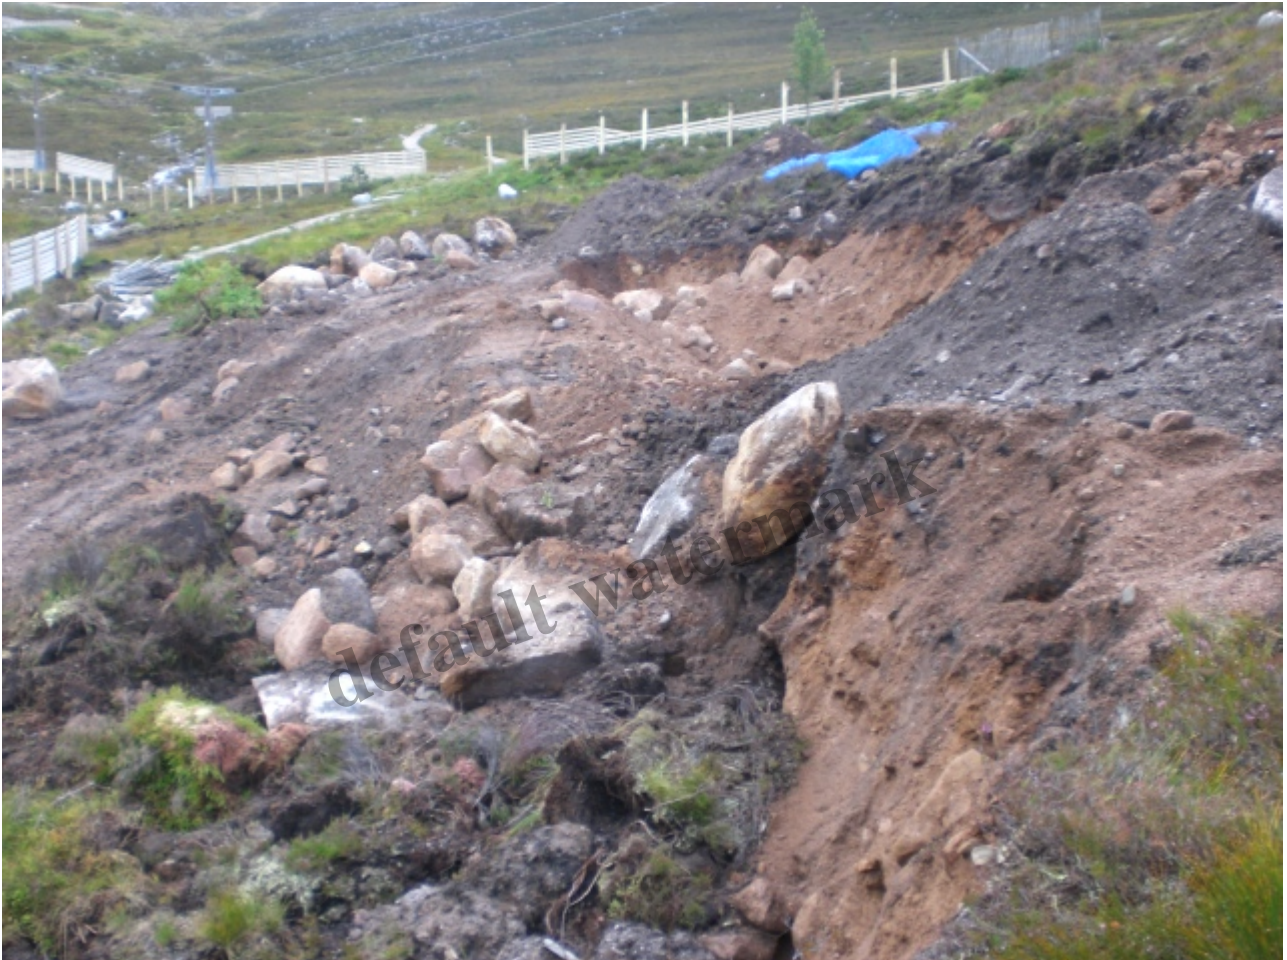
Photos of this hole and associated damage caused by Natural Retreats outwith the area granted planning consent was sent to Cairngorms National Park planners in early October a month after they were first alerted to the issues. Photo Credit Alan Bratney.

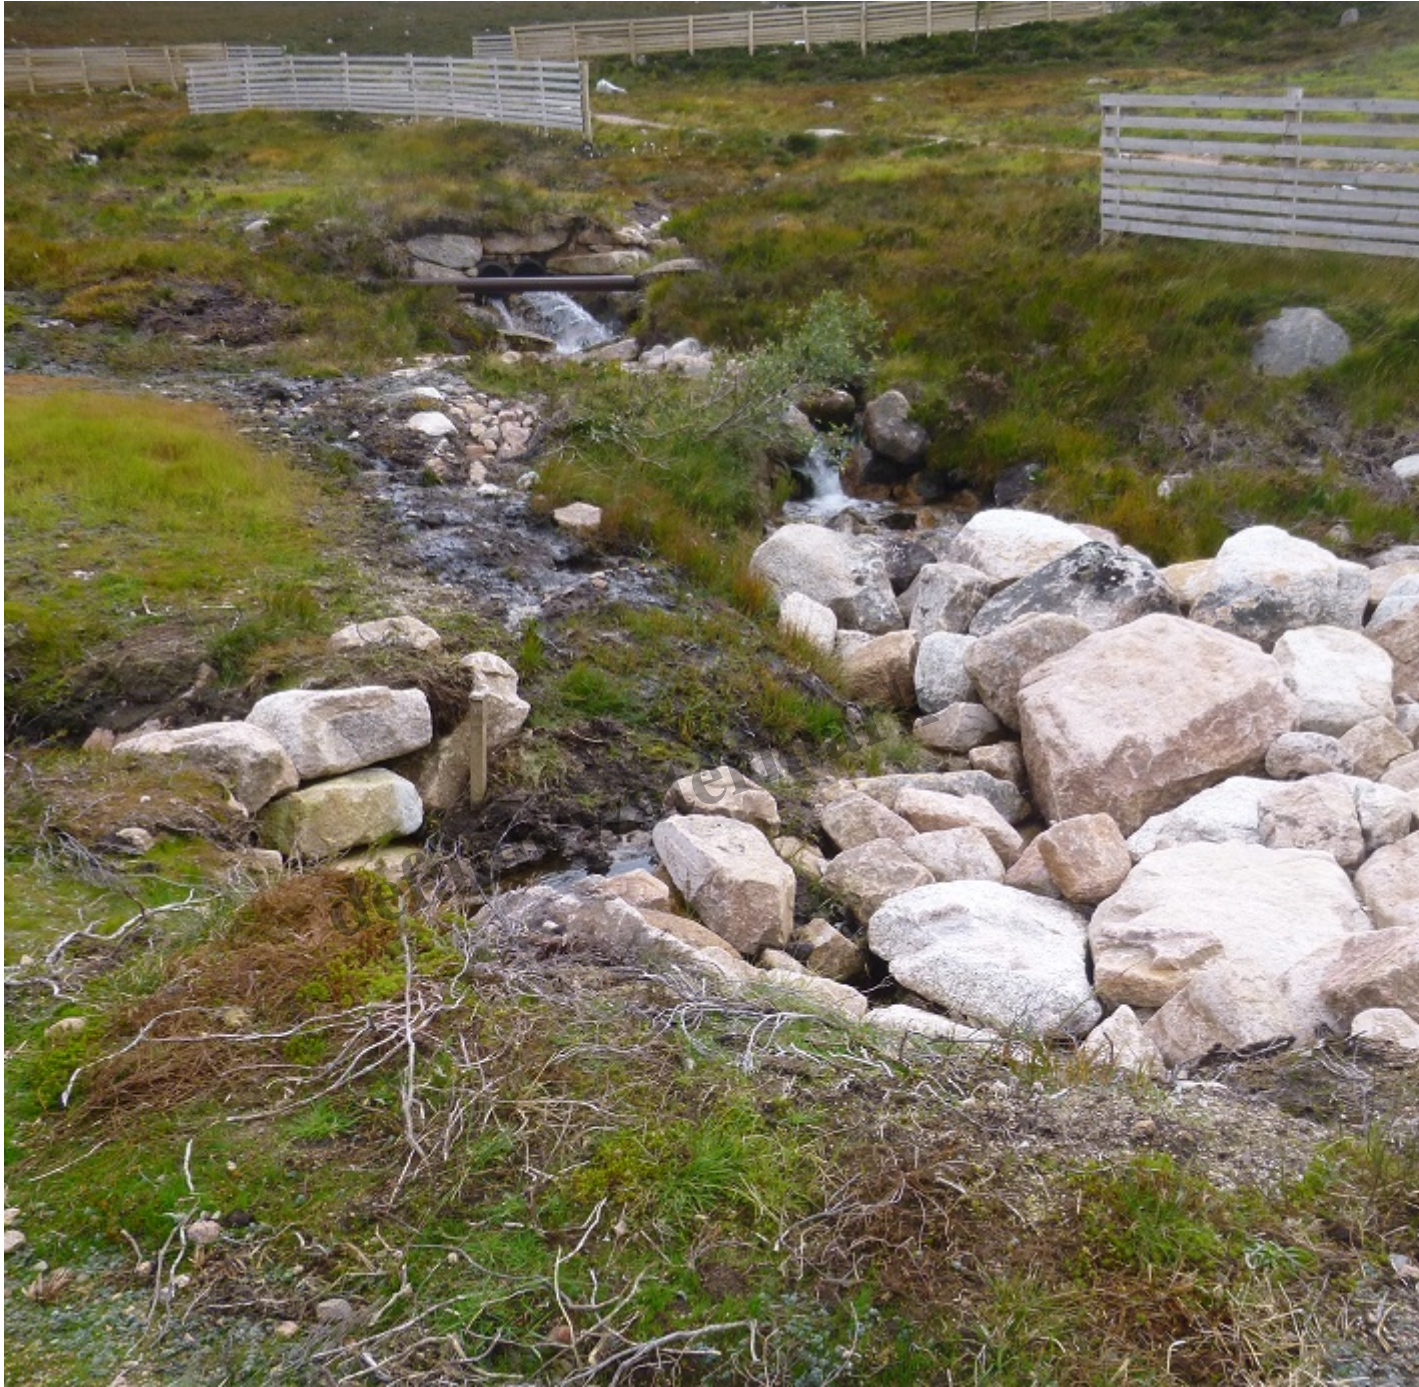
How does this fit in with the planning permission granted?

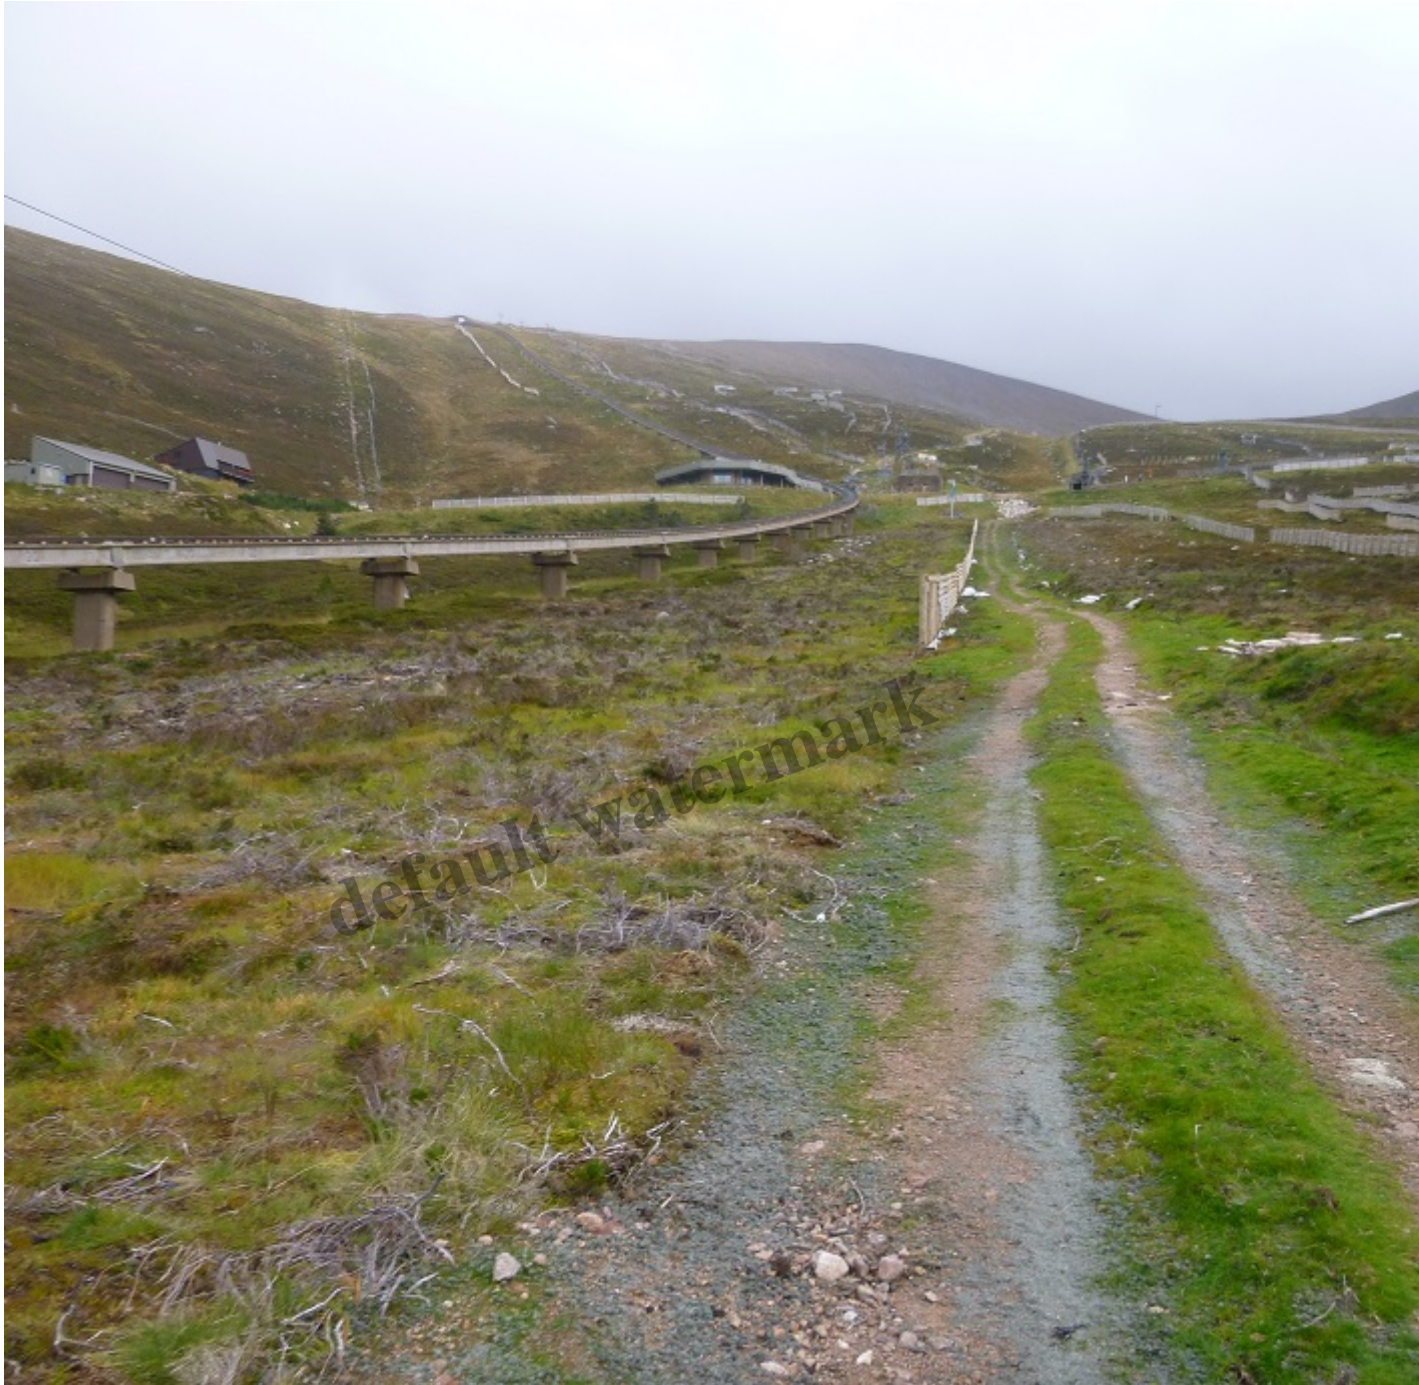
Half exposed pipes seem of no concern to the CNPA's landscape adviser

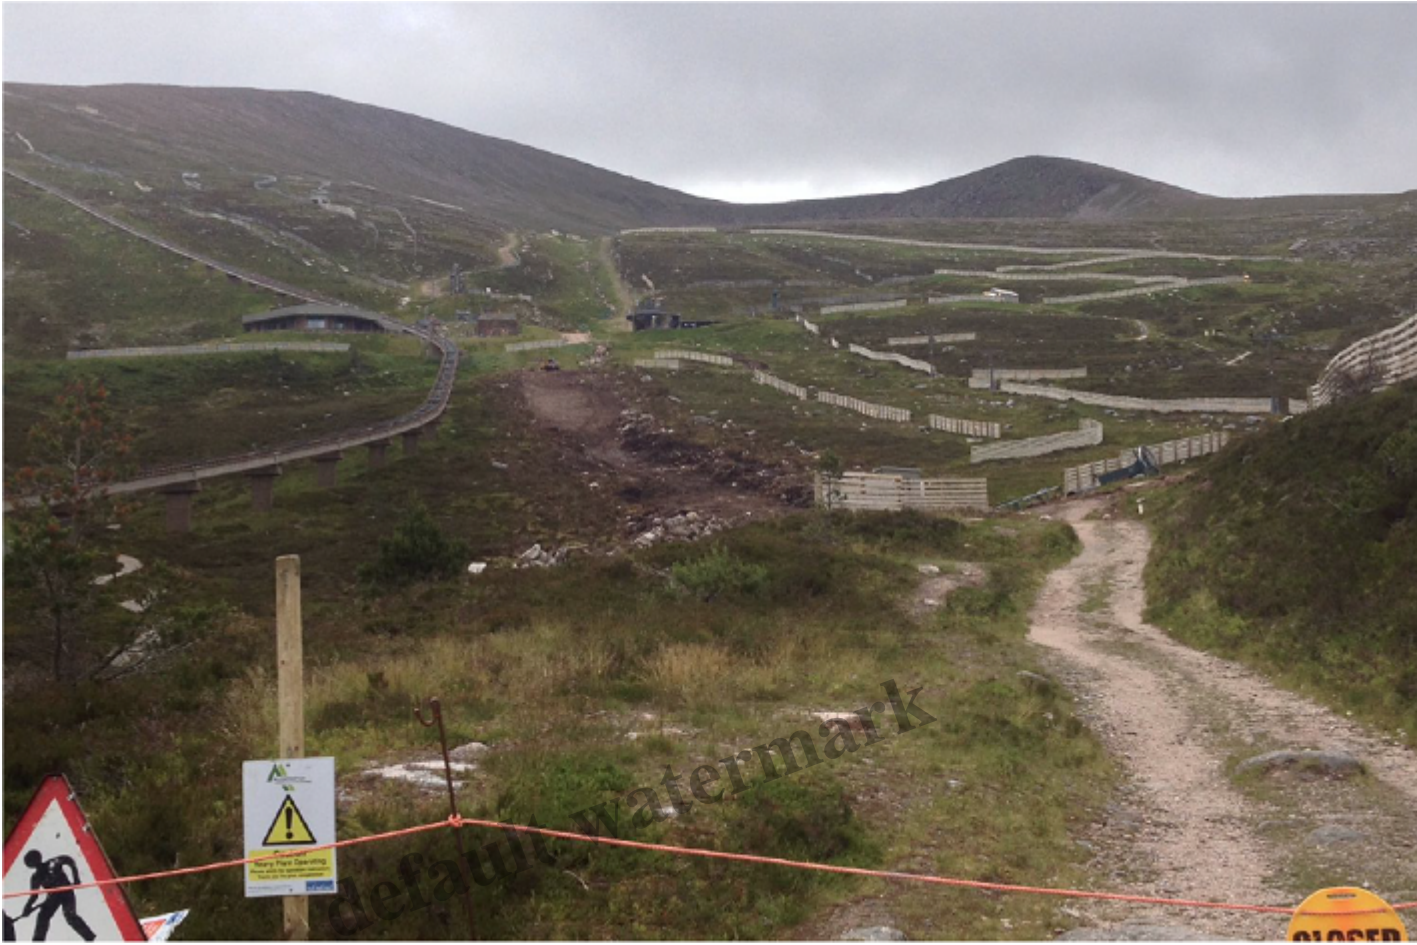
This is wrong, there was no erosion previously as this photo from Alan Mackay's response shows:

The bank on the right of the track was covered with vegetation when work on the Shieling Rope tow started yet the CNPA claims it was eroding and appears to have used that claim as a justification for ignoring a serious breach of planning permission when Natural Retreats dug up this bank “to make it more natural” (their words). Photo Credit Alan Mackay

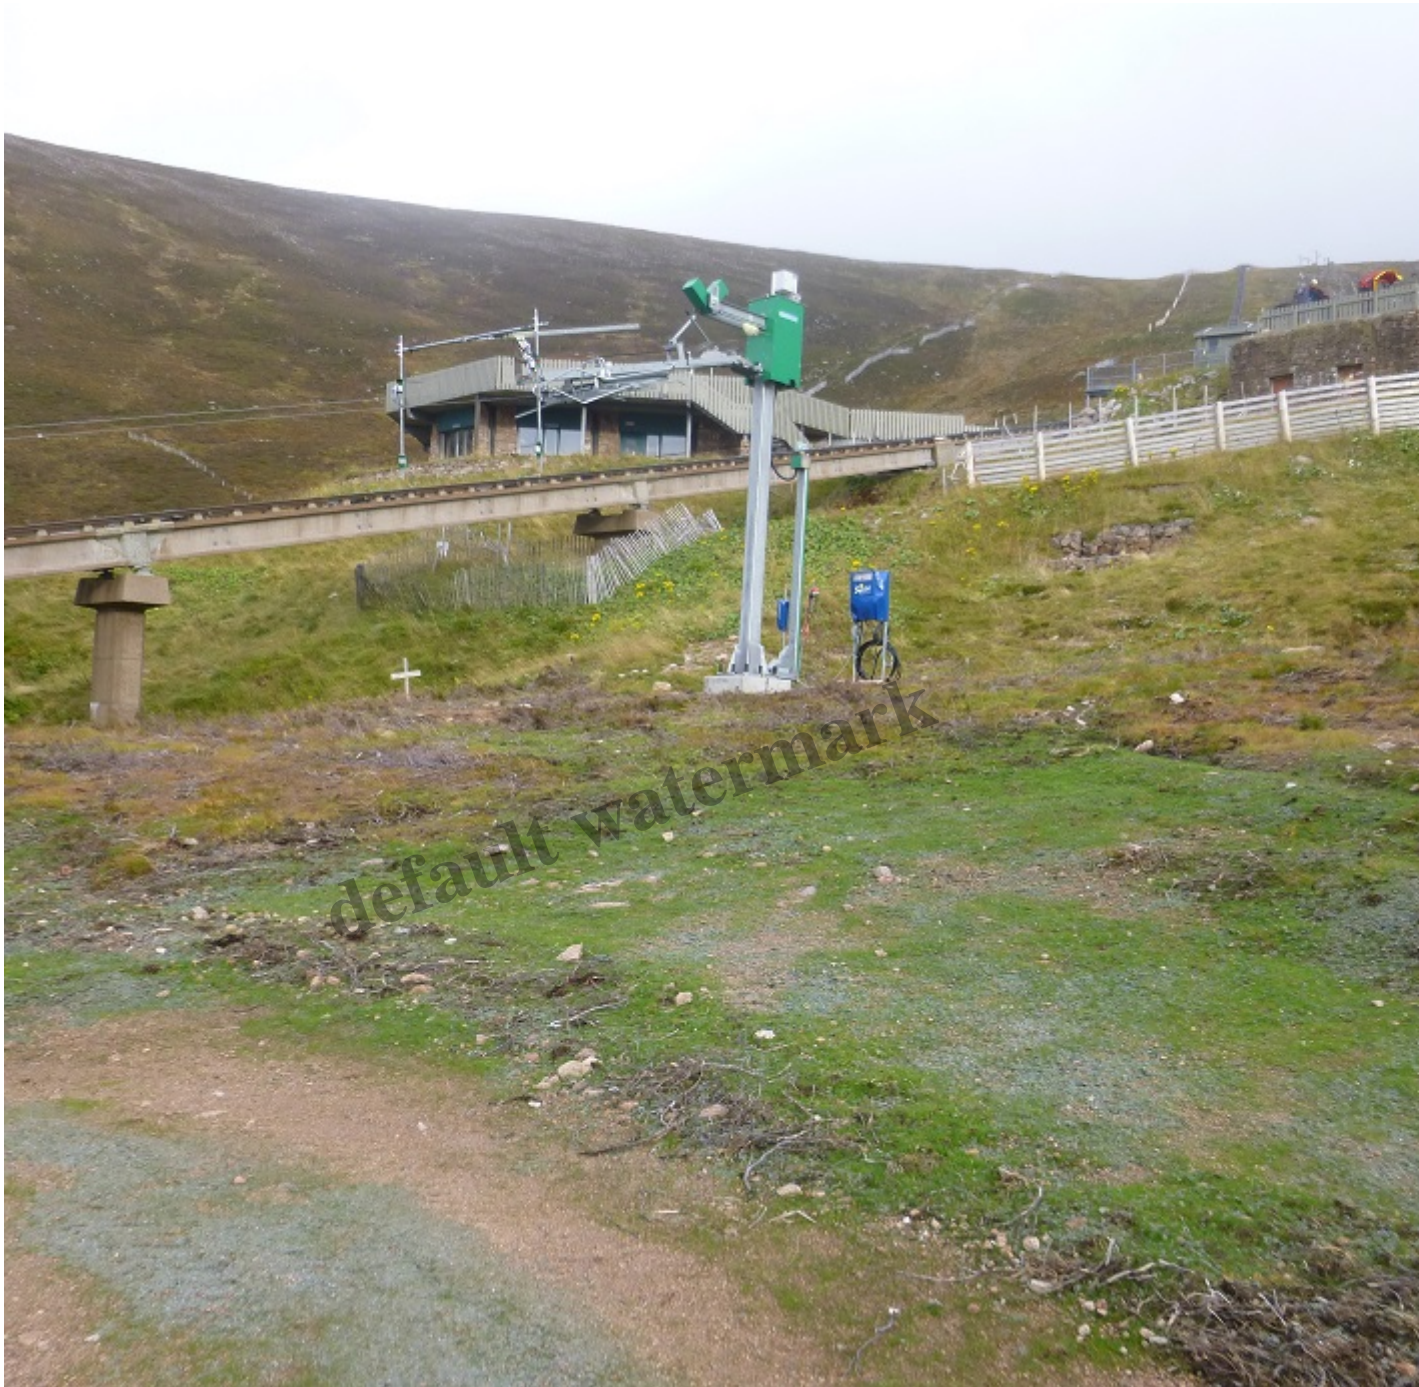
Extensive re-seeding near the top of the shieling rope tow – showing how little vegetation restoration
Credit Terry Smith

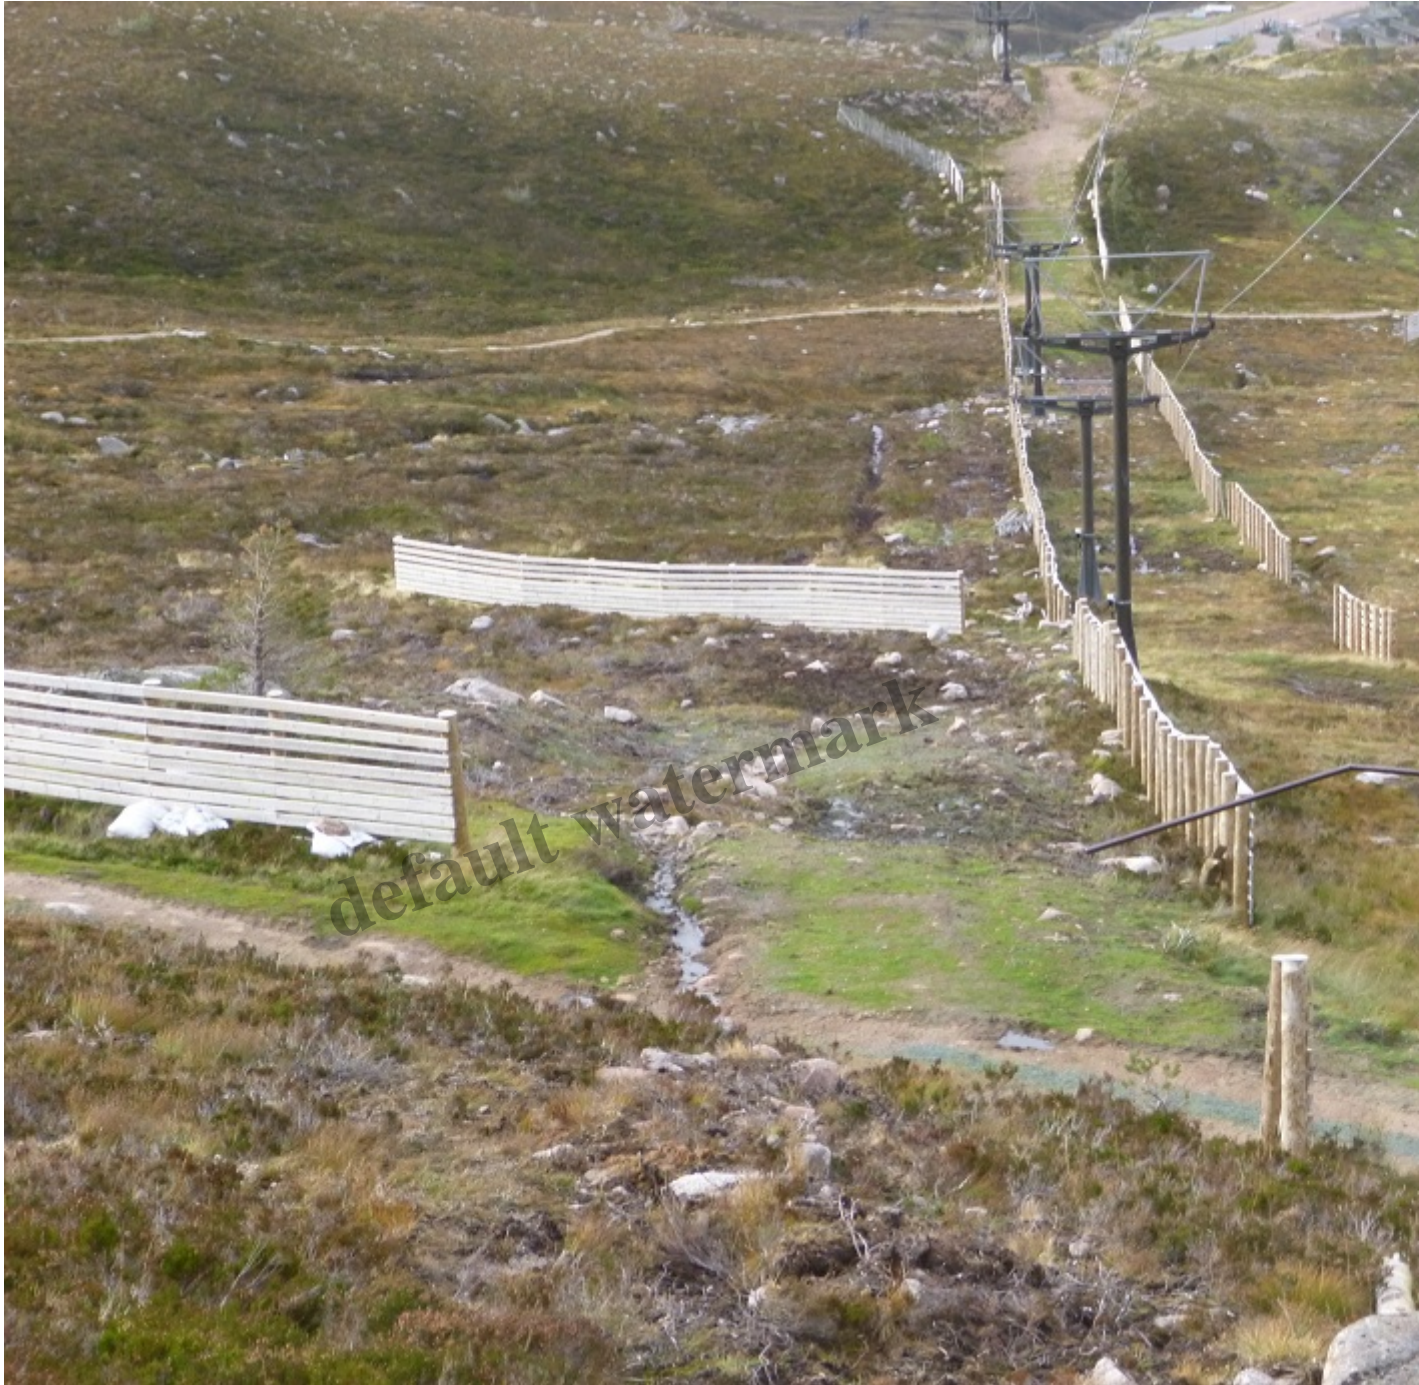
Re-seeding to the south of the car park t-bar well outside the zone granted planning permission. Par diggers working here – what were they doing and why? The re-seeding shows the extent of the dam Smith

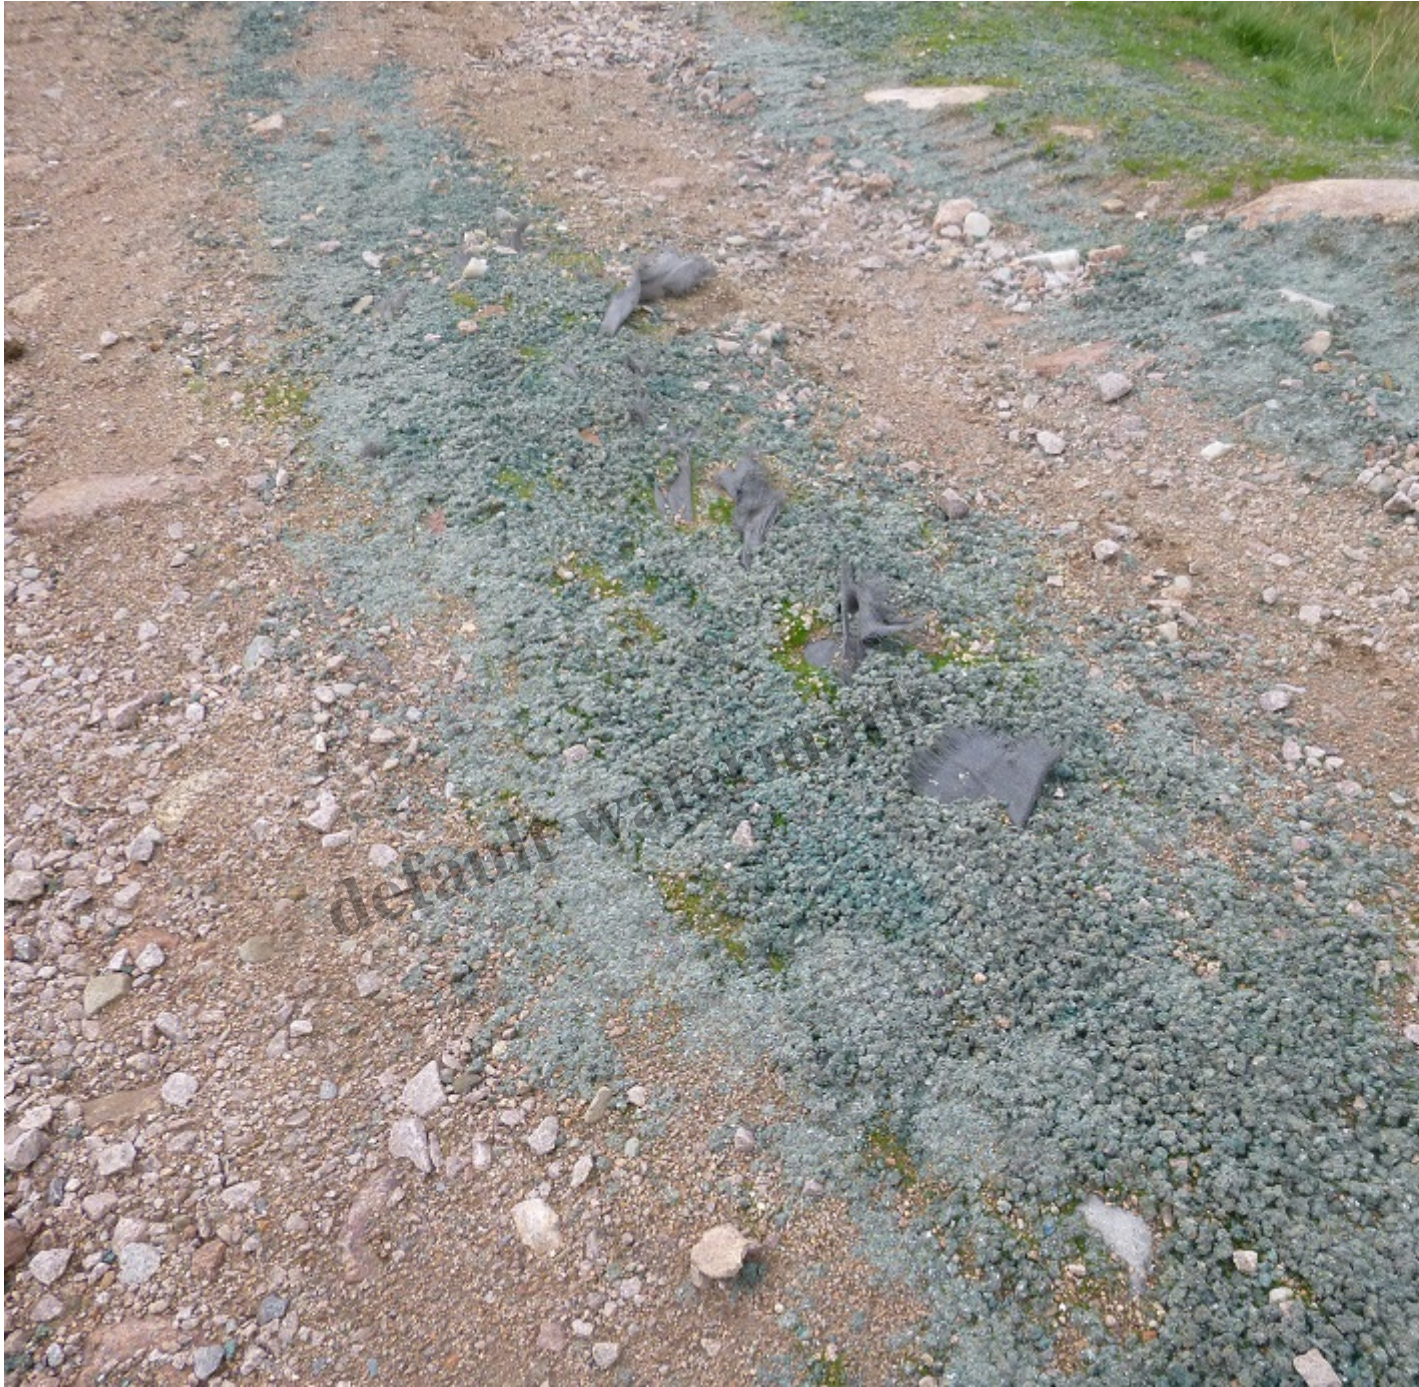
Is this high quality restoration work?

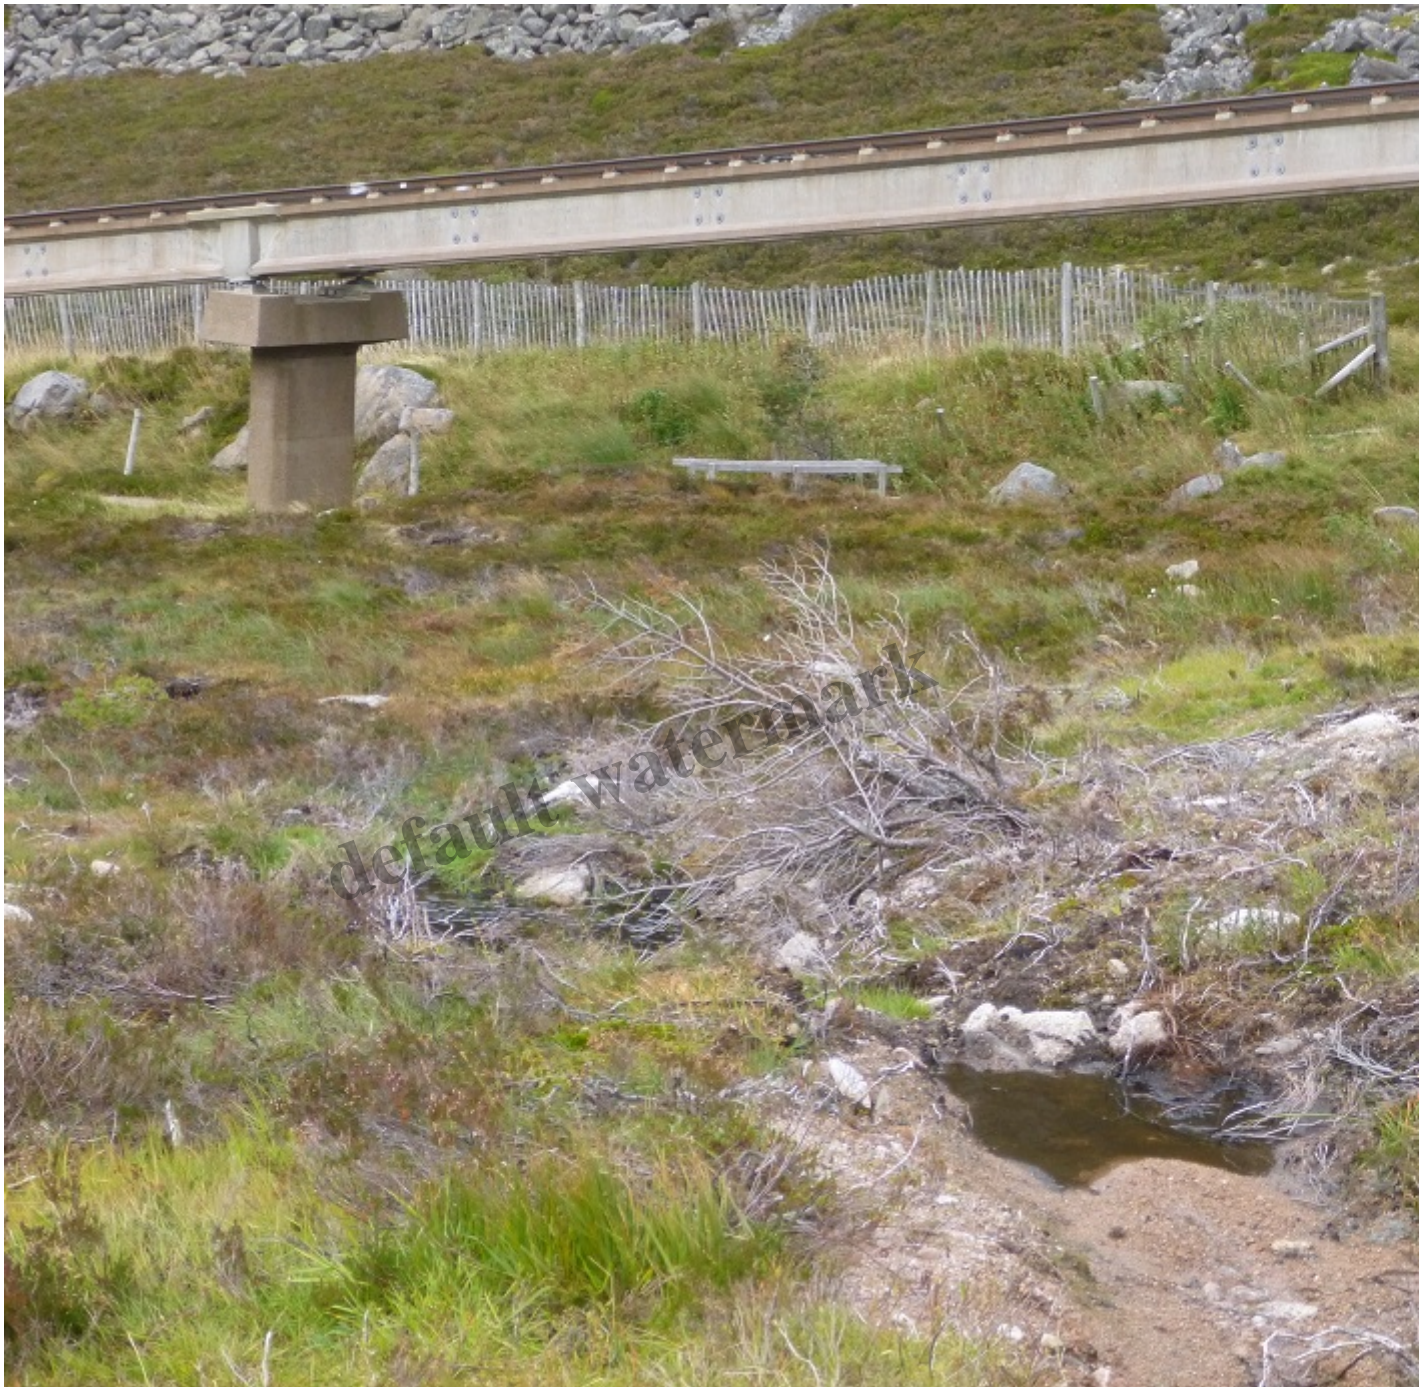
The ecological assessment makes no reference to the number of trees killed by Natural Retreats or out with diggers leaving holes across the bottom half of the slope Photo Credit Terry Smith

The one positive suggestion in the assessment is that “there is a good opportunity to plant Dwarf Willow, Birch and Scots Pine on the re-graded bank” but why only here? As I have argued previously, one way to compensate for the extensive destruction would be for the CNPA to require Natural Retreats to employ a properly qualified contractor to plant montane scrub across the area.

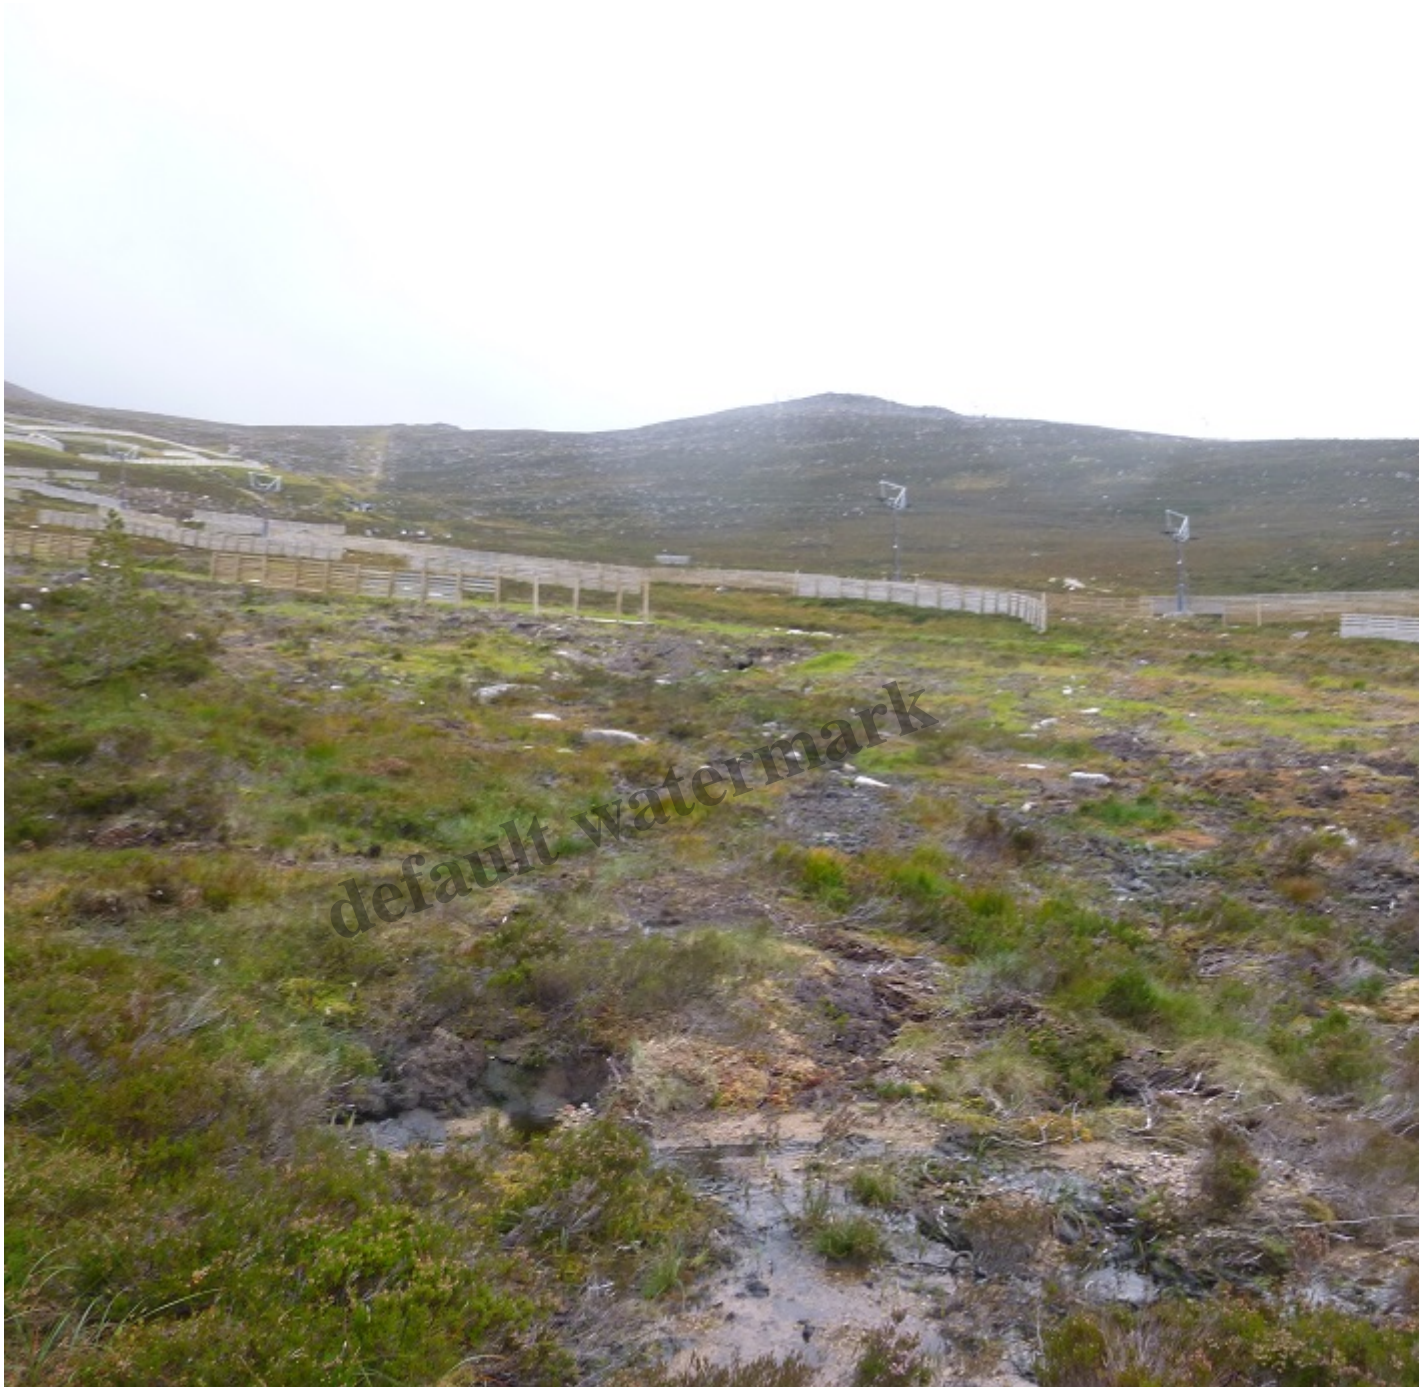
The ecological assessment contains no reference to the quagmire that has been created by diggers scooping holes out of the vegetation to “restore” the ski slope behind Photo Credit Terry Smith

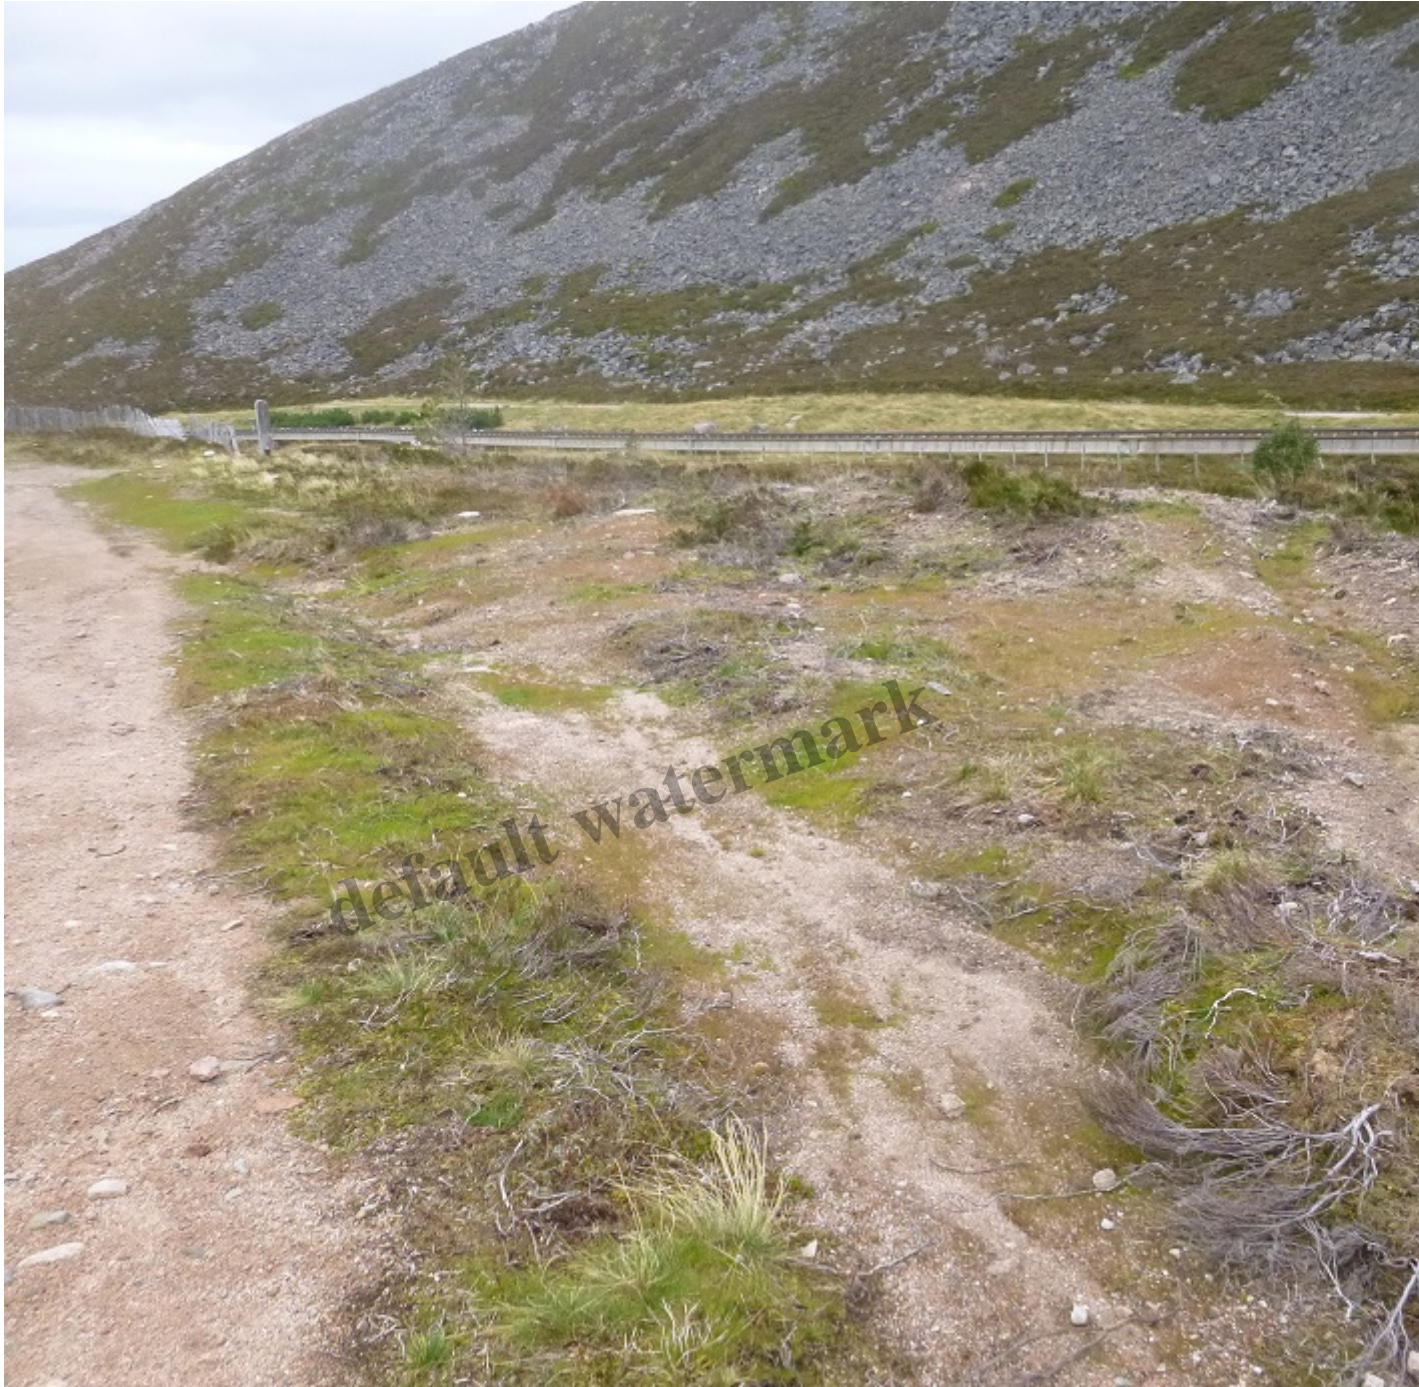
The ecological assessment makes no reference to all the granite gravel that has washed off the lower surrounding ground. Again the extent of destruction of the vegetation is striking. Photo Credit Terry S
