The CNPA is digging a deeper hole for itself at Cairngorm

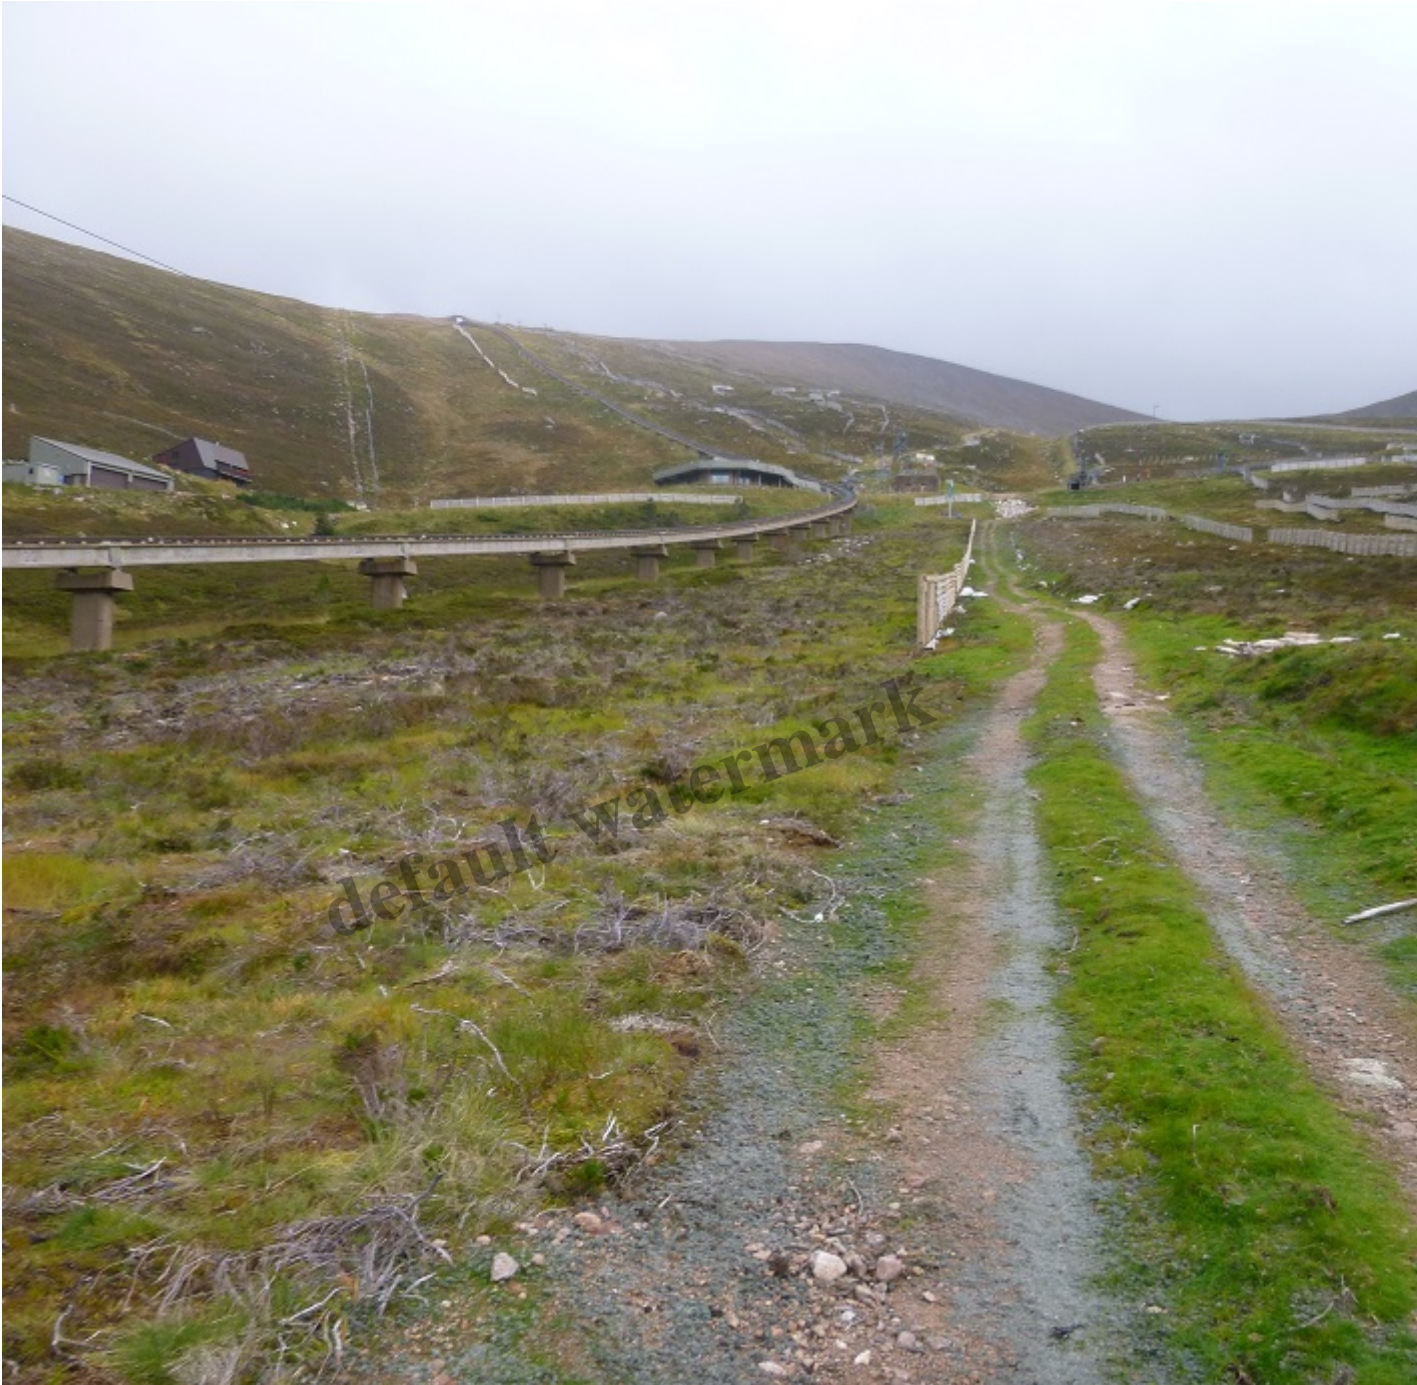
Half exposed pipes seem of no concern to the CNPA's landscape adviser

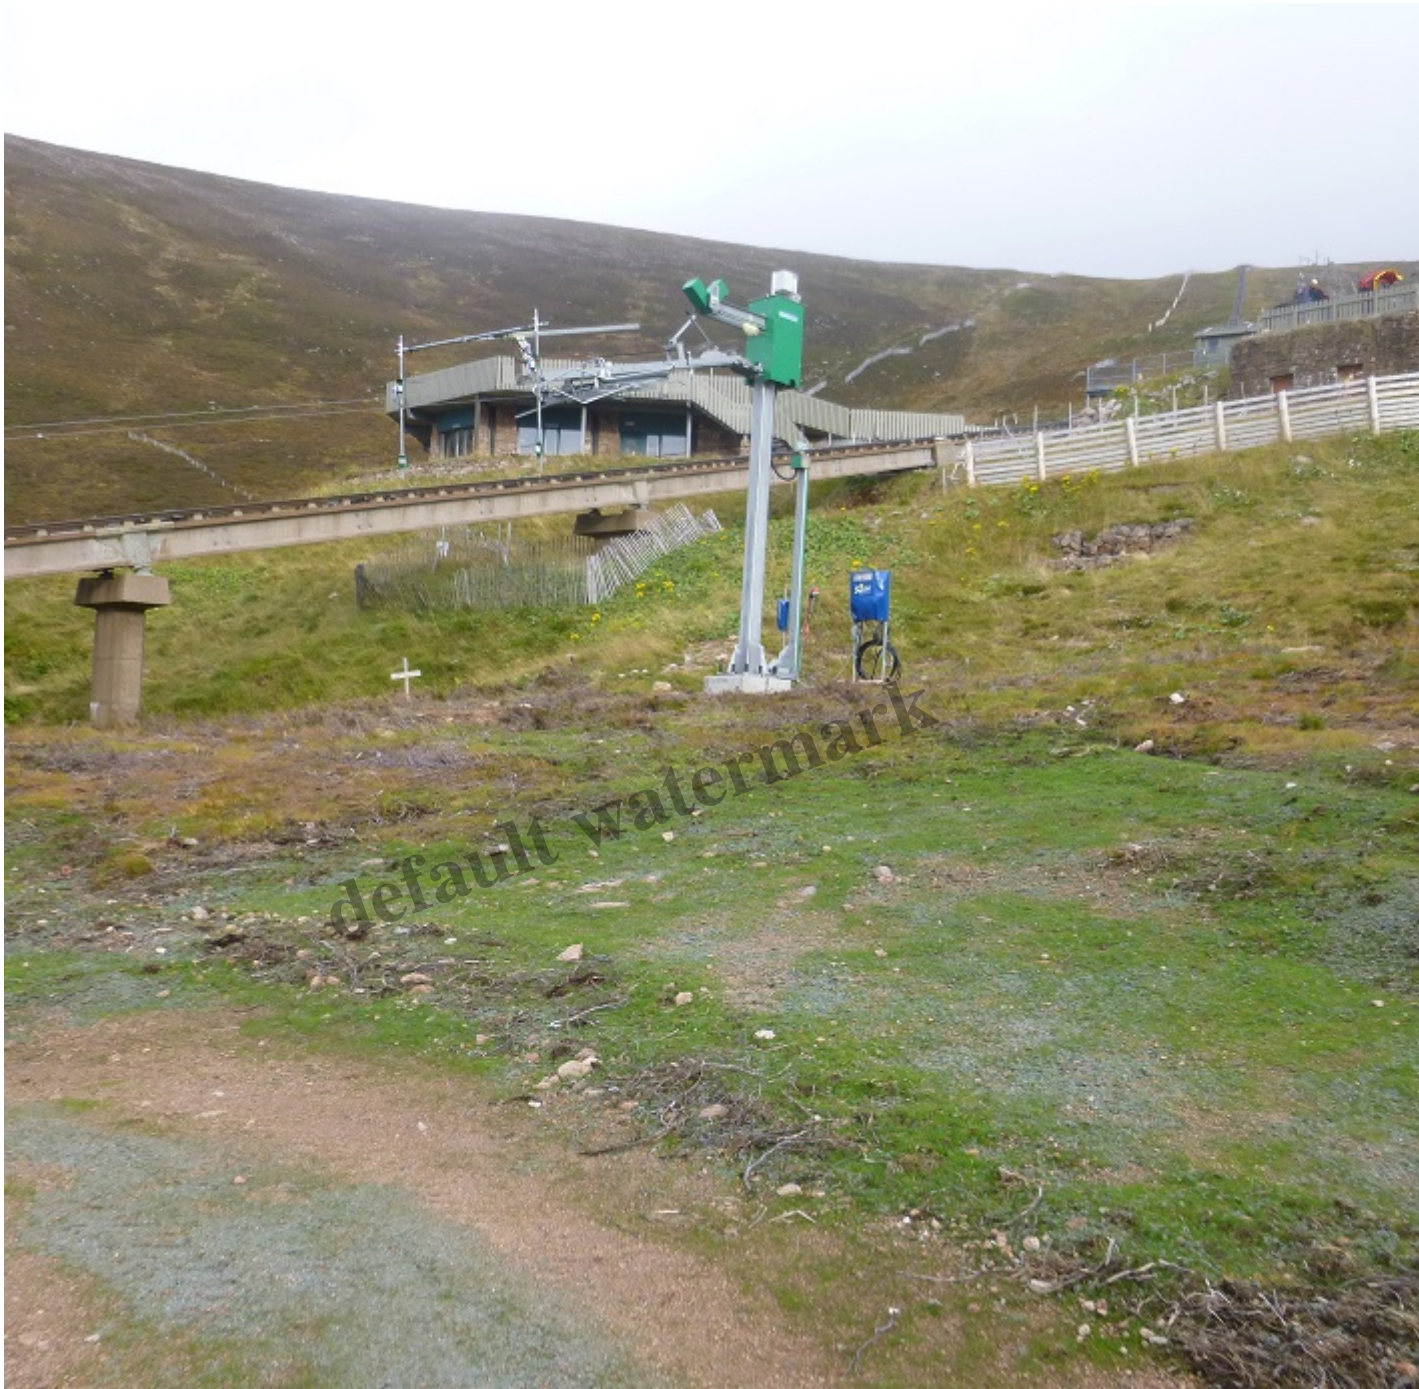
Extensive re-seeding near the top of the shieling rope tow – showing how little vegetation restoration
Credit Terry Smith

No mention here that Natural Retreats was supposed to store all vegetation on terram matting and then replace it so there should have been no need to “win” vegetation from anywhere else. The need for re-seeding should have been minimal but in fact has been required over large areas. The Ecological Assessment makes no mention or comment on this.

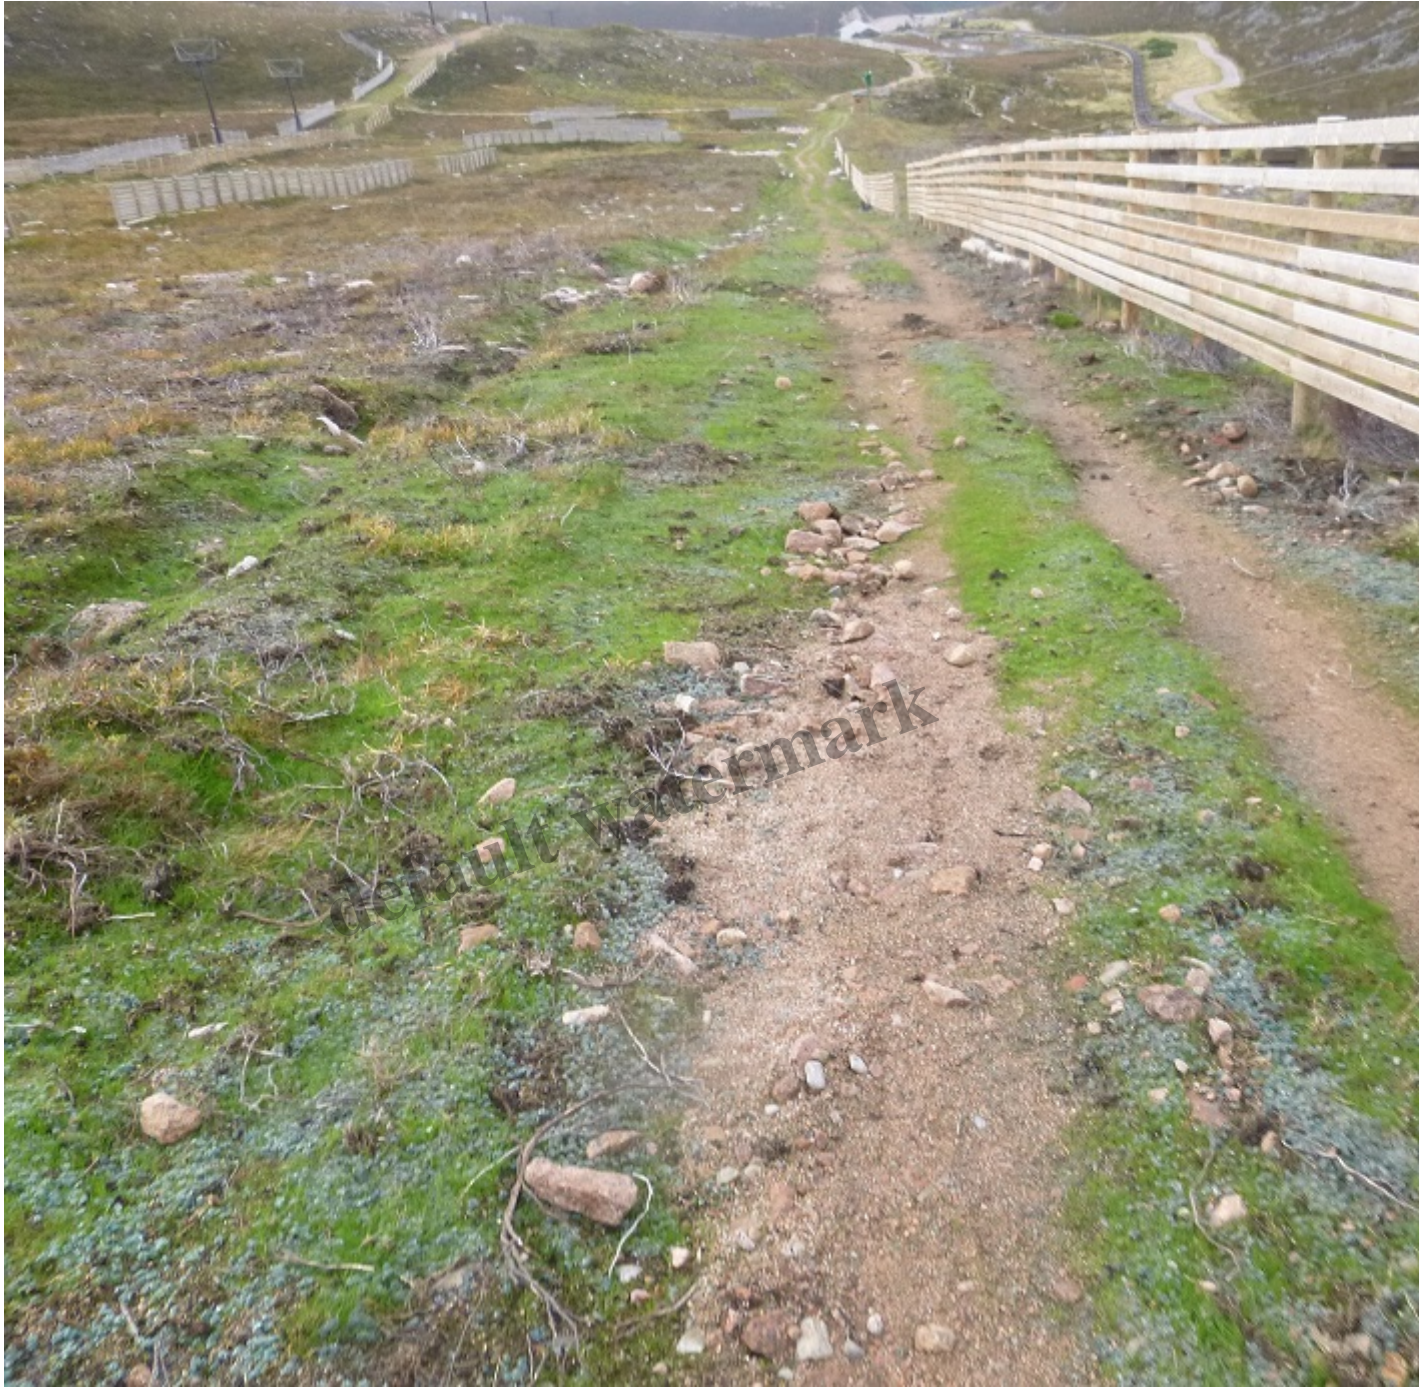
The steeper top half of the shieling track erodes each time there is a storm because its too steep and the track washes onto the surrounding re-seeded area Photo Credit Terry Smith

This is factually wrong and the thinking dangerous. The track is not a short stretch, its several hundred metres long. The angle of the top half of the track is 12 degrees, compared to the maximum angle of 8 degrees recommended by Scottish Natural Heritage to prevent erosion (see Alan Mackay's excellent [critique](#) of the retrospective planning application in which he went out and measured the angle of the track! Its essential reading for anyone concerned about this and should be read by all Board Members on the Park's Planning Committee). The Landscape report contains no consideration of the implications of installing "access tracks" alongside all the ski tows in Scotland – the cumulative impact would be considerable. The tracks are also completely unnecessary. CNPA staff seem totally unaware of the publication "Environmental design and management of ski areas in Scotland: a practical handbook" which showed tracks were unnecessary back in 1987. Nothing has changed except our Public Authorities are no longer prepared, it seems, to enforce basic environmental standards.

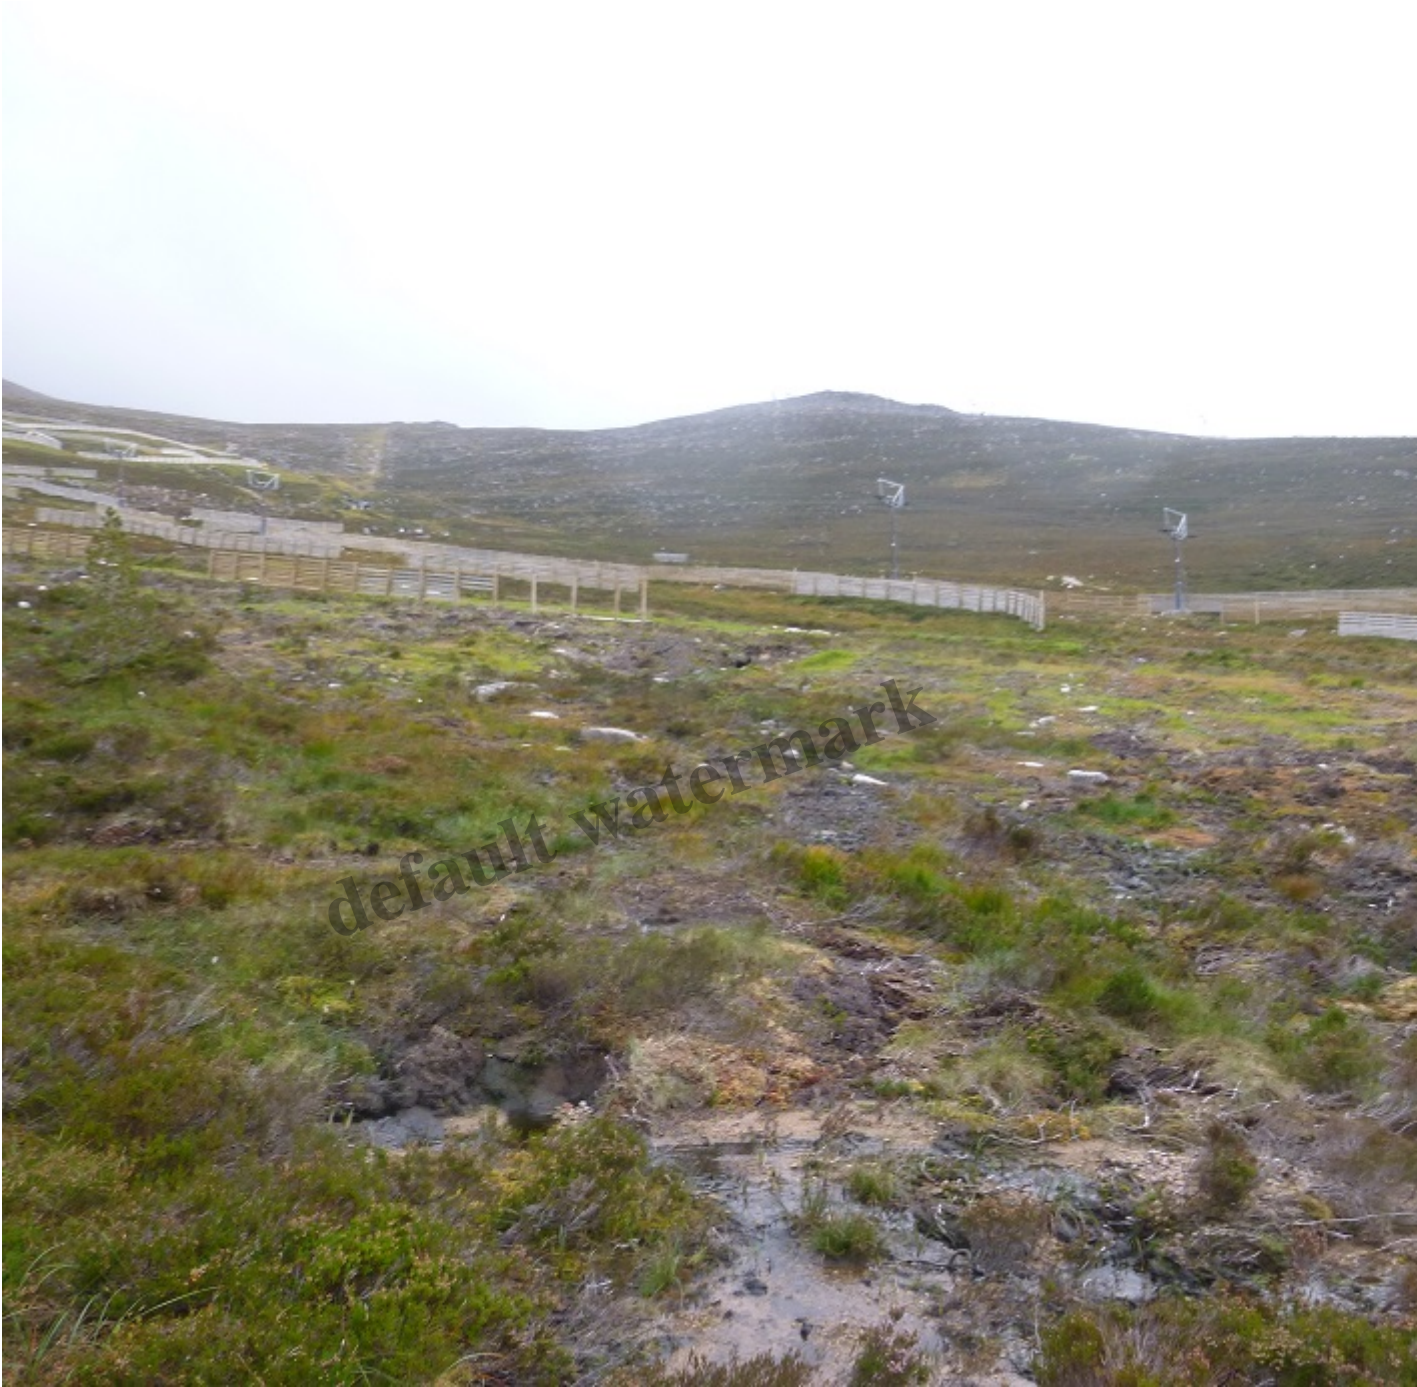
The ecological assessment contains no reference to the quagmire that has been created by diggers scooping holes out of the vegetation to “restore” the ski slope behind Photo Credit Terry Smith
