The CNPA is digging a deeper hole for itself at Cairngorm

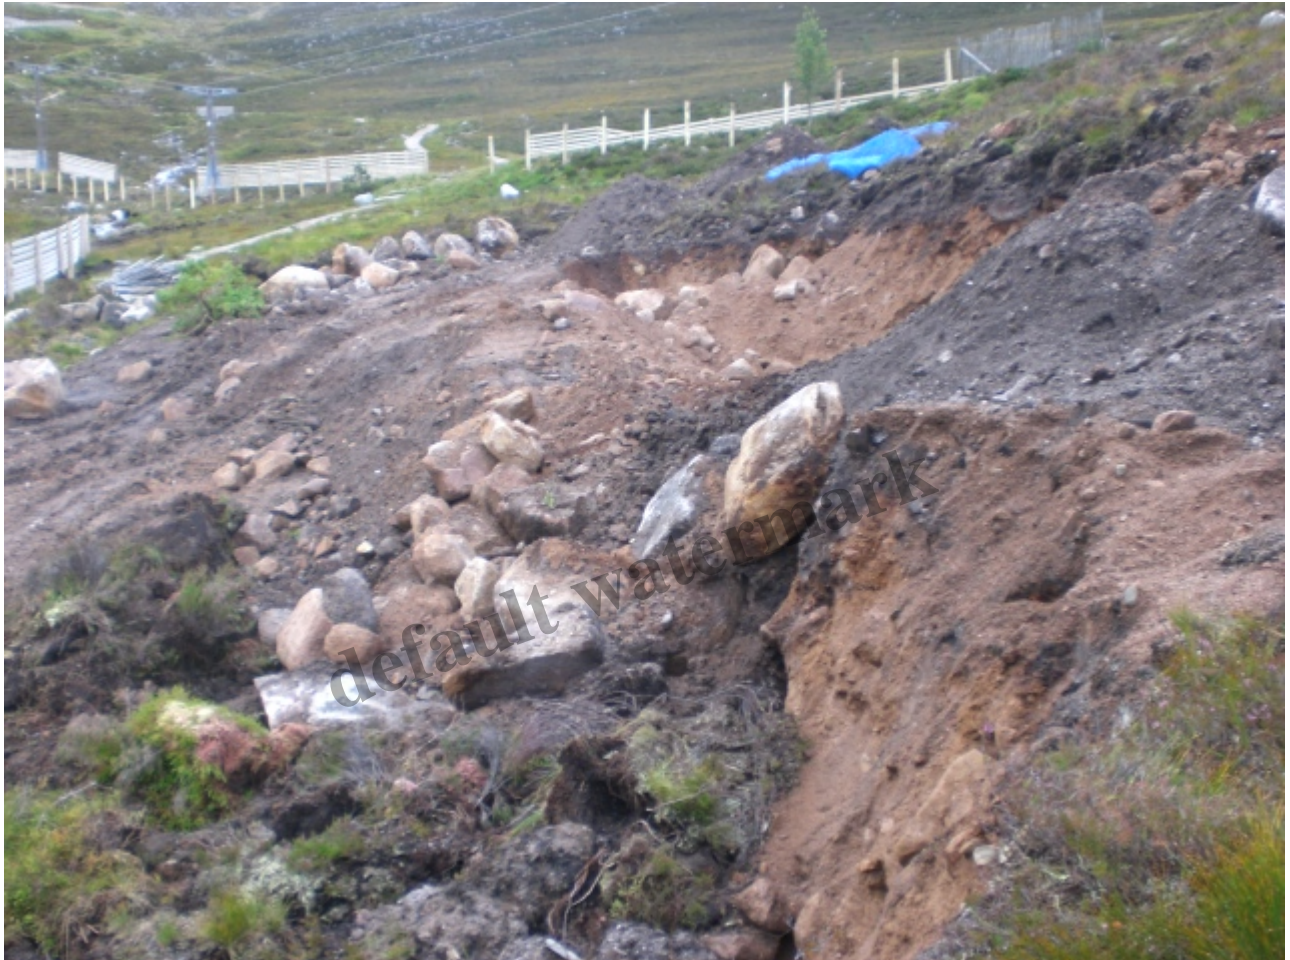
Photos of this hole and associated damage caused by Natural Retreats outwith the area granted planning consent was sent to Cairngorms National Park planners in early October a month after they were first alerted to the issues. Photo Credit Alan Bratney.

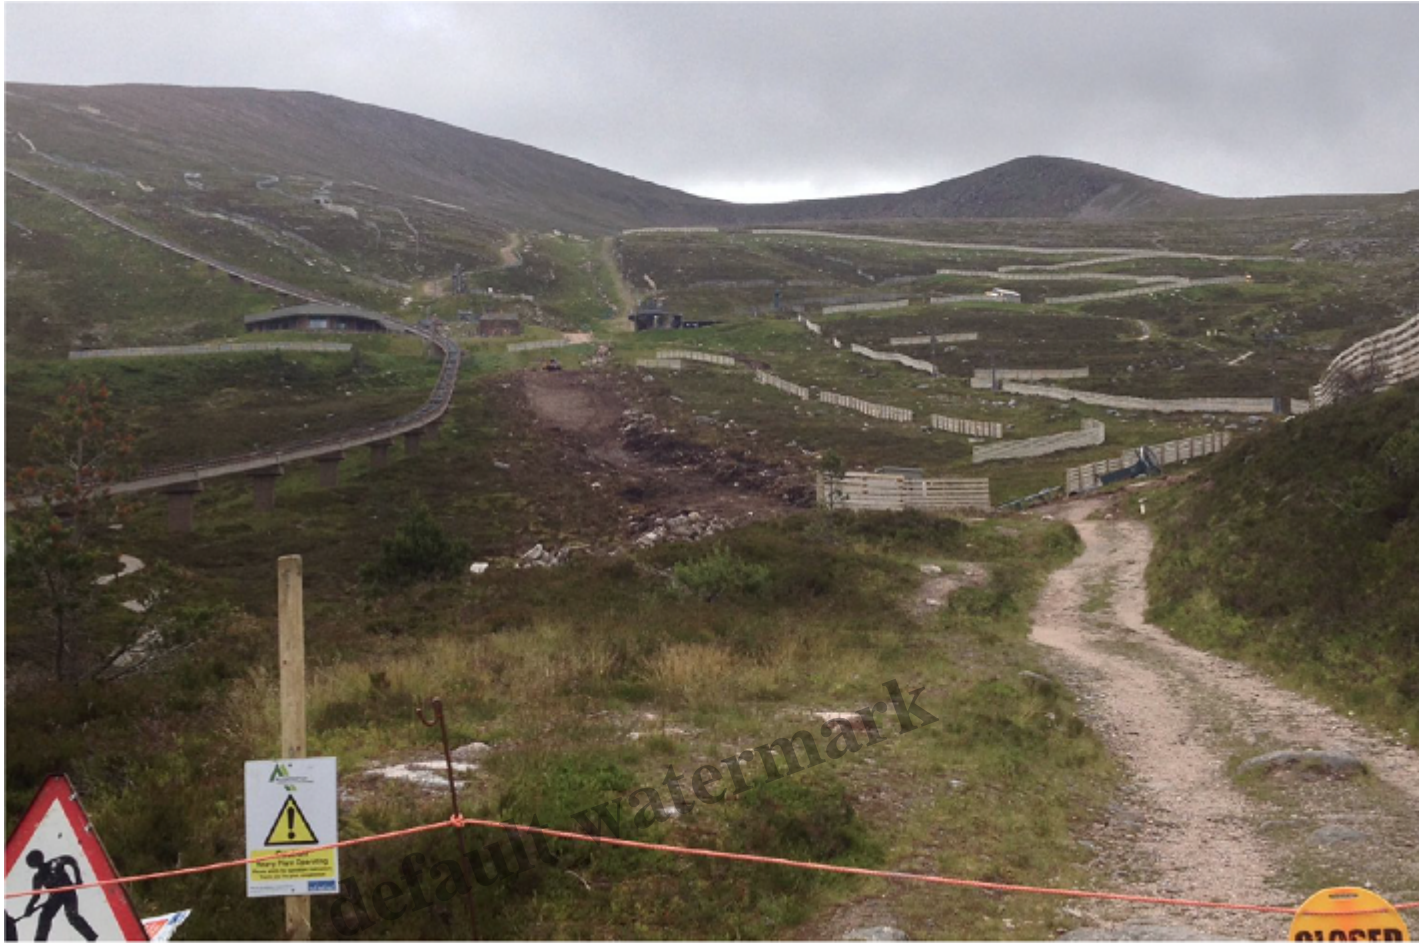
This is wrong, there was no erosion previously as this photo from Alan Mackay's response shows:

The bank on the right of the track was covered with vegetation when work on the Shieling Rope tow started yet the CNPA claims it was eroding and appears to have used that claim as a justification for ignoring a serious breach of planning permission when Natural Retreats dug up this bank “to make it more natural” (their words). Photo Credit Alan Mackay

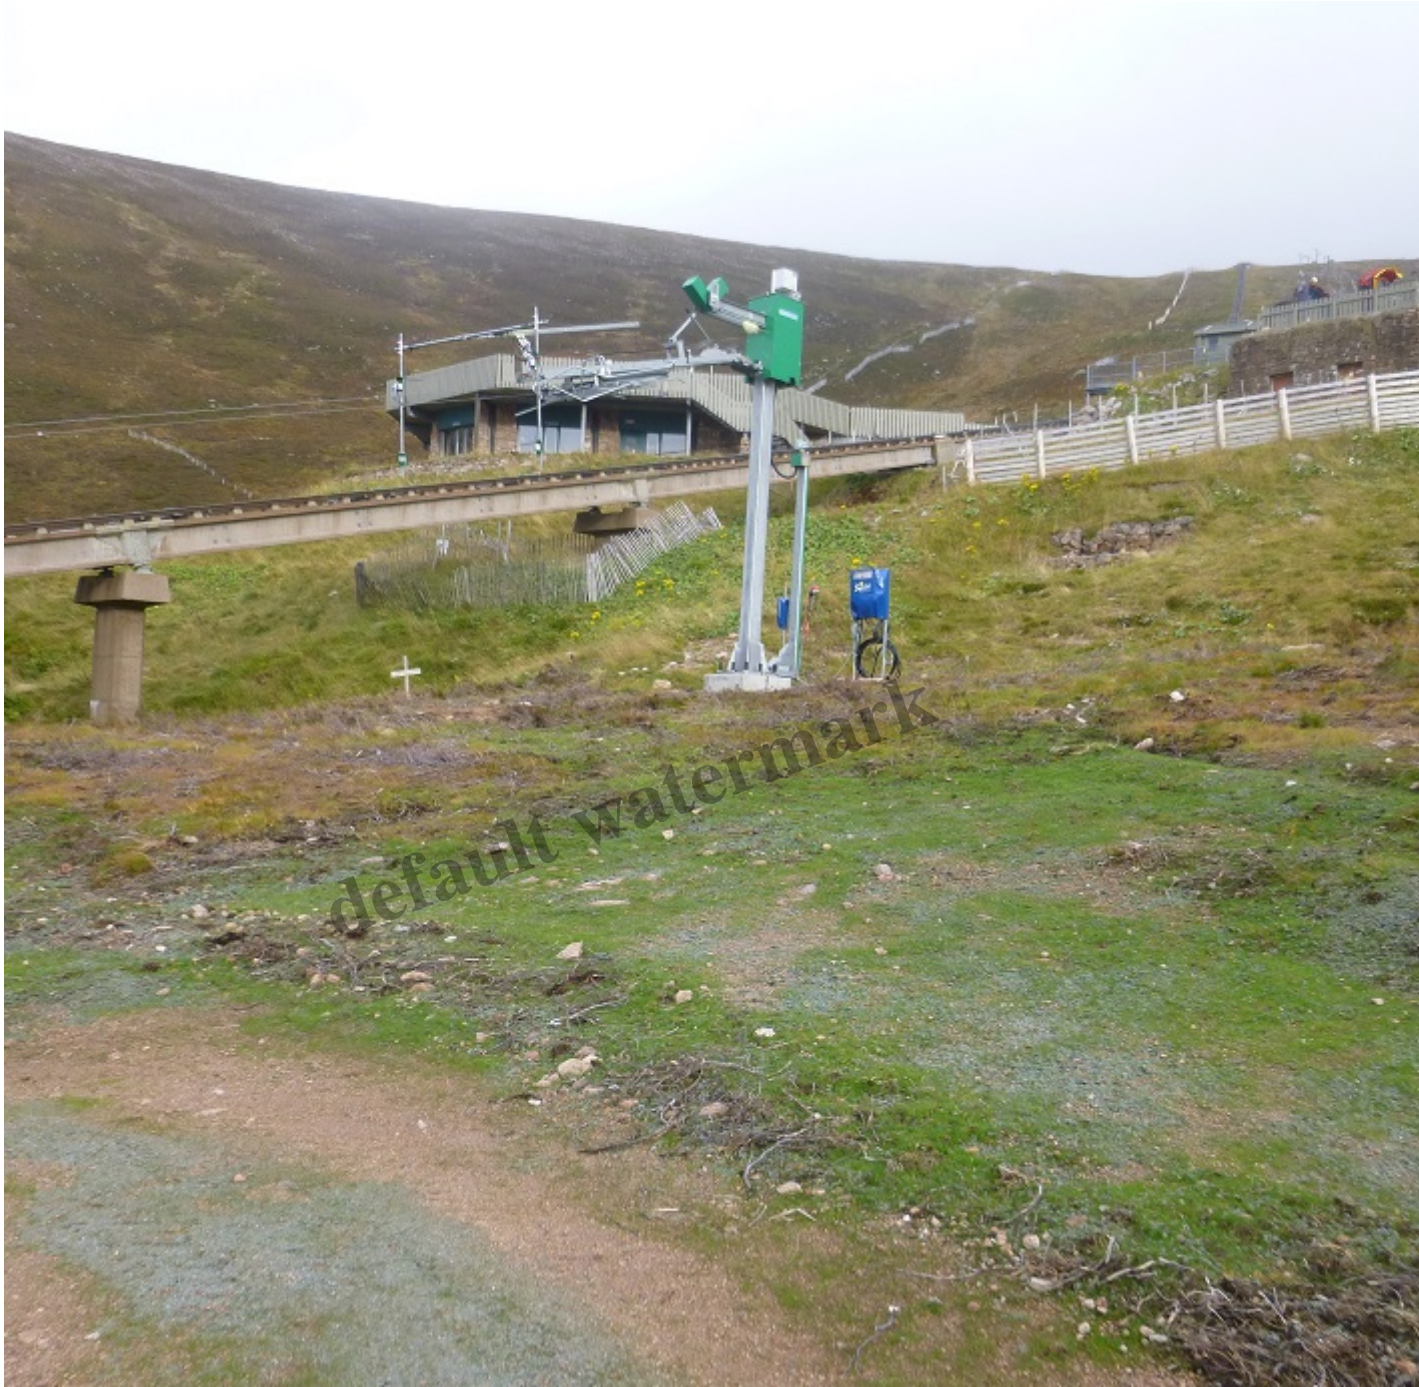
Extensive re-seeding near the top of the shieling rope tow – showing how little vegetation restoration
Credit Terry Smith

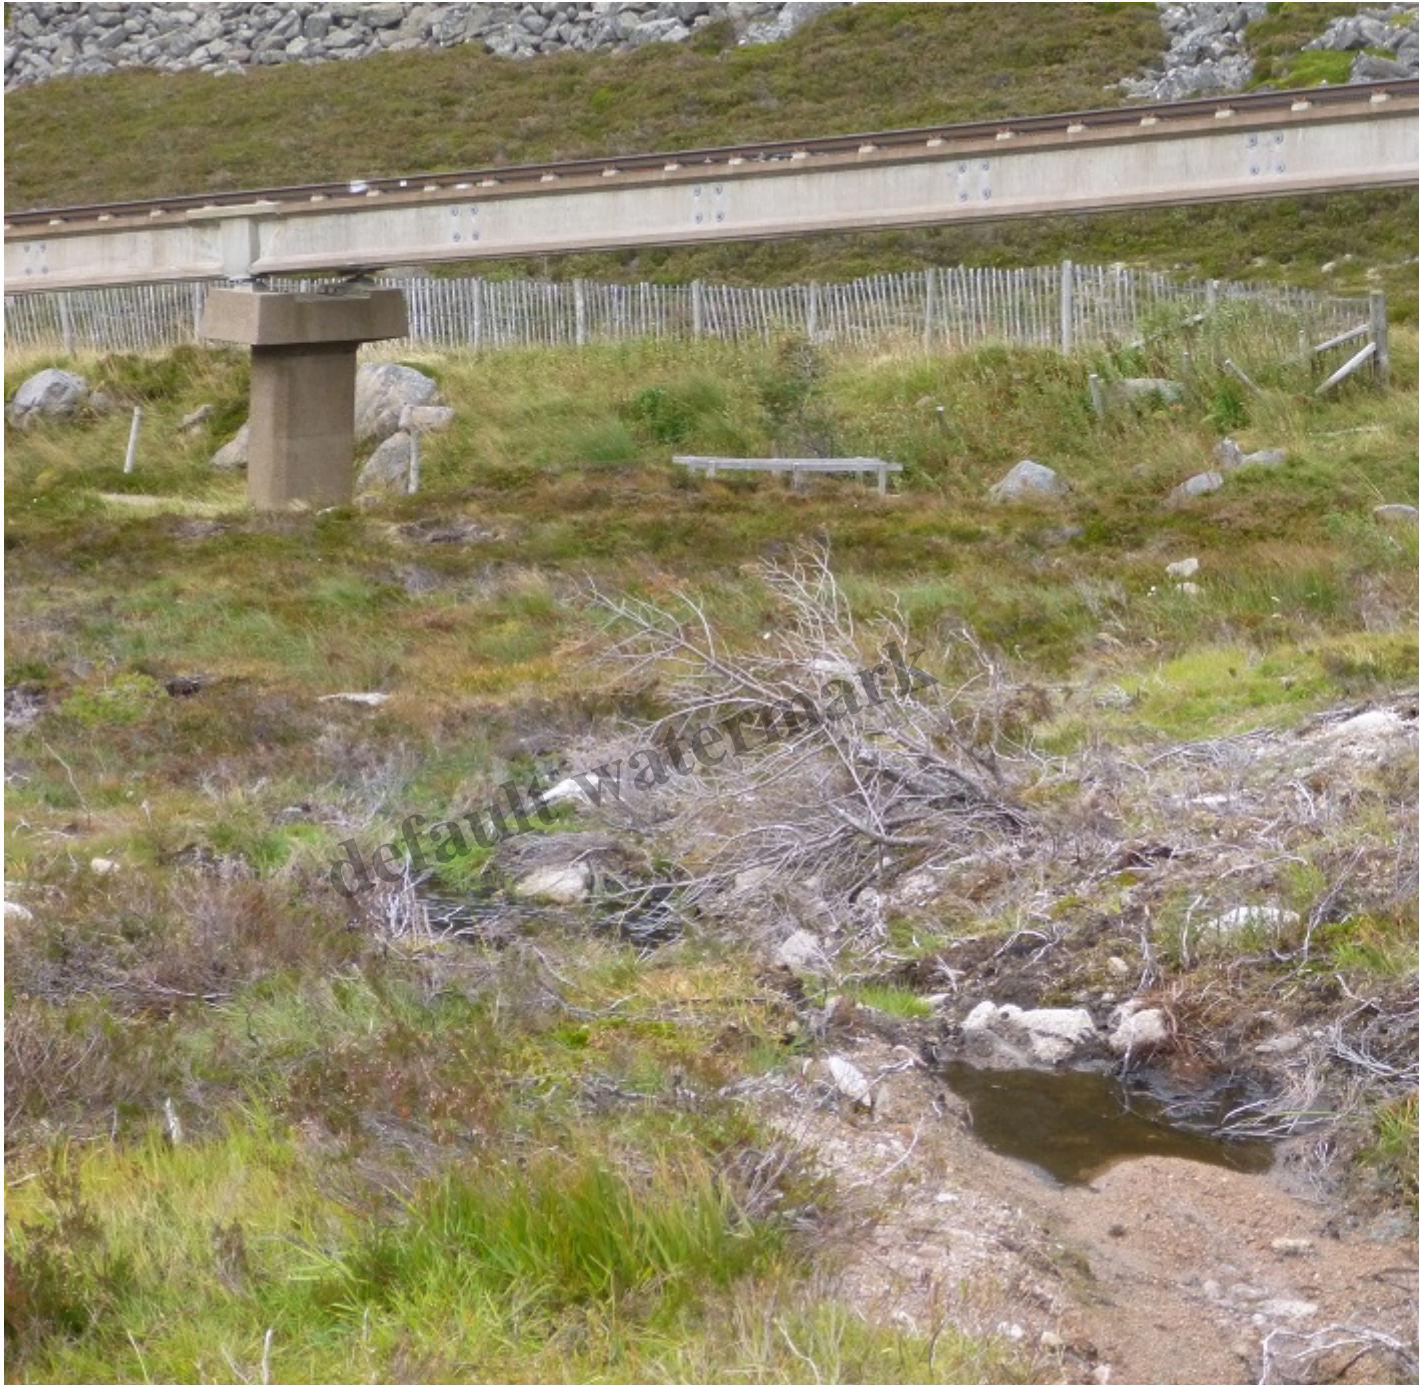
The ecological assessment makes no reference to the number of trees killed by Natural Retreats or out with diggers leaving holes across the bottom half of the slope Photo Credit Terry Smith

The one positive suggestion in the assessment is that “there is a good opportunity to plant Dwarf Willow, Birch and Scots Pine on the re-graded bank” but why only here? As I have argued previously, one way to compensate for the extensive destruction would be for the CNPA to require Natural Retreats to employ a properly qualified contractor to plant montane scrub across the area.

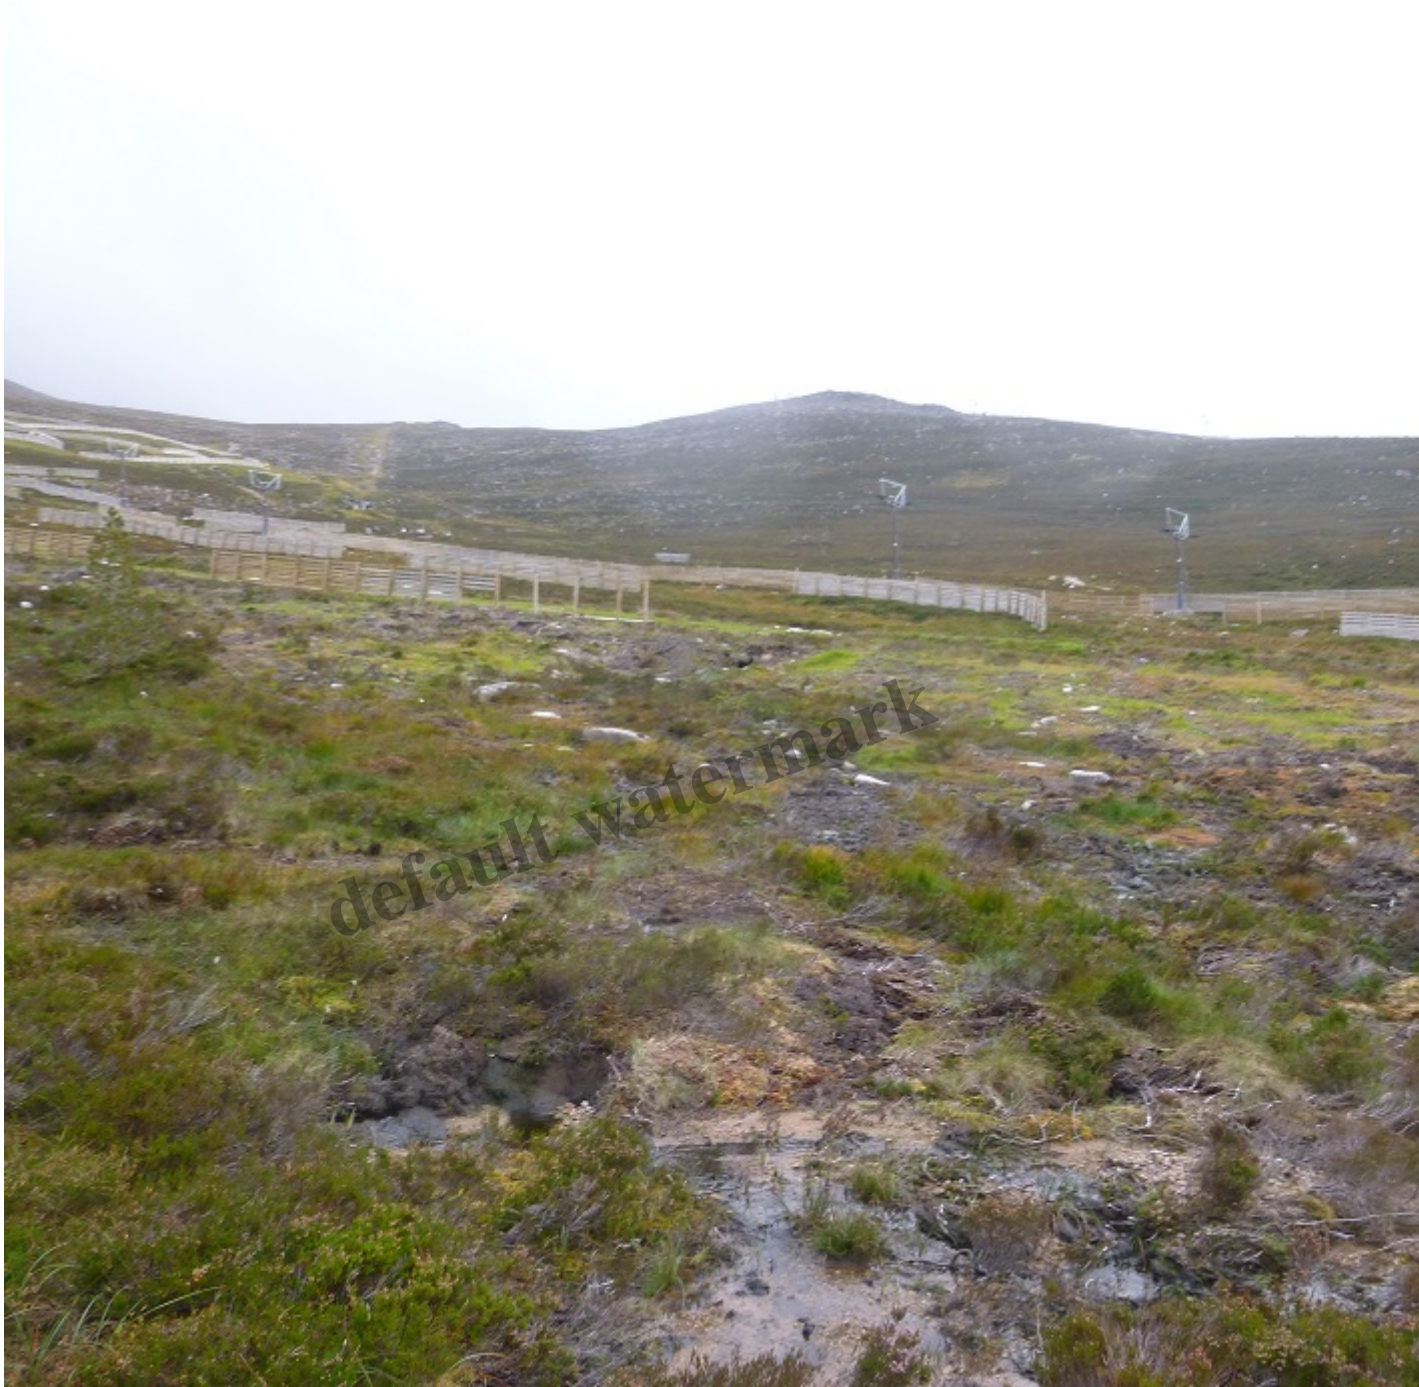
The ecological assessment contains no reference to the quagmire that has been created by diggers scooping holes out of the vegetation to “restore” the ski slope behind Photo Credit Terry Smith

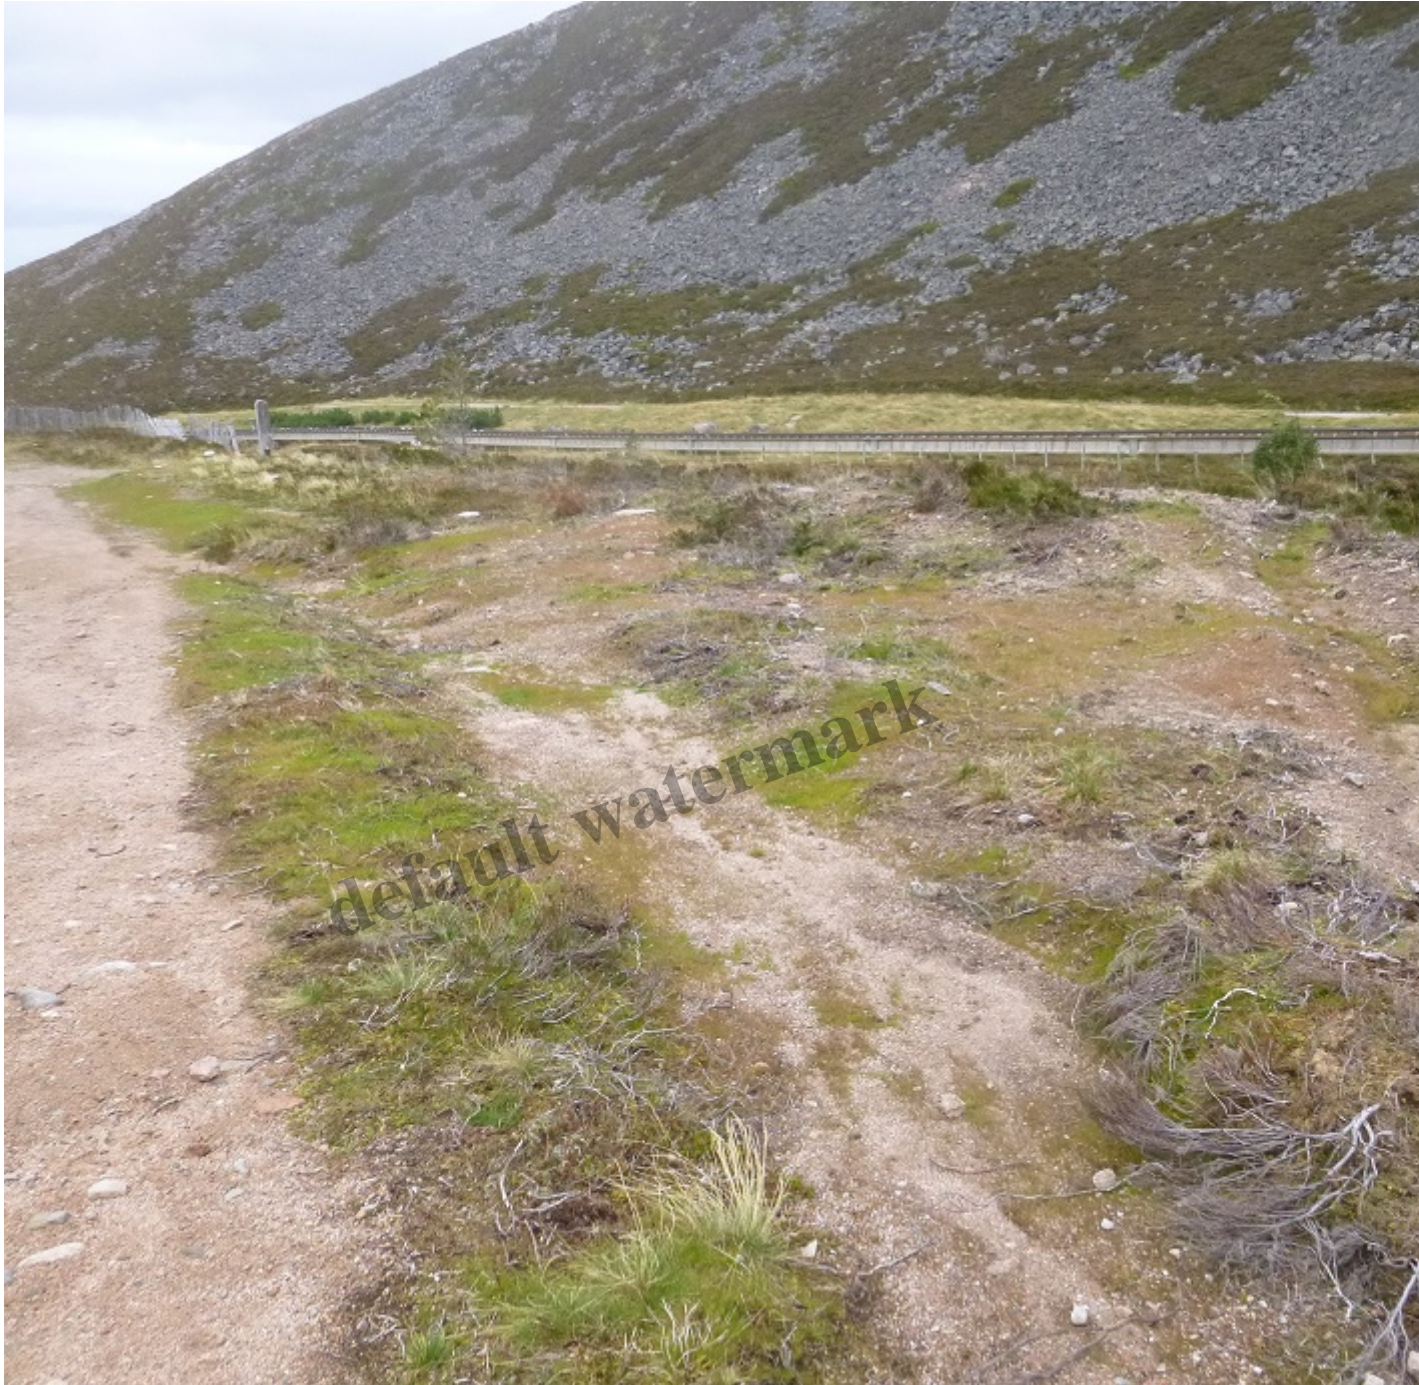
Th ecological assessment makes no reference to all the granite gravel that has washed off the lower surrounding ground. Again the extent of destruction of the vegetation is striking. Photo Credit Terry S
