The restoration of the Beauly Denny access track between Feagour and Dalwhinnie

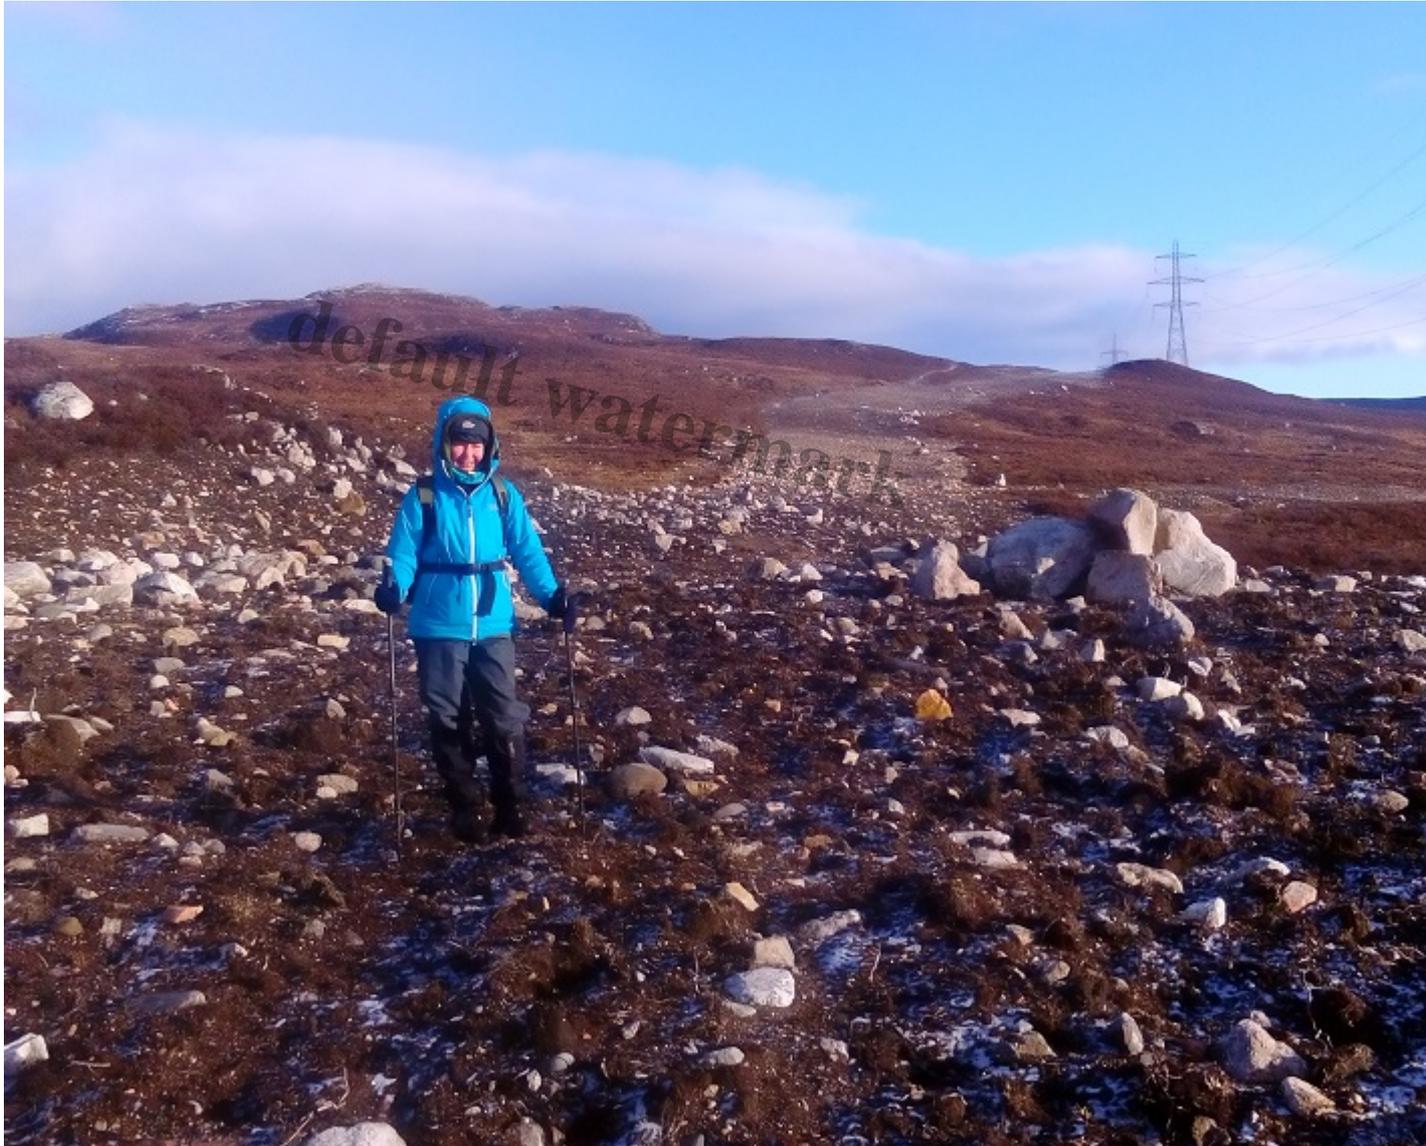
The construction track as it looks after "restoration". It appears very little vegetation was saved to construction for use once the track was removed and the pile of boulders created by the construction has simply been left without any attempt to re-position so they would appear more natural. Photo by Jonathan Binny

The Scottish Government, which overruled the objections of Cairngorms National Park Authority to the Beaully Denny, required all construction tracks to be restored to their original condition. These restoration works were supposed to be complete last year, so the photos show the “final restoration” – clearly not the original condition.

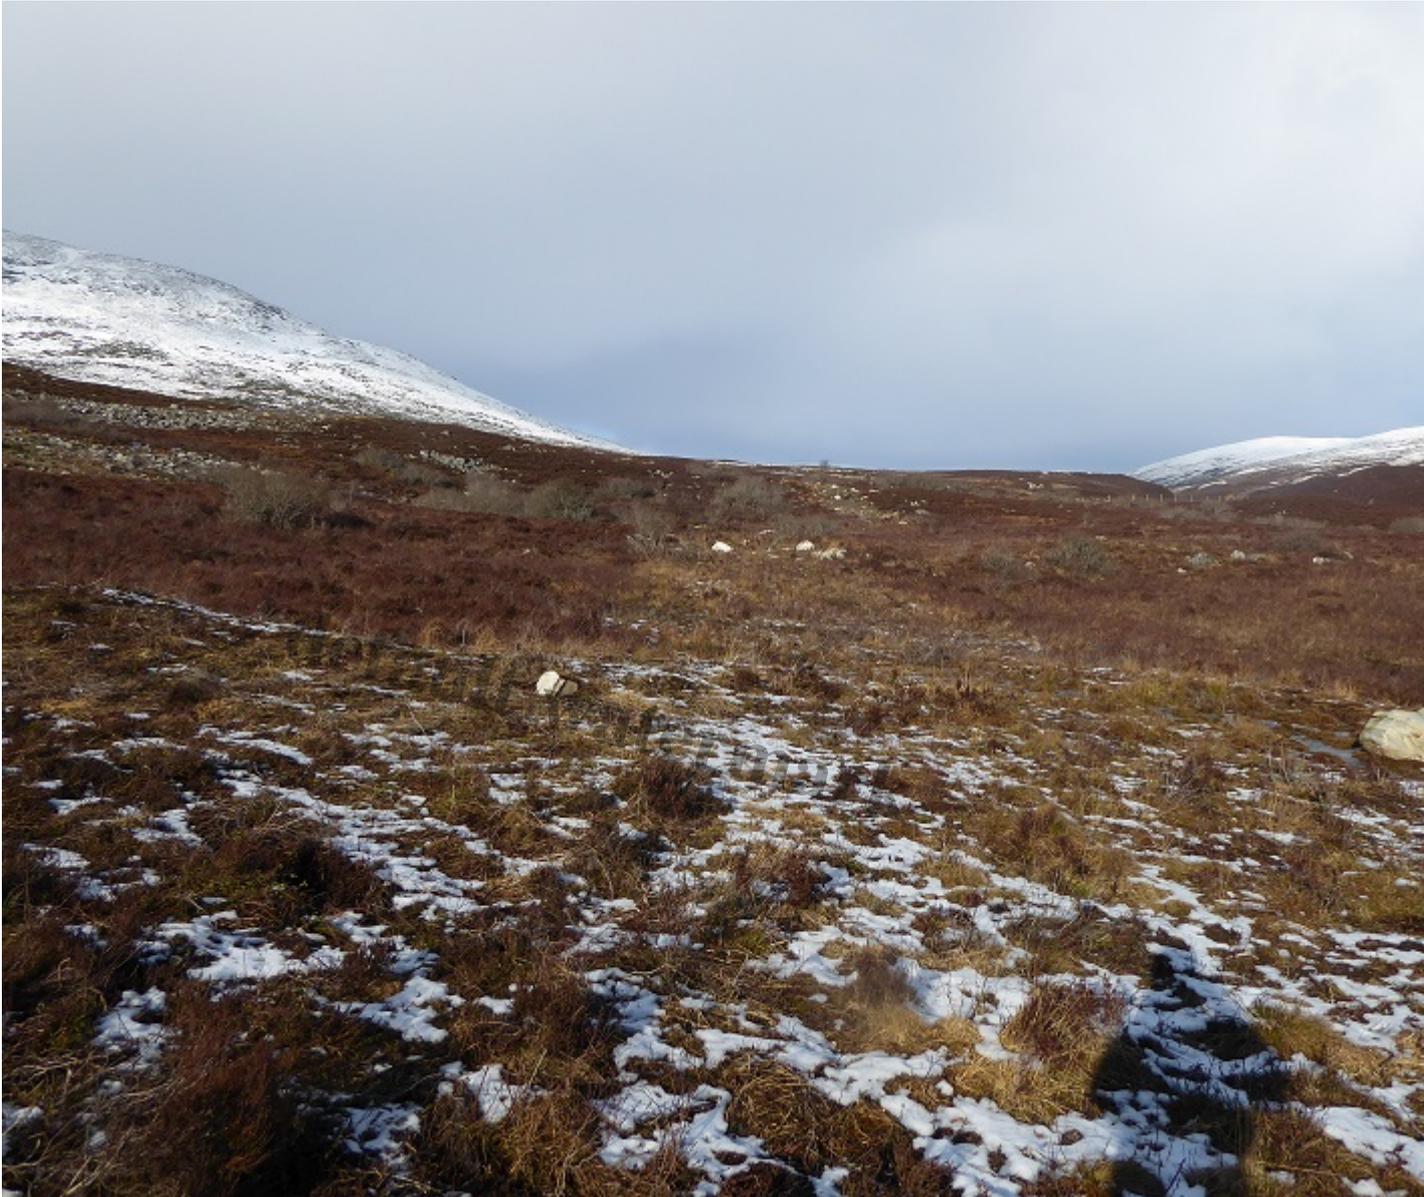
Photo of moorland restoration on the upper Gynack hydro scheme Kingussie February 2016. The line of the pipeline runs from the view up the centre of the photo.

The Pitmain Estate avoided constructing a new track here and used different construction techniques for this hydro (which I will feature in a future post) but you can see quite clearly that heather has been retained and then replanted. Most hillwalkers probably walk past this pipeline without realising its there. That is not going to happy any time soon with Beaully Denny â?? in fact they are now talking of 20-30 years before the land â??recoversâ??. That is NOT restoration but a very slow reclamation by nature processes.

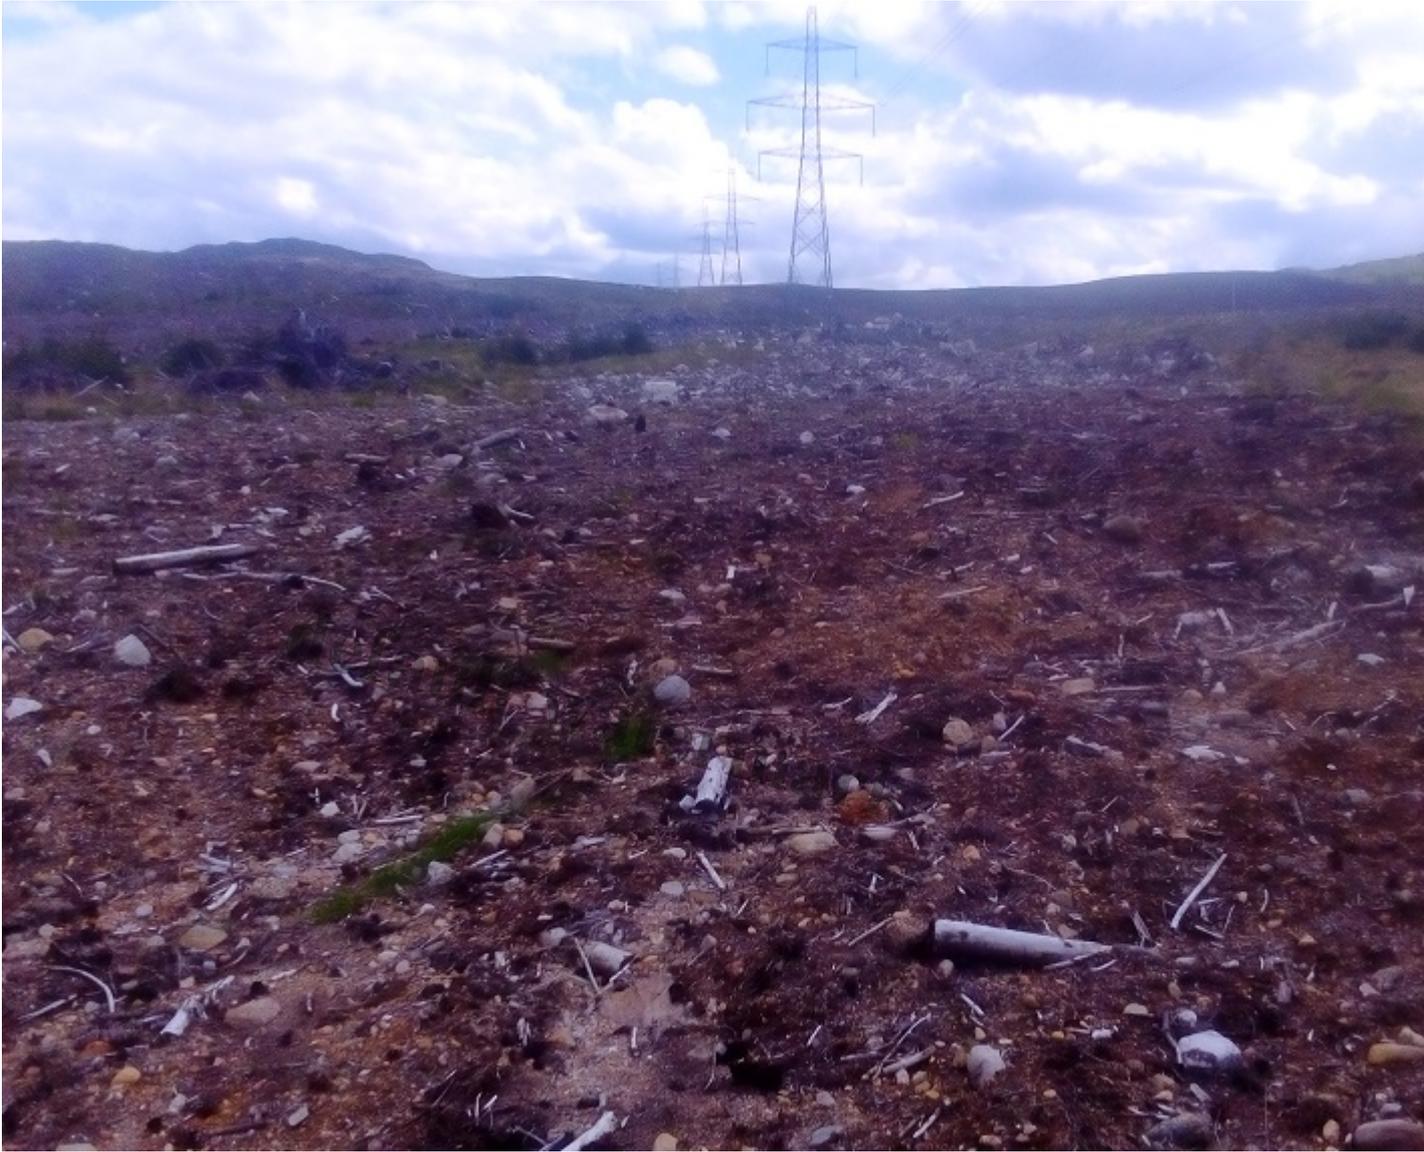
Part of the track from Feagour went through woodland. Photo Credit Jonathan Binny.

The land looks just like any other clearfell, a mess, which will take years to recover. Contrast this with the restoration of the ground in Stank Glen by Loch Lubnaig in the Loch Lomond and Trossachs

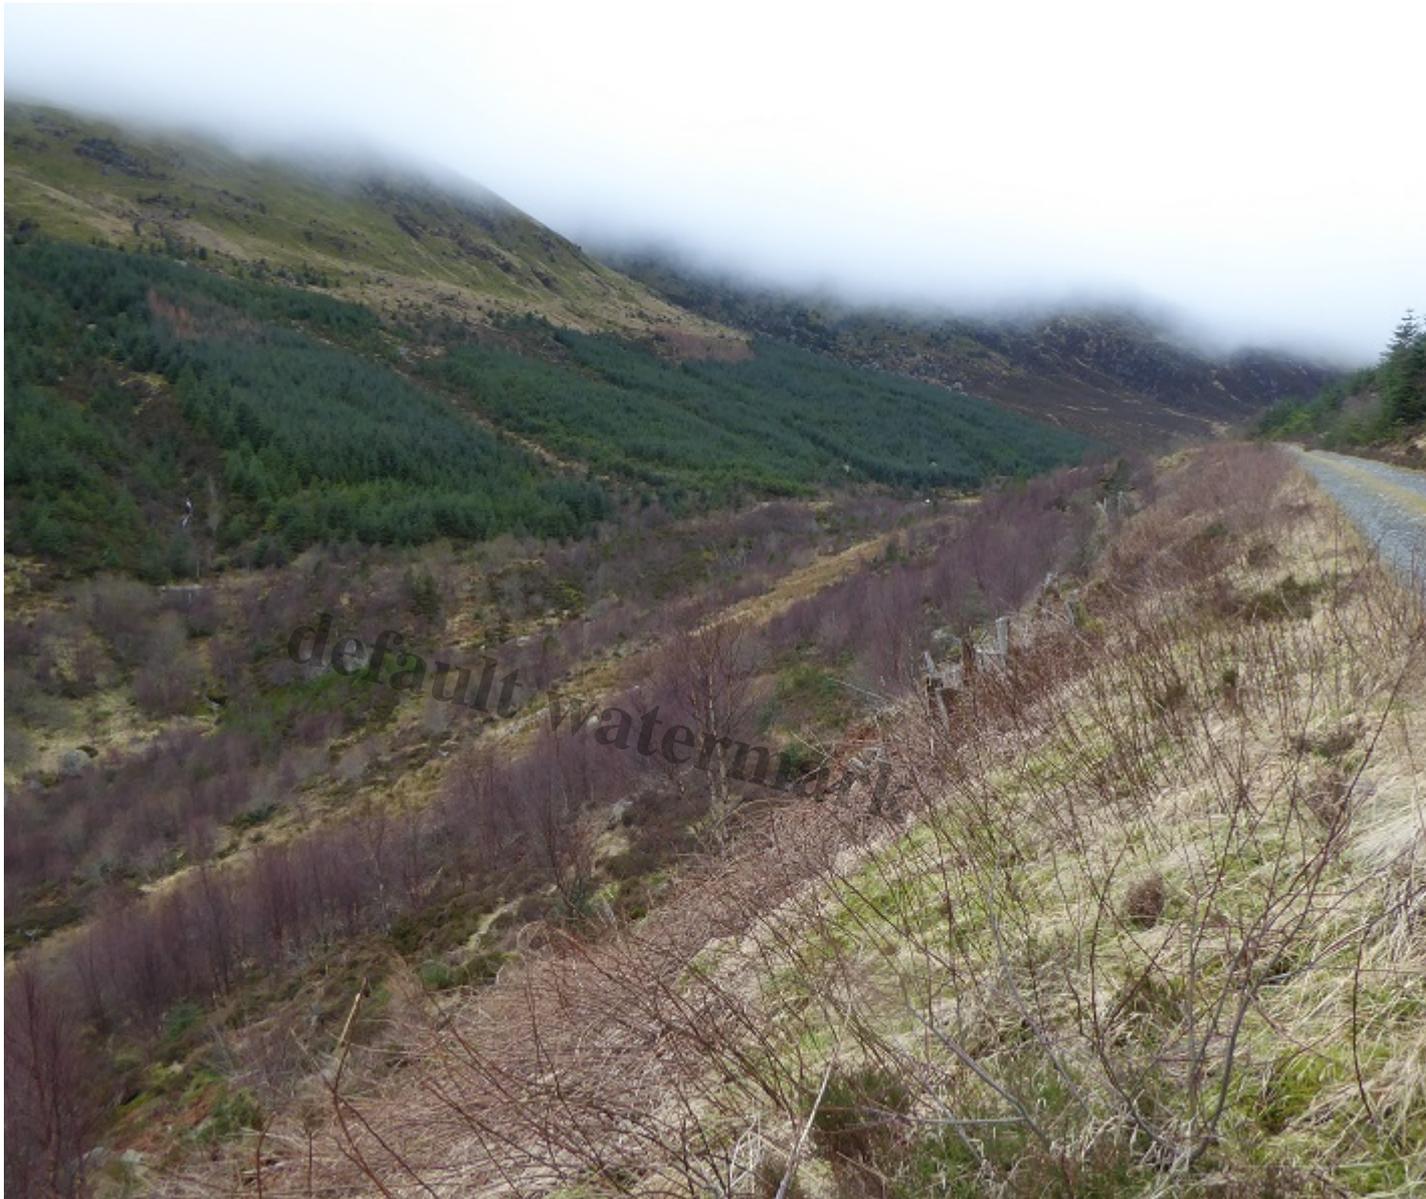
The line of the pipeline runs diagonally across photo from bottom left and has been cut through the t

Again, this was not restoration of a track as shows, but does show how woodland can be restored after major construction works. The work here post-dates the Beauty Denny and will be all but invisible long before nature reclaims the Beauty Denny destruction.

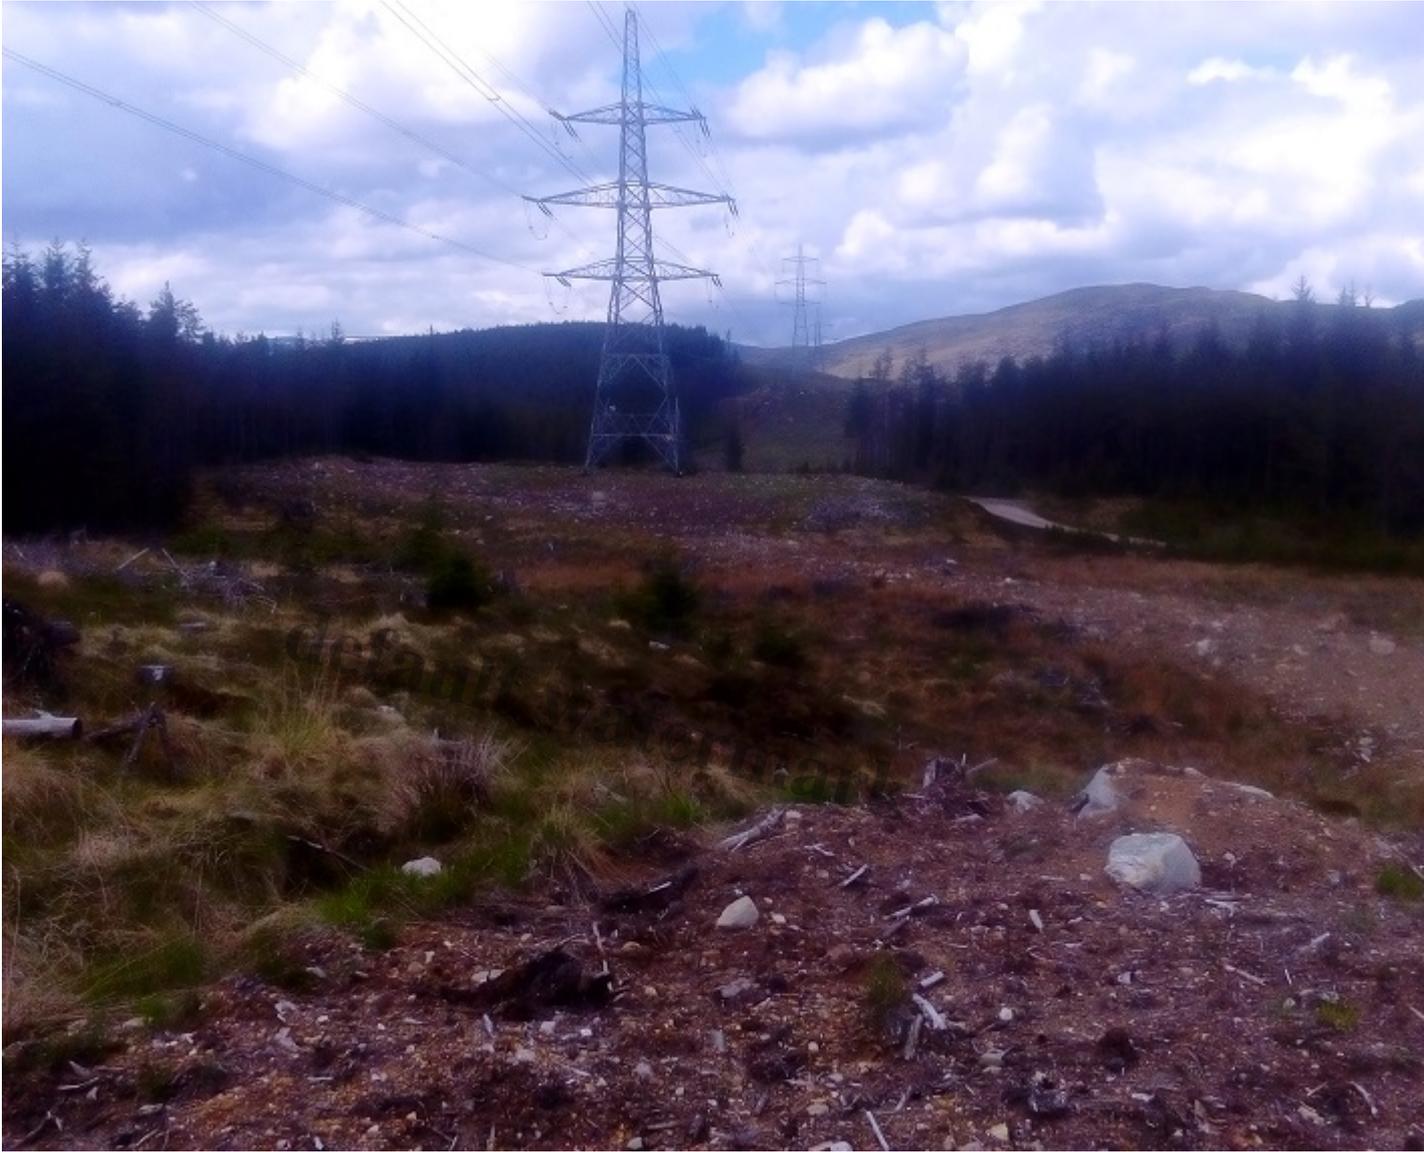
In addition to the destruction caused by the construction track, which appears to have been in addition to a forest track far right, you can see the usual failure to restore the ground around the base of the pylon. Credit Jonathan Binny
