# The Beauly Denny and persecution tracks at Drumochter

On Wednesday evening I went to have another look at the northern section of the access track which had been created for the construction of the Beauly Denny powerline and which was due to be restored last year (see here). Its situated on the east side of the A9 behind the tree shelter belt and opposite the southern turn off to Dalwhinnie.

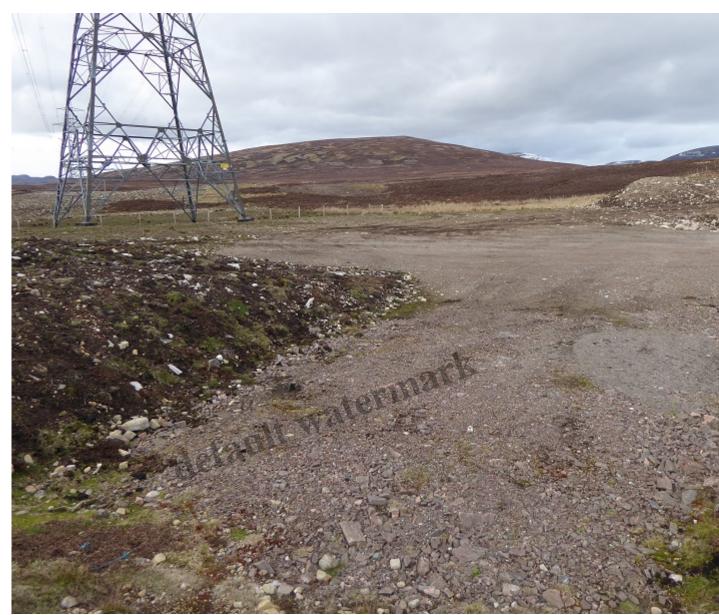
The north end of the track, which is blighted by a so-far unrestored large turning area

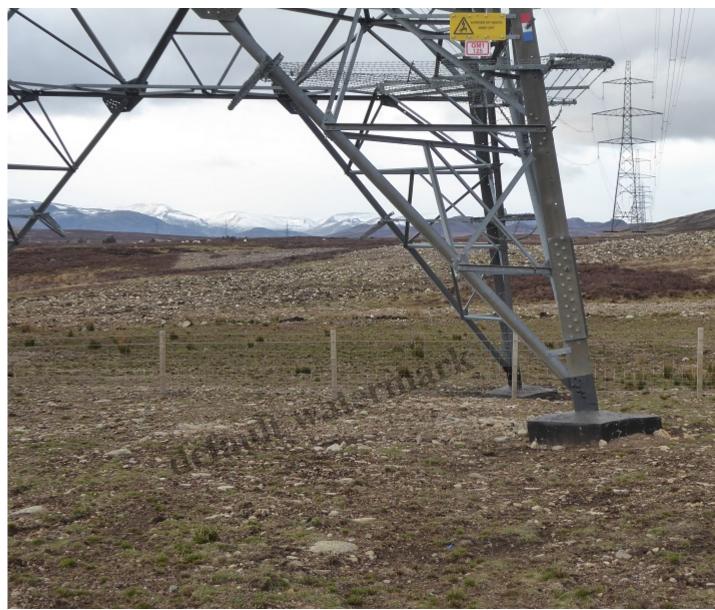
Tower 125 just beyond the end of the track. There is a patch, just behind the tower, where vegetation recovering, unlike the scar in the middle distance

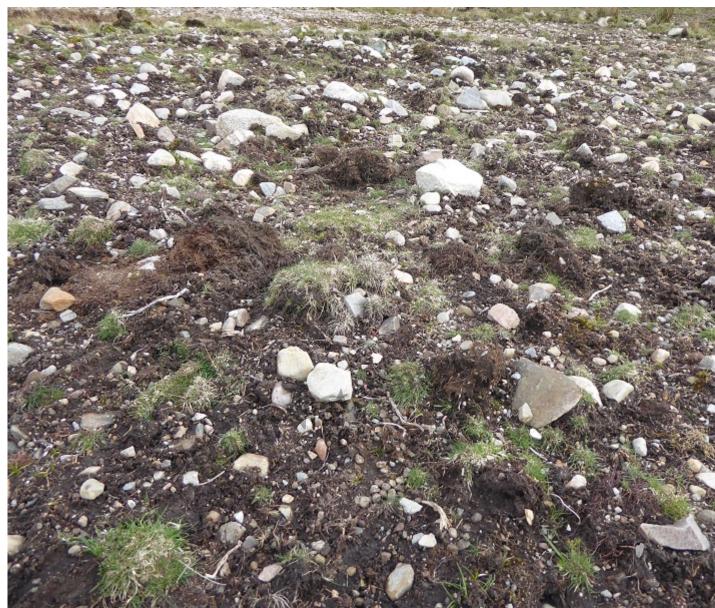
Photo of ground north of tower 125. Stones have been mixed with soil and insufficient turf retained to the whole. To make matters worse clumps of turf have simply been dumped on along with stones on

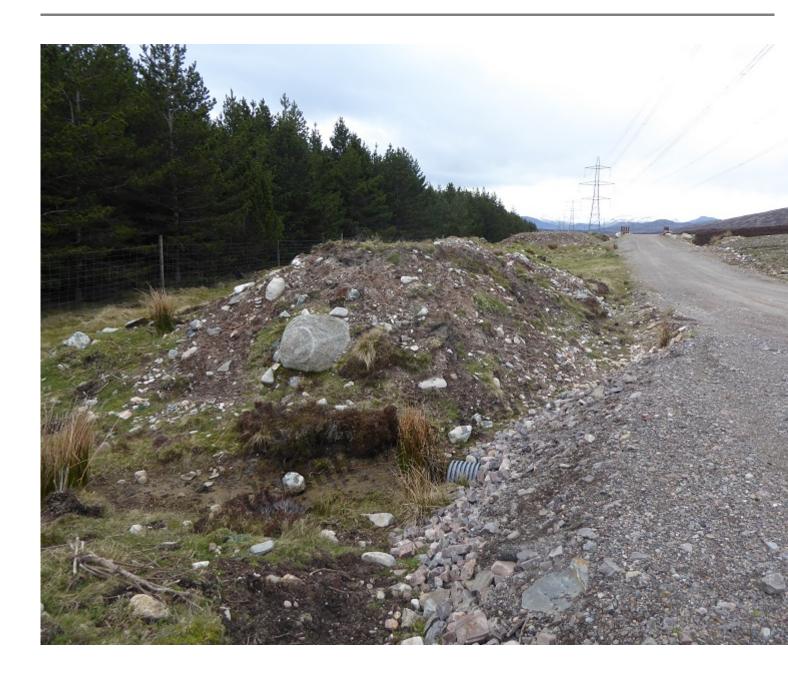
The amount of work – and therefore cost – in meeting the approved design plans for the track are considerable. The 4.7 km of track needs to be reduced from its current width of 5-7m to 3m.

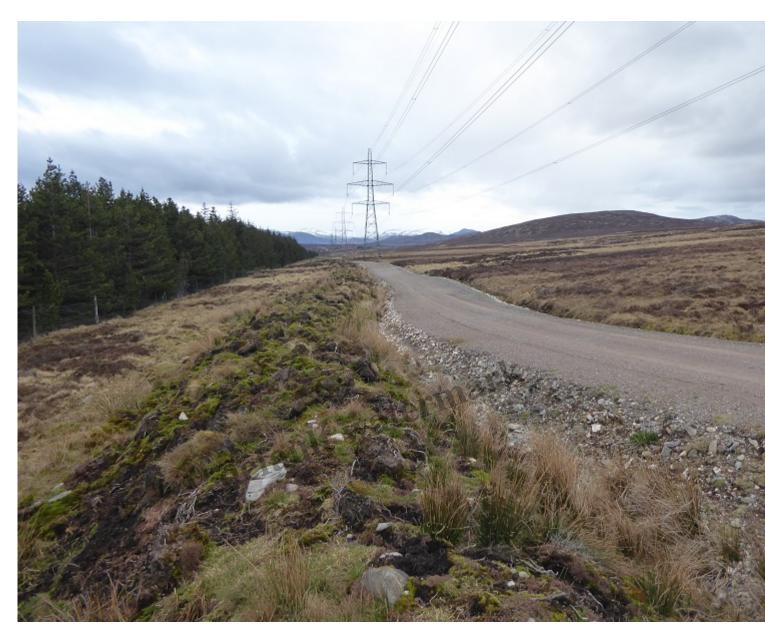
So much aggregate has been imported to construct the track that even where turves have been properly stored, re-landscaping will be a real challenge. The planning permission granted by the CNPA specifies that excess materials will be removed, which would make landscaping considerably easier – a great requirement but will the estate do it?

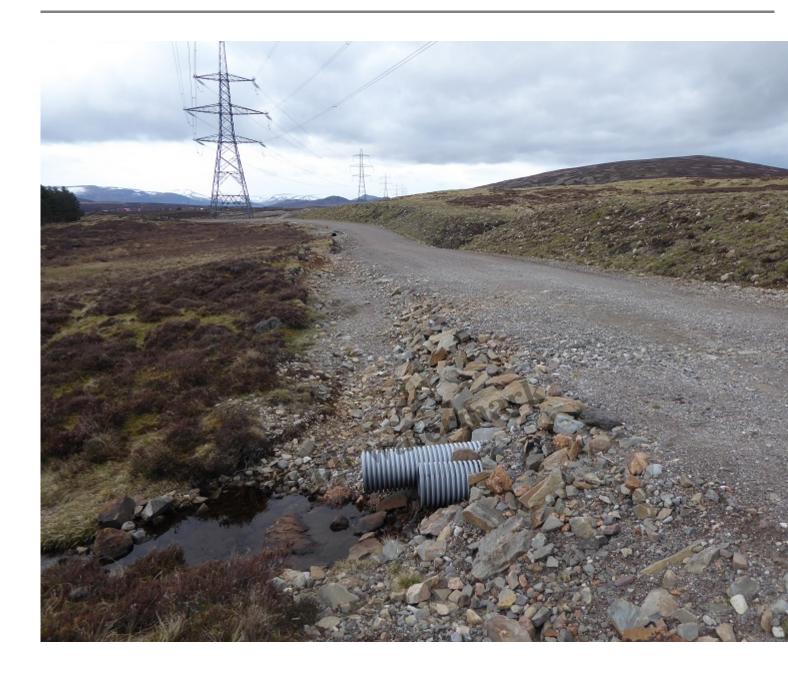
The job will not be made any easier because so much of the temporary construction work was so poor. If this track is to be halved in width, so will the drainage pipes.

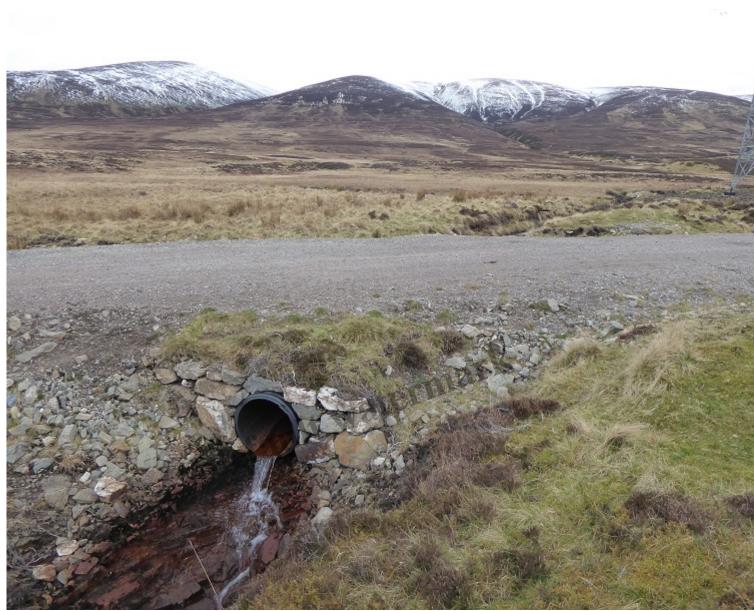
Bizarrely, among all the protuding pipes, there was one example of a culvert which had been properly finished – at both ends too! Unfortunately, the track here was even wider than normal, 7m rather than 5m, and at least one of the finished culverts will need be ripped out if the track is to be reduced in width to 3m. If this work was done by SSE, one wonders why? If by the Estate, that would suggest they are intending to keep the track at its current width, contrary to planning requirements.

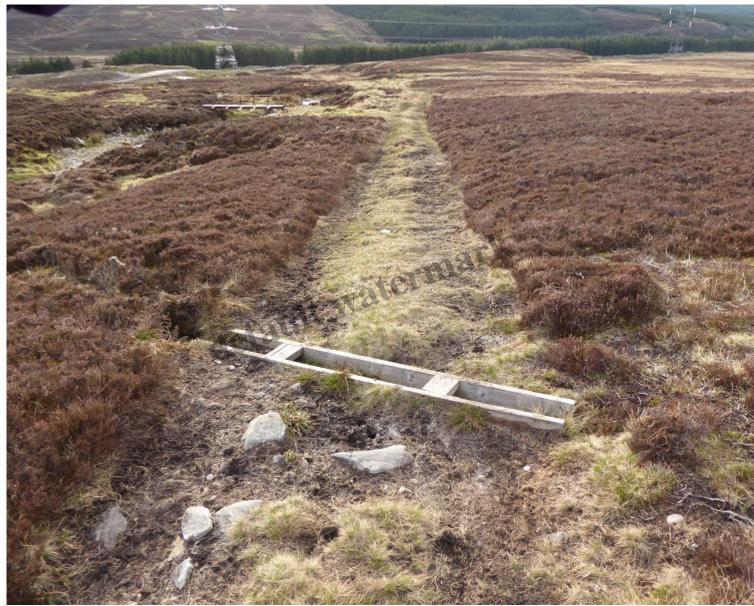
The track that has been developed along the line of grouse butts on the north side of the Allt Coire nan Cisteachan. The installation of a water bar means, I believe, that this counts as a constructed track and should have had full planning permission – its purpose, along the line of grouse butts is only too clear and has nothing to do with agriculture (where developments only require "prior notification").

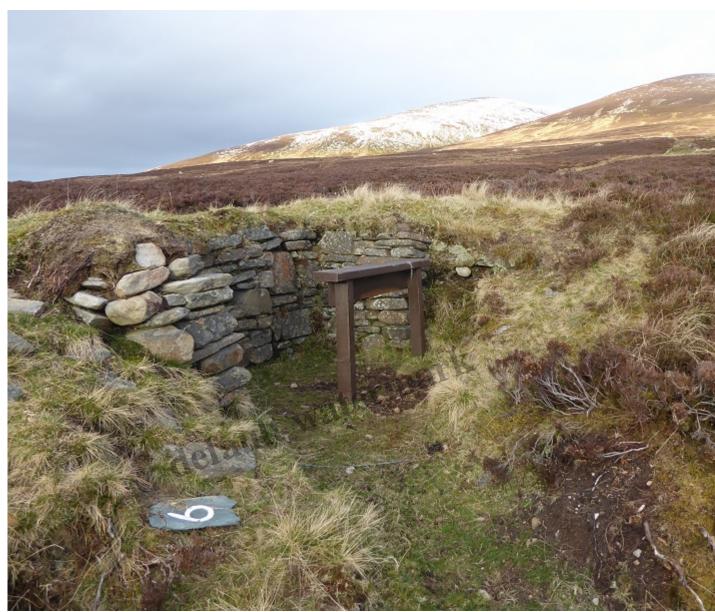
The track, as you can see far right, runs up in front of the grouse butts

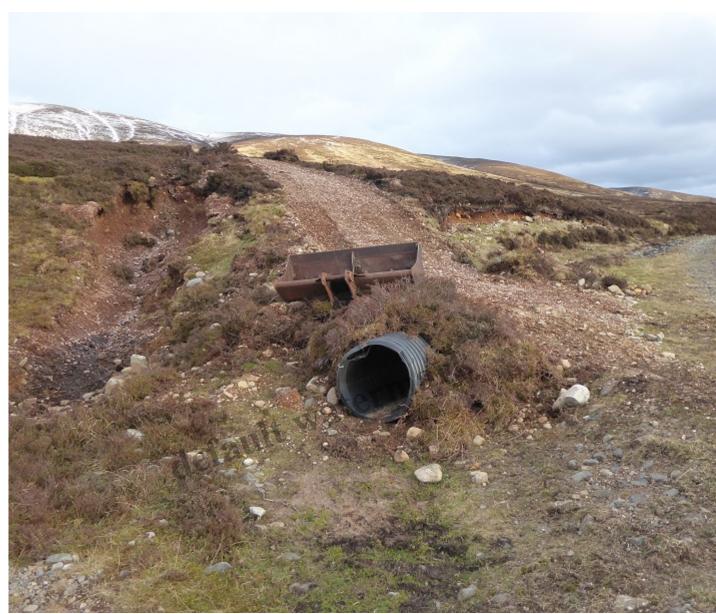
New track, running up south side of Allt Coire na Cisteachan and branching off track used by many v access A Bhuidheanach

The constructed nature of the track on the south side of the burn is even more obvious and to an appalling standard (I will report it to the National Park). Although the newly "constructed" section is short, its intention is clearly to enable vehicle access up the hillside easier and yet more scars on the Drumochter.

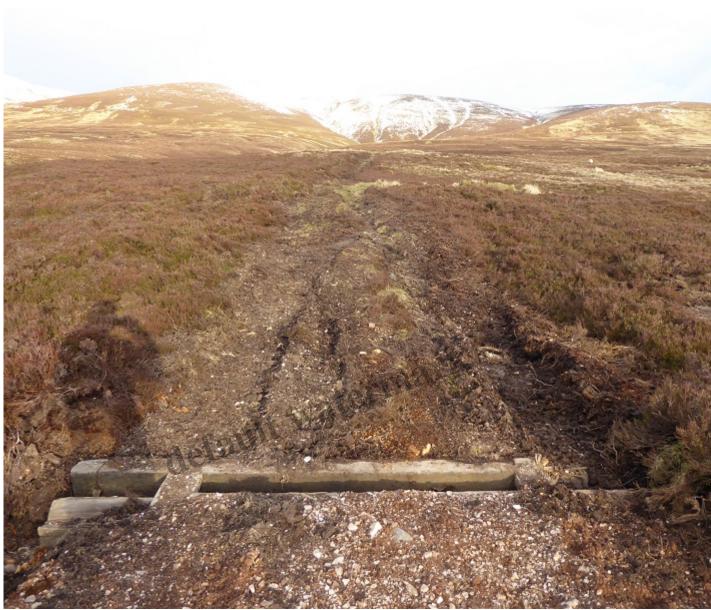
End of the 20m section of track showing erosion created beyond
