The Beaully Denny and persecution tracks at Drumochter

On Wednesday evening I went to have another look at the northern section of the access track which had been created for the construction of the Beaully Denny powerline and which was due to be restored last year ([see here](#)). It's situated on the east side of the A9 behind the tree shelter belt and opposite the southern turn off to Dalwhinnie.

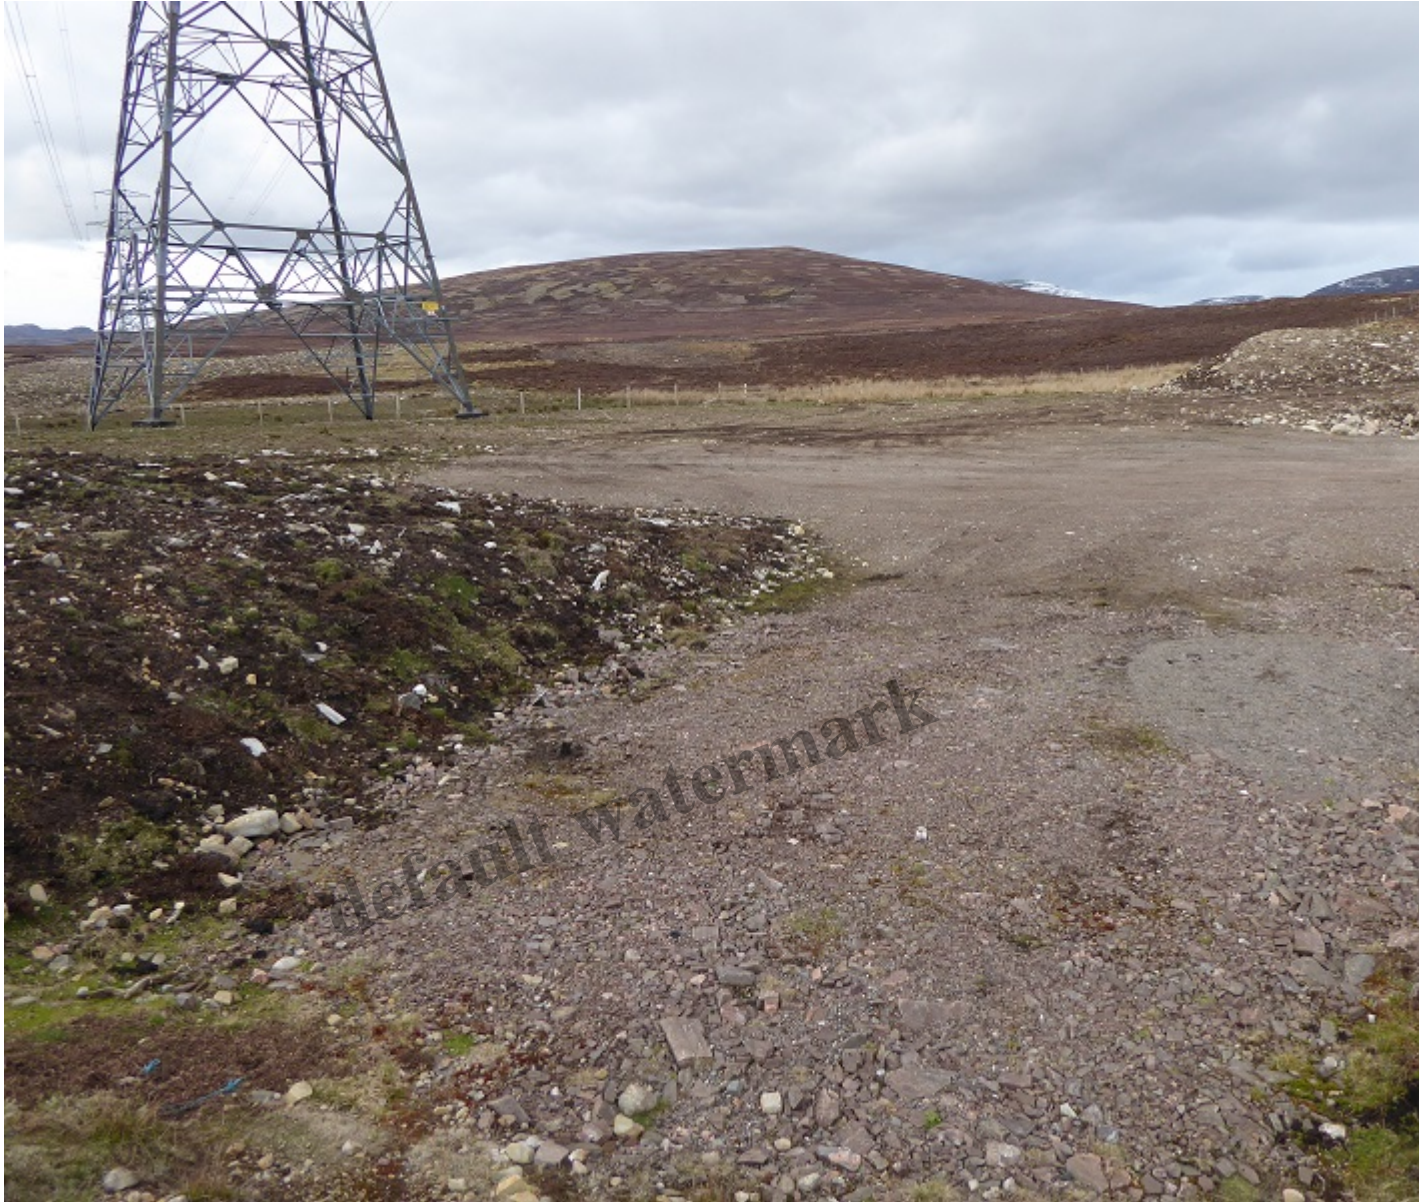
The north end of the track, which is blighted by a so-far unrestored large turning area

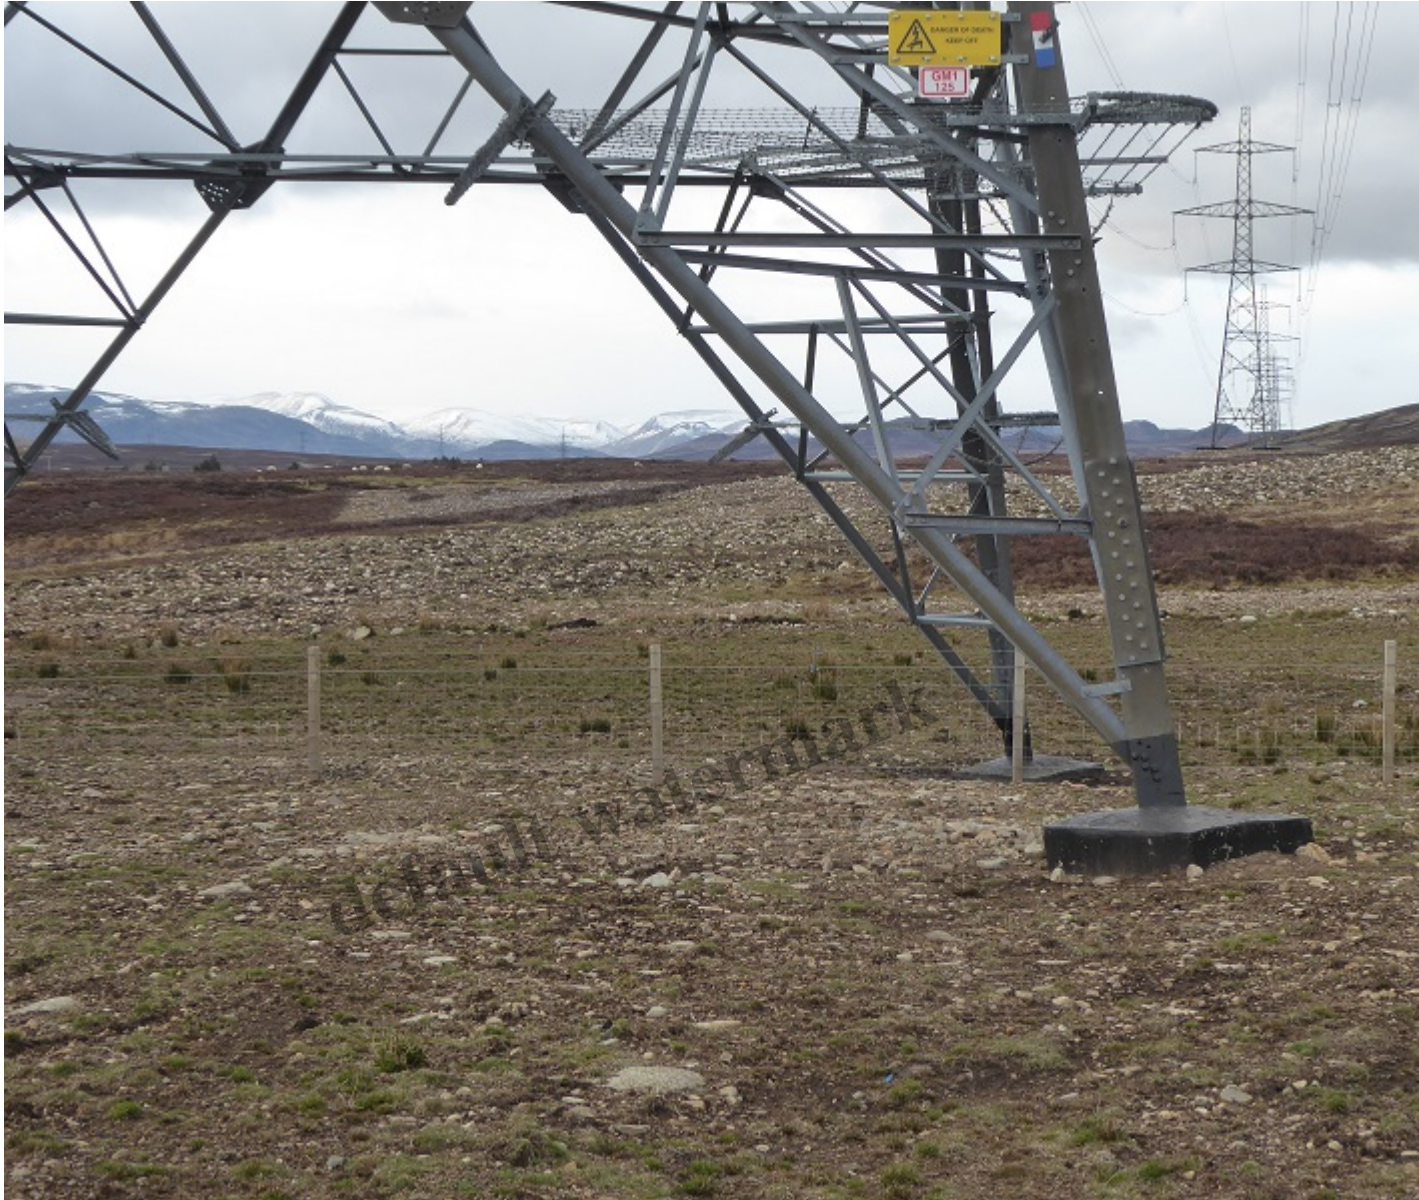
Tower 125 just beyond the end of the track. There is a patch, just behind the tower, where vegetation is recovering, unlike the scar in the middle distance

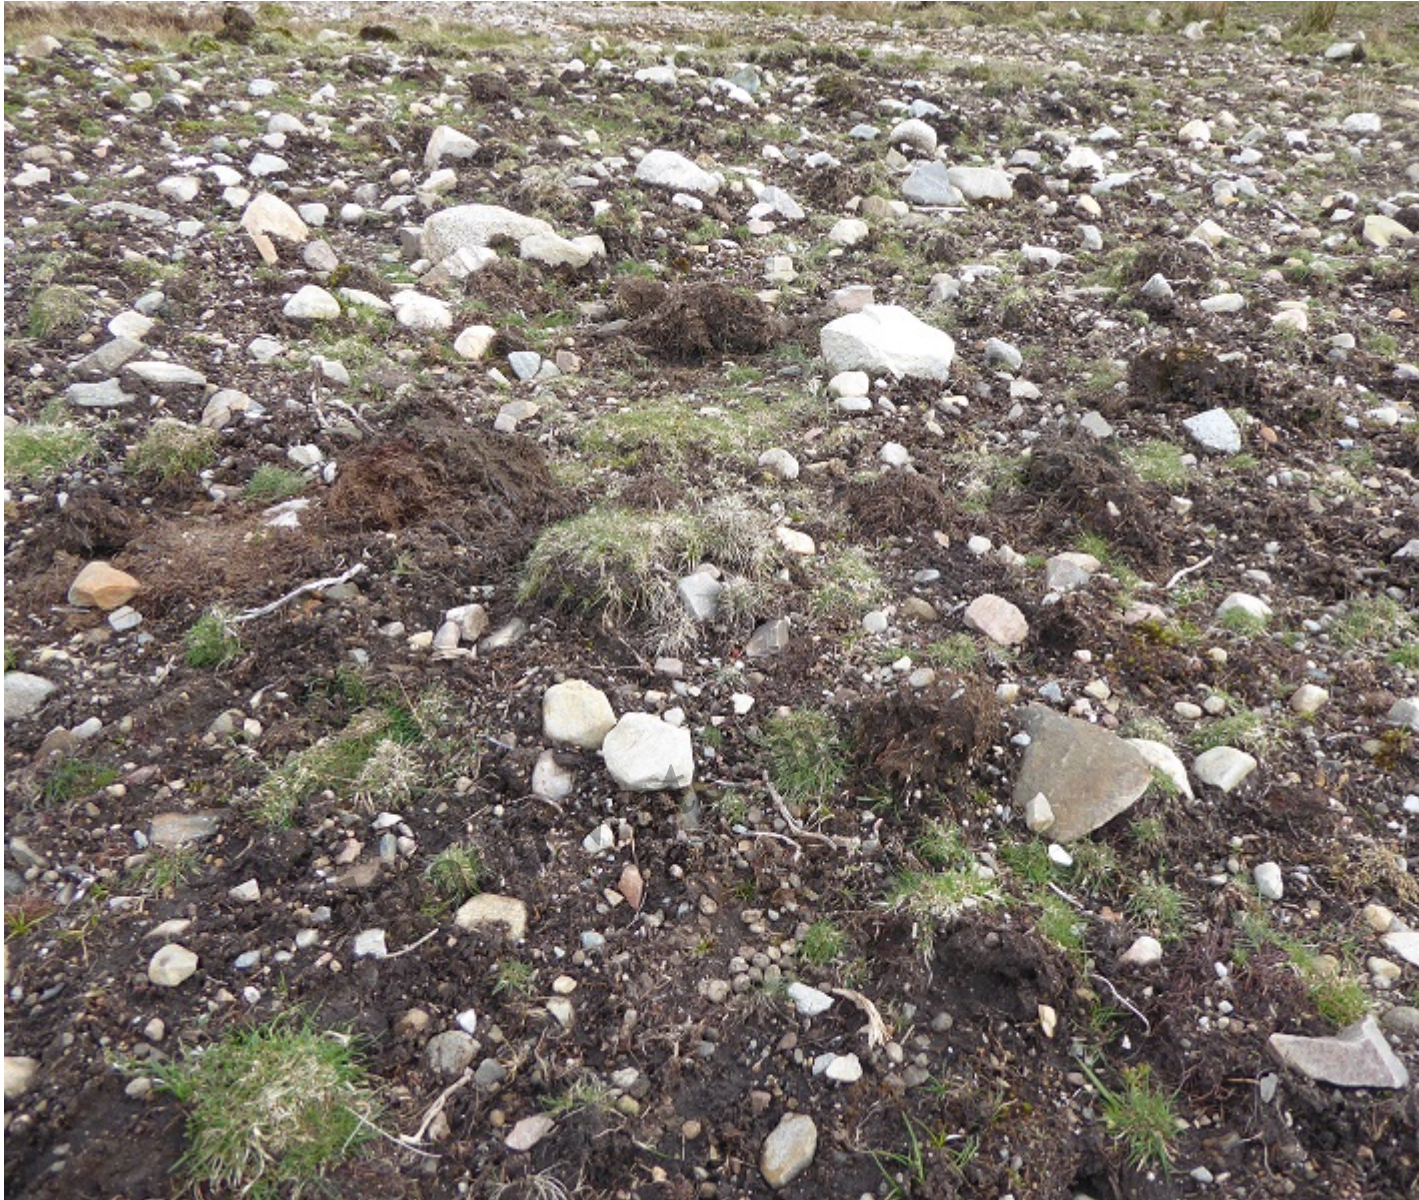
Photo of ground north of tower 125. Stones have been mixed with soil and insufficient turf retained to cover the whole. To make matters worse clumps of turf have simply been dumped on along with stones on

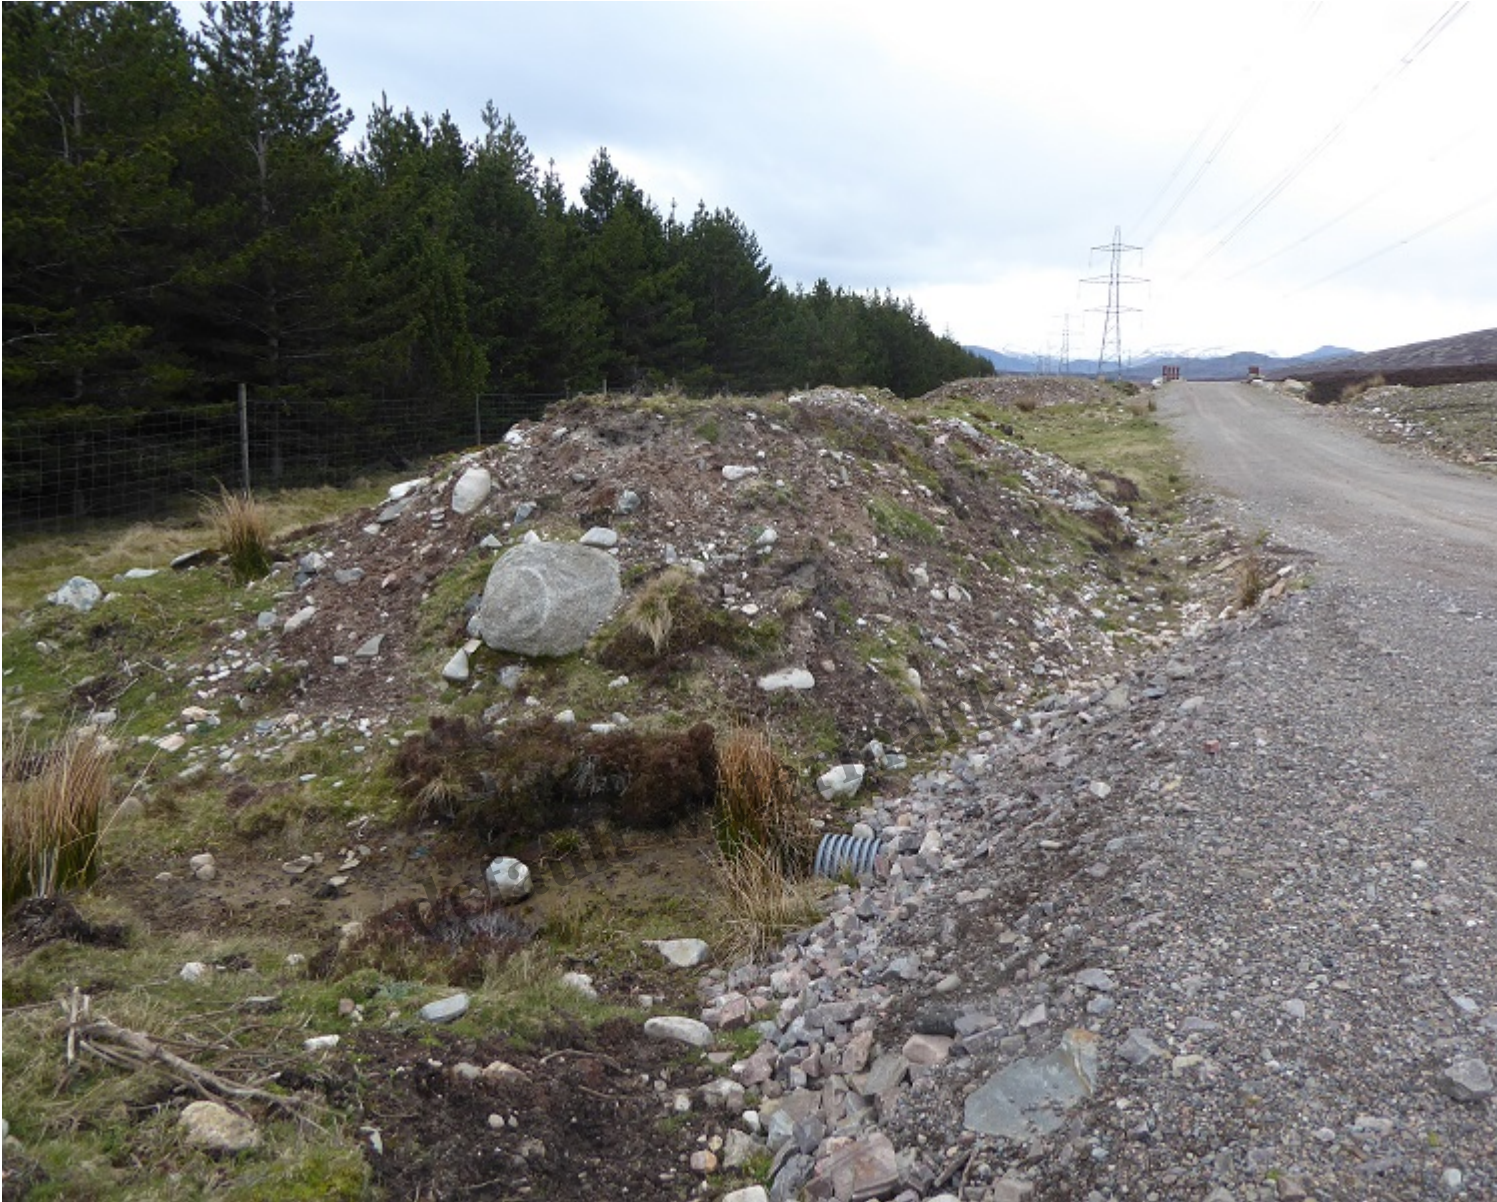
The amount of work – and therefore cost – in meeting the approved design plans for the track are considerable. The 4.7 km of track needs to be reduced from its current width of 5-7m to 3m.

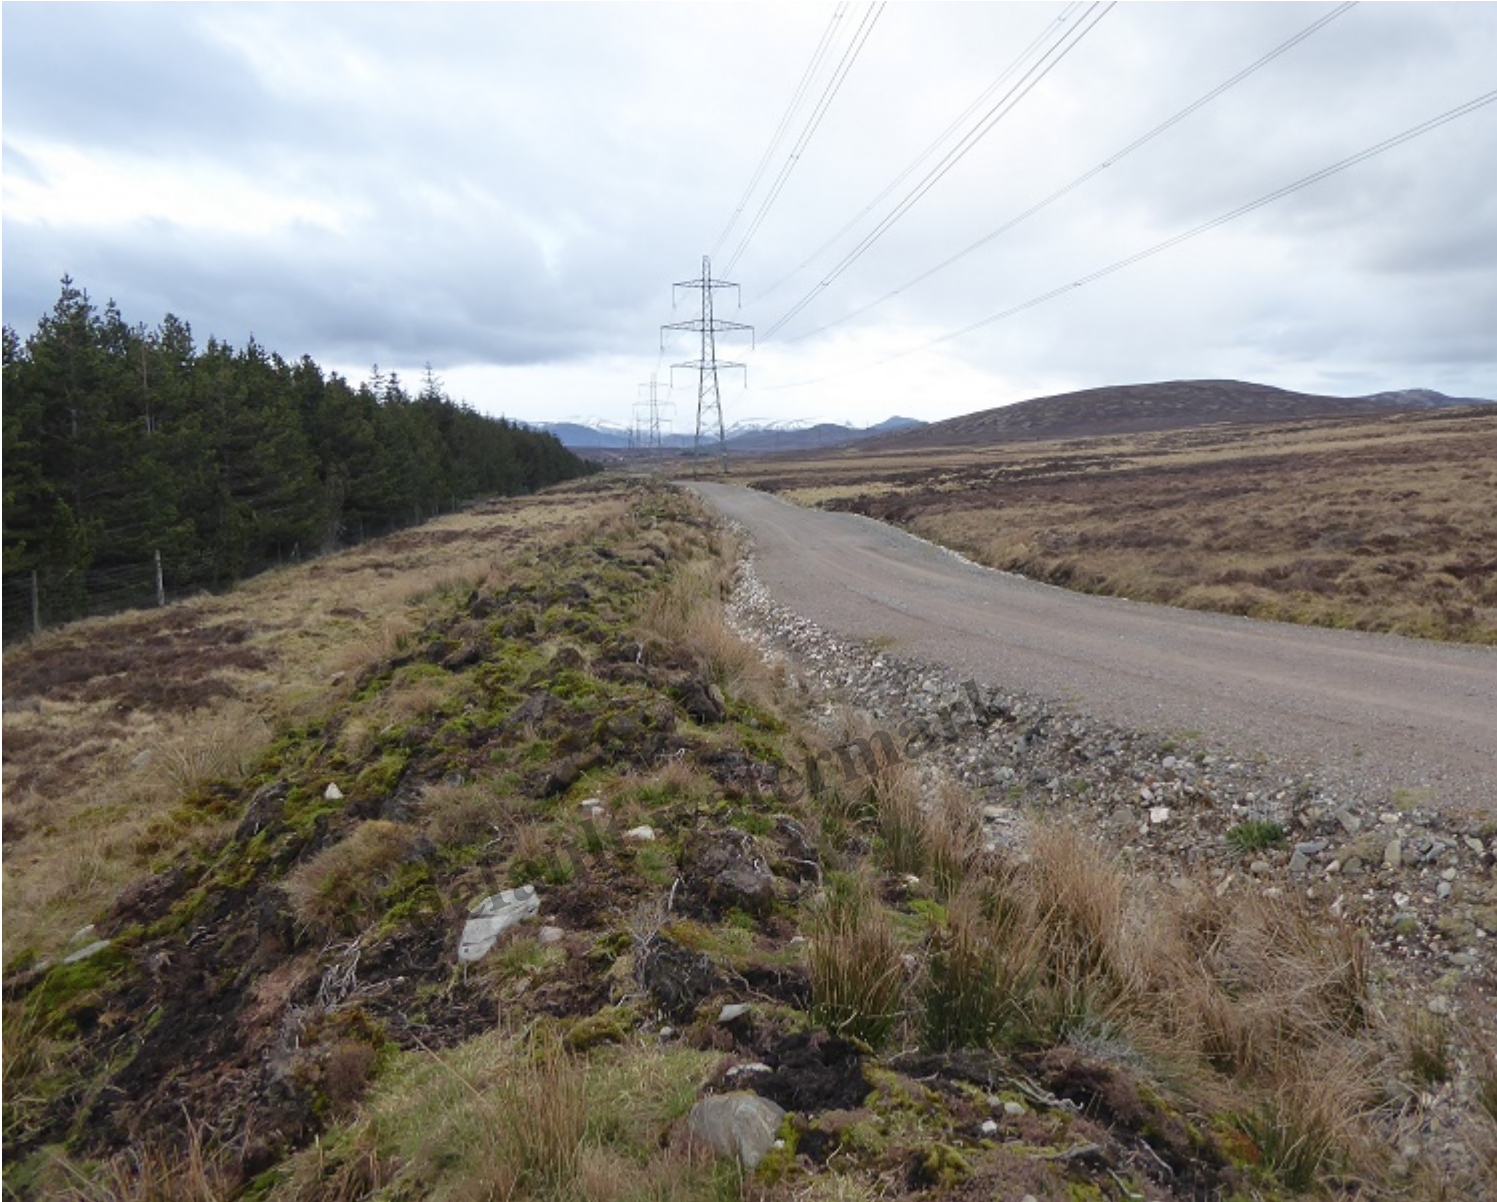
So much aggregate has been imported to construct the track that even where turves have been properly stored, re-landscaping will be a real challenge. The planning permission granted by the CNPA specifies that excess materials will be removed, which would make landscaping considerably easier – a great requirement but will the estate do it?

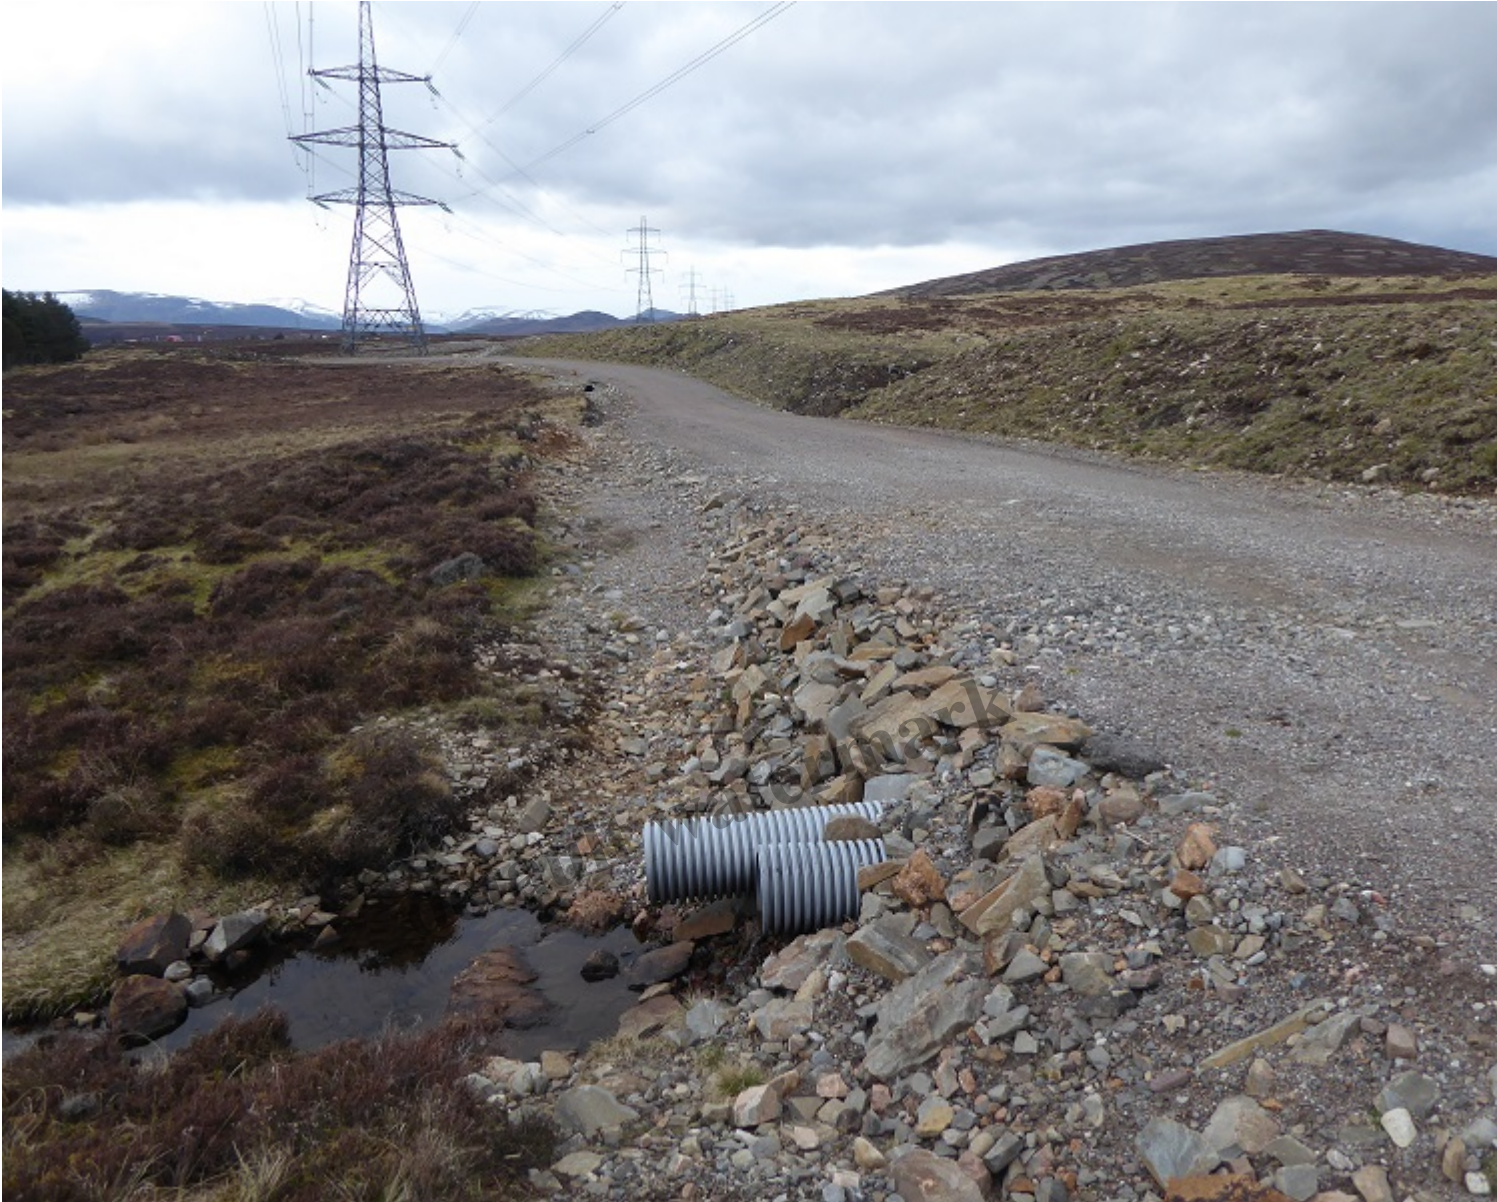
The job will not be made any easier because so much of the temporary construction work was so poor. If this track is to be halved in width, so will the drainage pipes.

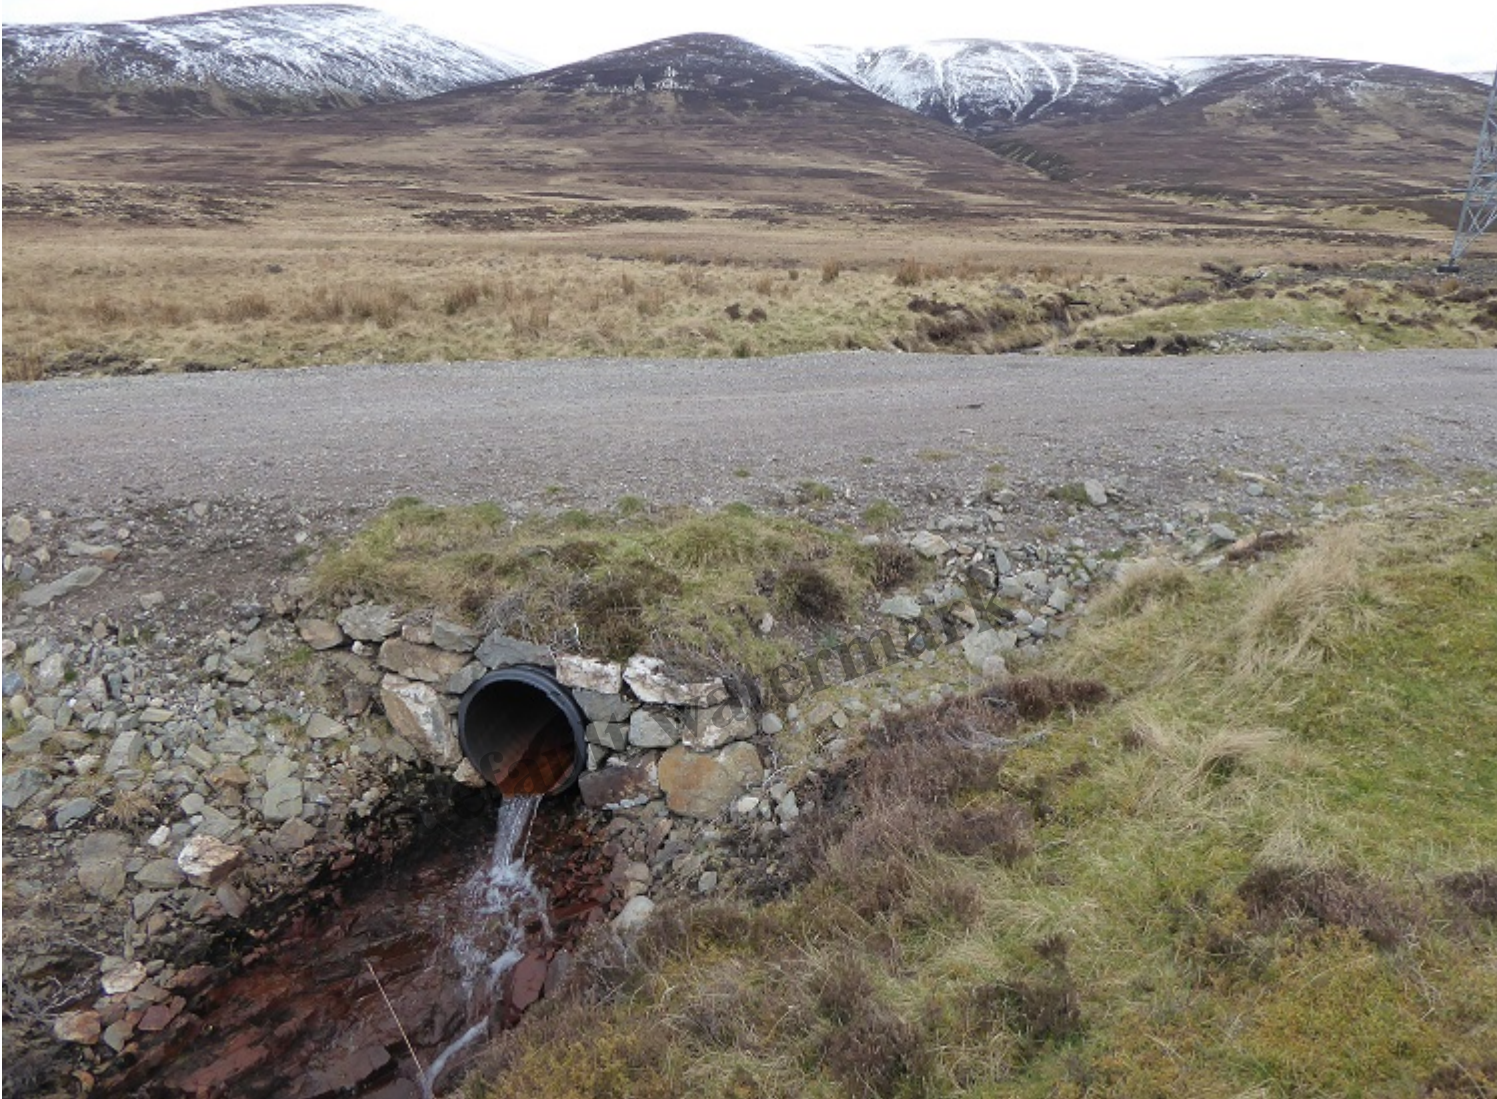
Bizarrely, among all the protruding pipes, there was one example of a culvert which had been properly finished – at both ends too! Unfortunately, the track here was even wider than normal, 7m rather than 5m, and at least one of the finished culverts will need be ripped out if the track is to be reduced in width to 3m. If this work was done by SSE, one wonders why? If by the Estate, that would suggest they are intending to keep the track at its current width, contrary to planning requirements.

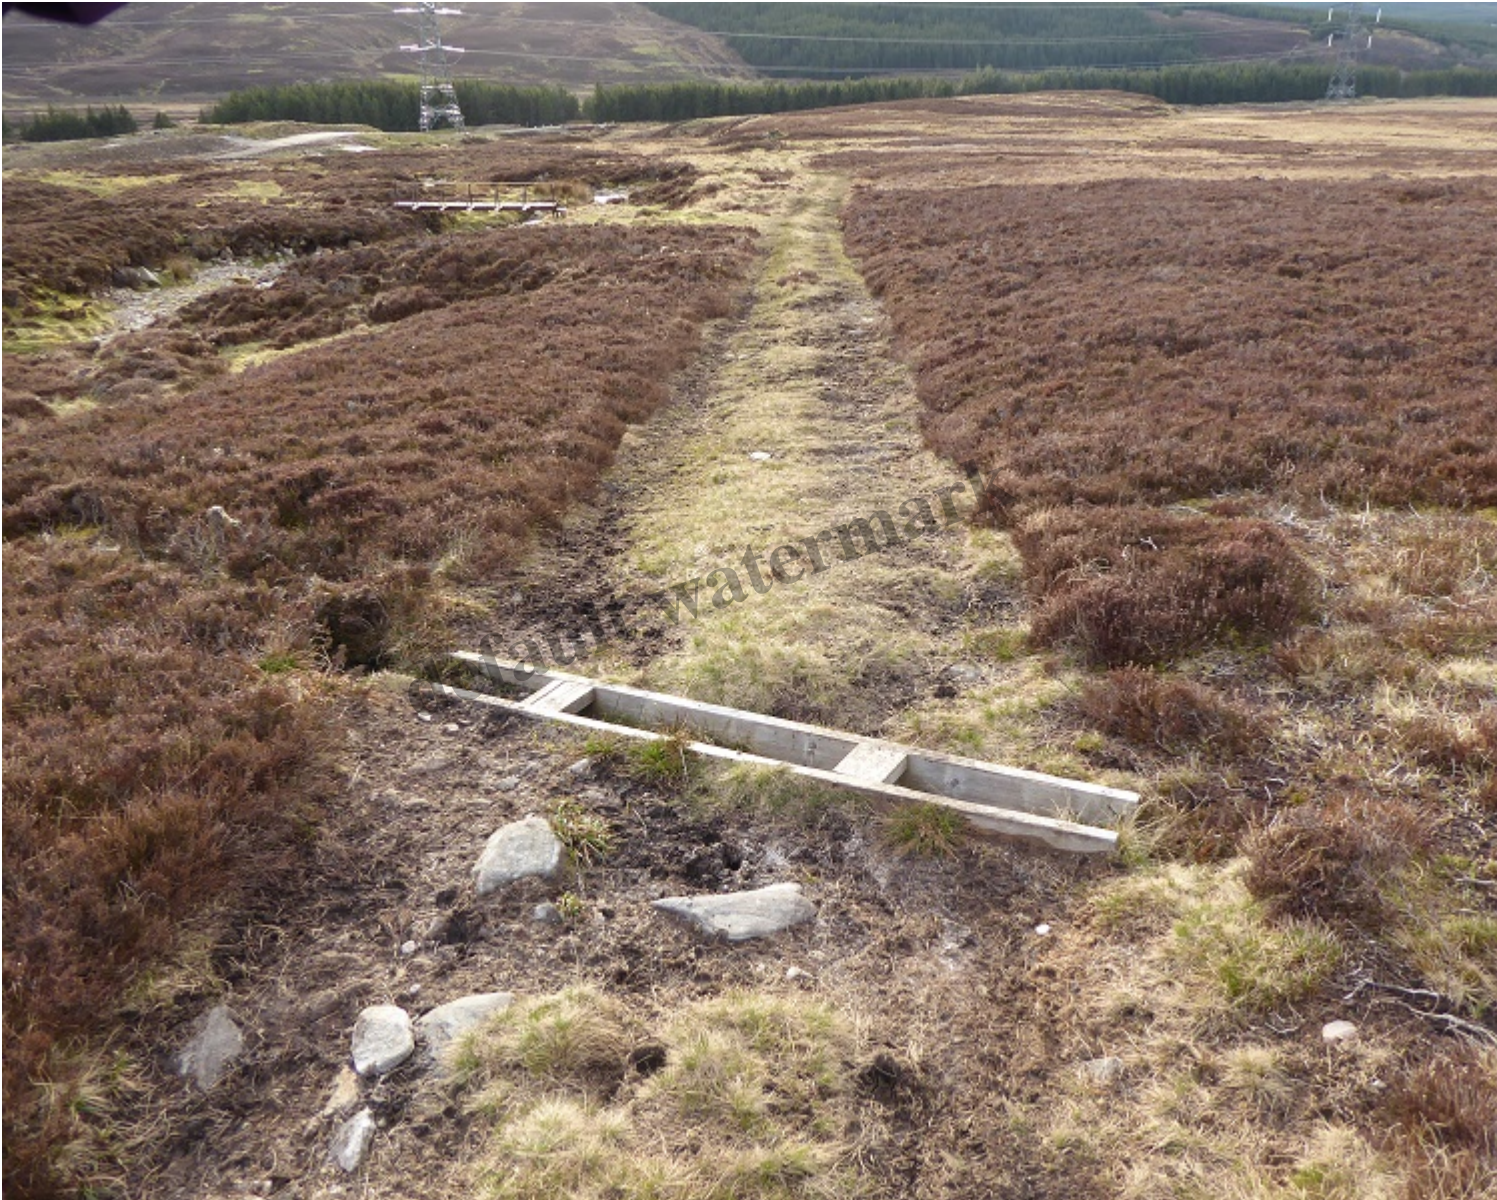
The track that has been developed along the line of grouse butts on the north side of the Allt Coire nan Cisteachan. The installation of a water bar means, I believe, that this counts as a constructed track and should have had full planning permission – its purpose, along the line of grouse butts is only too clear and has nothing to do with agriculture (where developments only require “prior notification”).

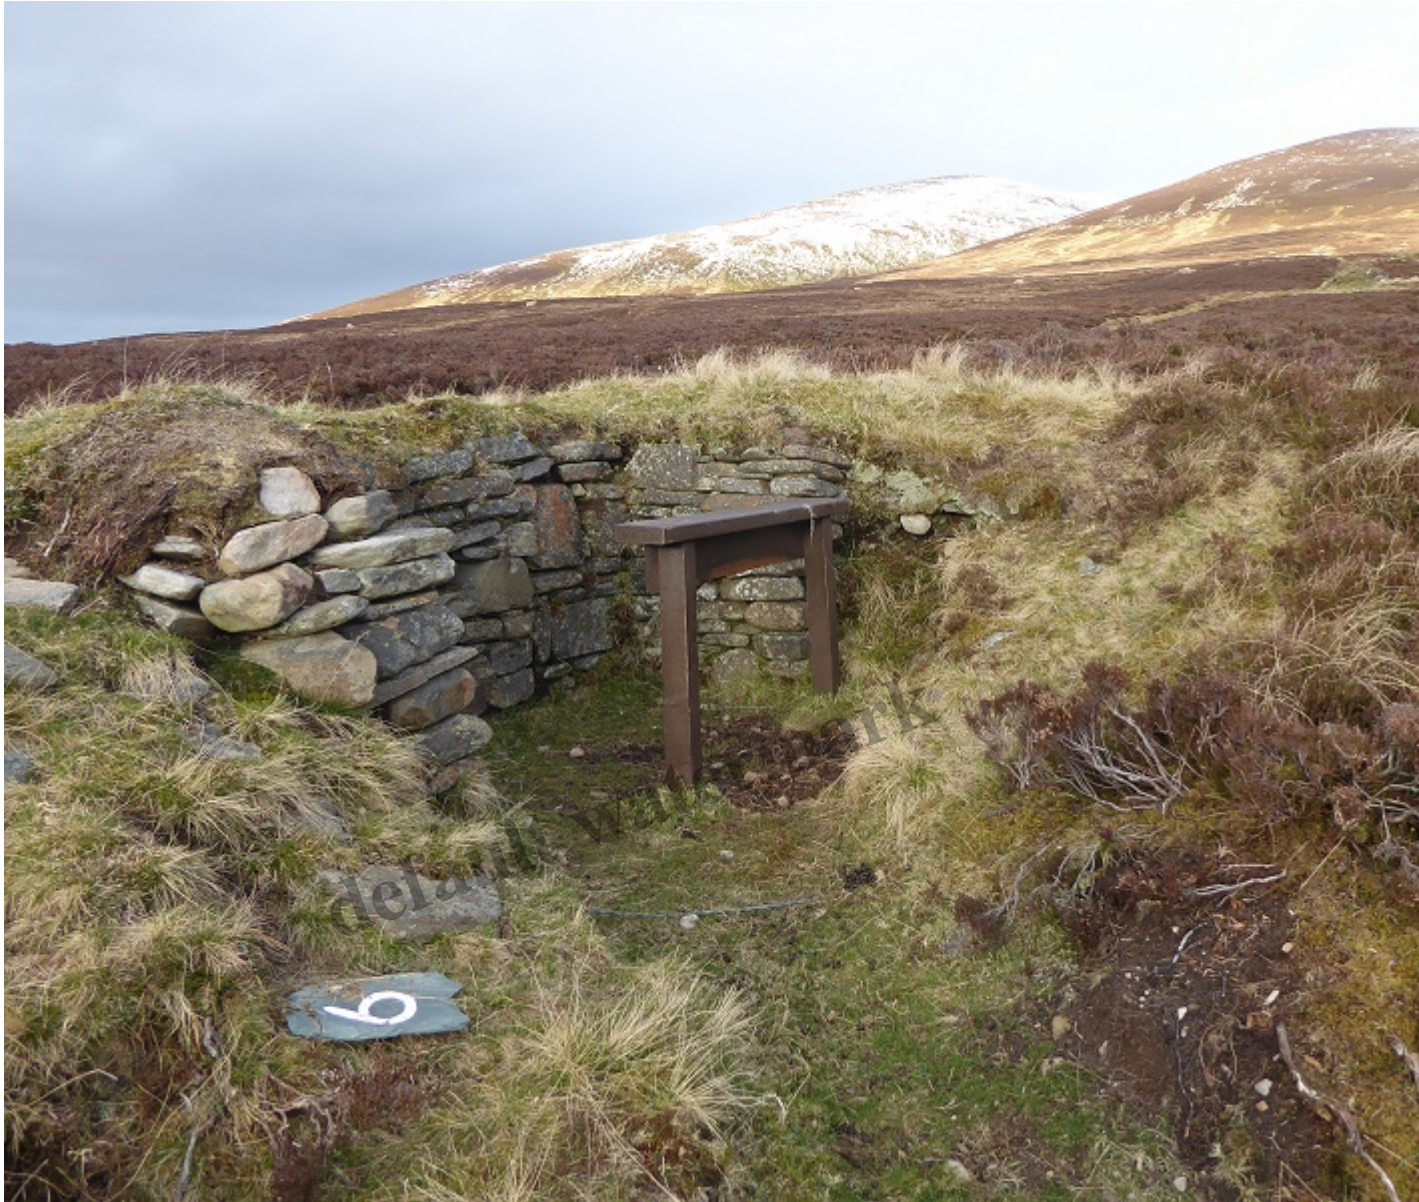
The track, as you can see far right, runs up in front of the grouse butts

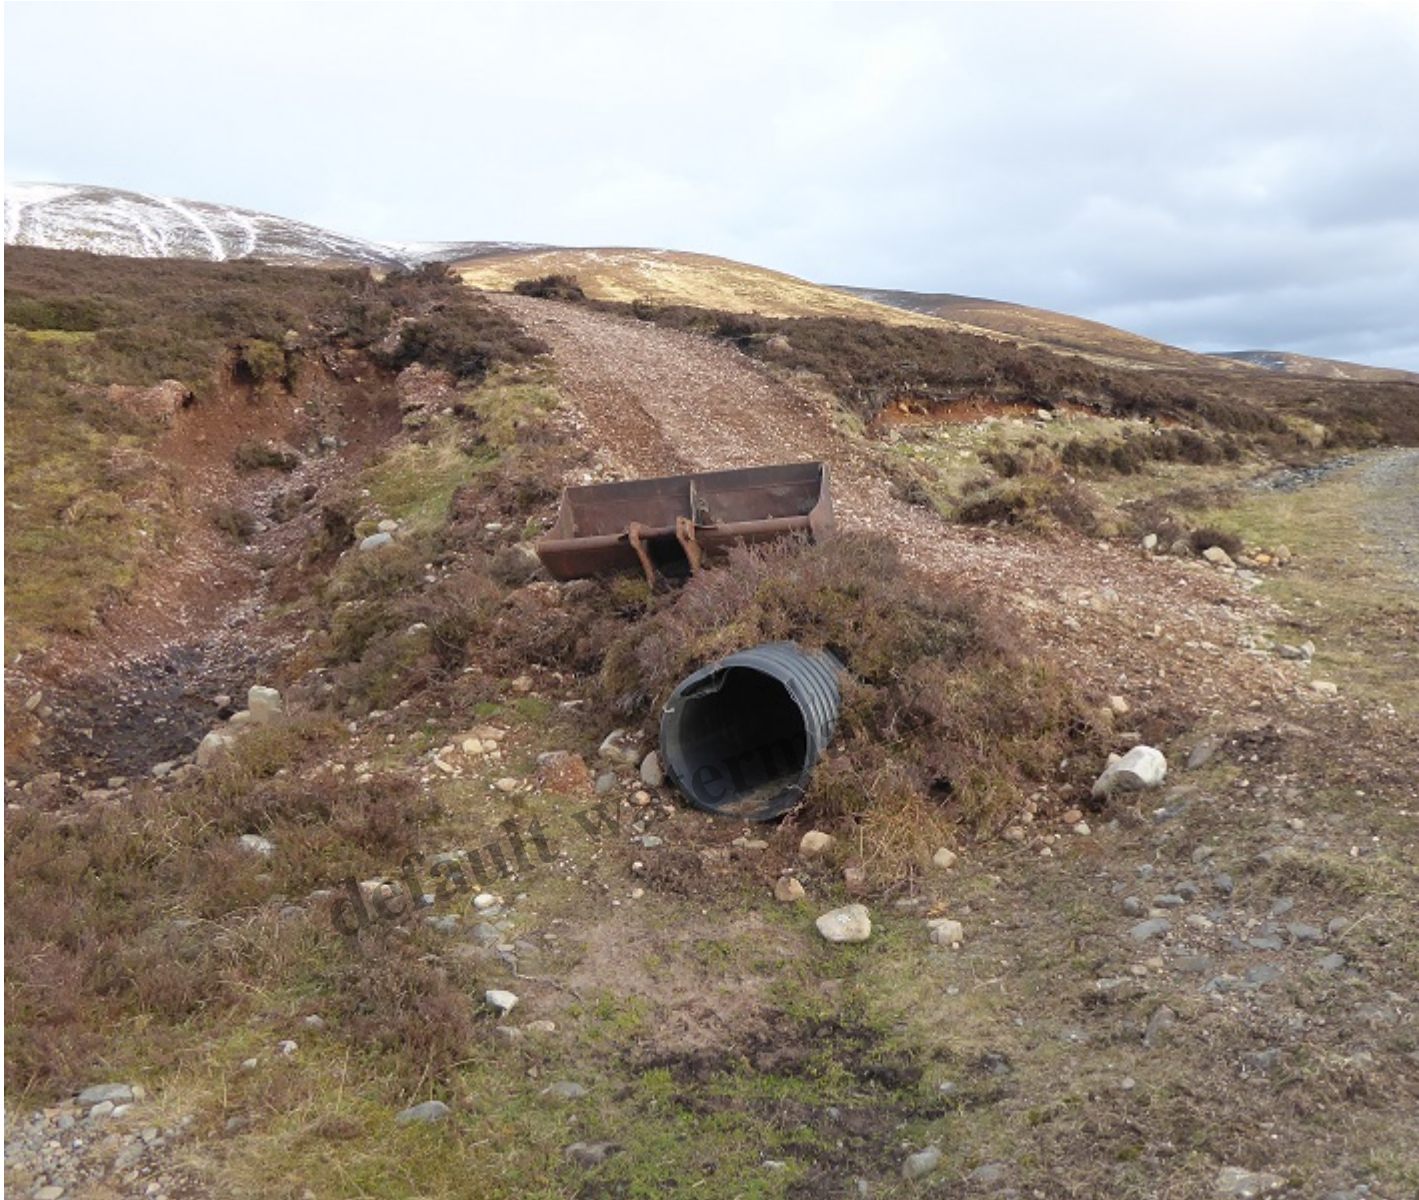
New track, running up south side of Allt Coire na Cisteachan and branching off track used by many vehicles to access A Bhuidheanach

The constructed nature of the track on the south side of the burn is even more obvious and to an appalling standard (I will report it to the National Park). Although the newly “constructed” section is short, its intention is clearly to enable vehicle access up the hillside easier and yet more scars on the Drumochter.

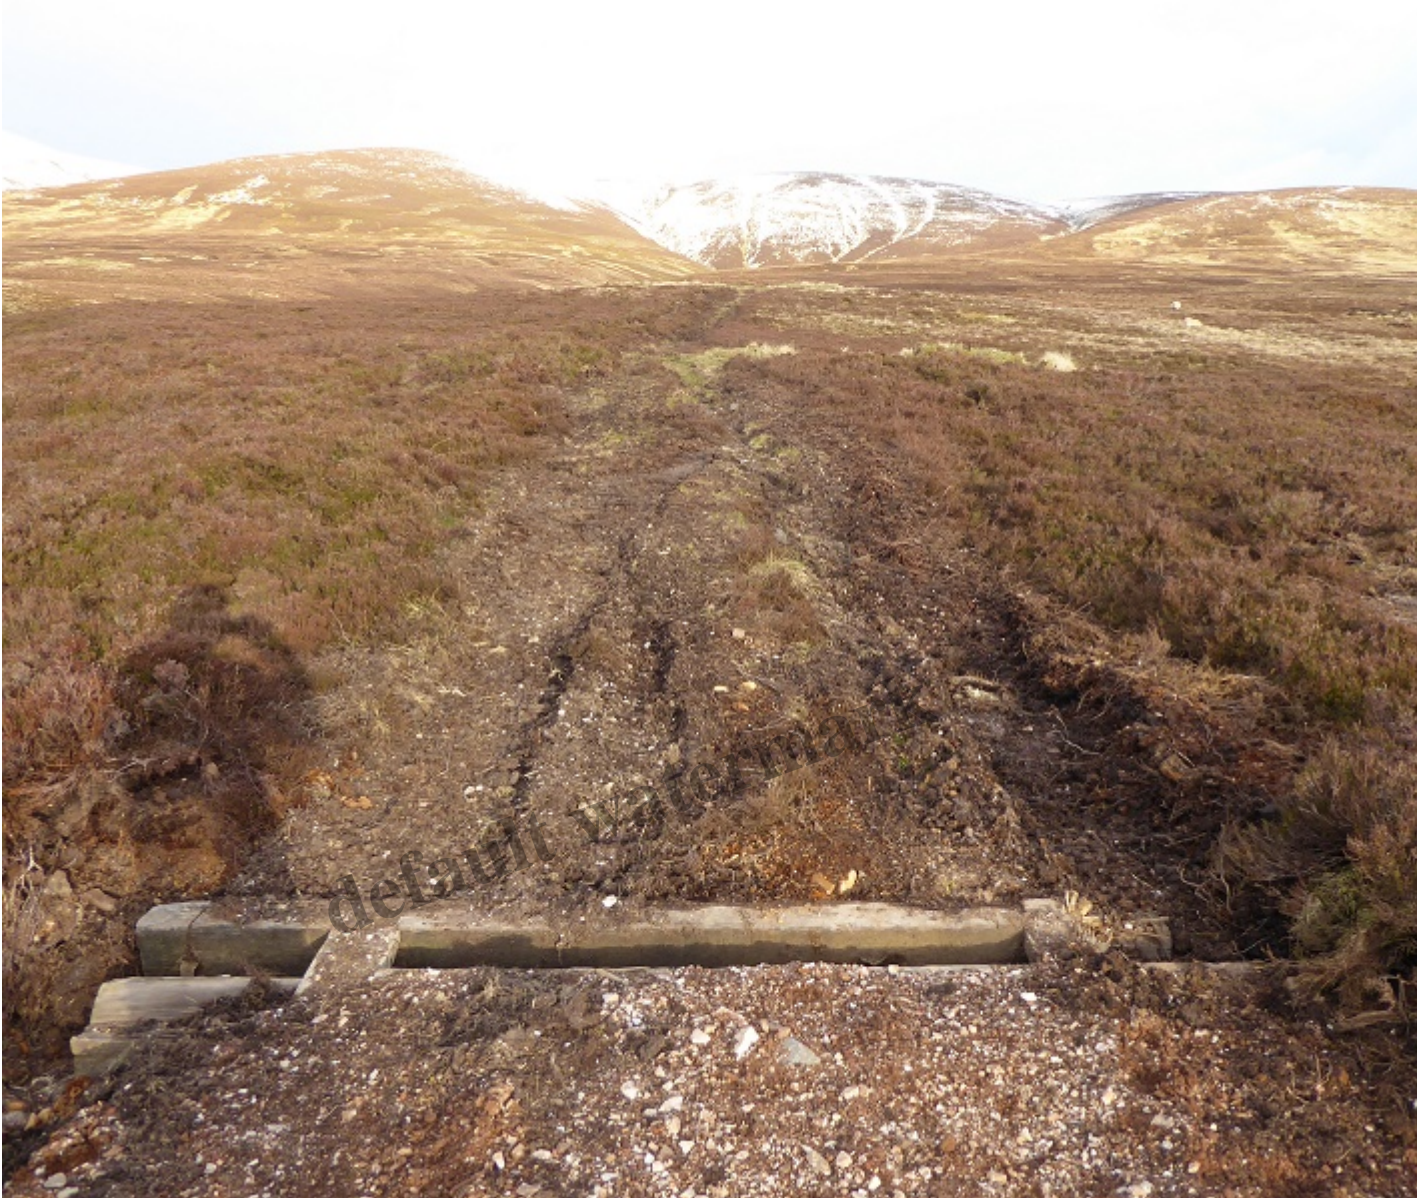
End of the 20m section of track showing erosion created beyond
