The Beaully Denny and persecution tracks at Drumochter

On Wednesday evening I went to have another look at the northern section of the access track which had been created for the construction of the Beaully Denny powerline and which was due to be restored last year ([see here](#)). Its situated on the east side of the A9 behind the tree shelter belt and opposite the southern turn off to Dalwhinnie.

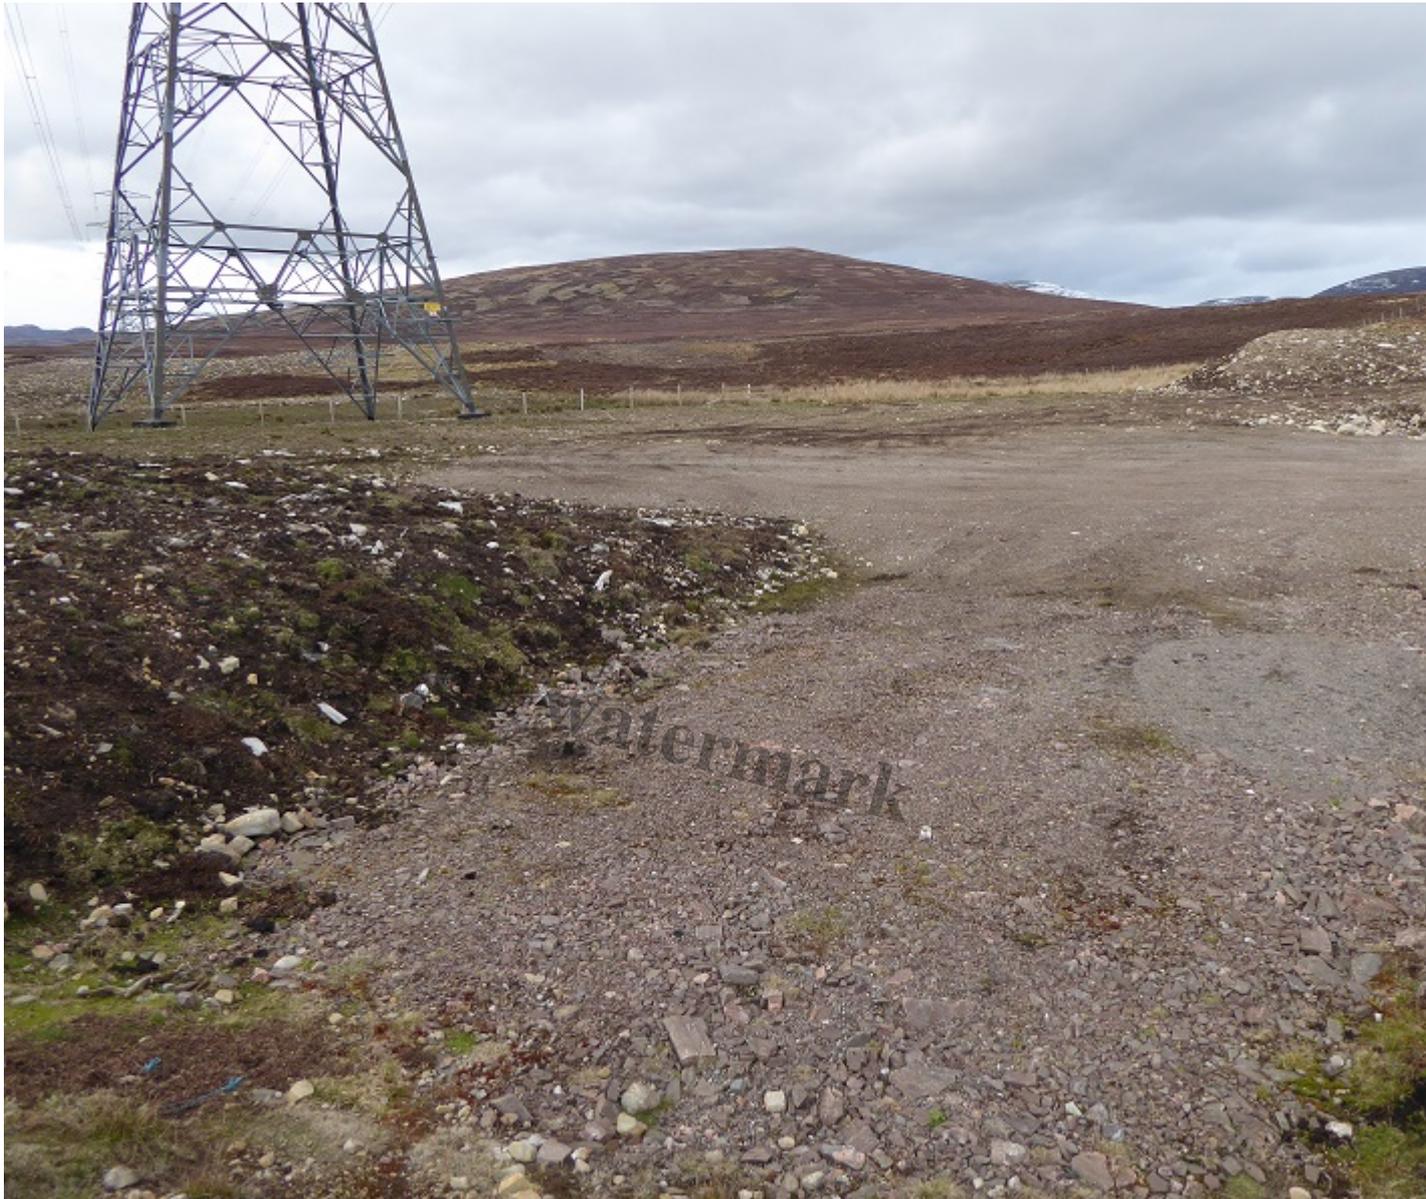
The north end of the track, which is blighted by a so-far unrestored large turning area

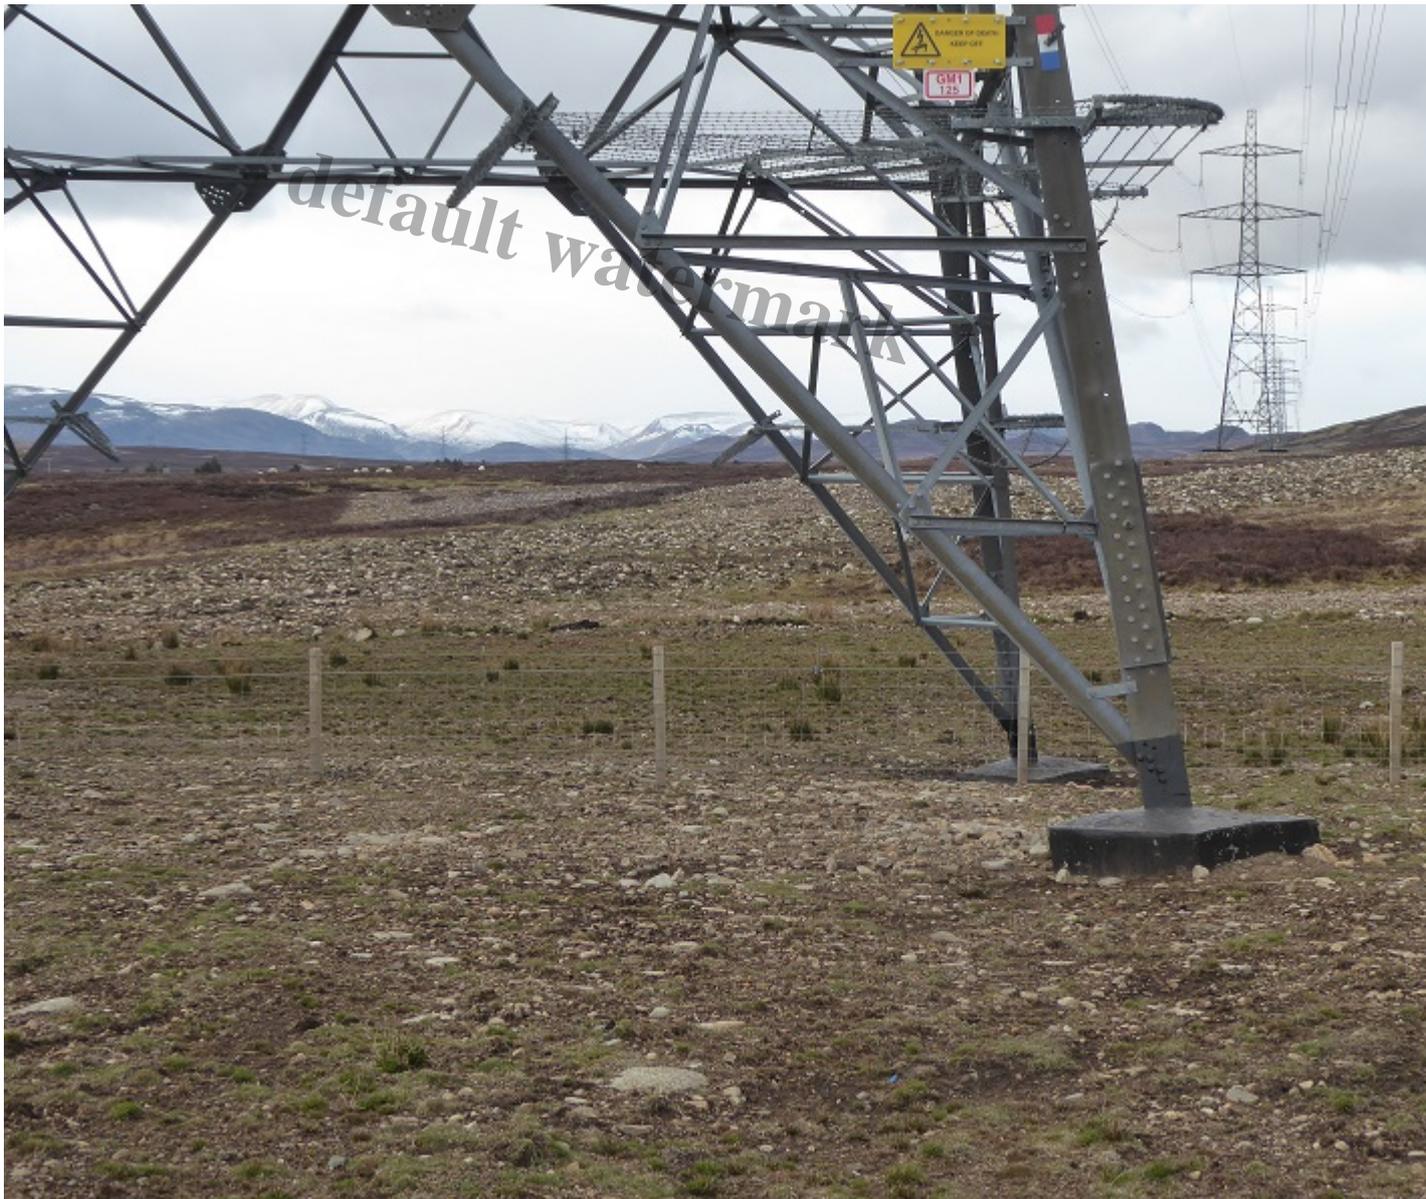
Tower 125 just beyond the end of the track. There is a patch, just behind the tower, where vegetation is recovering, unlike the scar in the middle distance

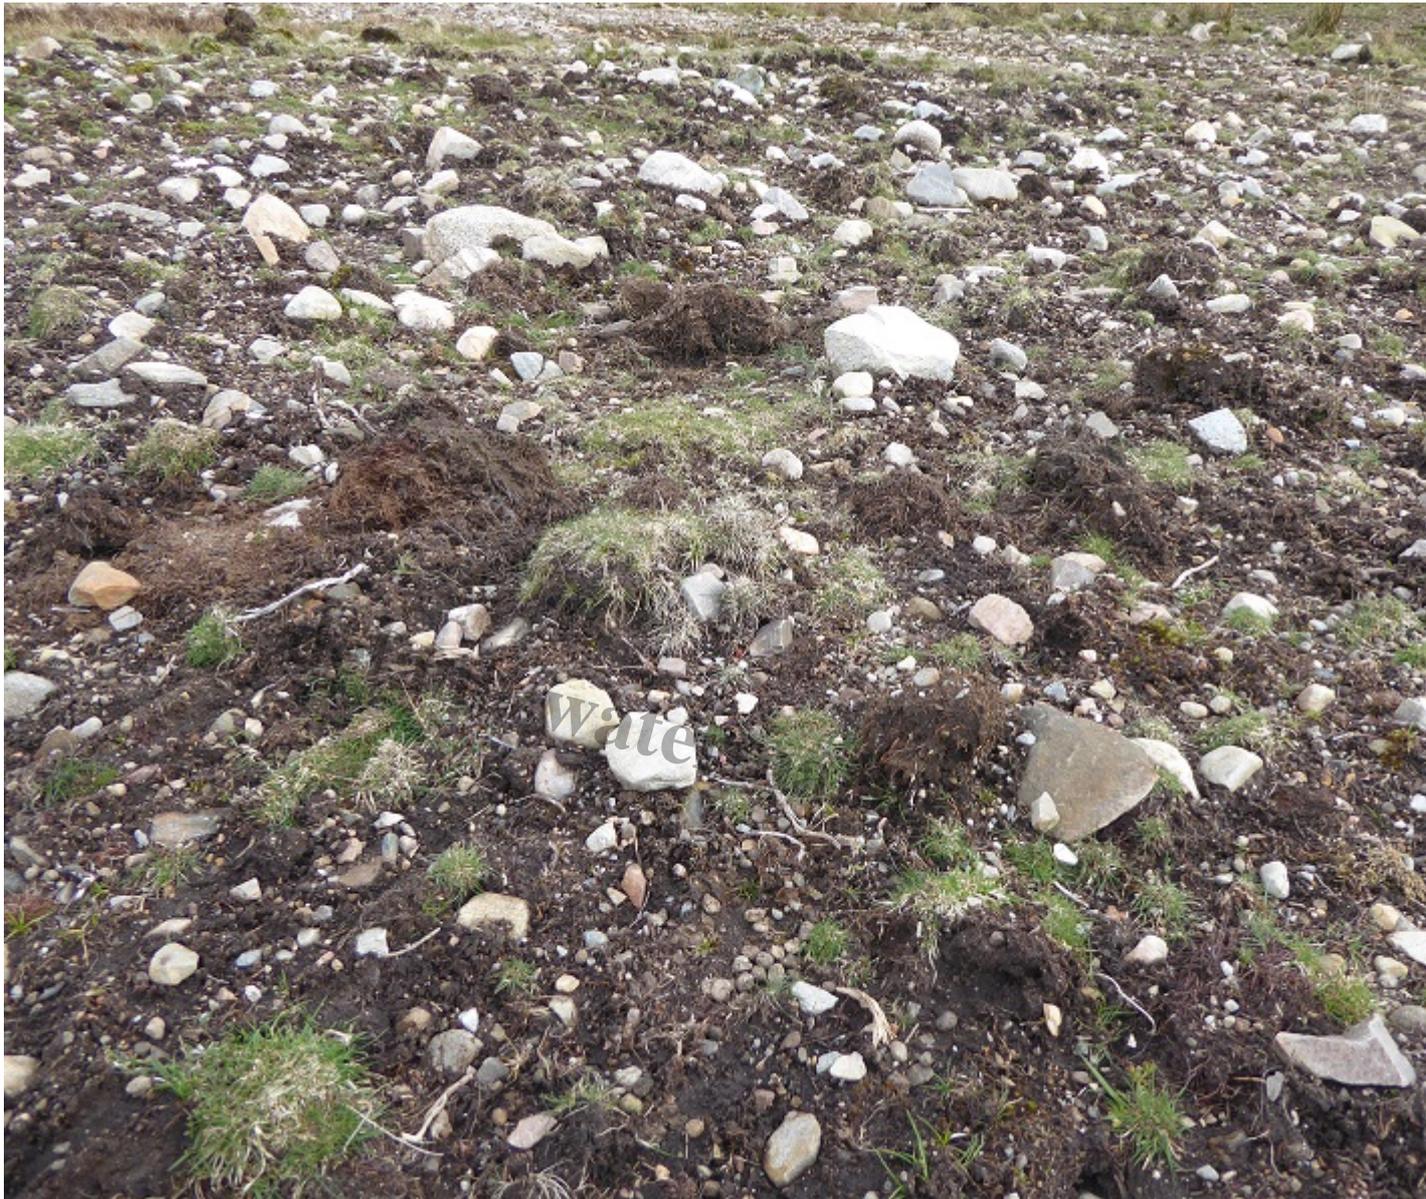
Photo of ground north of tower 125. Stones have been mixed with soil and insufficient turf retained to cover the whole. To make matters worse clumps of turf have simply been dumped on along with stones on

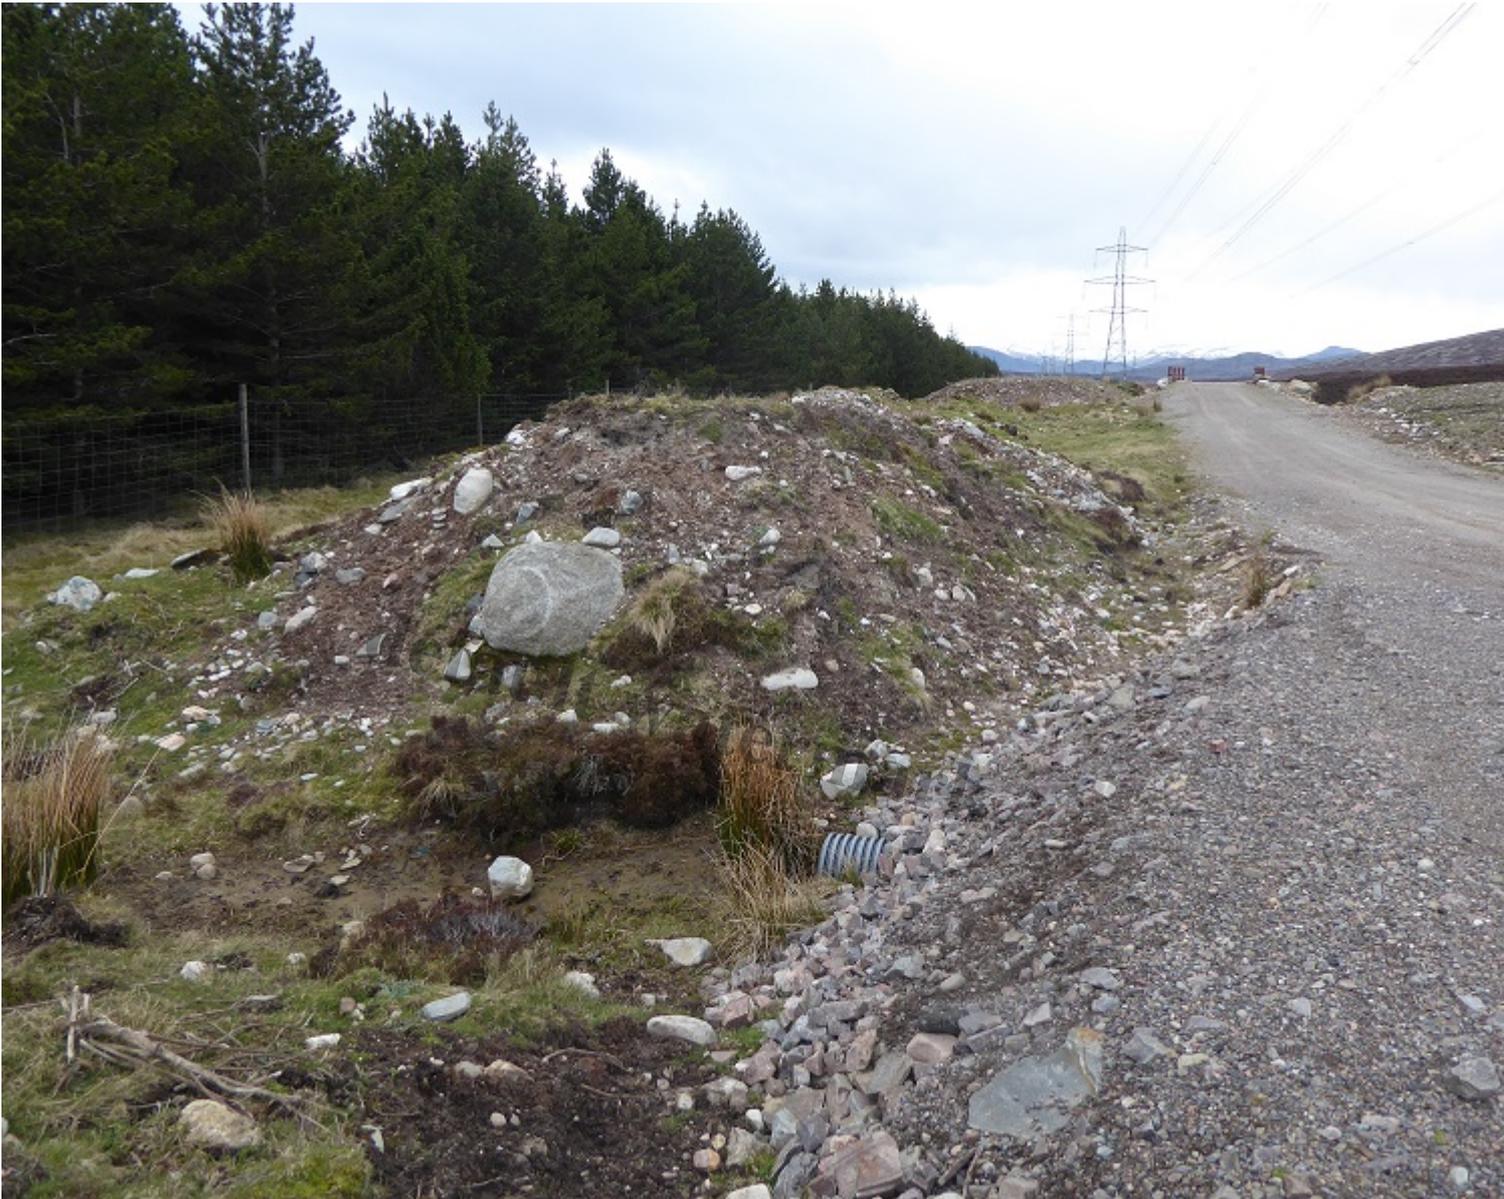
The amount of work â?? and therefore cost â?? in meeting the approved design plans for the track are considerable. The 4.7 km of track needs to be reduced from its current width of 5-7m to 3m.

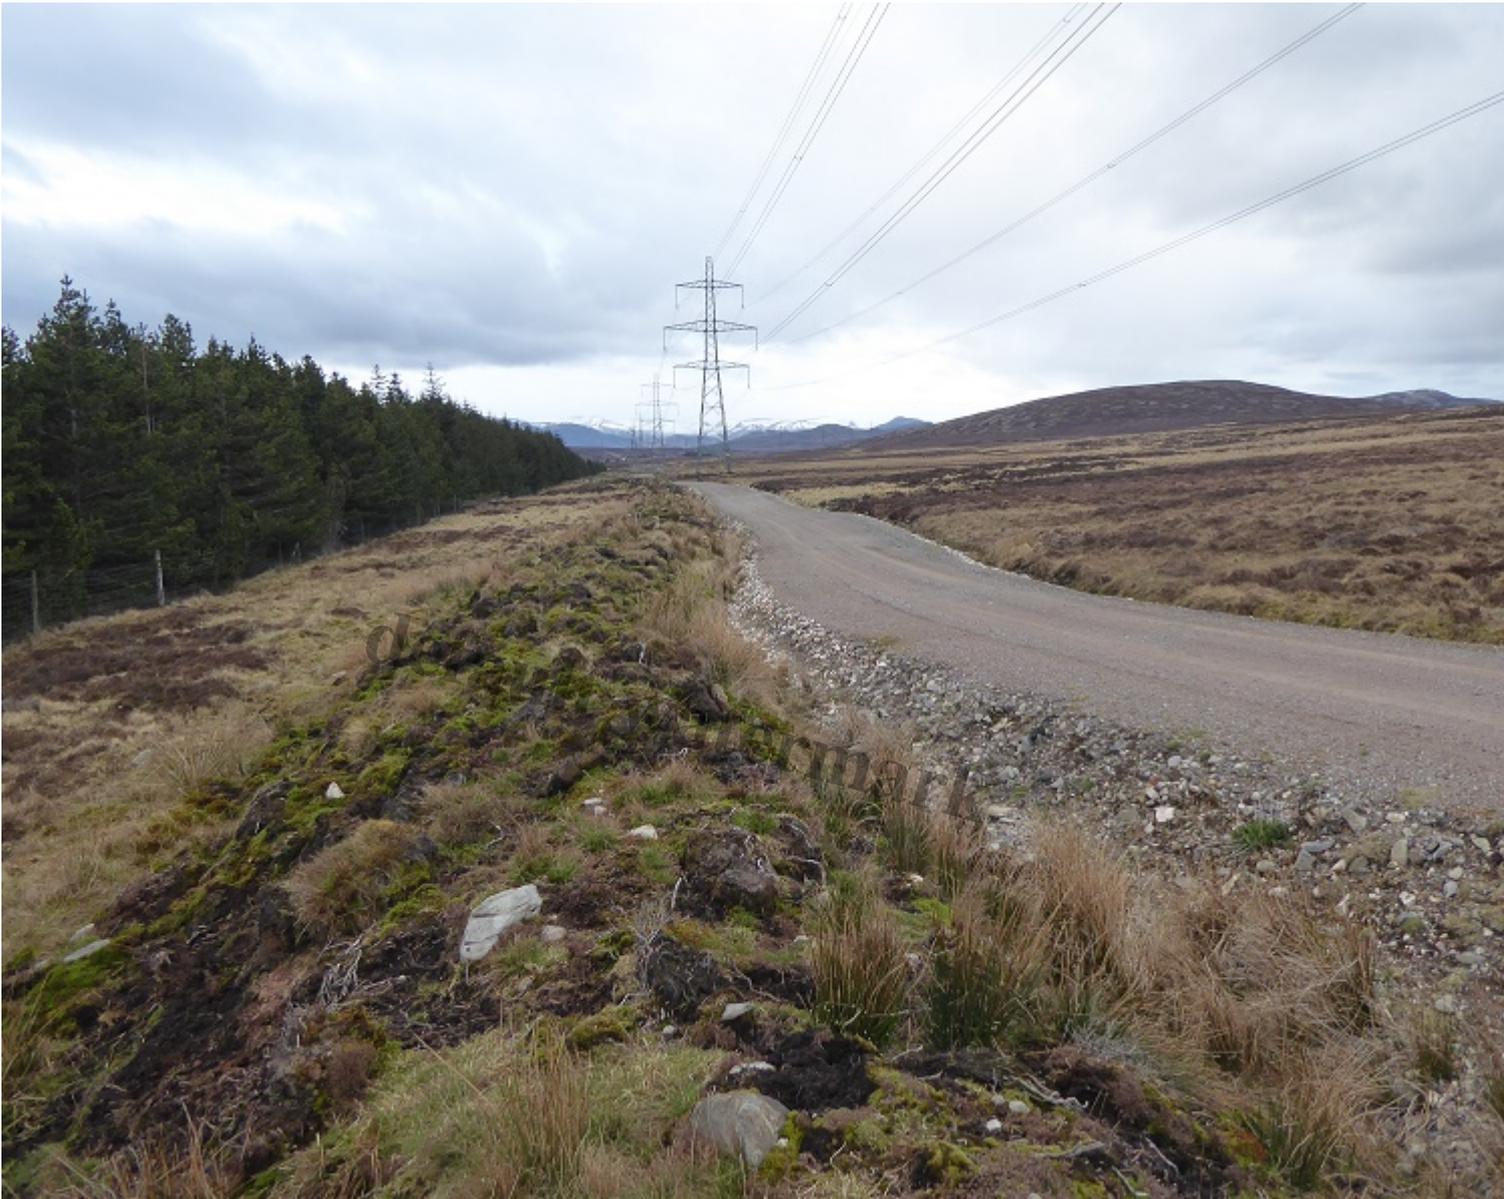
So much aggregate has been imported to construct the track that even where turves have been properly stored, re-landscaping will be a real challenge. The planning permission granted by the CNPA specifies that excess materials will be removed, which would make landscaping considerably easier â?? a great requirement but will the estate do it?

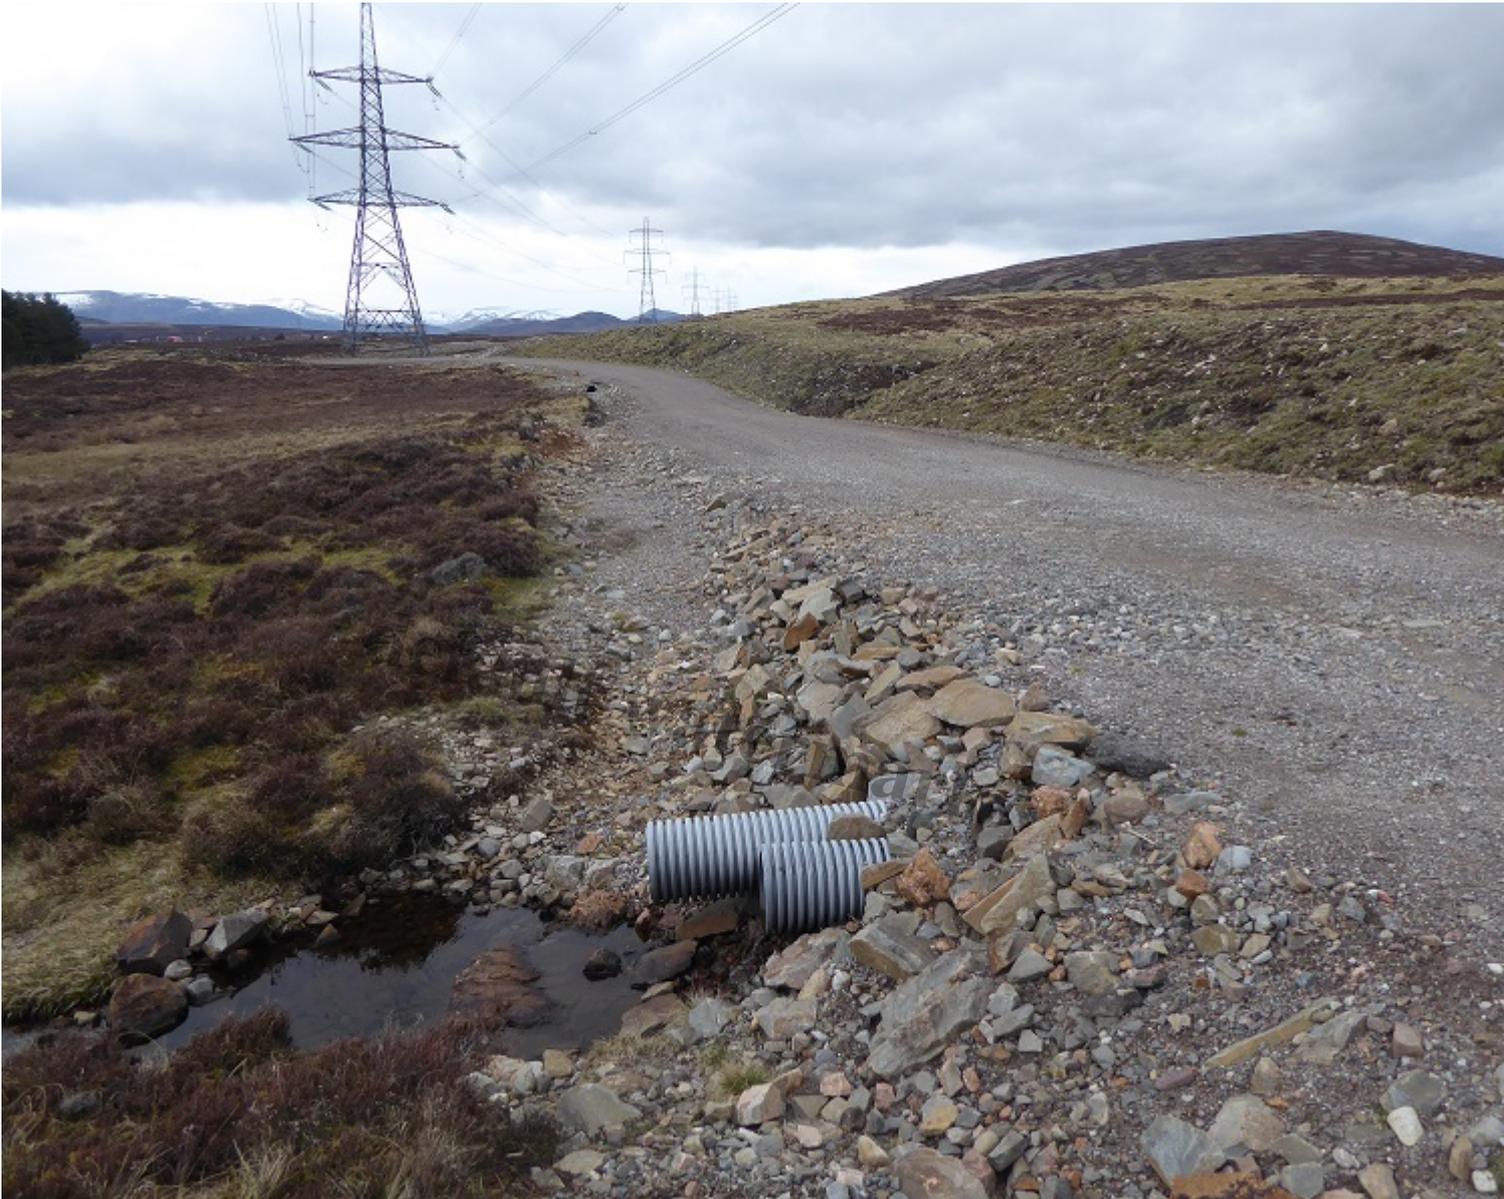
The job will not be made any easier because so much of the temporary construction work was so poor. If this track is to be halved in width, so will the drainage pipes.

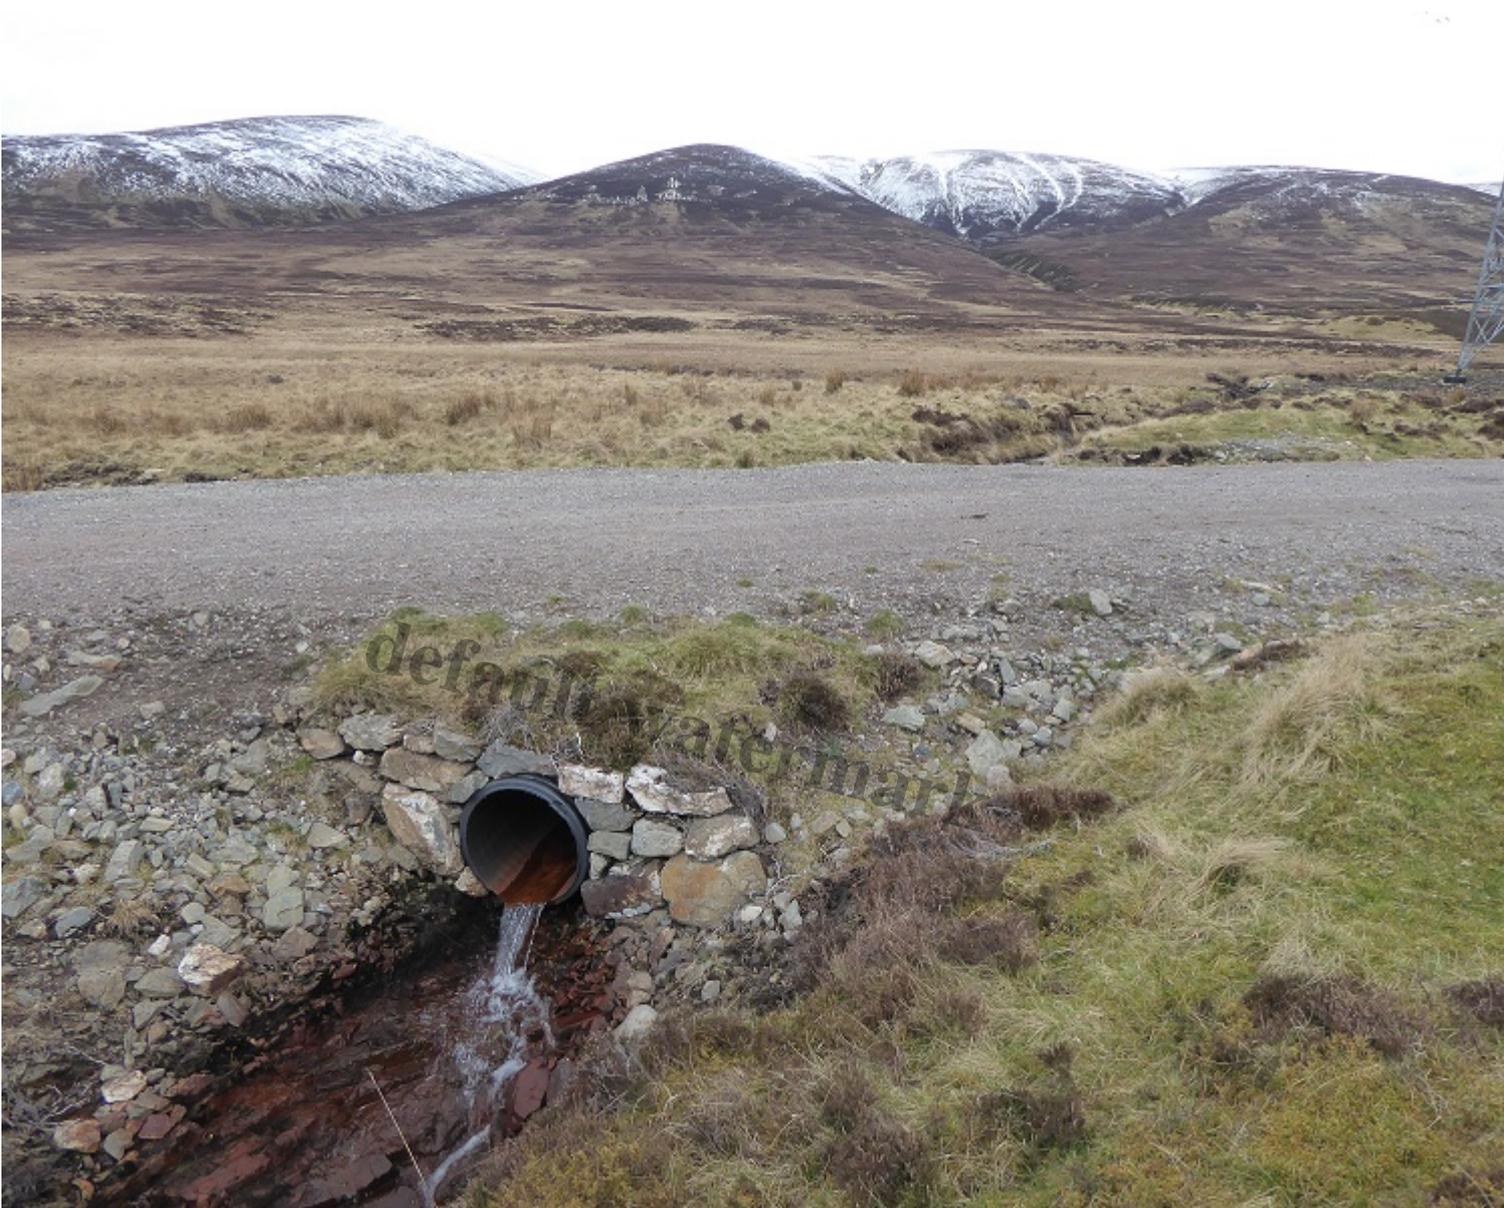
Bizarrely, among all the protruding pipes, there was one example of a culvert which had been properly finished – at both ends too! Unfortunately, the track here was even wider than normal, 7m rather than 5m, and at least one of the finished culverts will need be ripped out if the track is to be reduced in width to 3m. If this work was done by SSE, one wonders why? If by the Estate, that would suggest they are intending to keep the track at its current width, contrary to planning requirements.

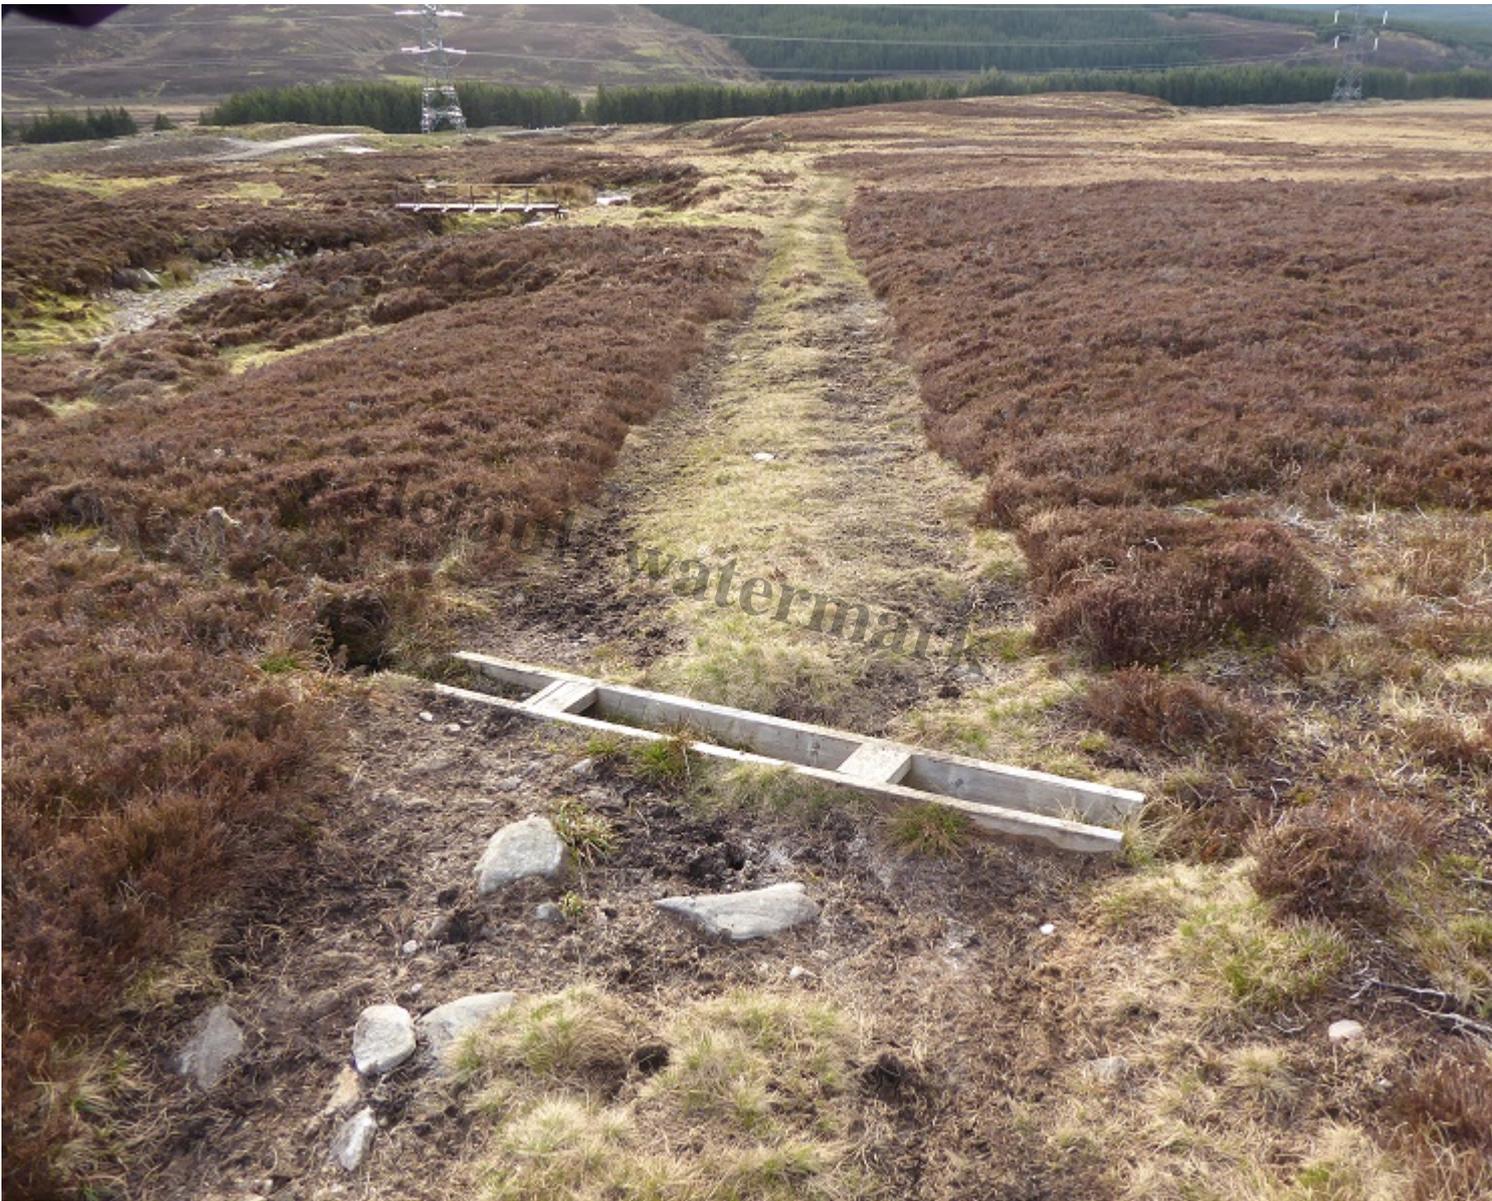
The track that has been developed along the line of grouse butts on the north side of the Allt Coire nan Cisteachan. The installation of a water bar means, I believe, that this counts as a constructed track and should have had full planning permission – its purpose, along the line of grouse butts is only too clear and has nothing to do with agriculture (where developments only require –prior notification–).

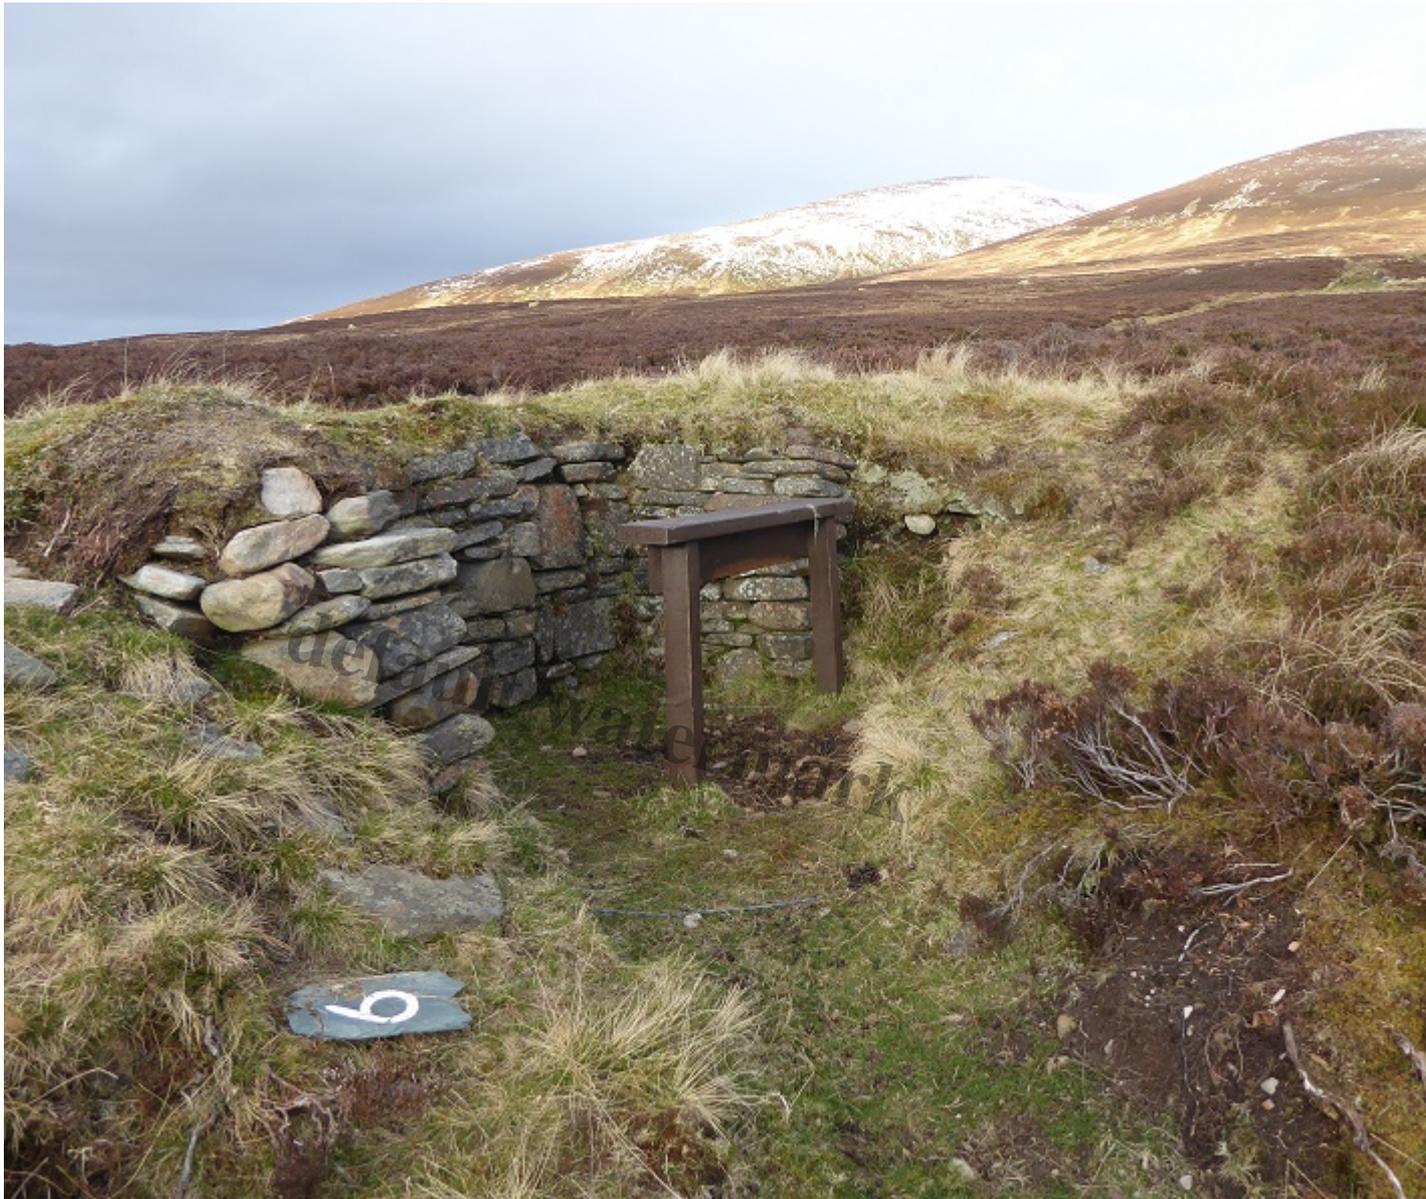
The track, as you can see far right, runs up in front of the grouse butts

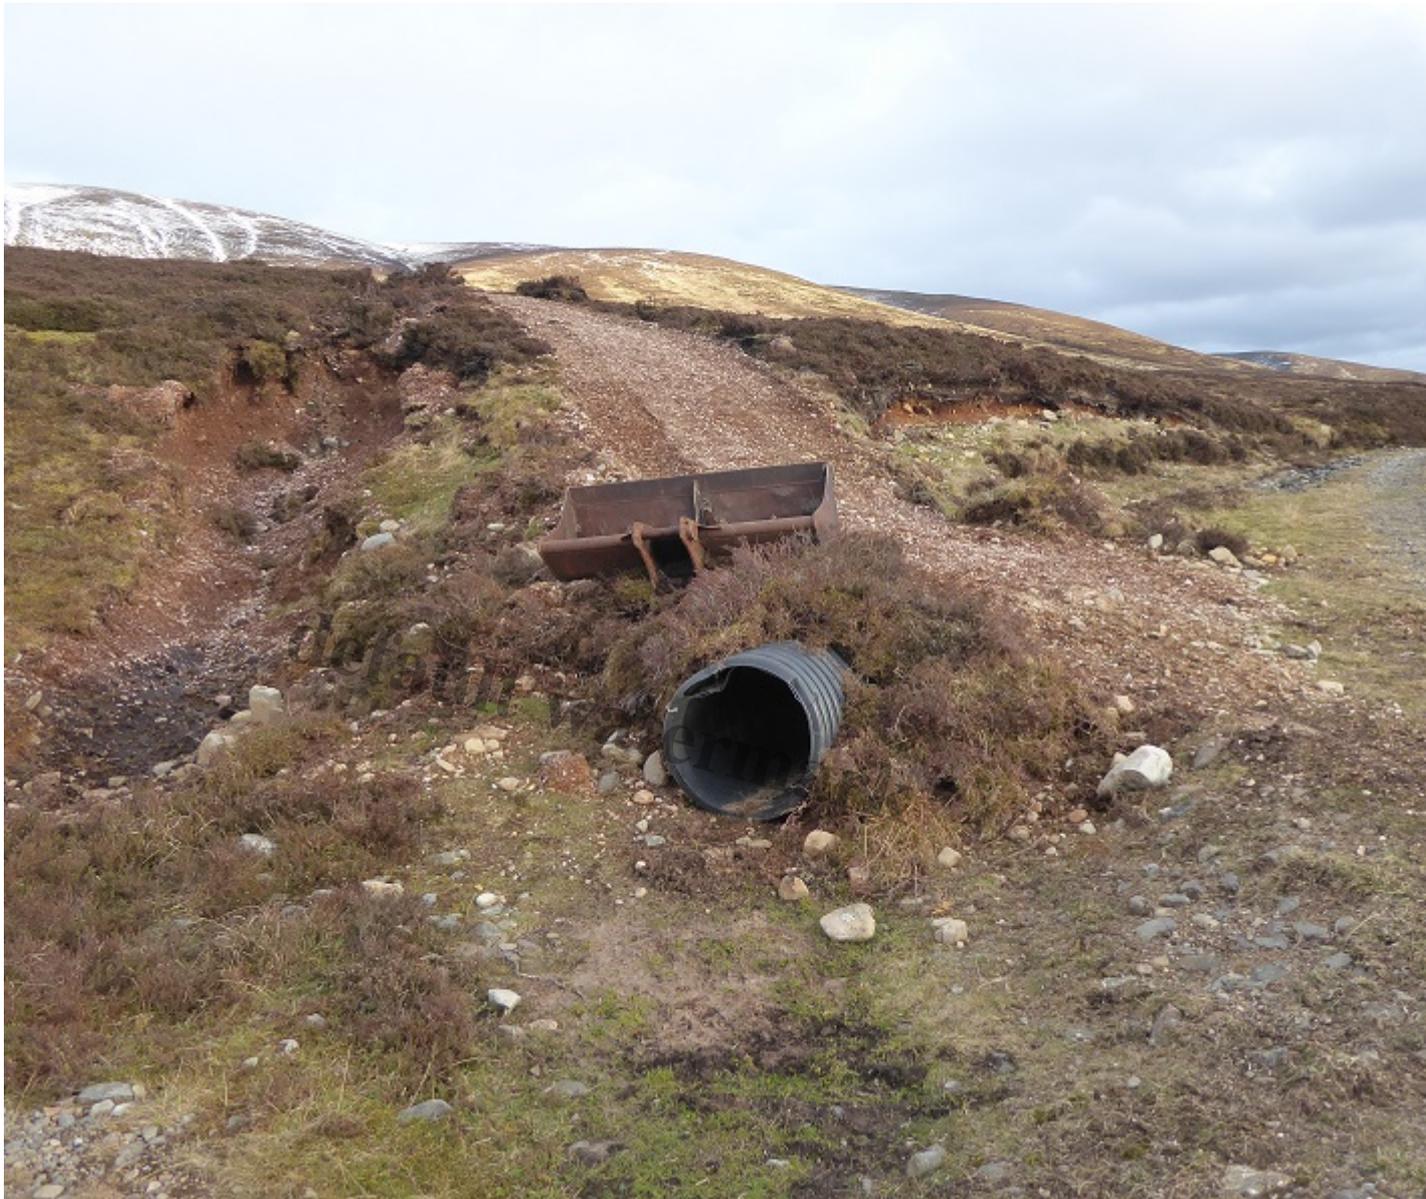
New track, running up south side of Allt Coire na Cisteachan and branching off track used by many v
access A Bhuidheanach

The constructed nature of the track on the south side of the burn is even more obvious and to an appalling standard (I will report it to the National Park). Although the newly “constructed” section is short, its intention is clearly to enable vehicle access up the hillside easier and yet more scars on the Drumochter.

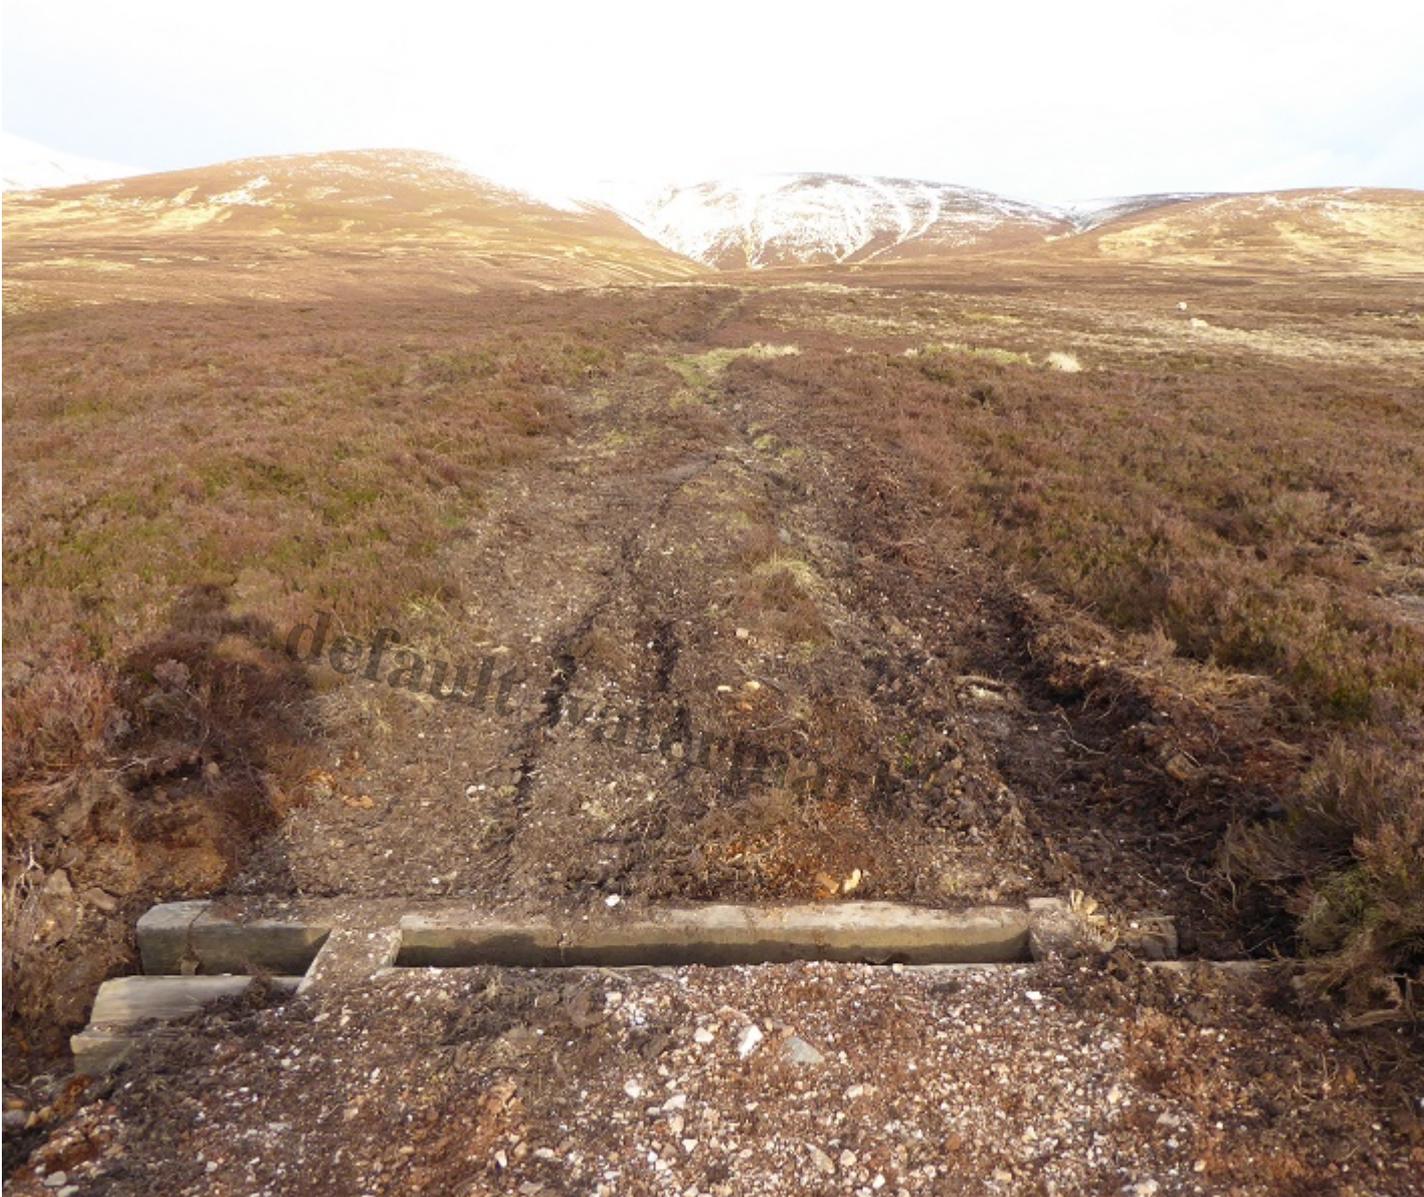
End of the 20m section of track showing erosion created beyond
